INSPECTION REPORT

Address: 310 Forestgate Ct. Sandy Springs, GA 30350

Inspection Date: 5-15-2026

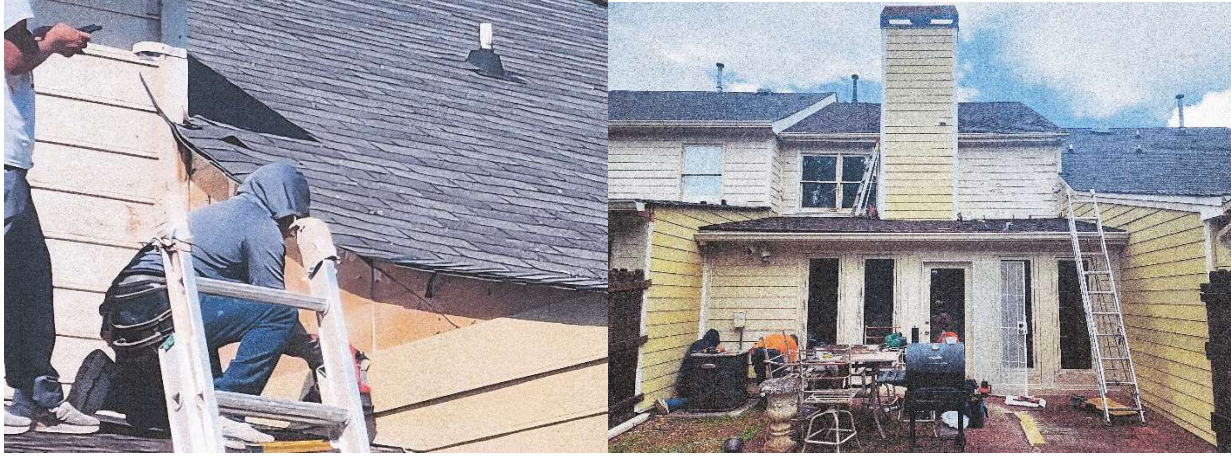
1. A section of the siding was lifted at the face side of the chimney and the inspector could not see a vapor retarder or house rap in place. Building code states if siding is replaced on a home that had only asphalt impregnated fiber board for the sheathing, it shall be wrapped with house wrap or a vapor retarder. IRC code R703.2
2. The cement fiber siding that was installed at the chimney and right-side wall is close to or in contact with the roof shingles. James Hardie and most cement fiber manufacturers says if their siding is installed without an air gap (a minimum of two inches) above the shingles, it will void the warranty (can absorb water). It is advised to have an air gap of two inches at all cellulose and or wood siding materials and roofs.
