PROPERTY INSPECTION REPORT

1237 Lucile Ave. Atlanta, GA.

Sep 4, 2021

1801

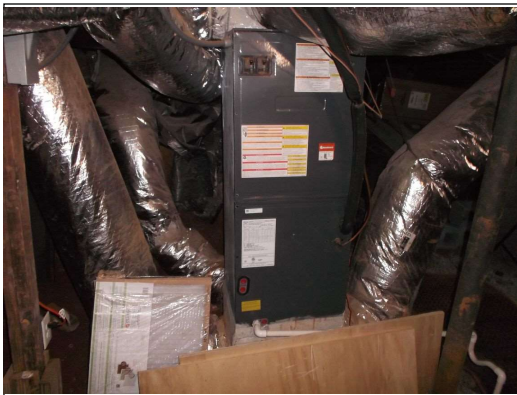
Heating Pictures

Seller verify the bottom of the furnace or the duct box is not resting on the soil at no areas. It is advised to have the air ducts professionally cleaned.
