Property Inspection Report

199 West Broad Street Monroe, GA.

Inspection Date:

March 17, 2020

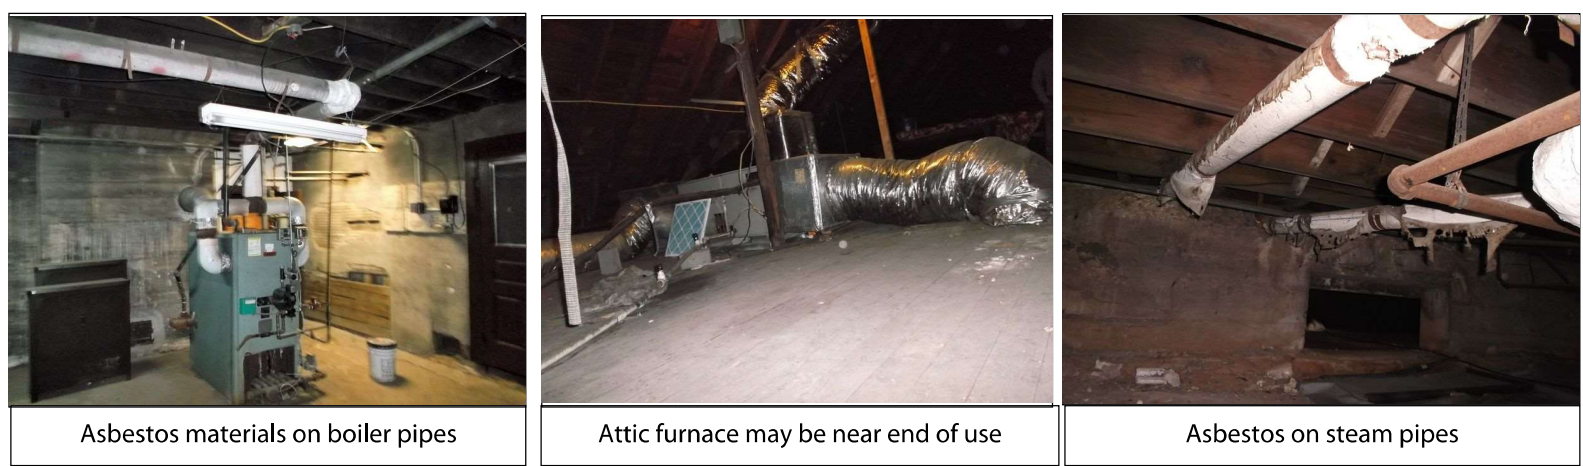
Heating Pictures

Maintenance:
 Furnace in the basement has defective components in the controls area; one furnace appears to be aging and may need ongoing service and repairs; boiler furnace in the basement has cracked heat exchanger, water leaks at the fill tank pipe, pipes are galvanized metal and nearing end of use and some pipes are rusting; missing refrigerant line insulation near the heat pump in the out house attic;
