# PROPERTY INSPECTION REPORT

203 Saint Nicholas Cir. Sandy Springs, GA. 30327

Mar 10, 2021

1599

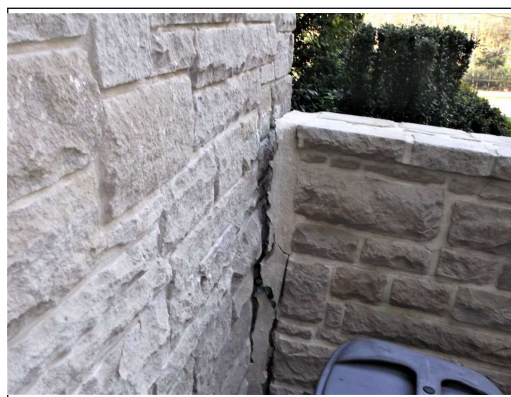
Wall detaching at side of house

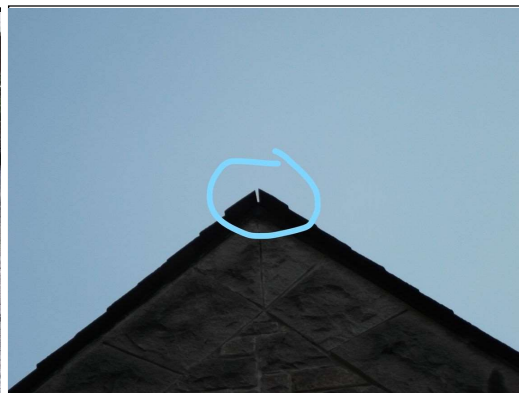
Split in slate shingle above garage gable

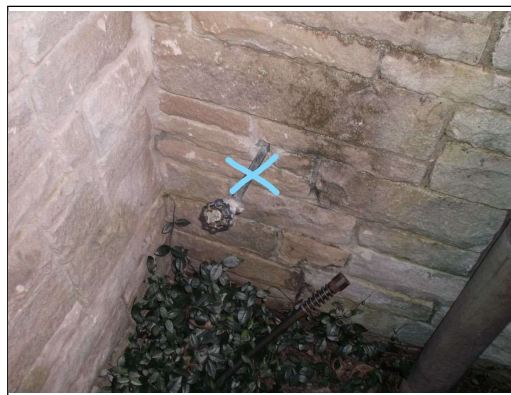
Hose faucet pipe too far out wall

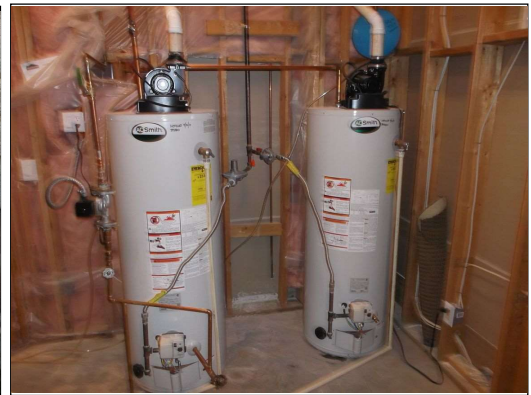
Copper and steel water pipe join above the water heaters without dielectric fittings can cause corrosion at pipe joints; could not locate a sediment trap in the gas pipe leading to the pool water heater at the rear yard (verify);

Copper & steel pipe join above water heaters

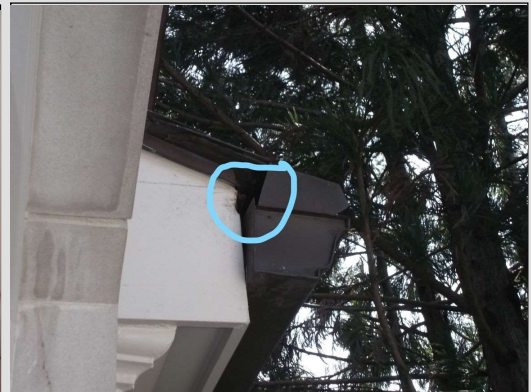
Hole in fascia seen from front bed window

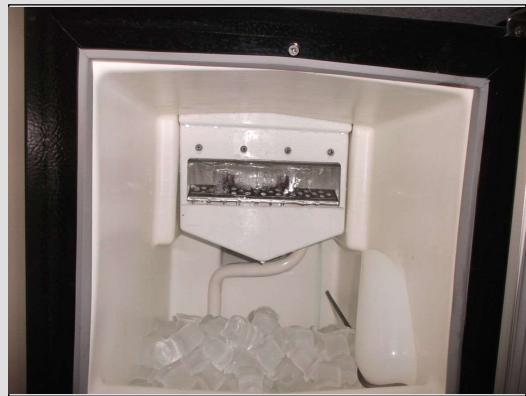
Water kept flowing into the bar icemaker

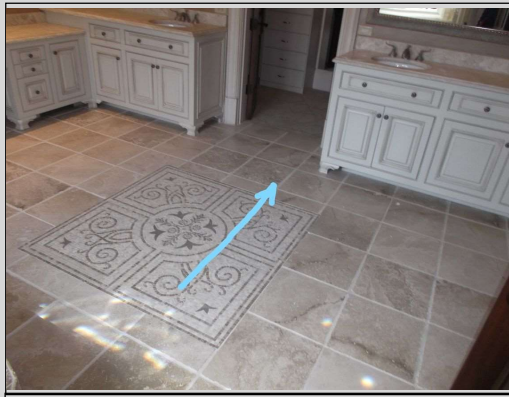
2nd Floor Master Bath; This bathroom mirrors master bath below, just different design elements. The floor system is settling towards the sink wall in same place the same way. These areas appears to be over the right side of the house. The type of floor joists used in this construction are called floor trusses. It has been found that these floor joist can sag and move.

Floor slopes to sink wall
