# PROPERTY INSPECTION REPORT

25 Rosemont Parkway, Covington, GA.

**Inspection Date:**

Oct 26, 2021

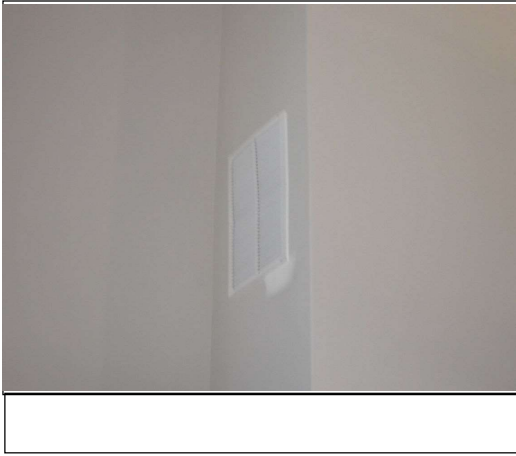
# Heating Pictures

The air return register grill on the wall in the great room to the right of the fireplace wall cabinet is bent or not properly flush to the wall.
