PROPERTY INSPECTION REPORT

3951 Glenhurst Dr. Smyrna, GA.

Oct 23, 2021

1599

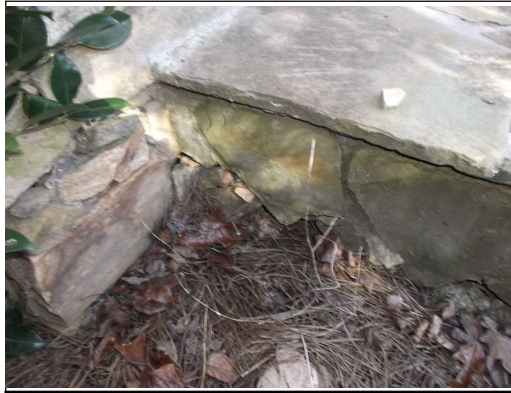
Front porch floor has loose stone on the left, soil erosion underneath, stones have had mortar repair and replacement (verify garage downspout is properly routed onto the driveway).

Soil erosion under front porch floor

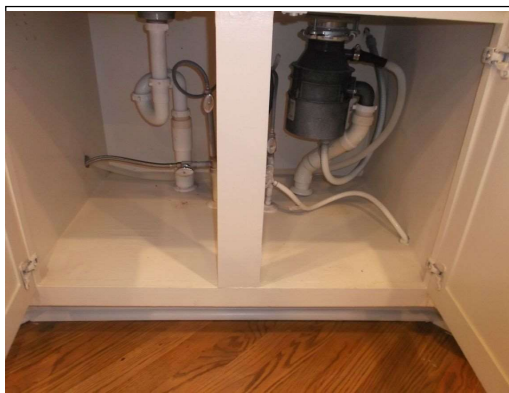
S-Trap and no trap at kitchen sink pipes
