PROPERTY INSPECTION REPORT

1802 Walker Ave. College Park, GA.

Sep 27, 2021

1599

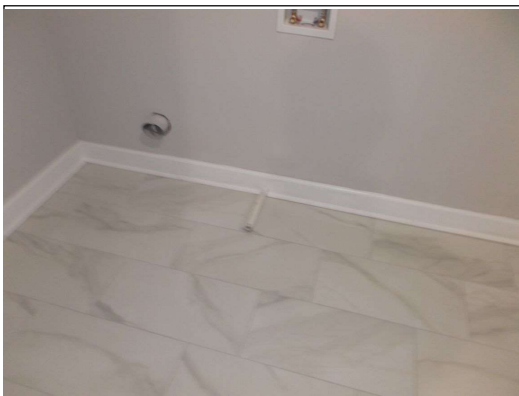
Laundry Pictures

Missing washer drain pan; door to the laundry room bump door frame. Verify dryer properly vented to the outside.
