Home Inspection Report

PROPERTY INSPECTED:
2925 Nantwich Lane
Saint Charles, MO 63301

Date of Inspection: 08/25/2025

Inspection No. 55661-4-26088

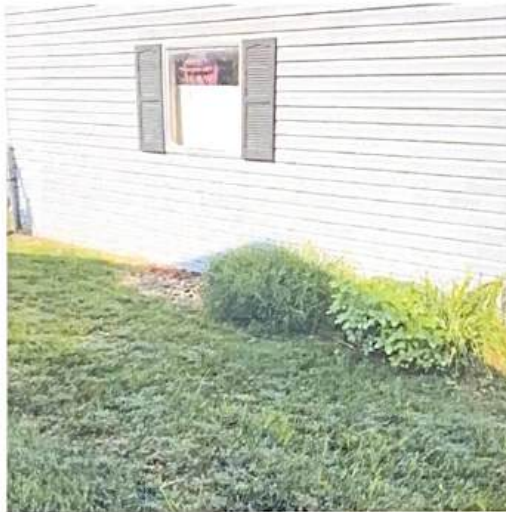
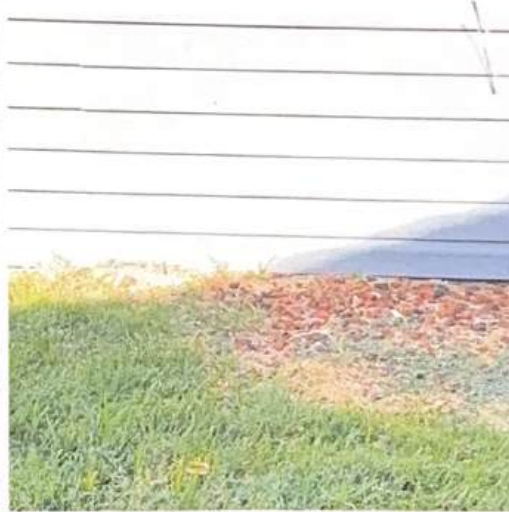
2.3.1 Lower the height of the flower beds and/ or soil where needed to below the bottom of the finished materials to limit moisture and/or insect related damage. **(Exterior Left)**

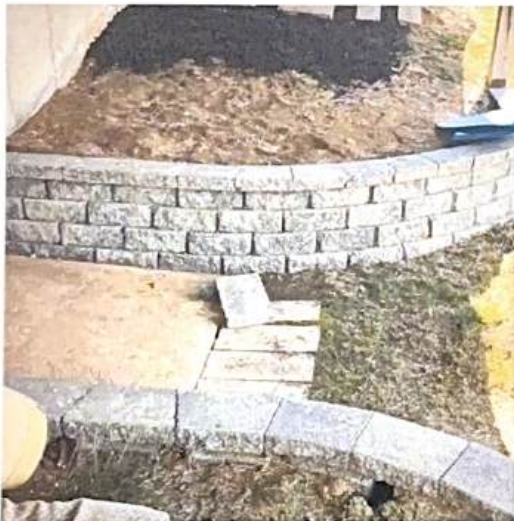
2.6.3 Retaining walls are showing signs of normal age and wear and appears to be performing as intended. Monitor retaining wall for signs of settlement or movement and repair as need to maintain intended soil retention. (Exterior Back)

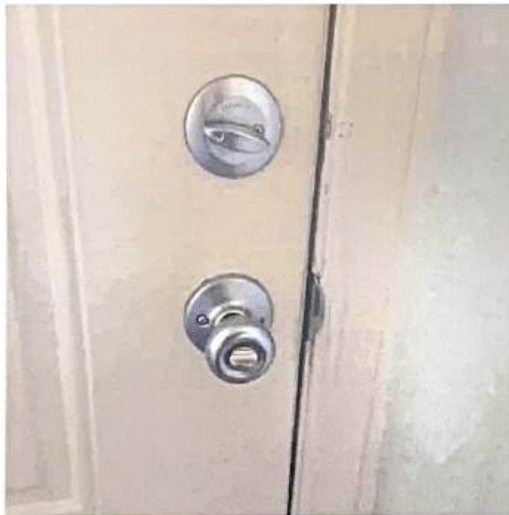
3.7.2 The door deadbolt does not line up and latch. Adjust door, hinges, and/or strike plates as needed to ensure proper operation (latch and lock) of all doors. (Exterior Front)

~~X~~ Adjusted and secured
striker plate. Door now
operating properly.

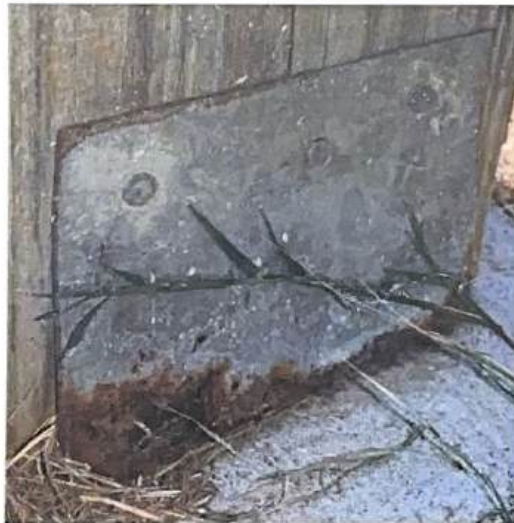
3.9.1 Corrosion observed/ improper installation at select base plates for the support posts. Recommend replacement as needed by a qualified contractor of the damaged base plate to ensure proper support. (Exterior Back)

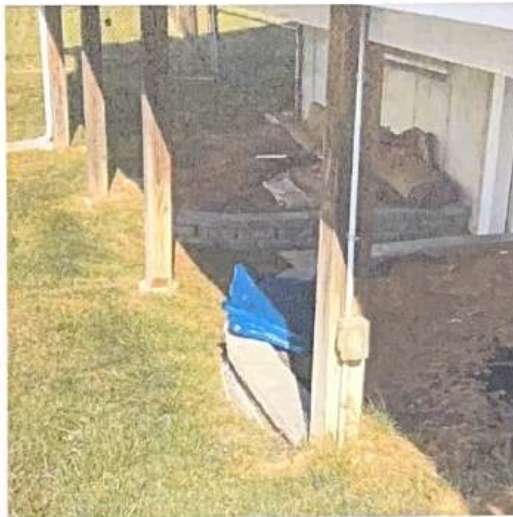
3.9.2 Deck posts are in contact with the ground. This could cause premature deterioration of the wood posts. Monitor for future deterioration and correct as needed. **(Exterior Back)**

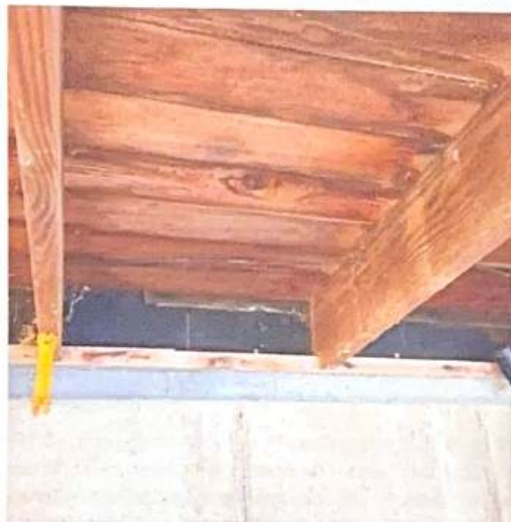
3.9.4 No visible signs of deck flashing which is a common omission in this area. Flashing helps to limit any potential moisture related entry at the deck area into the home. No visible damage noted at the time of the inspection but moisture related activity could still be present.

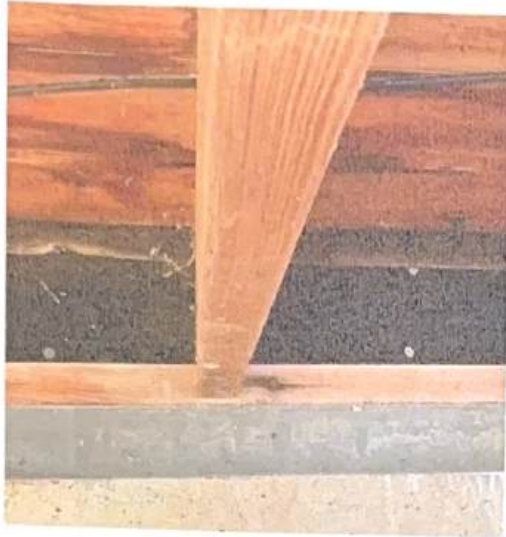
3.9.5 Ledger board was not entirely visible due to the felt paper. Consider adding additional ledger board bolts to the structure to ensure proper support. (Exterior Back)

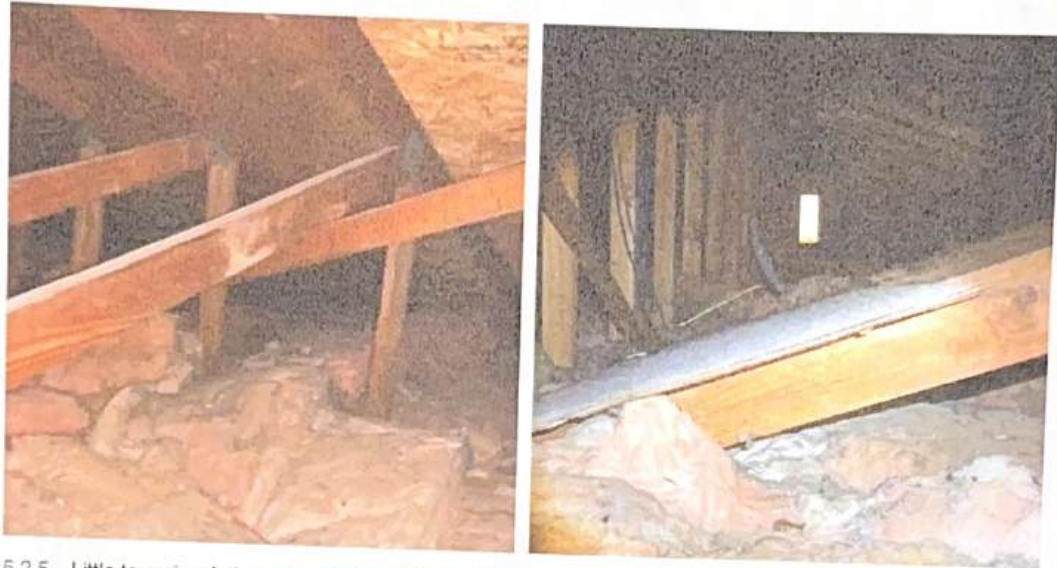
5.2.4 View of Insulation.

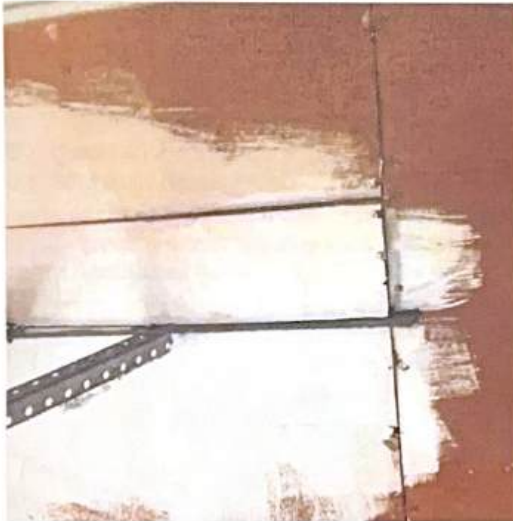
6.7.1 Damaged, loose or open panels on the ceiling with open seams noted at the garage ceiling. Recommend repair to provide proper fire barrier protection. (Garage)

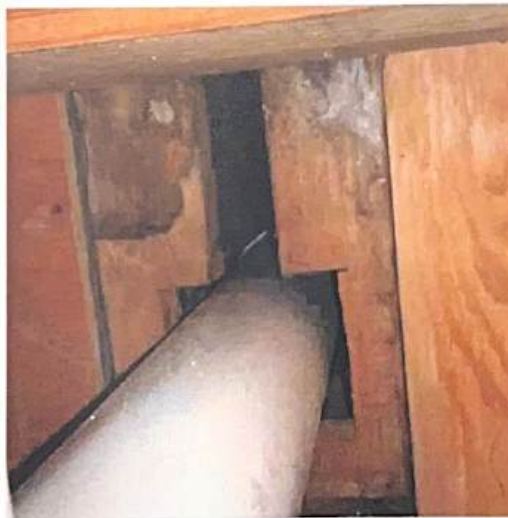
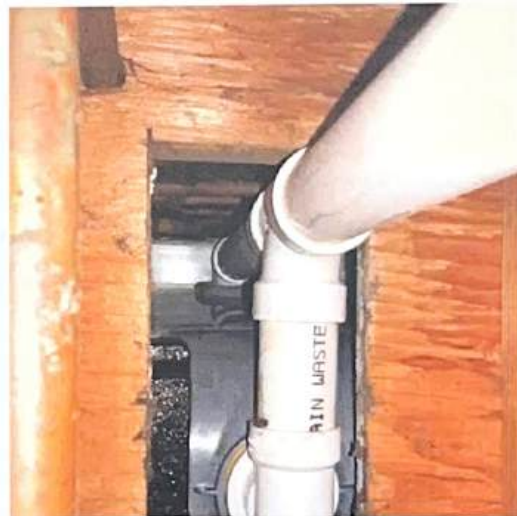
7.4.1 **No Fire Stop** around openings in the sub floor around plumbing penetrations. Recommend installation of a proper fire stop around all penetrations to limit the risk of fire spreading through this cavity. (Unfinished basement)

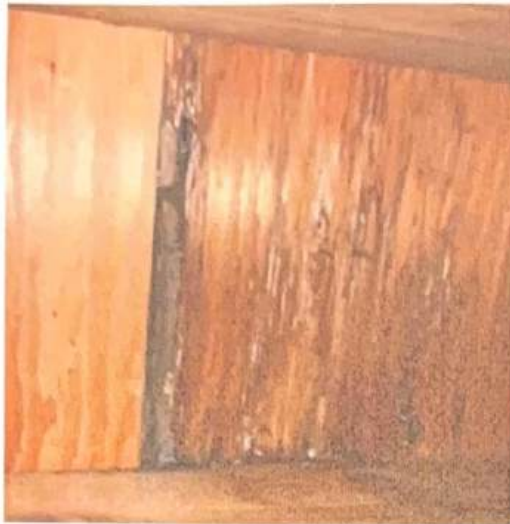
7.4.2 Several areas of staining from previous leaking noted in sub floor below bathrooms. This is very common in a building this age. Monitor for additional activity and repair as needed. (Unfinished basement)

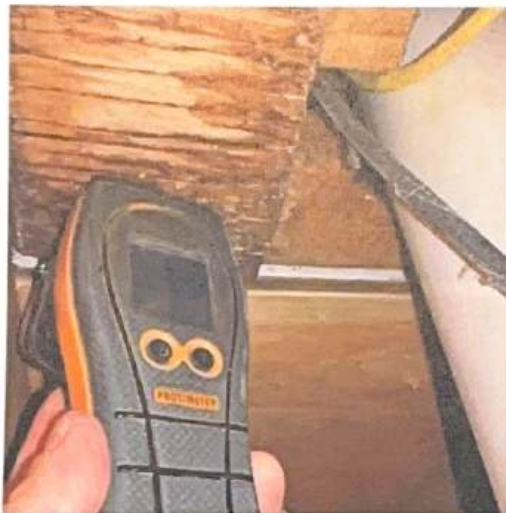
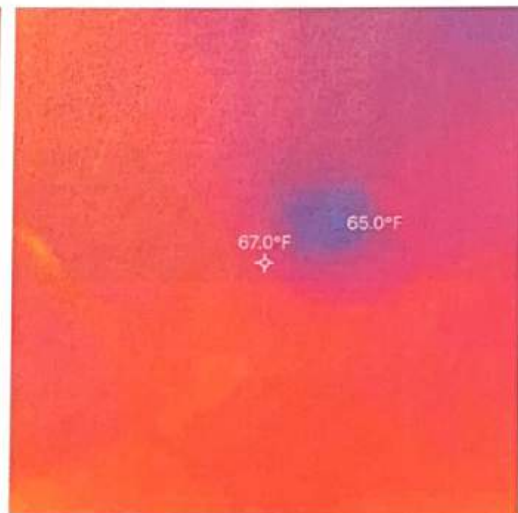
7.4.3 Staining from moisture activity noted. These areas were tested with a moisture meter and found to contain elevated moisture levels at the time of inspection. I suspect it to be related to loose toilet in the hall bathroom and something with primary shower. Recommend further evaluation and repair as needed by a qualified contractor to prevent continuing moisture entry and related damages. (Unfinished basement)

Shower leak identified in primary bathroom. Edges of shower professionally caulked and no further dampness or moisture has been observed since repair.

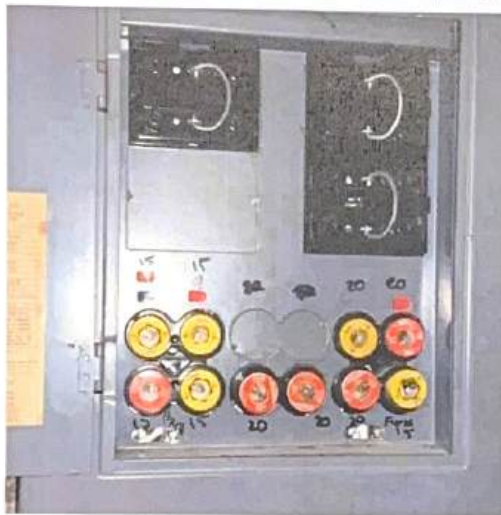
8.4.1 The presence of glass/screw type fuses alone is not a reason for concern. In many ways, these fuses are more sensitive and more reliable than a breaker. The hazards associated with fuses largely related to over-fusing or by-passing and were due to limited capacity (e.g. 60 Amp service). **(Laundry area)**

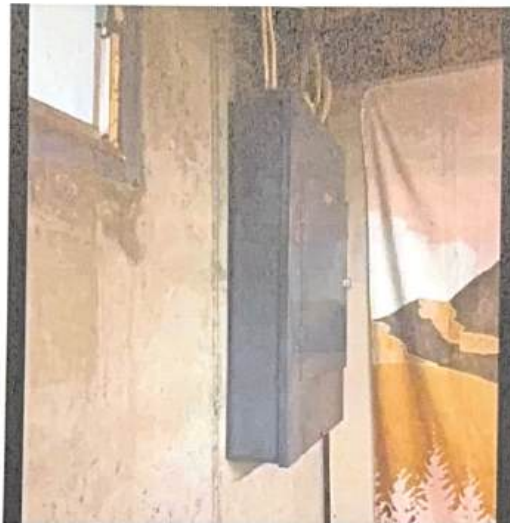
→ 8.4.3 Electrical subpanel is improperly attached to the wall and is loose to the wall. Recommend properly securing to ensure safe and proper function. (Laundry area)

Licensed electrician has properly secured subpanel. see report.

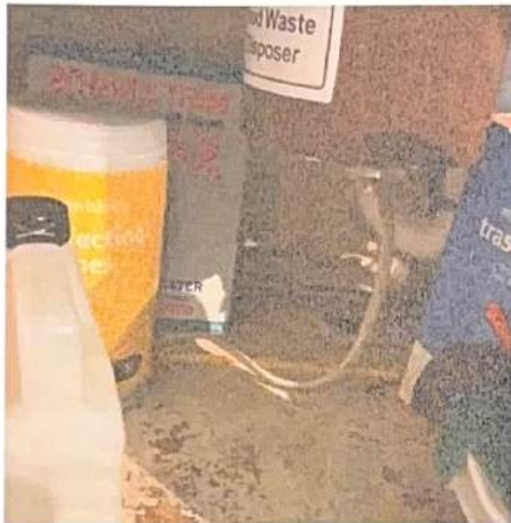
8.5.1 Kitchen cabinetry has exposed/unprotected wiring. Recommend adding conduit to reduce hazards associated with unprotected wiring. (Kitchen)

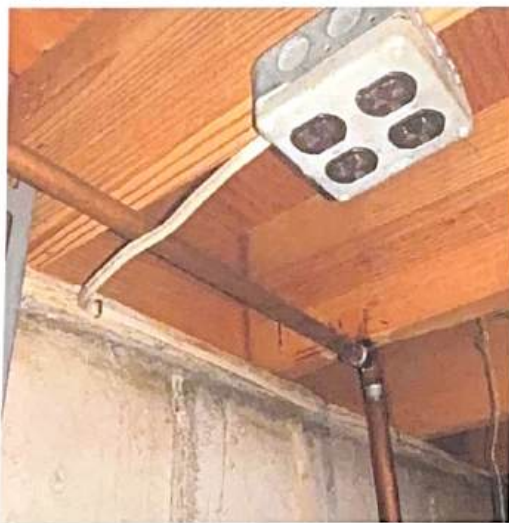
8.5.2 Unprotected wiring noted. Recommend providing conduit to reduce hazards associated with unprotected wiring. (Utility Room)

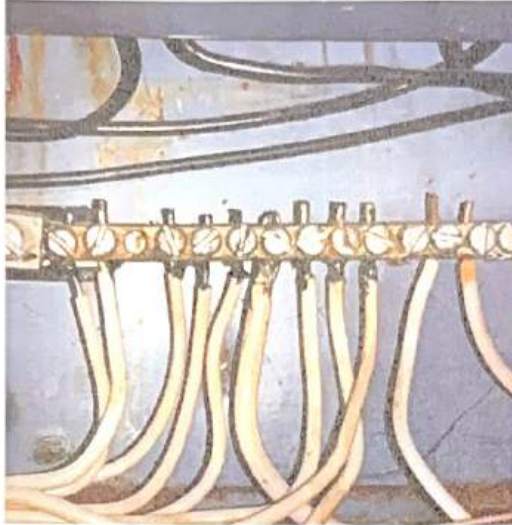
→ 8.5.3 House has a mix of copper and aluminum wiring present. It is only present in the original panel which is now the sub panel and most likely select 1st floor receptacles, switches and lights. While both materials are commonly used in residential electrical systems, it is crucial to ensure that proper connections and compatibility measures are in place to mitigate the risk of corrosion or potential fire hazards. Consult a qualified electrician to establish a routine maintenance schedule to maintain connections.

Licensed electrician evaluated home and completed recommended repairs. See report.

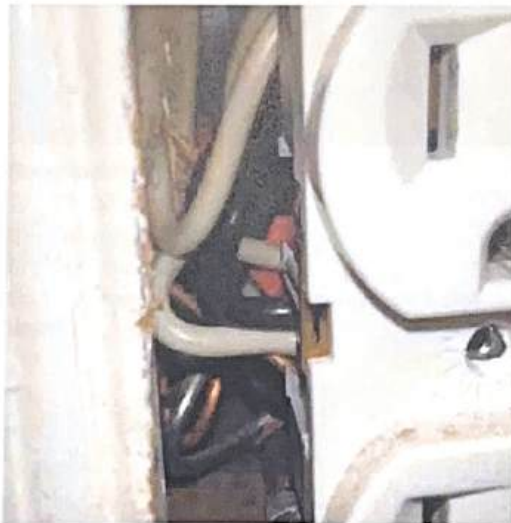
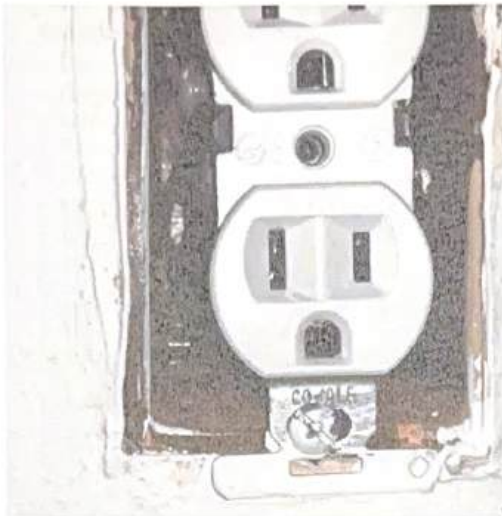
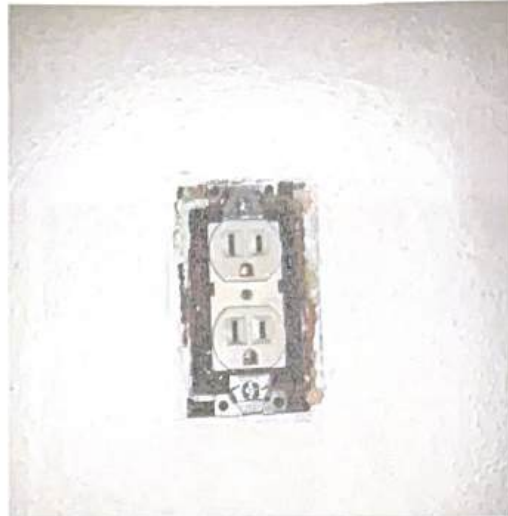
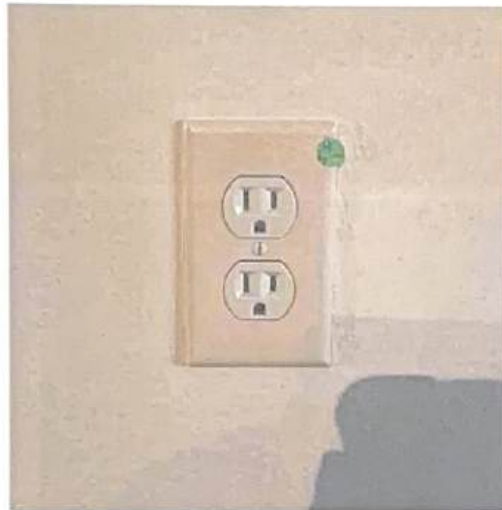
→ 8.5.4 Original branch circuit in the home is serviced by Aluminum Wiring and it appears that some receptacles and switches have been changed. For example, Dining room receptacle and kitchen wall marked with a green sticker was not CO/ALR stamped and/ or have a proper Alumicon connector, but are done correctly. Not all were inspected and for that reason, I recommend further evaluation of the branch circuit wiring (receptacles, switches and lighting) with correction only as necessary by a qualified electrical contractor to limit potential hazards.

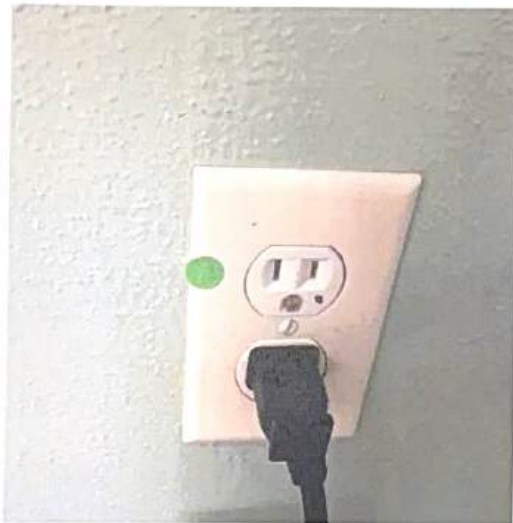
8.6.4 Damaged receptacle noted. Ground pin stuck. Recommend replacement by a qualified contractor to promote safe operation. (Primary Bedroom)

All electrical repairs completed as recommended. See report

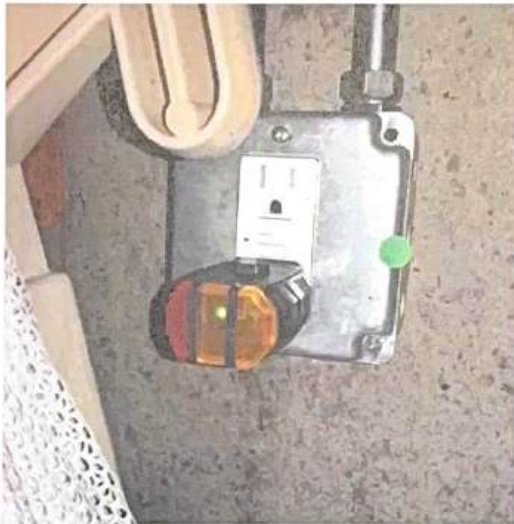
8.6.6 Open ground noted at receptacle marked with a green sticker. Recommend correction by a qualified contractor to ensure proper ground protection. (Utility Room)

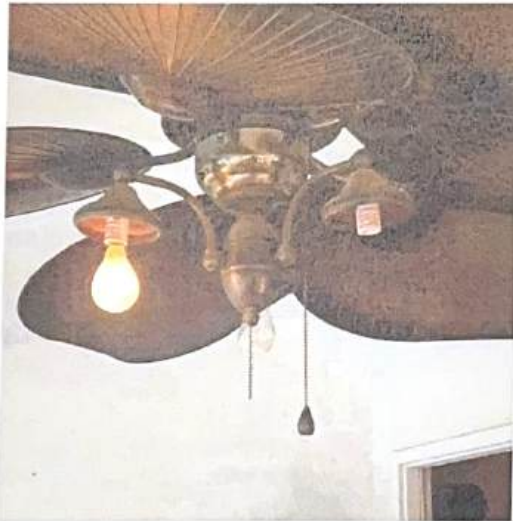
8.7.2 Missing bulb covers noted at ceiling fan. Recommend replacement to limit the risk of future damage and related hazards.

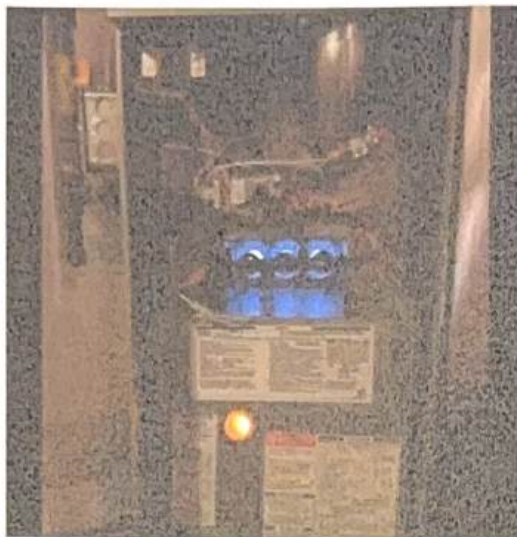
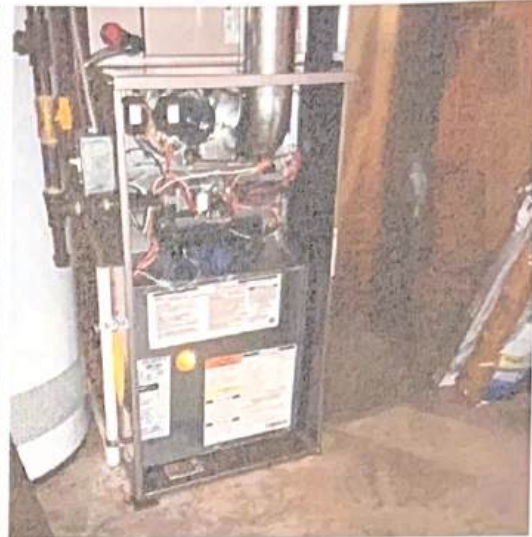
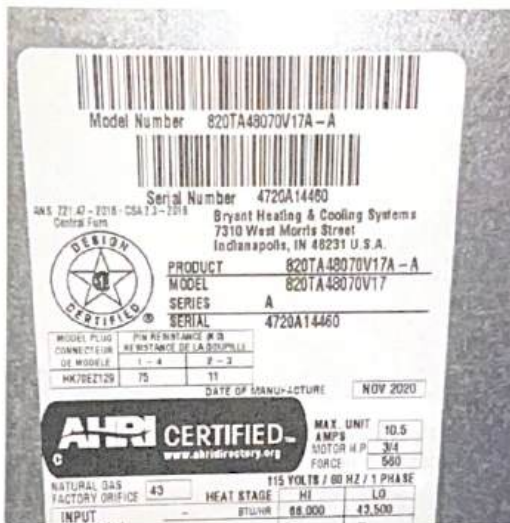
9.5.4 Furnace is from 2020 (Utility Room)

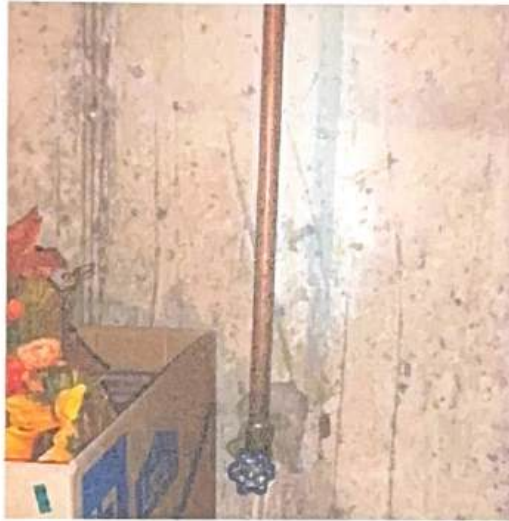
10.2.2 View of the Water Main (Utility Room)

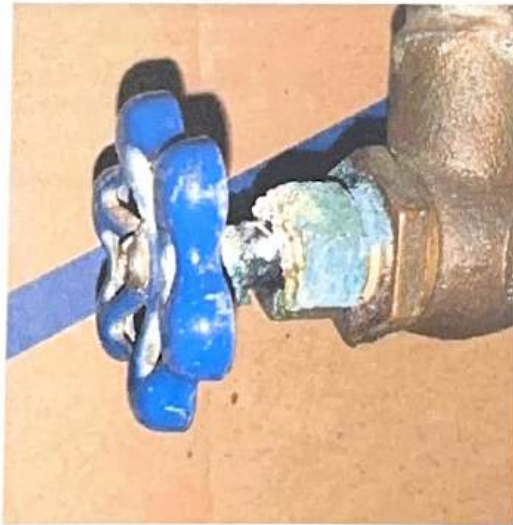
10.2.3 Main water shut off valve has seepage leak at the time of the inspection. Recommend repair by a qualified plumbing contractor. (Utility Room)

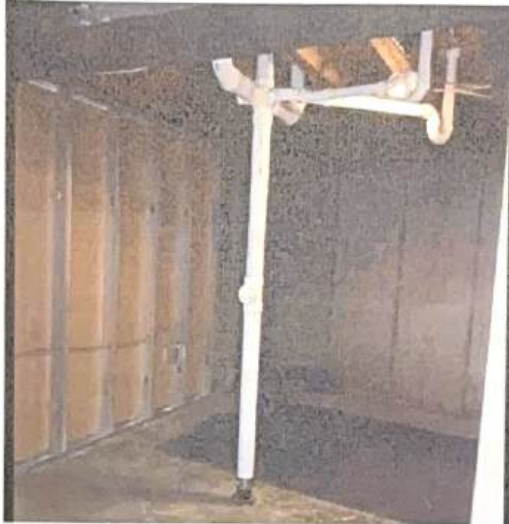
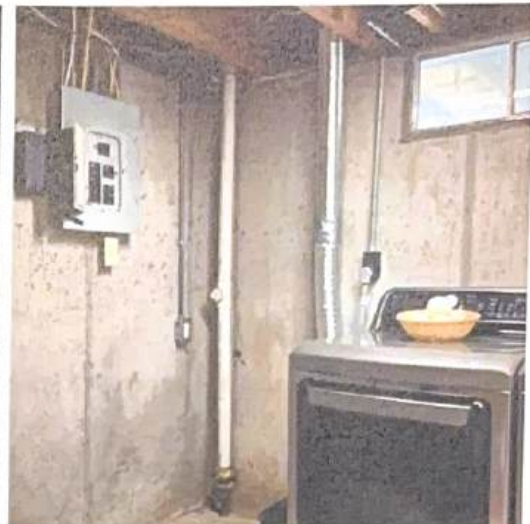
10.4.2 View of updated PVC waste stacks.

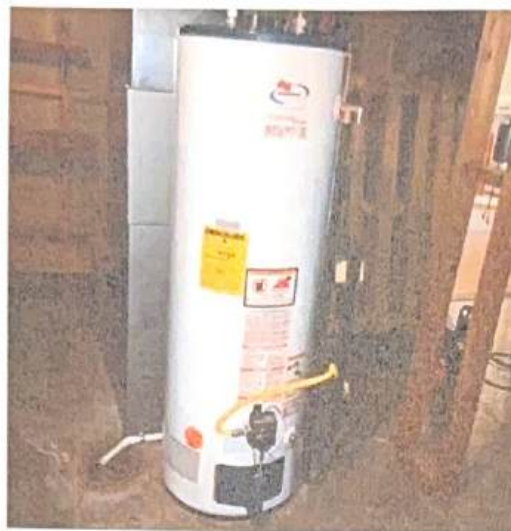
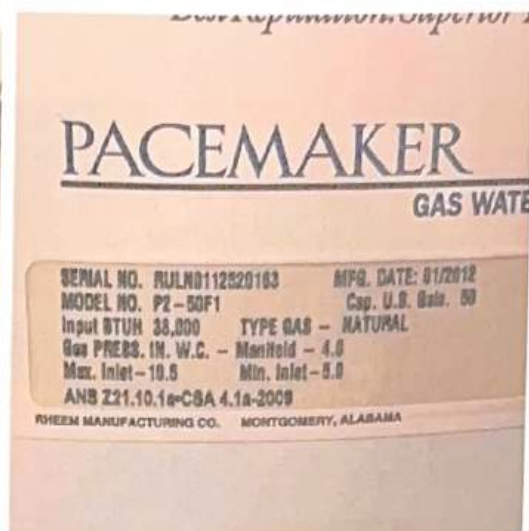
10.5.4 View of Water Heater (Utility Room)

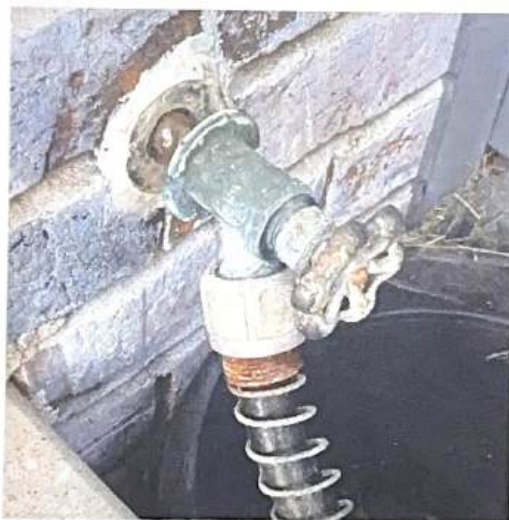
10.7.2 Secure loose faucet to the exterior of the house to limit the risk of future damage to the plumbing and related issues. (Exterior Front)

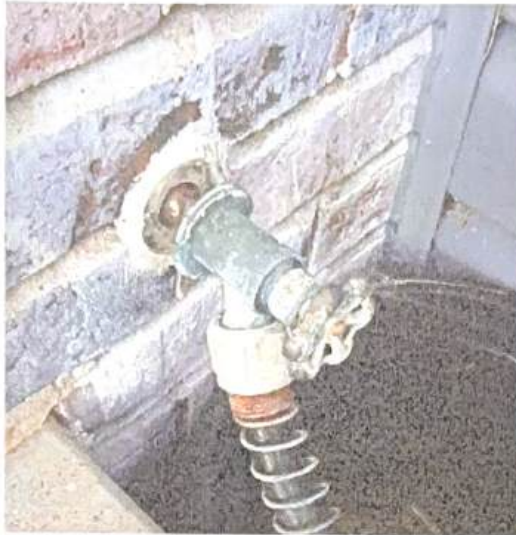
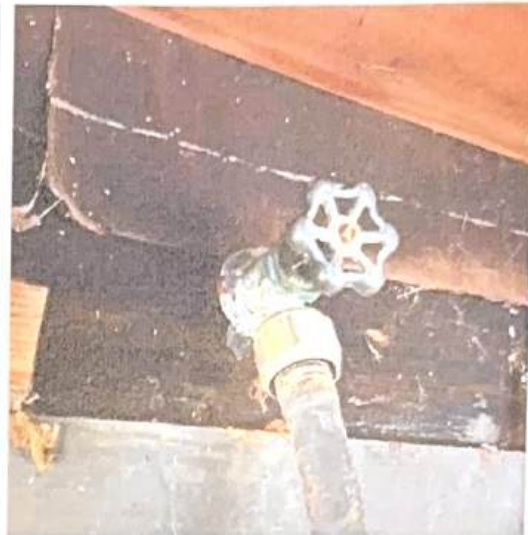
- Exterior Back
- Exterior Front

10.7.3 Consider installation of frost free, anti-siphon hose faucets to limit risk of damage associated with freezing pipe and contamination of potable water.

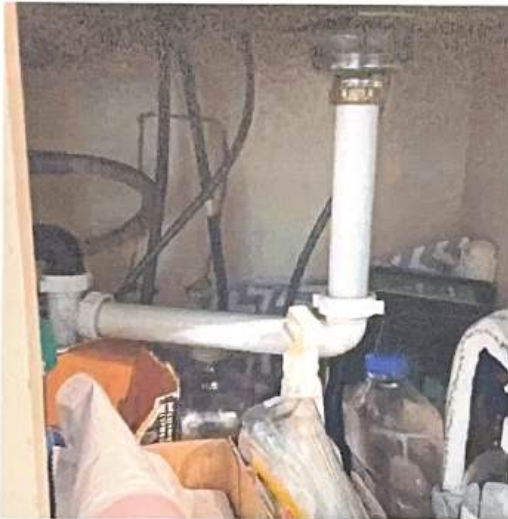
10.8.1 Waste pipe under the sink is level / slopes slightly uphill which can be prone to blockages and/or leaks. Recommend correction to ensure proper drainage. (Kitchen)

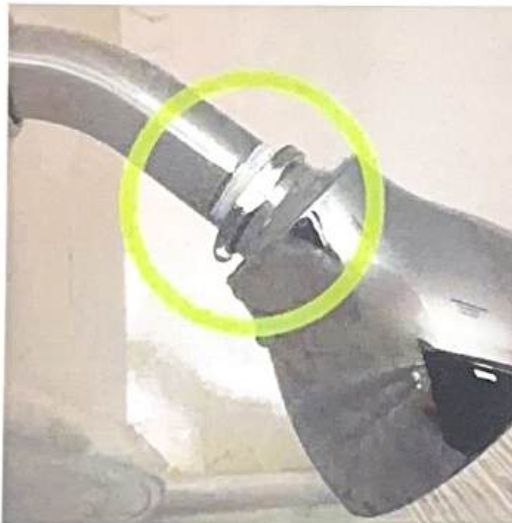
10.10.2 Shower head is leaking at the stem connection. Recommend repair by a qualified contractor to limit further leaks and related damage. (1st Floor Hall Bathroom)

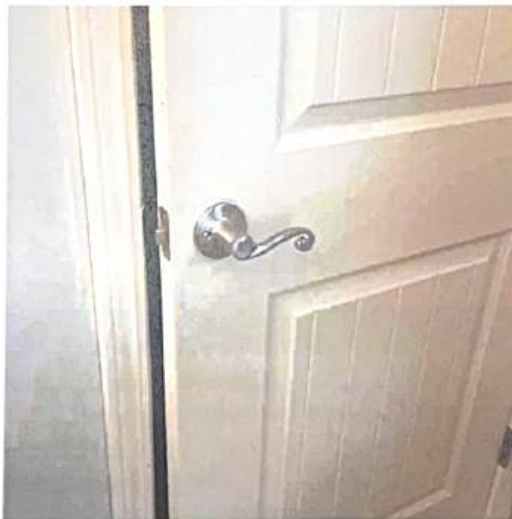
11.5.2 The door does not line up and latch. Adjust door, hinges, and/or strike plates as needed to ensure proper operation (latch and lock) of all doors. (Middle bedroom)
