BUILDING SURVEY

**House
The Lane
Town
County
Postcode**

1. INTRODUCTION

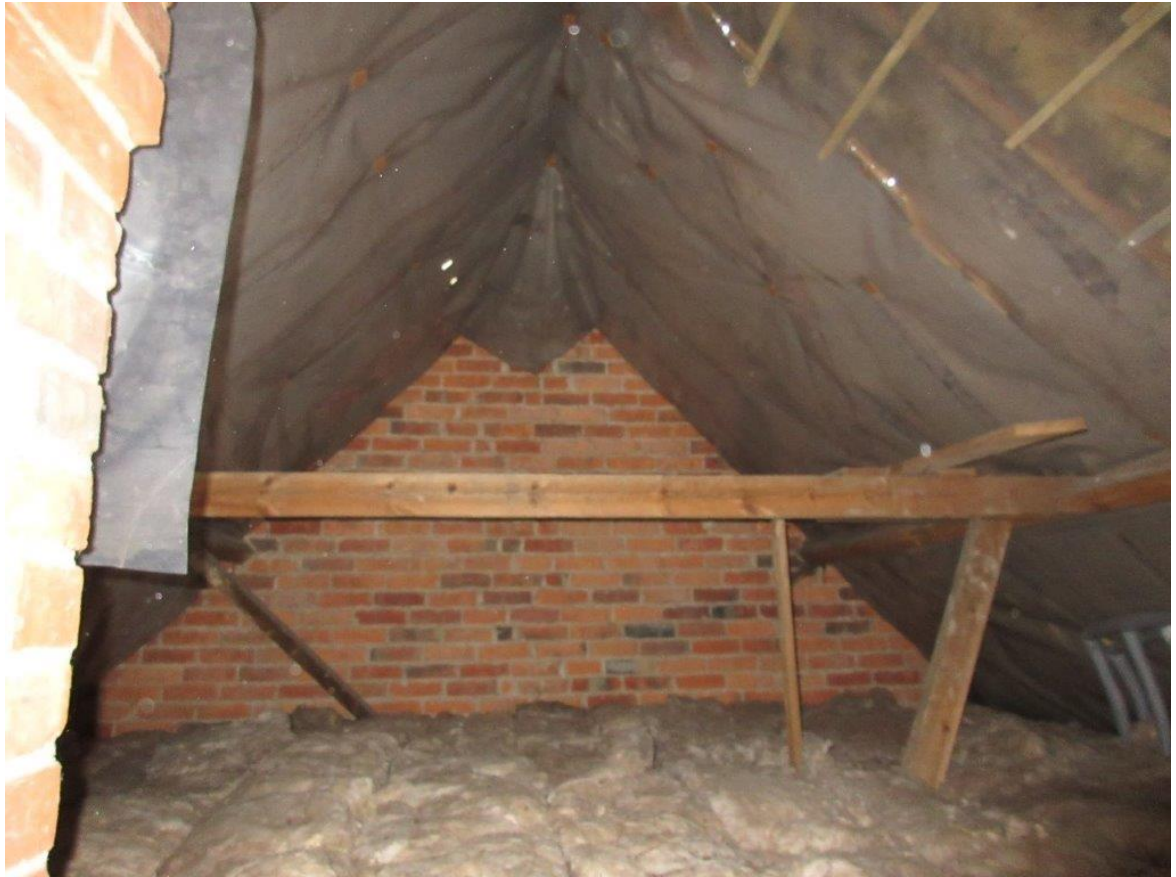
ROOF SPACE

From ground level observation no distortion to the roof slopes was noted, but my internal inspection confirmed that the original roof has no felt to the underside of the tiles as a secondary protection against damp penetration and, as a result, some dampness is inevitable during periods of driving rain and snow. This could only be alleviated by the complete stripping and re-covering of the roof which would enable felt to be provided.

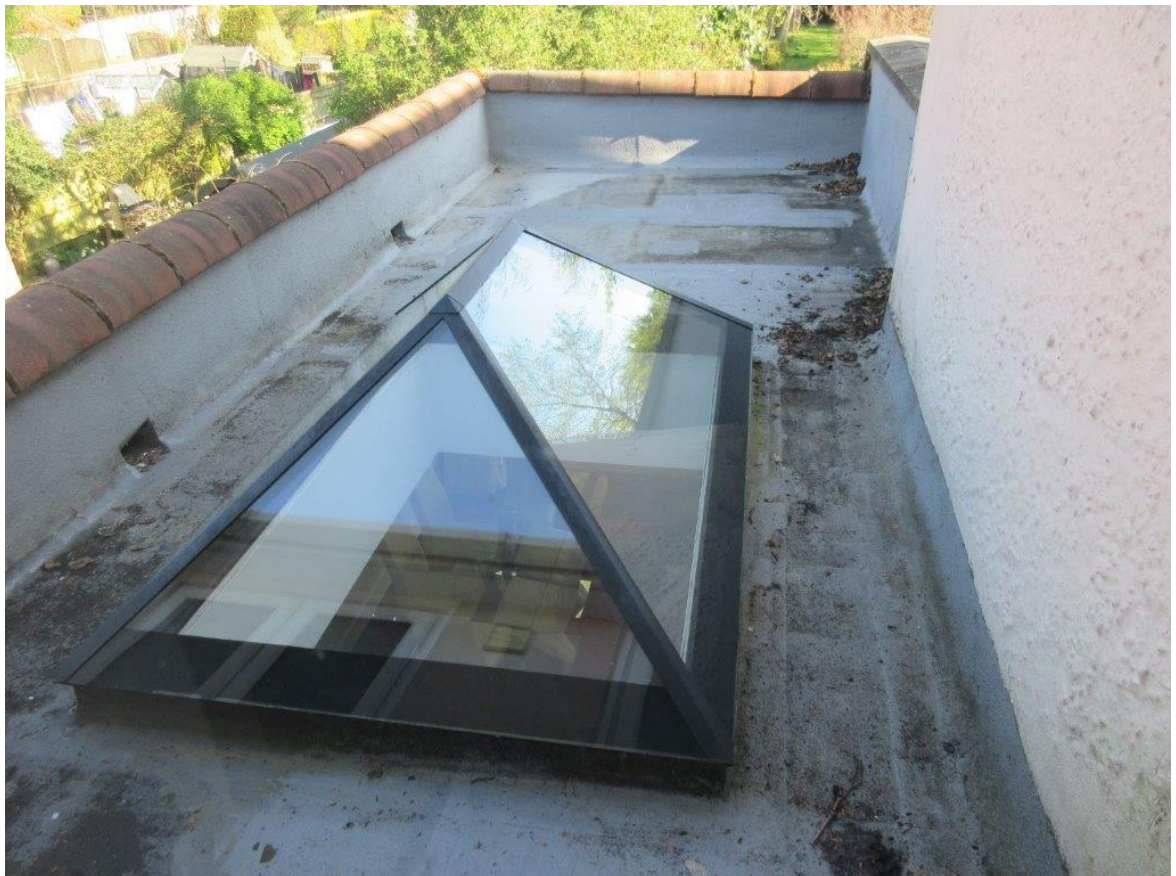
ROOF TO EXTENSION

The roofs appear to be in good condition with only a few damaged tiles requiring replacement, although hip to tiles to the extension require re-bedding in sand and cement mortar. It could not be confirmed whether this extension roof has been felted, as no access was available.

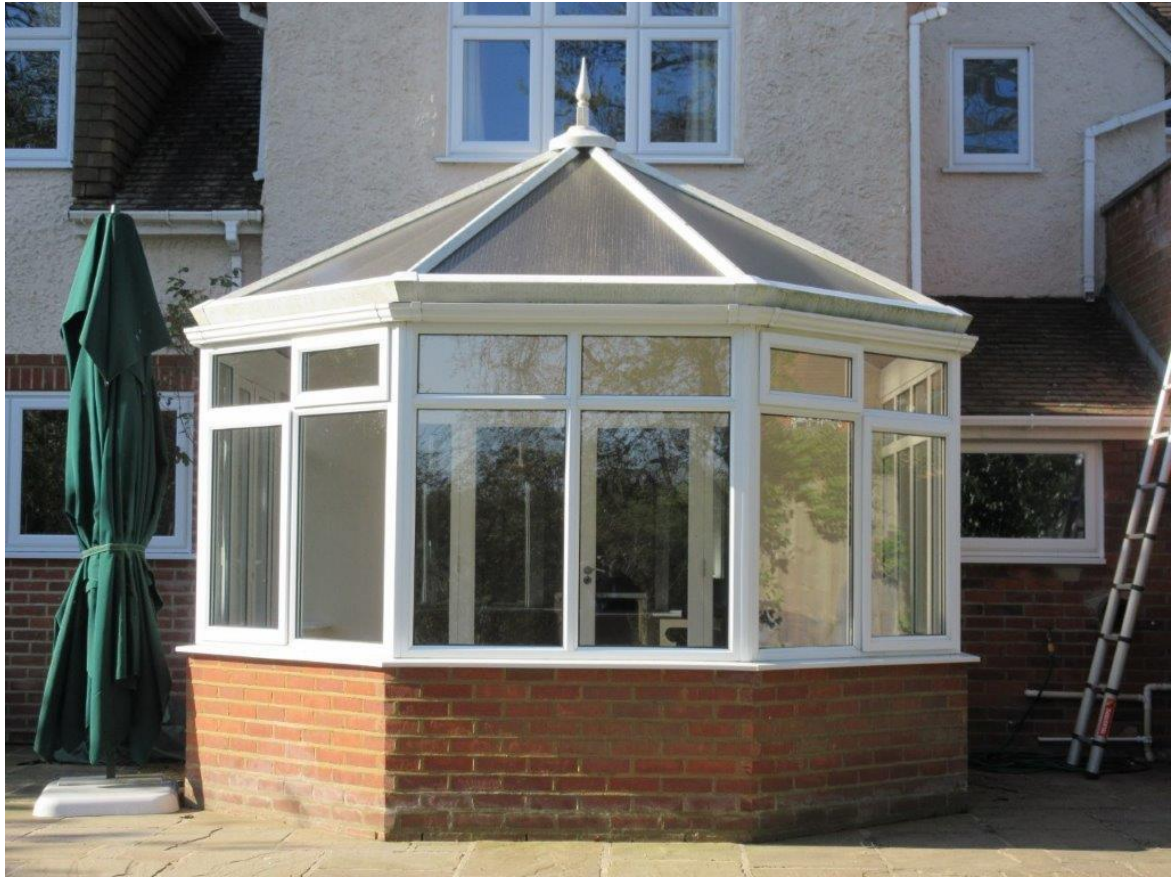
CONSERVATORY

There are double wooden doors within the conservatory, also in satisfactory condition.
