# Right Way Home Inspectors

## Inspection Report

Inspected on Mon, Mar 16 2026 at 11:30AM

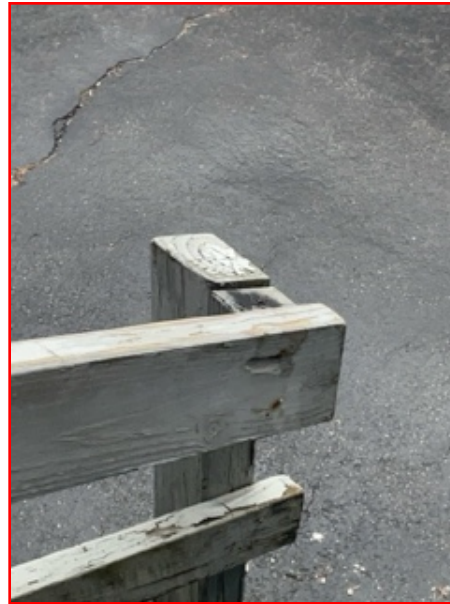
Figure 12-2

1) Safety issue : Floor joist of the rear deck appeared to be broken and was moving under foot, causing deck boards to be unsupported.

Railings of both decks were damaged and loose.

Further evaluation by a qualified contractor is needed for repairs or replacement.

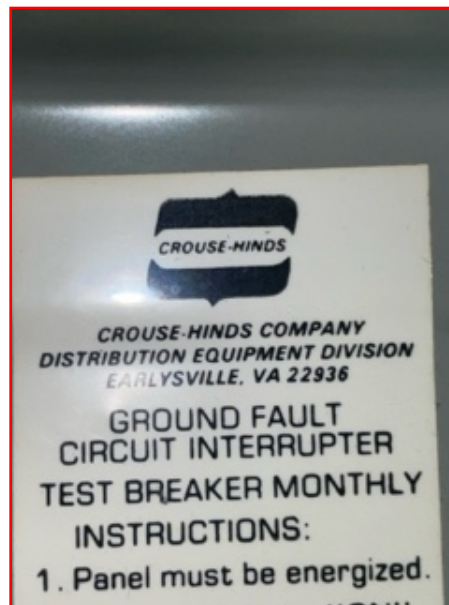
Figure 83-2

2) MARGINAL- The electrical panel appears to be an older Crouse-Hinds model, likely installed several decades ago. While no immediate defects may be visible, the panel and breakers are considered obsolete and may not meet current performance expectations. Replacement parts are limited. Recommend evaluation and budgeting for future upgrade by a qualified electrician.

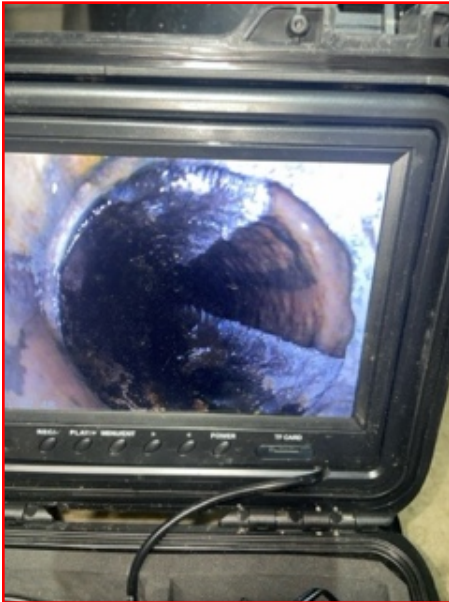
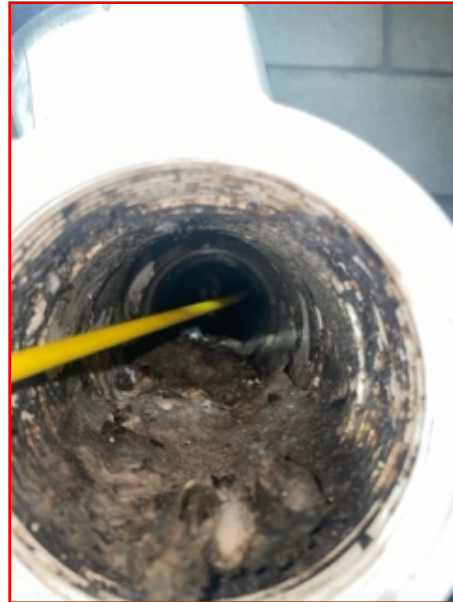
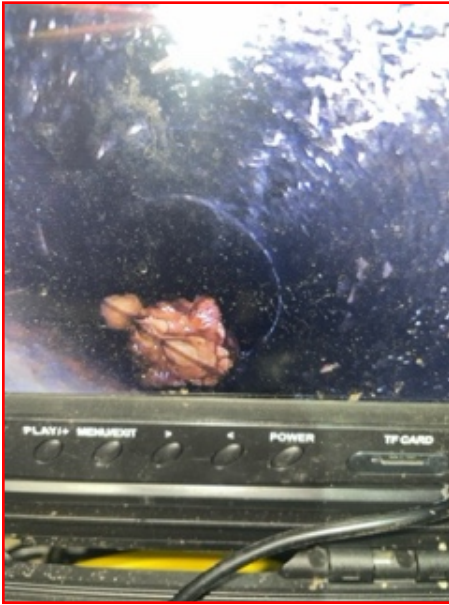
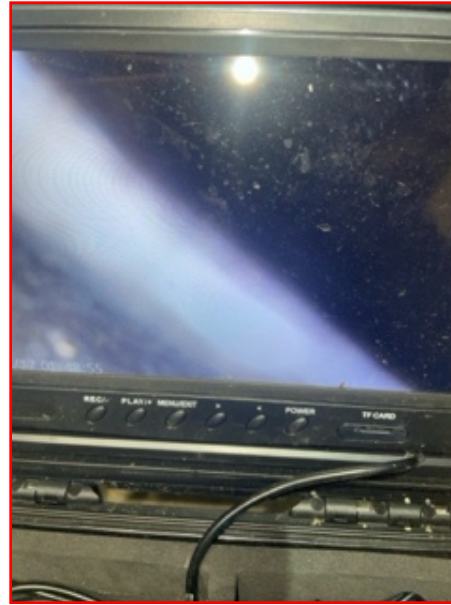
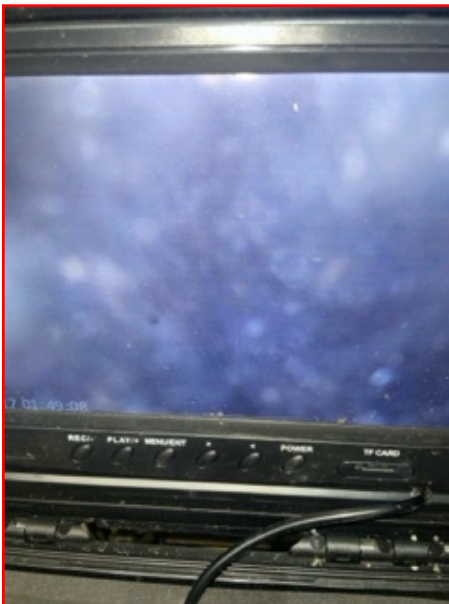
4) MAJOR CONCERN: A possible popped seam was noted just passed the foundation wall.

Also evidence of past and active backing up or high waste levels were noted in the outlet pipe, as well as debris.

Evidence noted typically indicates a failure of the pipe or of the absorption area.

Recommend a full reinspect once the tank has been pumped and the waste line is cleaned out.

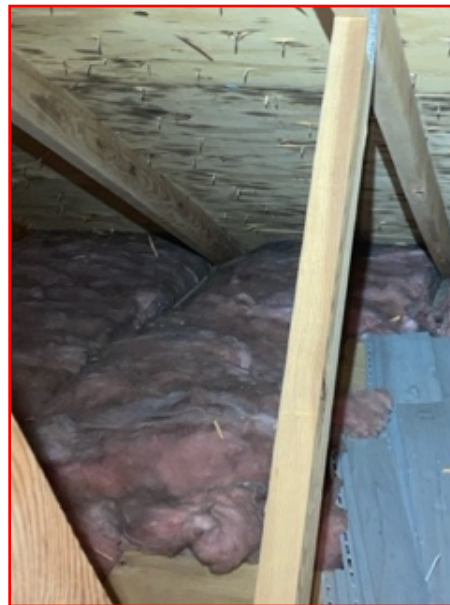
Figure 149-2

6) Large garage- POSSIBLE MAJOR CONCERN: A suspicious discoloration or stain was noted. Discoloration may indicate a larger issue adversely affecting the building materials and the structure. Recommend a qualified specialist ( Who is accountable to you) be contacted to evaluate the area and recommend corrective course. Additional areas of the house may require assessment at the discretion of the specialist.

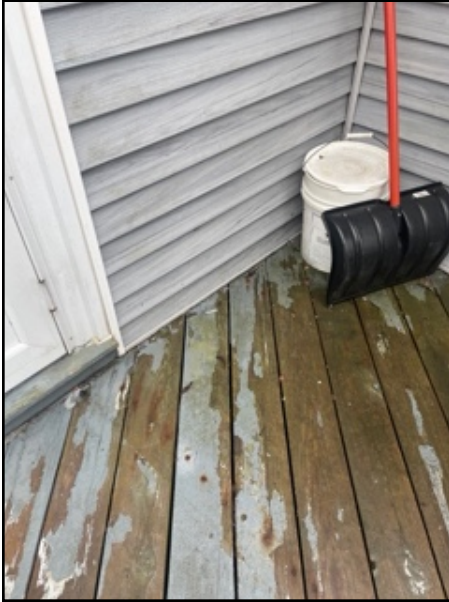
Figure 11-1

The inspector was unable to determine if the decks were properly flashed and lagged or not.

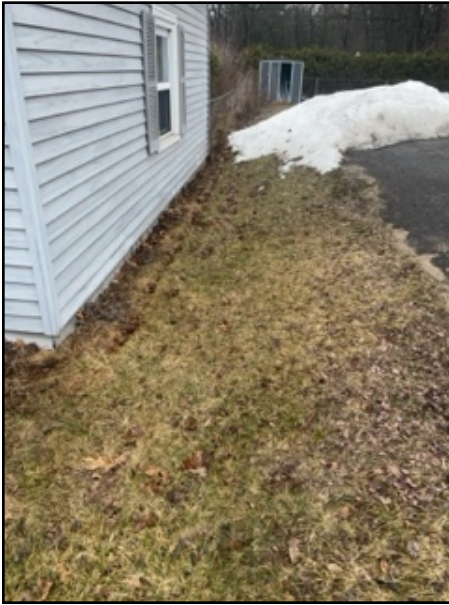
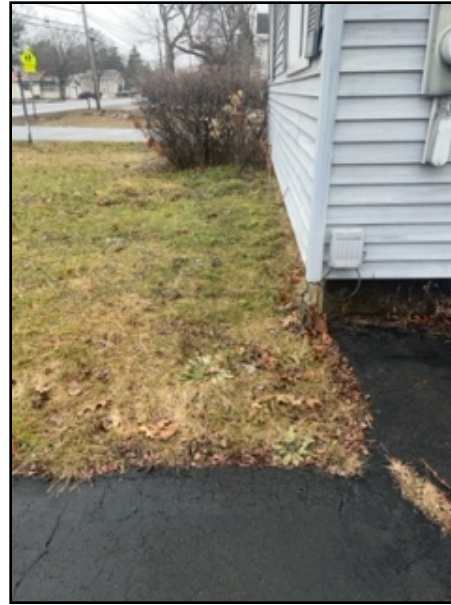
NOTE: Grading was flat or pitched towards the structures in some areas and may encourage water to pool around or saturate the structures.

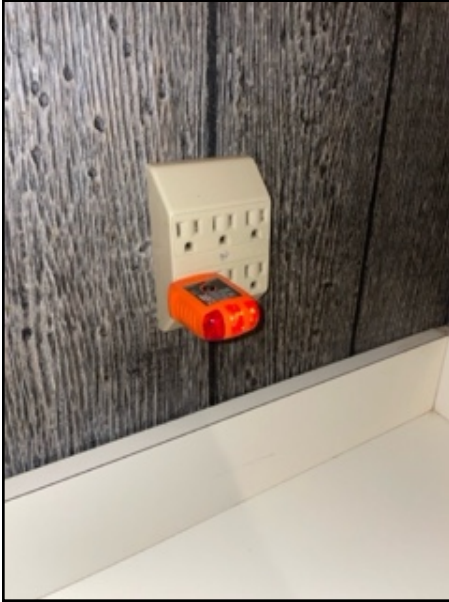
Figure 28-1

**Comment 28:**  
**ATTENTION REQUIRED:** Outlets appeared to not be GFCI protected or not functioning properly at the time of the inspection.

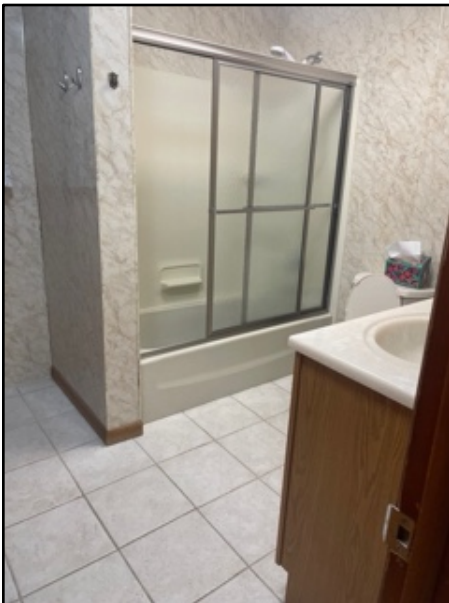
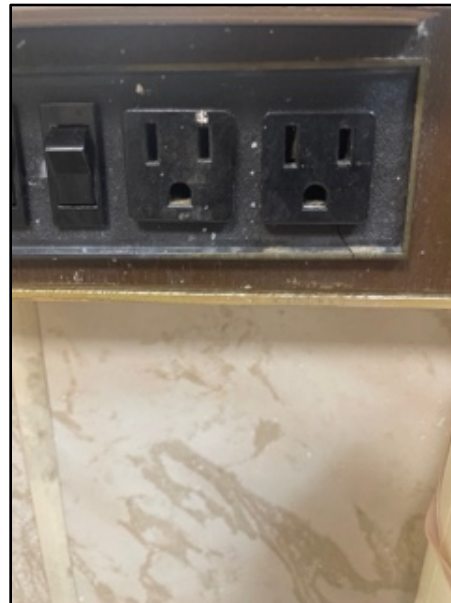
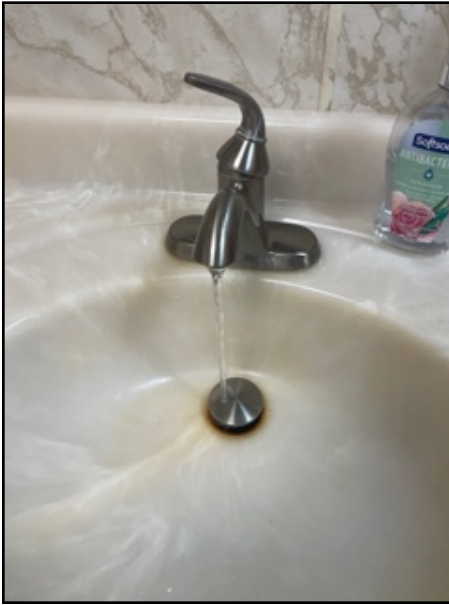
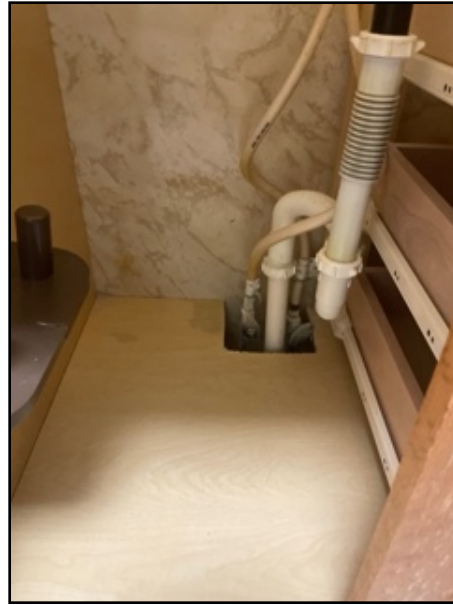
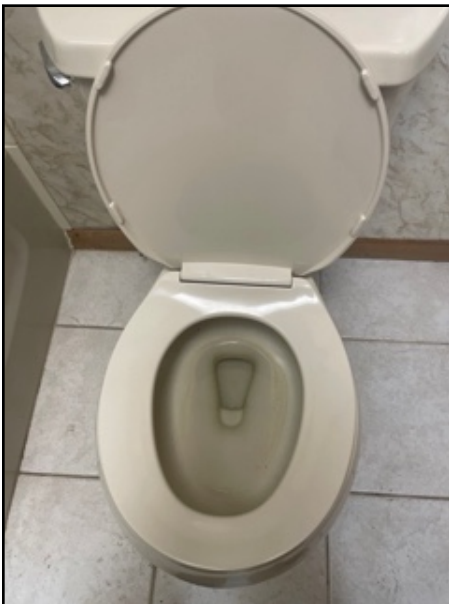
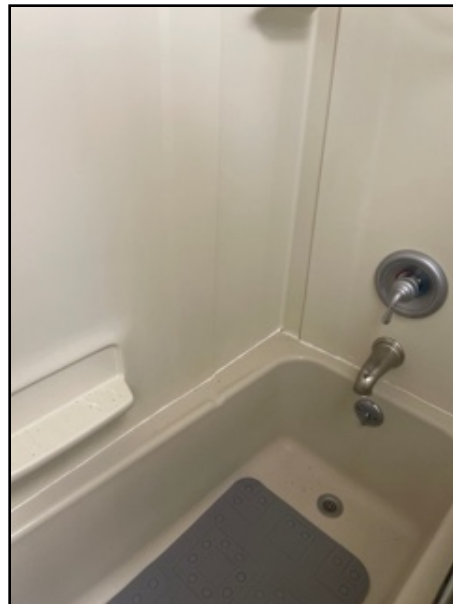
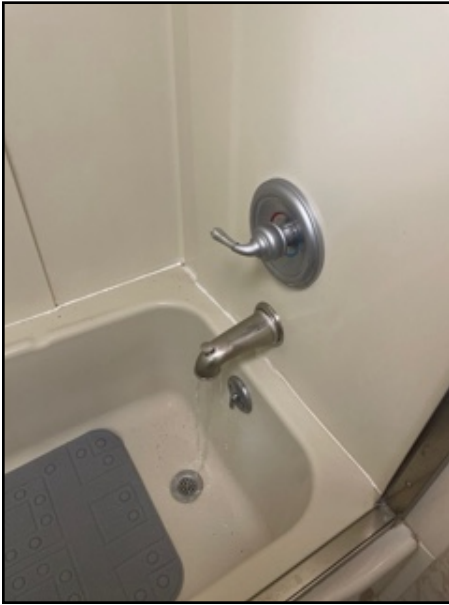
**FUNCTIONAL:** A representative number of accessible plumbing and electrical items were inspected and found working. Please note this is not a guarantee that all outlets and lights were functioning as deigned, as some outlets or lights may require repair or replacement.

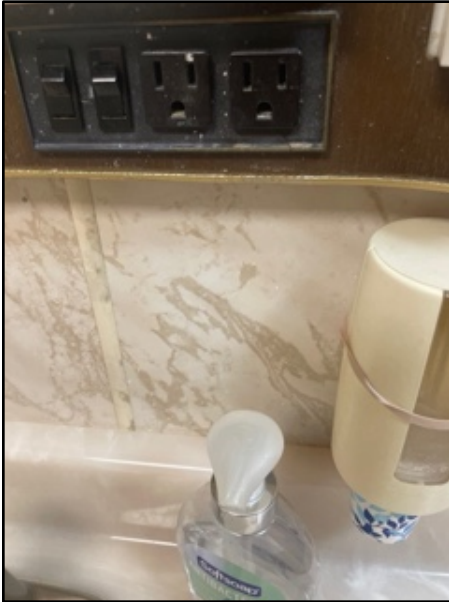
Figure 38-1

Comment 38:  
ATTENTION REQUIRED: GFCI outlets were found missing or not operating as designed on the day of the inspection.

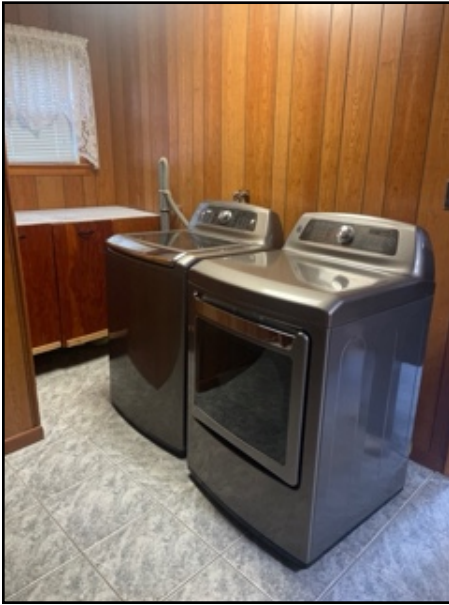
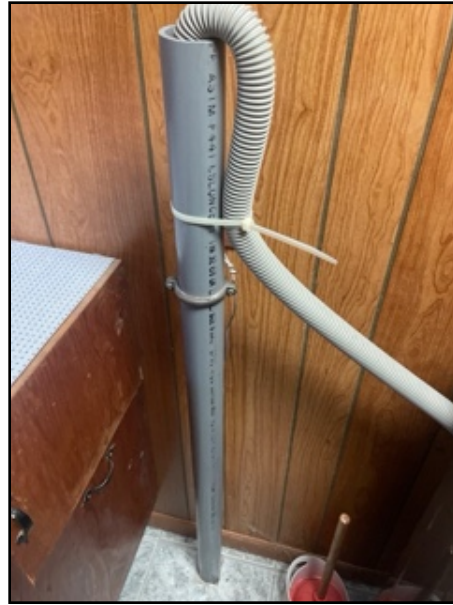
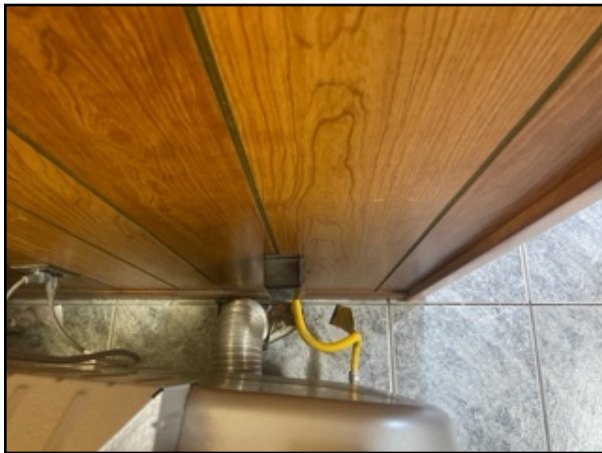
Comment 39:  
Visually inspected, no active leaking was found. A gas line was noted. Recommend always installing burst control hoses.  
Recommend always having a regular program of cleaning out the dryer vent, and that it vents properly to the exterior of the structure.

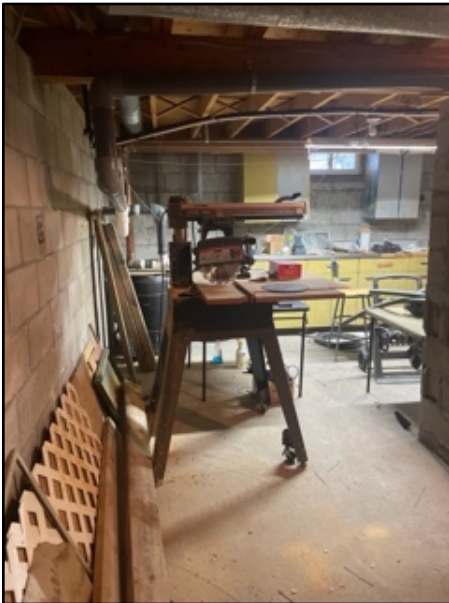
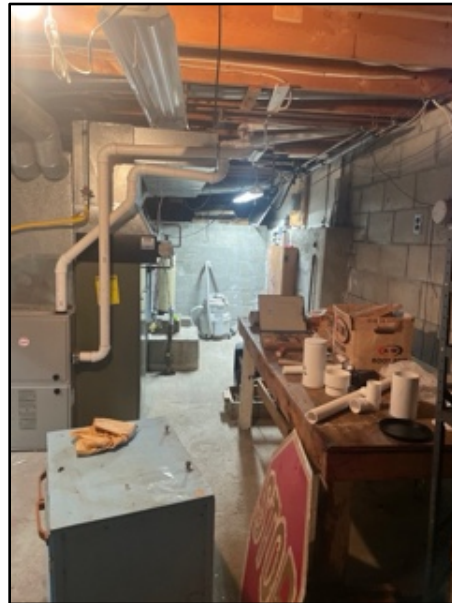
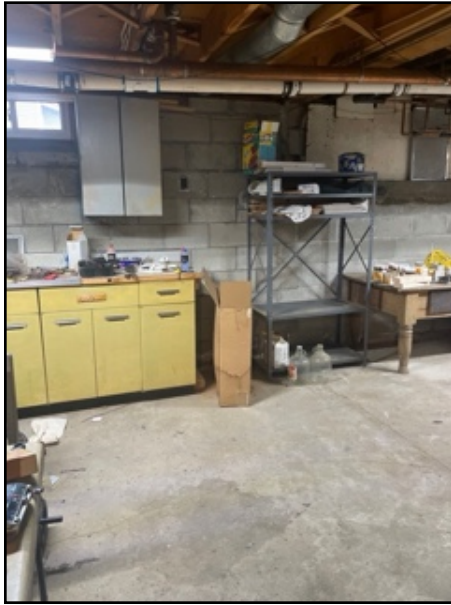
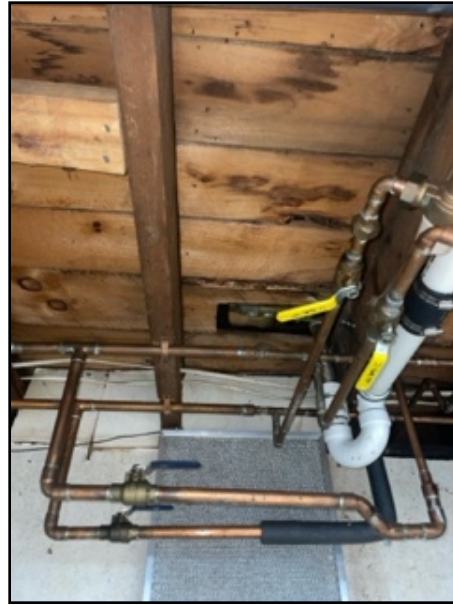
Basement walls, supports, framing appeared functional.

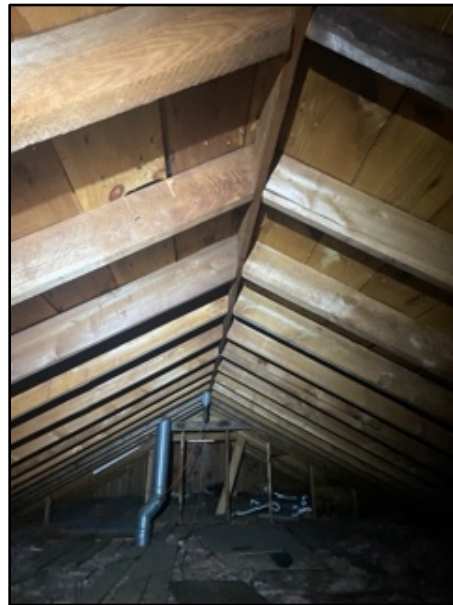
Figure 54-2

Comment 54:  
Note: Areas were found where additional supports or bracketing may be desired. Attic rafters did not all have cross ties or brackets and may be found desirable to install to prevent settling and movement due to the age and design structure.

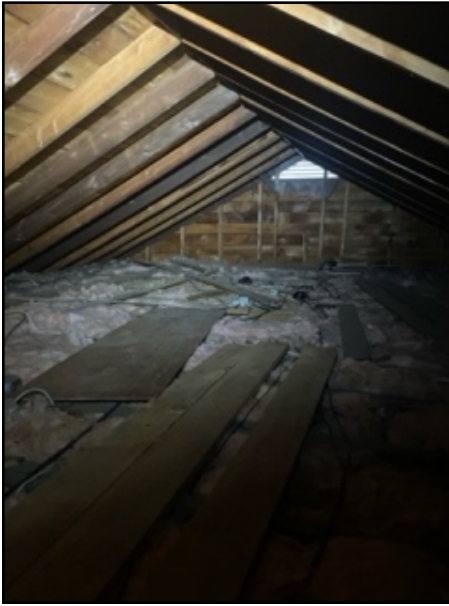
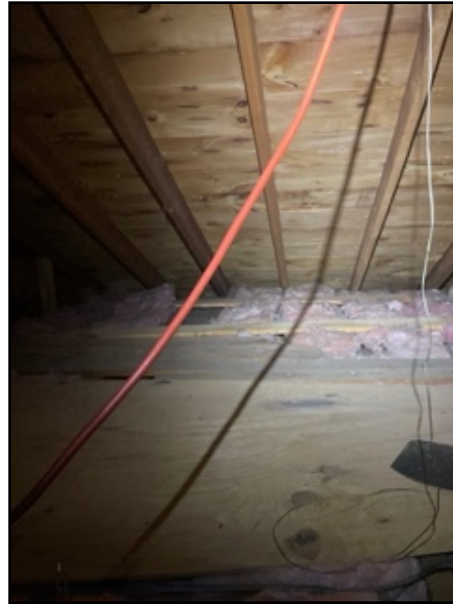
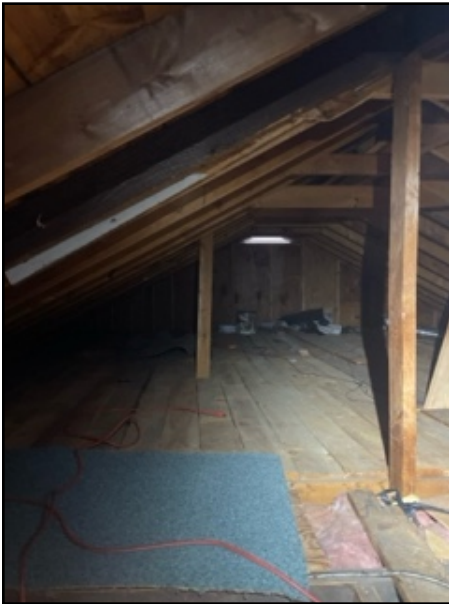
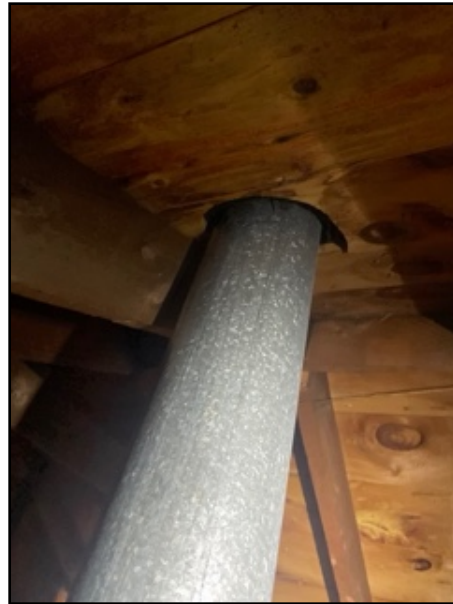
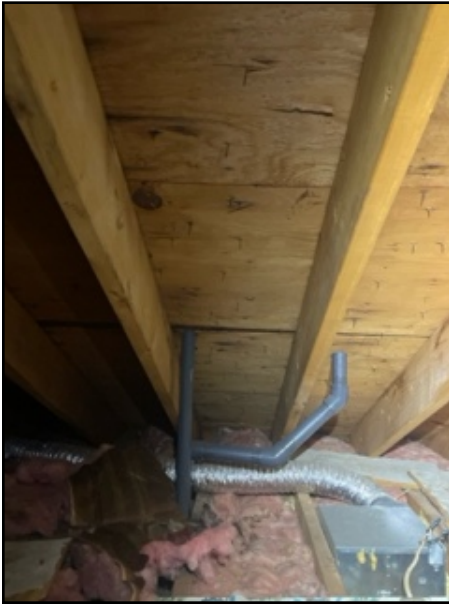
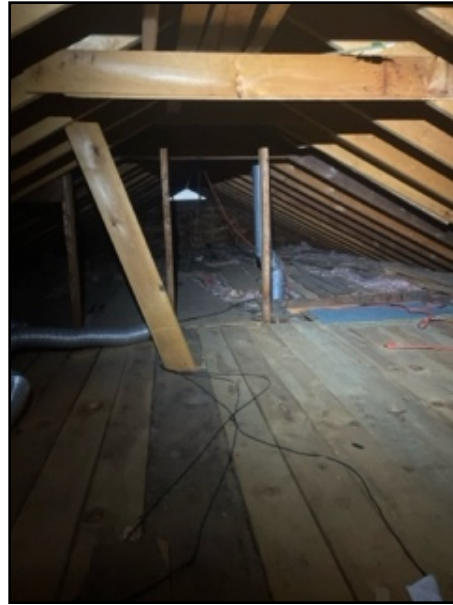
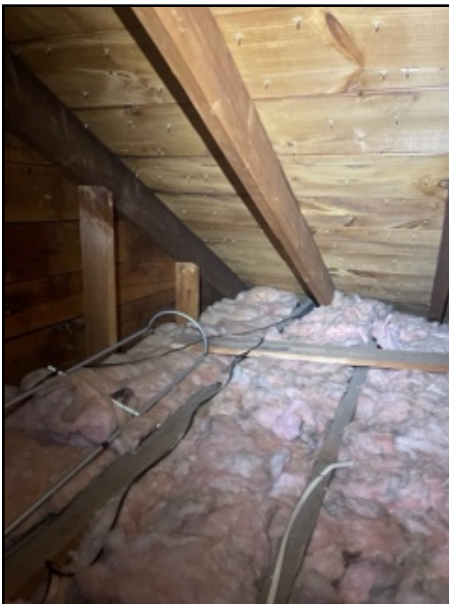
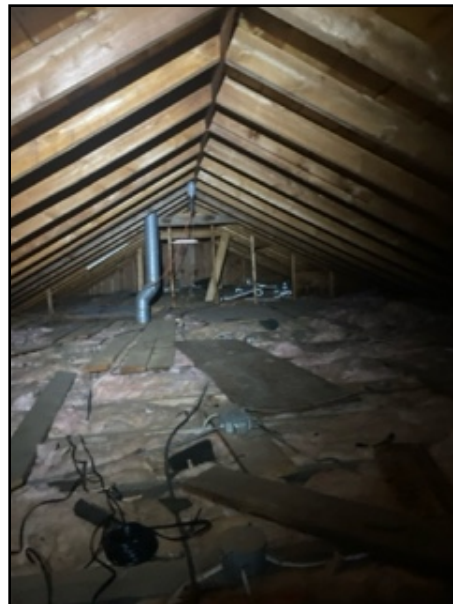
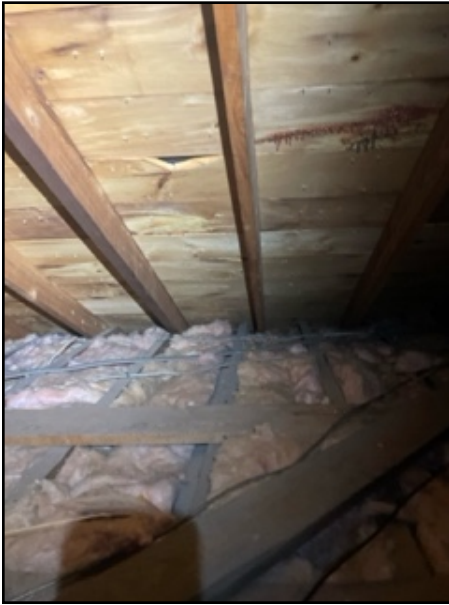
ATTENTION REQUIRED: Staining noted around nails .Small areas of possible growth noted. Staining of this type can be an indication of past high temperature or high humidity issues in the attic.

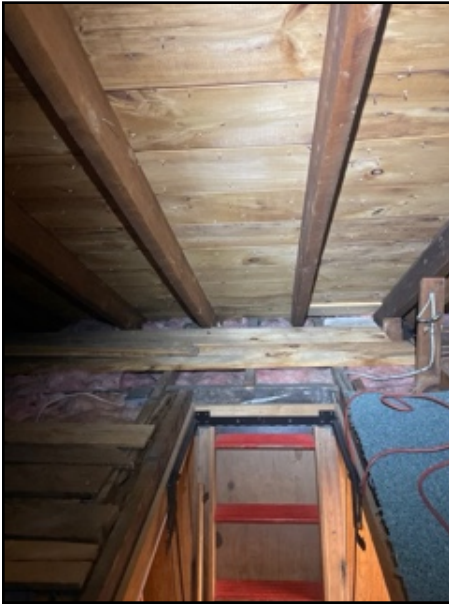
Figure 66-1

ATTENTION REQUIRED: Soffit areas appeared to be occluded with insulation in many areas and not breathing properly.

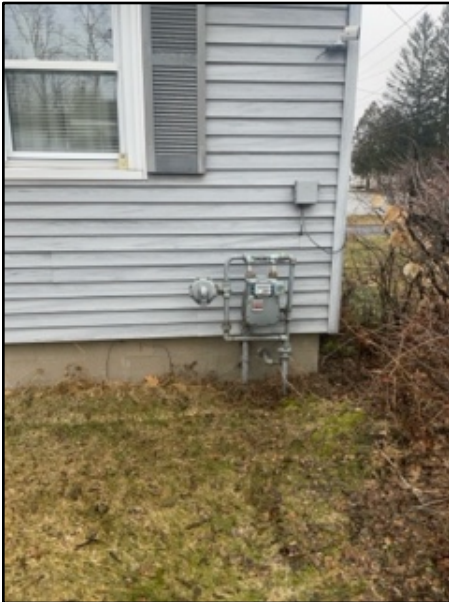
Figure 70-1

**i** Comment 70:  
A gas meter was noted on the left side of the home.  
Shut off was located at the meter.

Recommend addressing the rust on the gas lines, as well as adding bracketing and protection.

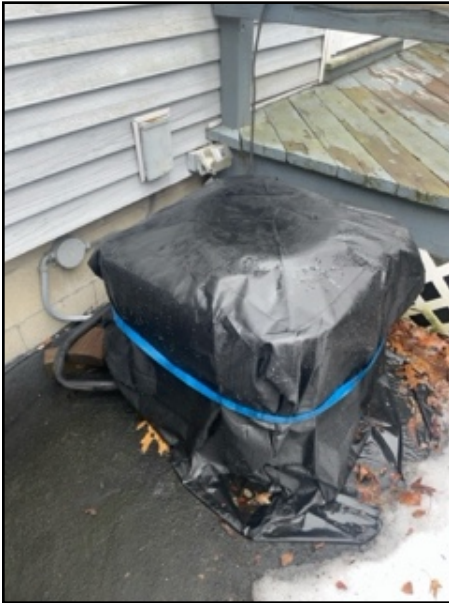
Figure 74-1

Unit was not operated as it may have been damaged by operating it during the inspection ( Due to NYs guide lines/cold temperature outside). Functionality remains unknown at this time.

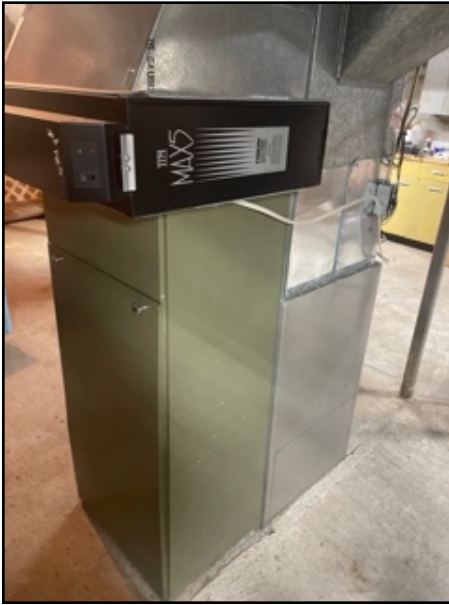
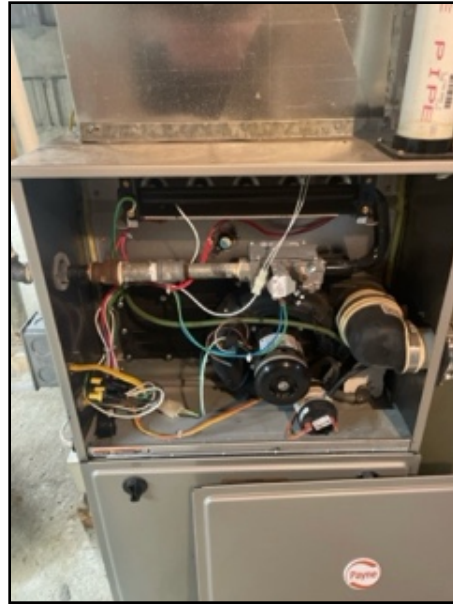
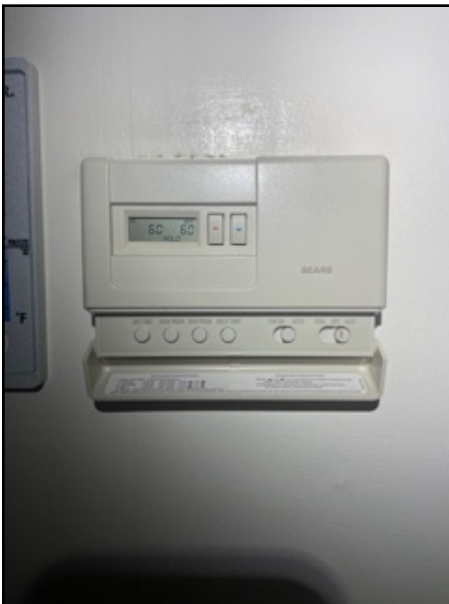
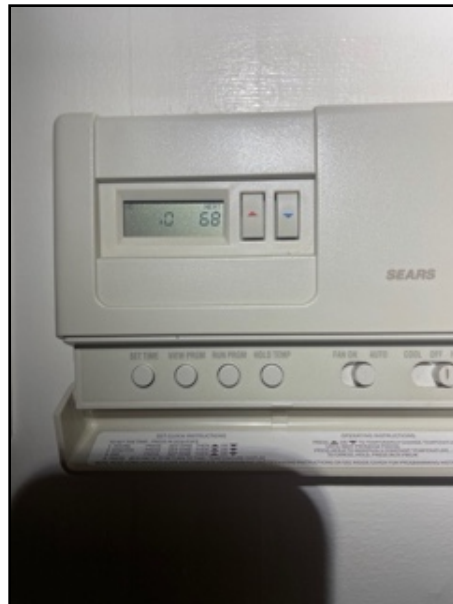
Comment 77:  
FUNCTIONAL: A forced air gas furnace was noted and operated using standard controls on the day of the inspection.

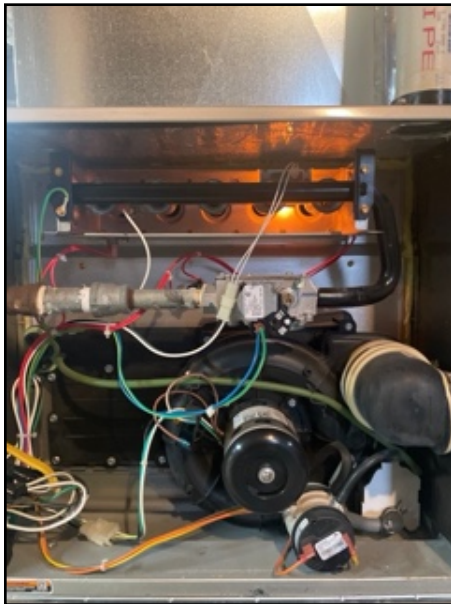
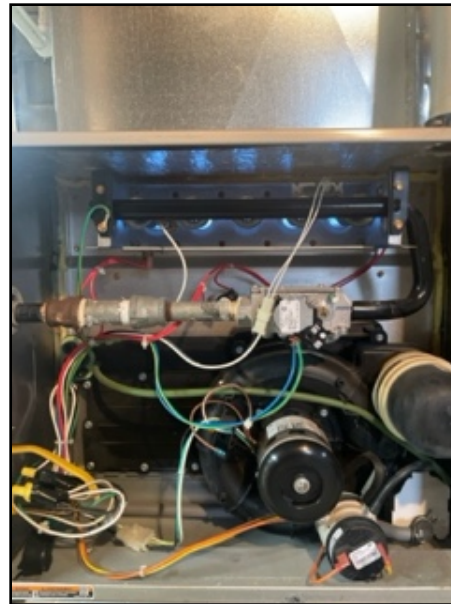
ATTENTION REQUIRED: A screen was noted on the exhaust side of the high-efficiency furnace. The screens can trap condensation and freeze in winter months, blocking off the exhaust to the furnace and trapping moisture.

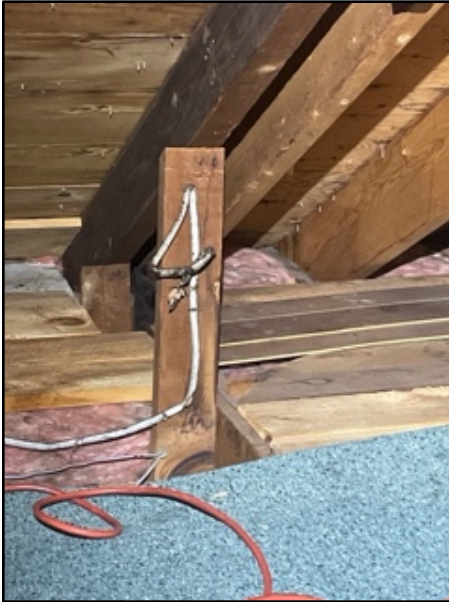
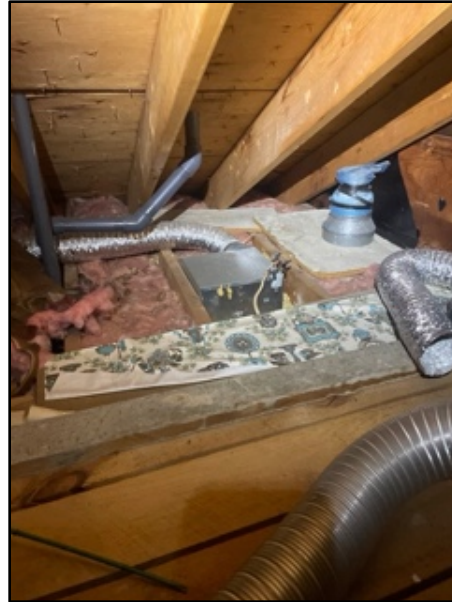
ATTENTION REQUIRED- Open and missing junction boxes were noted. Recommend contacting a qualified electrician for repairs.

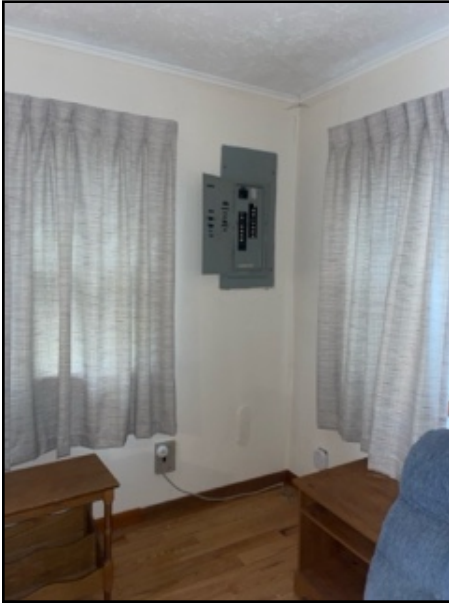
Figure 80-1

A 200Amp 120/240Volt main disconnect was noted in the panel in the living room.

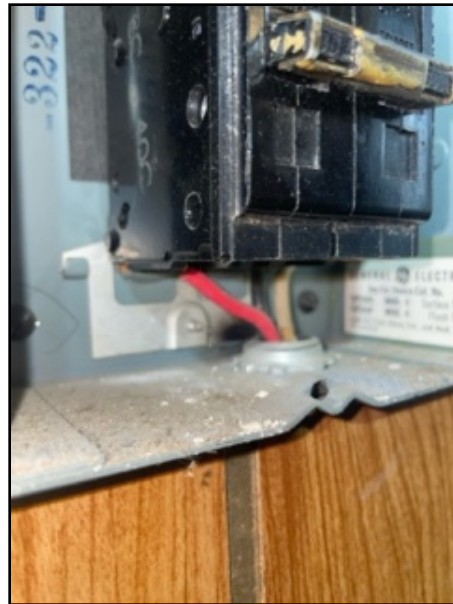
Figure 81-2

ATTENTION REQUIRED: A 30amp disconnect was noted in the laundry area. It was energized but off.

A possible burn mark was noted.

Recommend further evaluation by a qualified electrician for repair or removal.

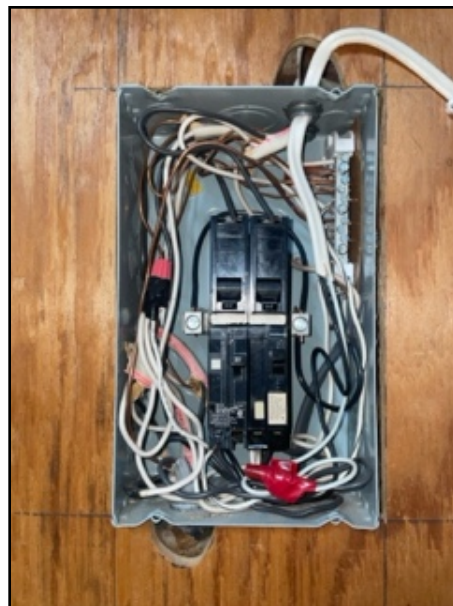
Figure 82-2

ATTENTION REQUIRED: A 20amp subpanel was noted in the garage. The wiring appeared unconventional. Recommend further evaluation by a qualified electrician.

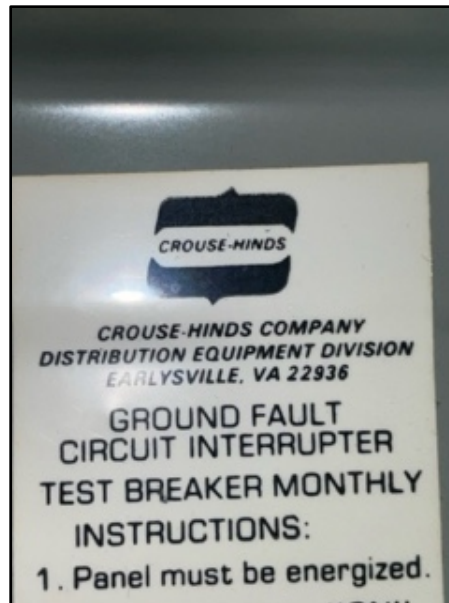
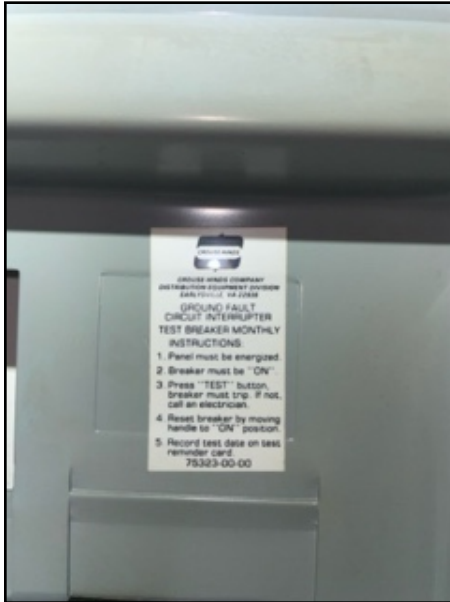
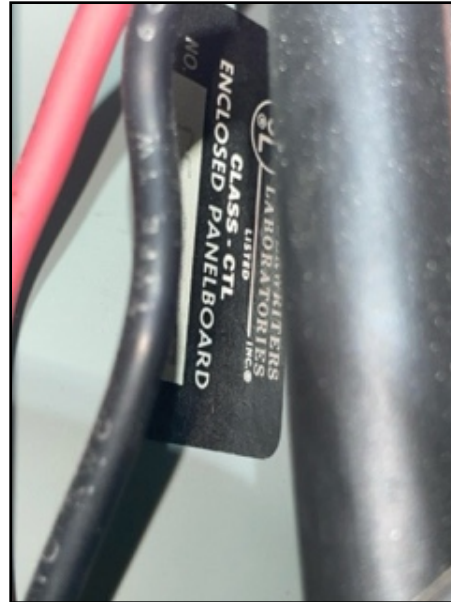
MARGINAL- The electrical panel appears to be an older Crouse-Hinds model, likely installed several decades ago. While no immediate defects may be visible, the panel and breakers are considered obsolete and may not meet current performance expectations. Replacement parts are limited. Recommend evaluation and budgeting for future upgrade by a qualified electrician.

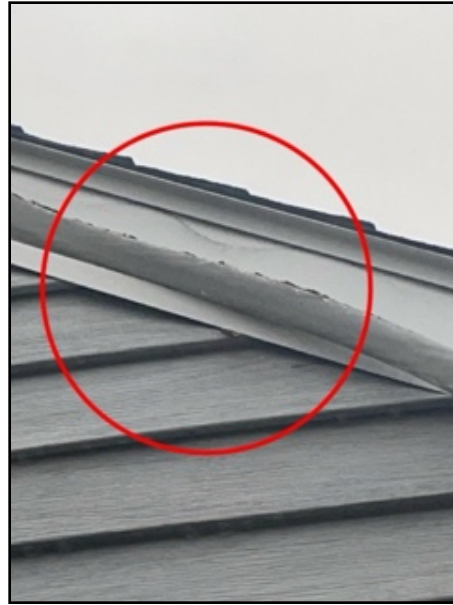
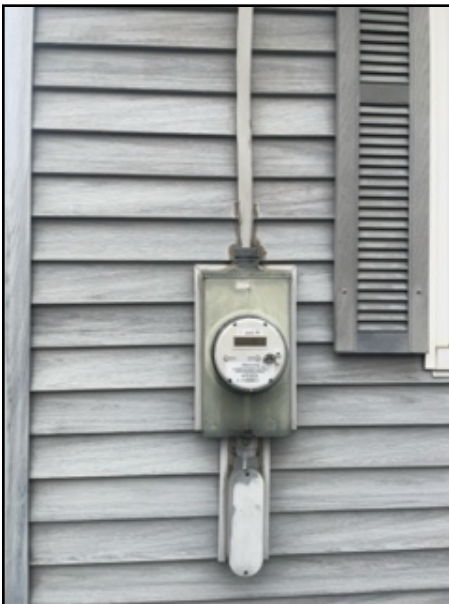
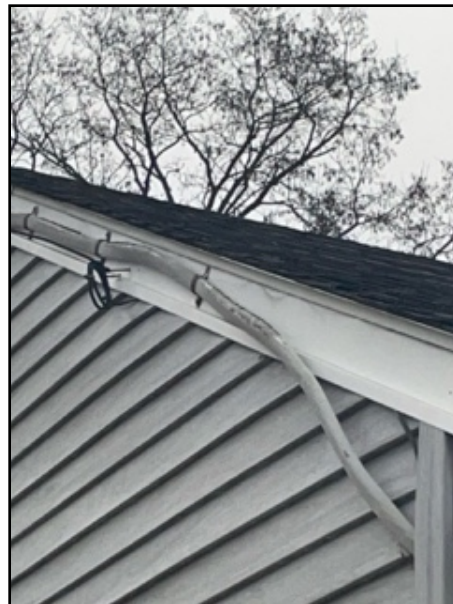
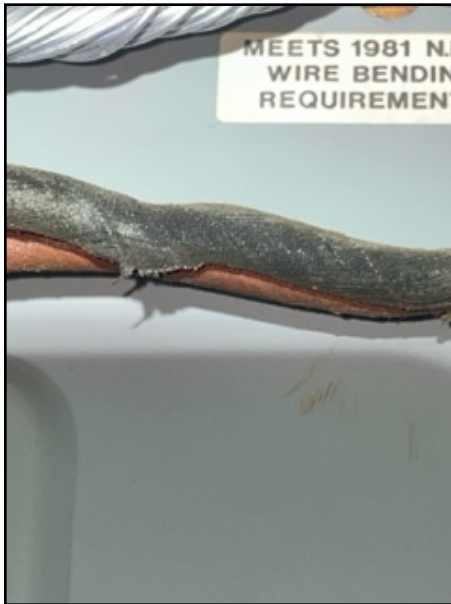
POSSIBLE MAJOR CONCERN/HAZARD: Main service entrance cable appeared damaged and compromised.

Recommend further evaluation by a qualified electrician for cost of immediate repair or replacement.

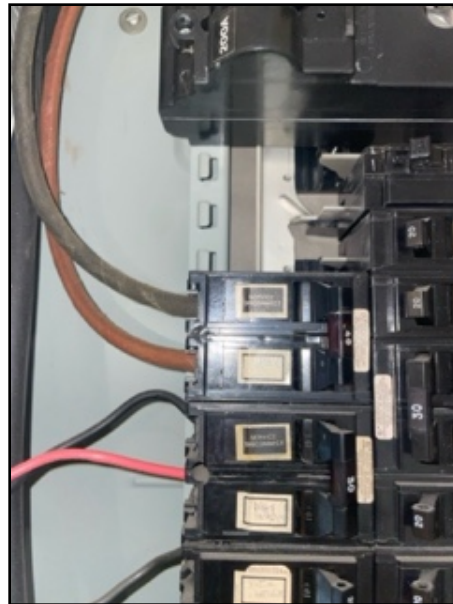
Figure 88-2

**ATTENTION REQUIRED:** The wire for the kitchen stove appeared damaged in the panel.

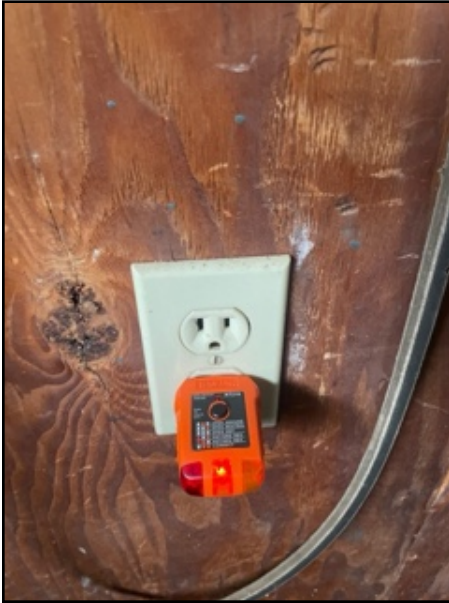
Figure 91-1

Outlets in garages also tested as being wired incorrectly.

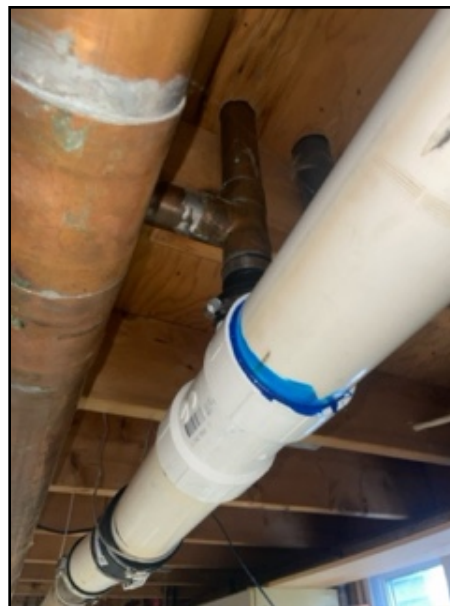
Figure 103-2

Unconventional waste lines were found that may prove problematic at times.

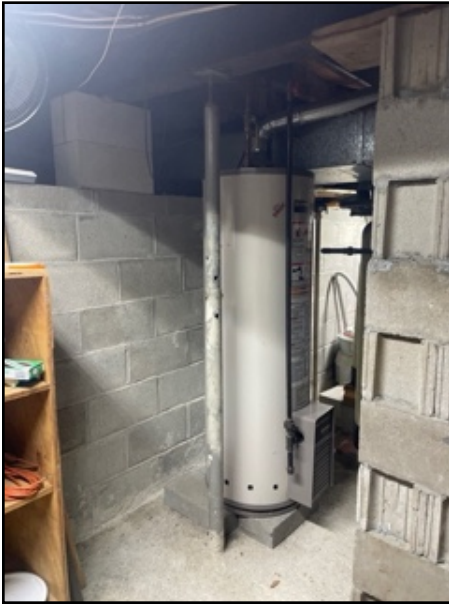
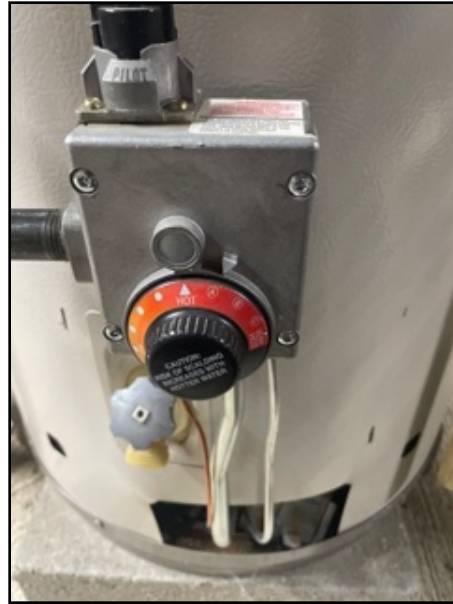
Unit appeared older. Average lifespan of water heaters is approximately 10 years. Unit may require replacement at any time. Recommend budgeting for replacement in the near future.

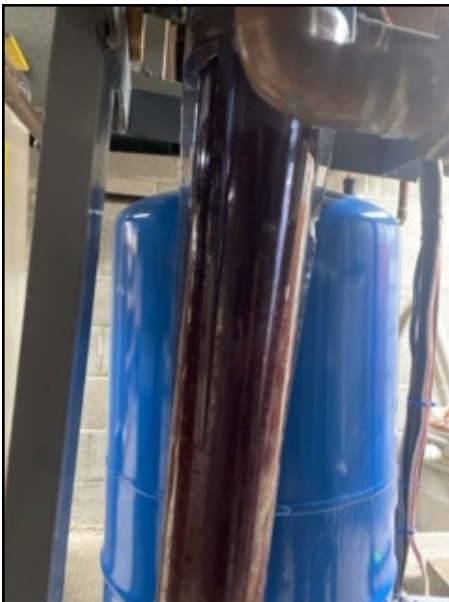
Figure 117-1

ATTENTION REQUIRED: The filters appeared partially occluded and in need of replacing.

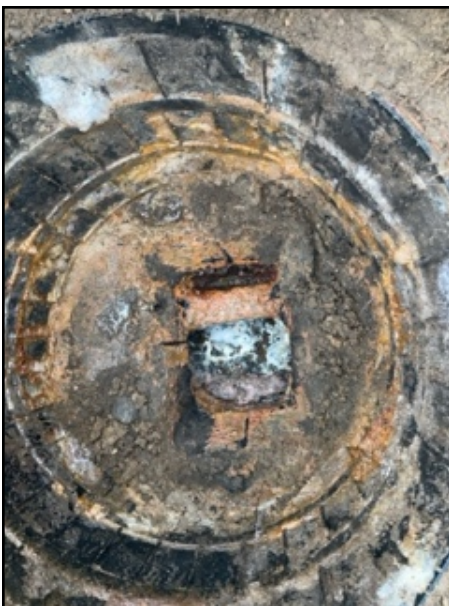
Figure 126-1

Comment 126:  
Outlet baffle was intact.

Note: Concrete and baffles can fail without notice. Recommend monitoring with normal pumping and repair or replacing as needed.

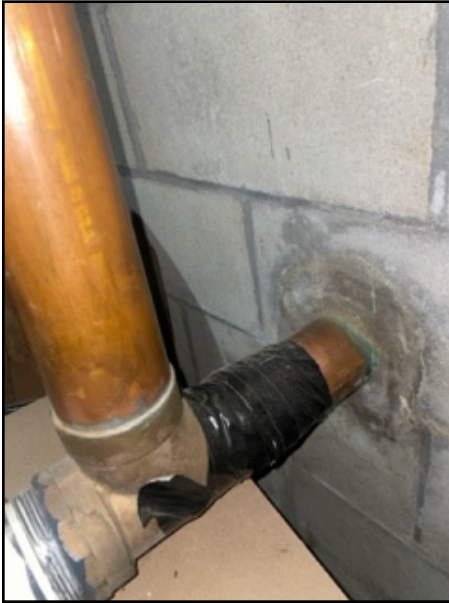
Figure 131-1

**Comment 131:**  
**ATTENTION REQUIRED:** Unconventional repairs noted on outlet pipe.

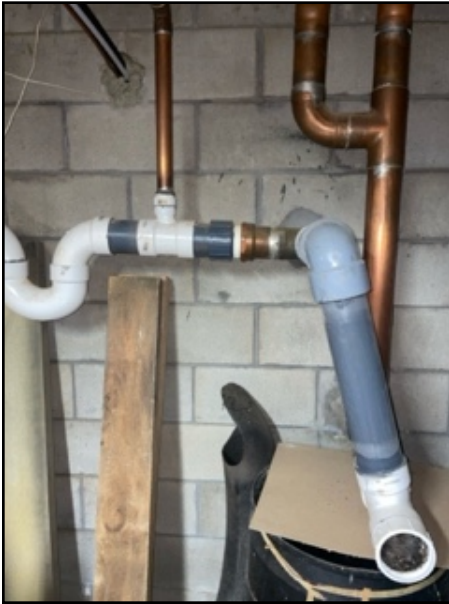
Figure 133-1

**MAJOR CONCERN:** A possible popped seam was noted just passed the foundation wall.

Also evidence of past and active backing up or high waste levels were noted in the outlet pipe, as well as debris.

Evidence noted typically indicates a failure of the pipe or of the absorption area.

Recommend a full reinspect once the tank has been pumped and the waste line is cleaned out.

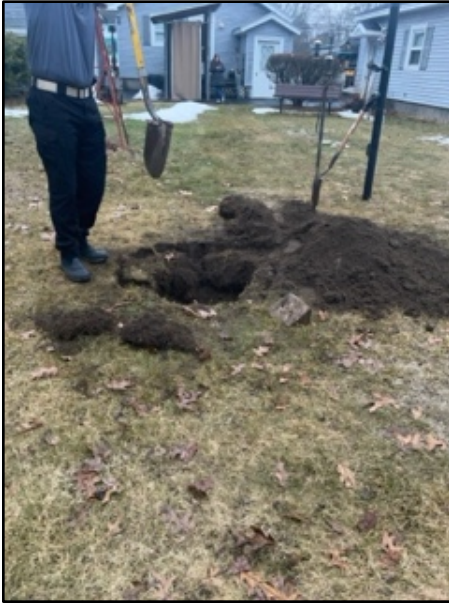
Figure 137-1

The system was found backing up.

RECOMMEND a full pump out and back jetting of all the lines to remove all debris and a full re-evaluation of the pipes and absorption area after all repairs and maintenance have been performed.

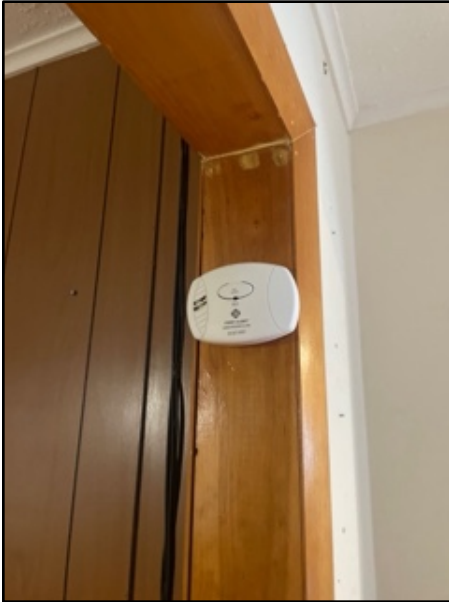
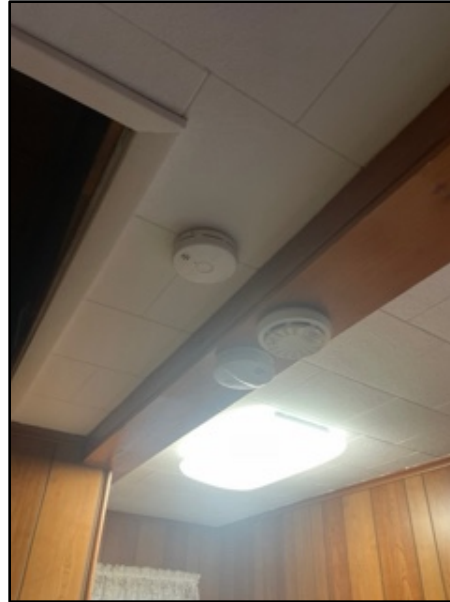
ATTENTION REQUIRED: Detectors were found missing in areas they are required by modern standards.

We always recommend placement/updating of appropriate smoke and carbon dioxide detectors in the proper locations prior to occupancy to monitor the building and protect the home and family.

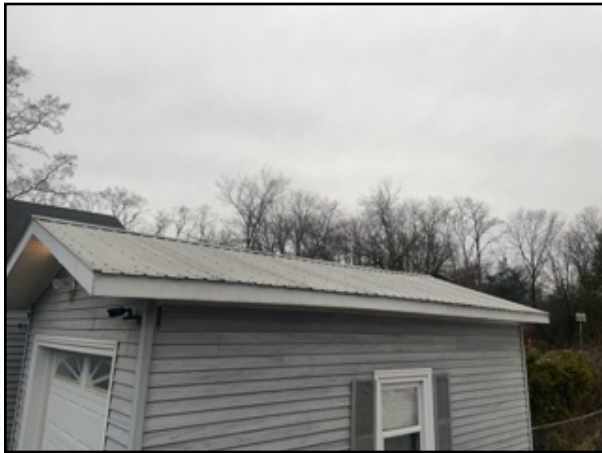
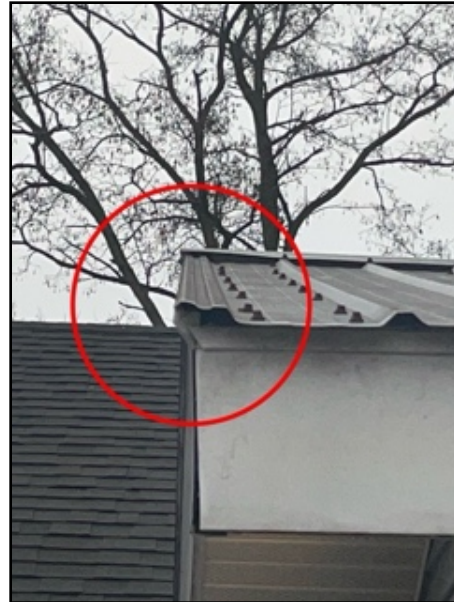
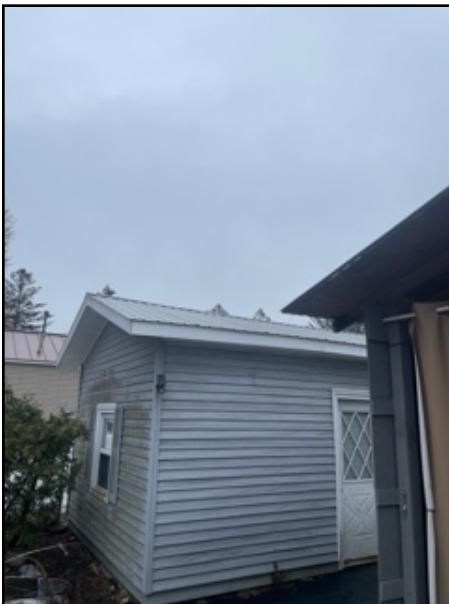
Small garage - A trim piece typically called the gable rake was not installed on the metal roofing and may be desired .

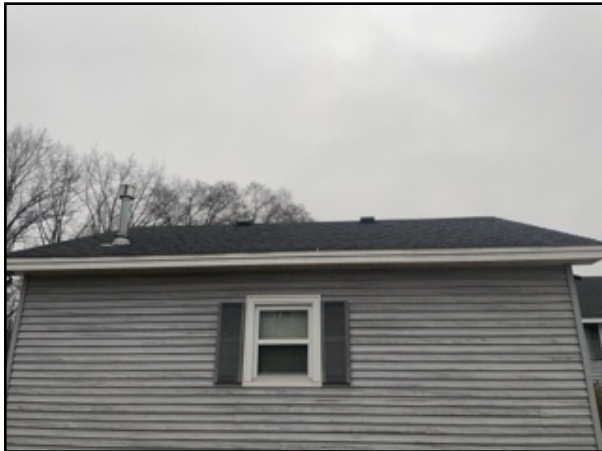
Figure 143-1

Large garage- FUNCTIONAL: Roof appeared functioning as designed.

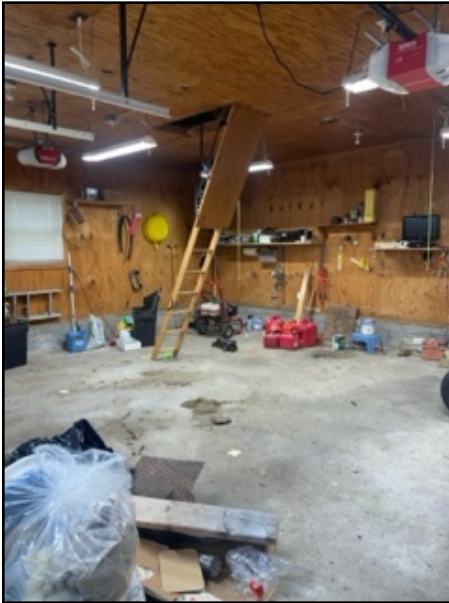
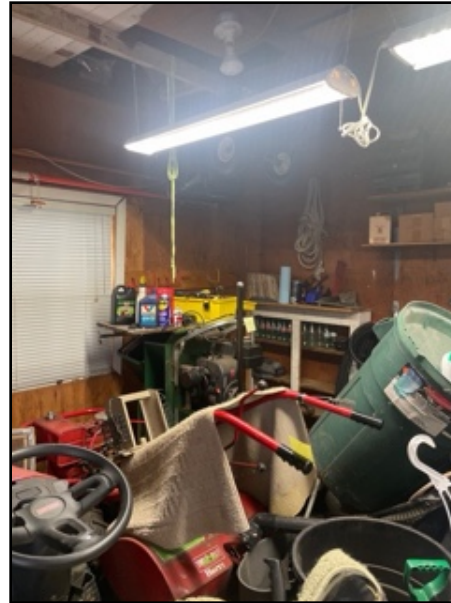
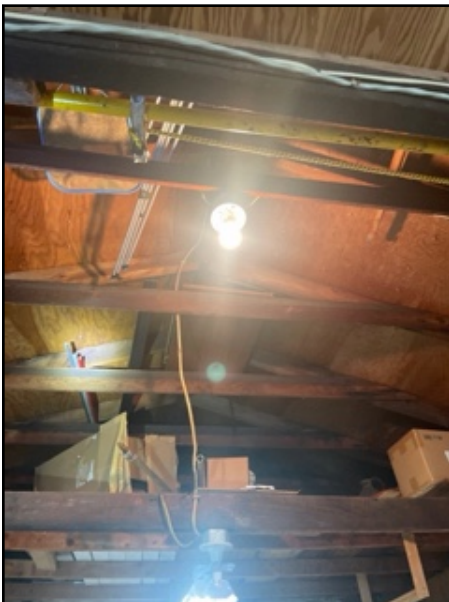
Large garage - FUNCTIONAL: Multiple cosmetic and or minor repairs were noted at the time of the inspection but nothing that would be considered a possible major concern.
