# Right Way Home Inspectors

## Inspection Report

Inspected on Mon, Mar 16 2026 at 11:30AM

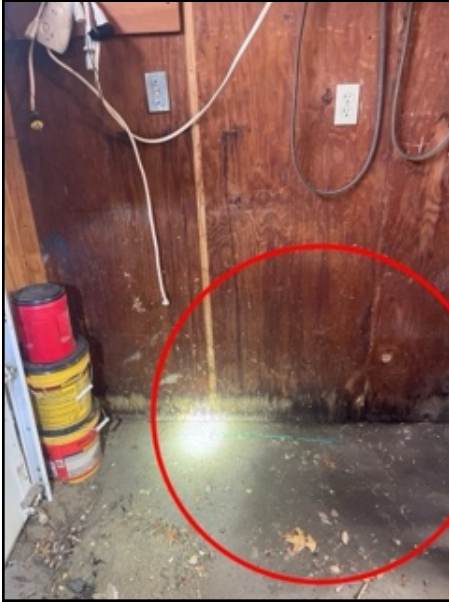
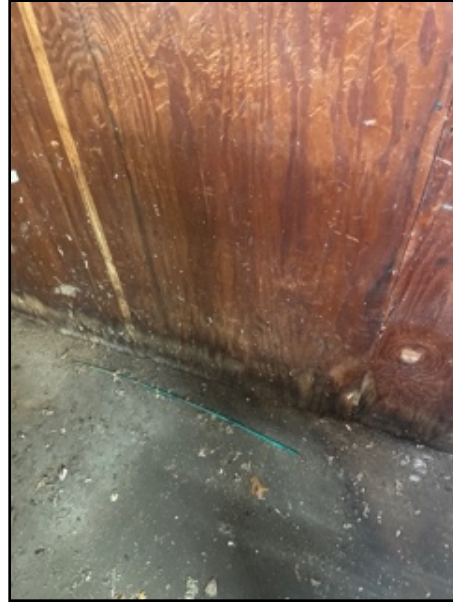
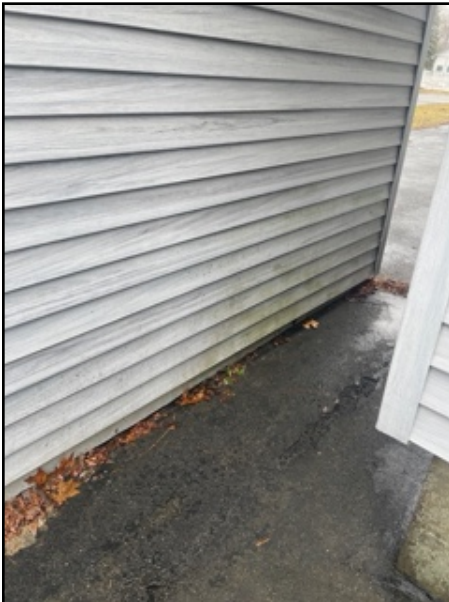
MARGINAL- Evidence of past moisture intrusion was noted on the walls of the small garage .

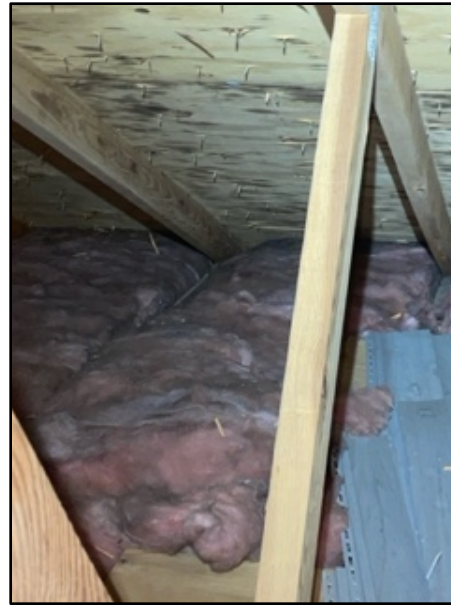
Figure 149-2

Large garage- POSSIBLE MAJOR CONCERN: A suspicious discoloration or stain was noted. Discoloration may indicate a larger issue adversely affecting the building materials and the structure. Recommend a qualified specialist ( Who is accountable to you) be contacted to evaluate the area and recommend corrective course. Additional areas of the house may require assessment at the discretion of the specialist.

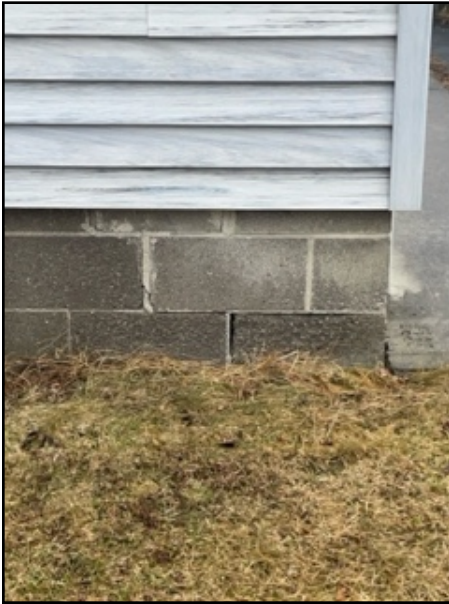
Figure 150-1

LARGE GARAGE- The structure showed evidence of settling and movement consistent with its age and design.

Although not visibly adversely affecting the structure on the day of the inspection, effort may be required to restore the areas to like new condition if desired.
