123 Anywhere Street Charlotte, NC 28215

Inspection Prepared For Valued Client

Date: 10/2/2024 Time: 11:00 AM

Year Built: 2000 | Size: 1748 sq.ft.

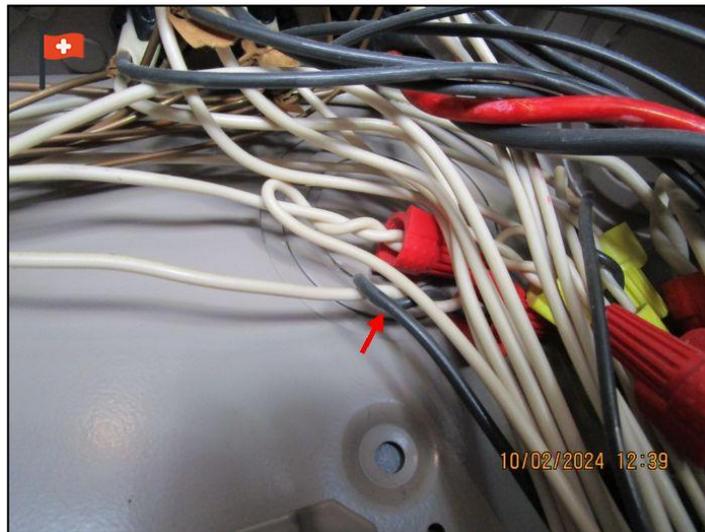
- **SAFETY CONCERN:** Shelving is restricting access to the main panel. All electrical panels must have a service clearance of 3 feet in front of them. Recommend a qualified individual/contractor relocate the shelving and/or panel for ease of access (especially in an emergency).
- **SAFETY CONCERN:** Black wire was used to extend the neutral at the time of inspection. This is unprofessional/not a common practice. Recommend further evaluation by a qualified electrical contractor and professionally repair/install the wiring as necessary for optimal/safe function.

Black Wire Used To Extend Neutral (Unprofessional) (Main Panel)

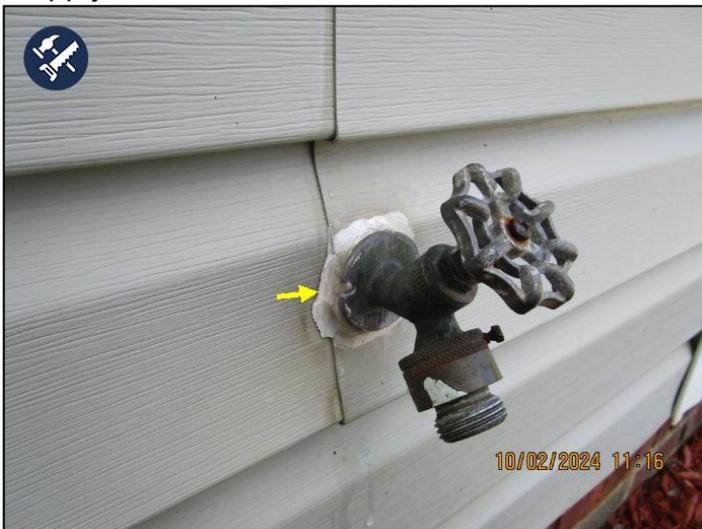
- **IMPROVE:** Exterior faucets were missing hardware/loose to the structure at the time of inspection. Recommend a qualified individual repair/secure the faucets to prevent potential damage to the supply lines.

Missing Hardware/Loose

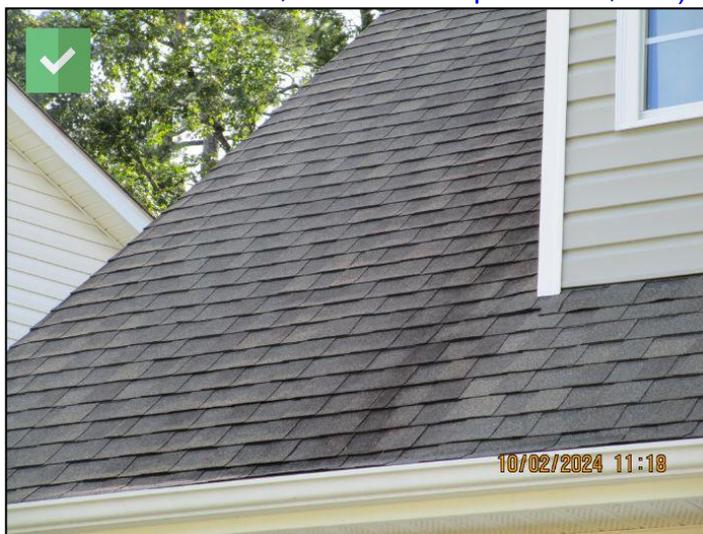
- **NOTE:** Asphalt shingles were noted. This roof is approximately 6-10 years of age and appropriate for the pitch of the roof. The roof was inspected from the ground as well as from a ladder at the eaves using binoculars/digital camera with zoom.
- **NOTE:** The average lifespan of asphalt roofs can range from 15-25 years depending on a number of factors (climate, adequate attic ventilation, extreme temperatures, etc.).

6-10 Years

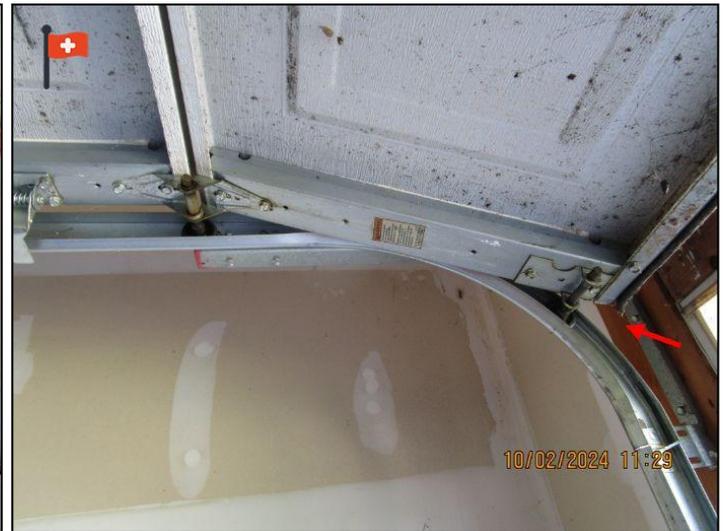
- **NOTE:** The garage door safety/reversing features were tested. The eye beam functioned properly at the time of inspection.
- **SAFETY CONCERN:** Garage vehicle door safety/auto-reverse did not pass the resistance test. Recommend a qualified individual/garage door specialist repair for proper function/safety.

Resistance Test Did Not Pass Safety Test

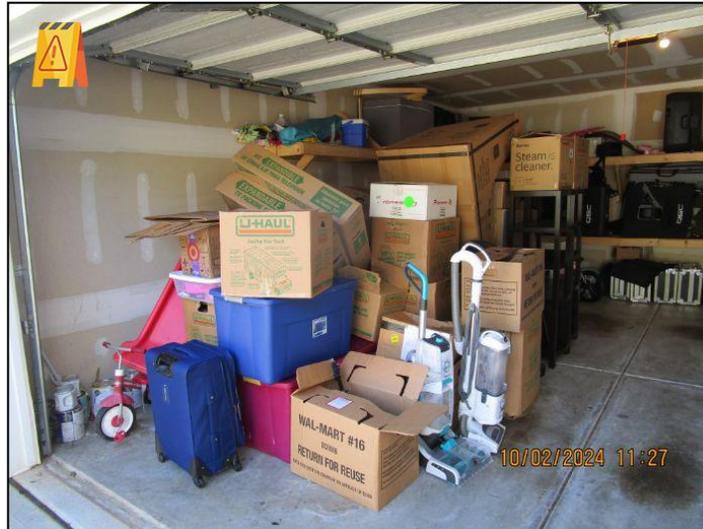
- **NOTE:** The inspector had limited visual of the garage walls/floor due to personal items/insufficient space to move around in at the time of inspection.

Limited Visual To Walls And Floor

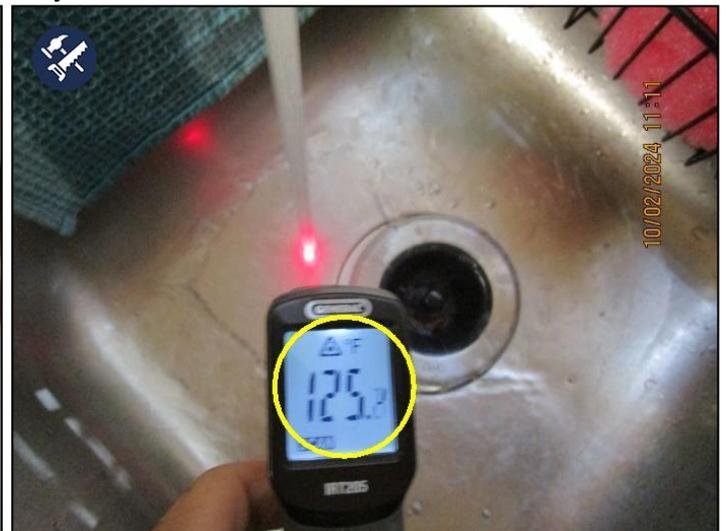
125.2 Degrees F

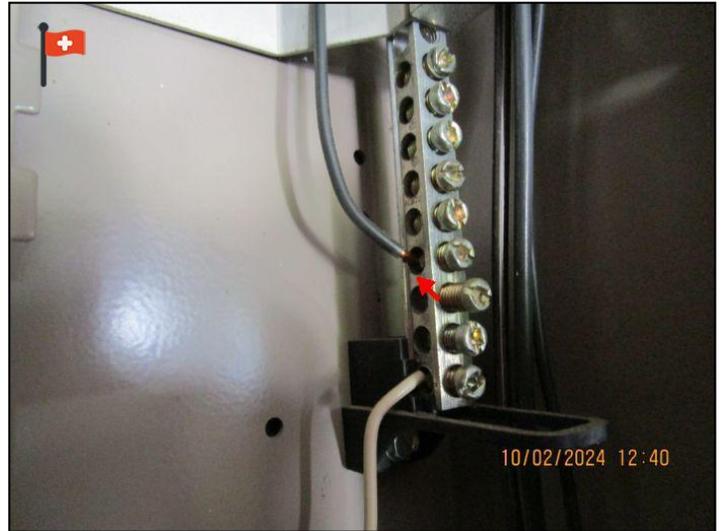
Black Wire Used To Extend Neutral (Unprofessional) (Main Panel)

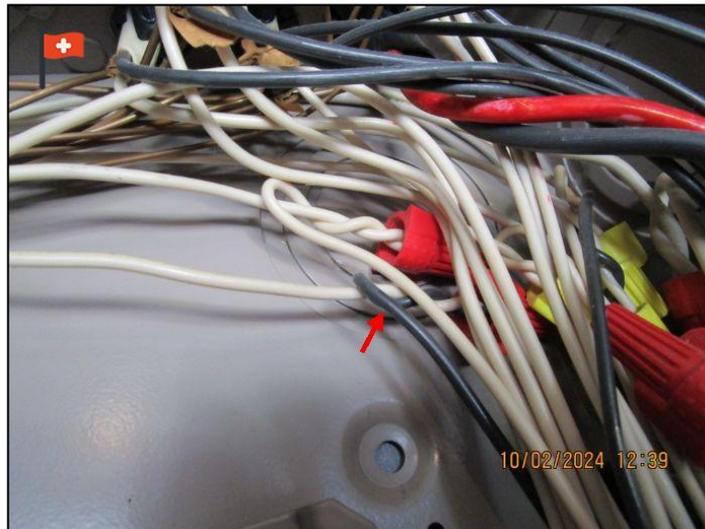
Black Wire Used To Extend Neutral (Unprofessional) (Main Panel)

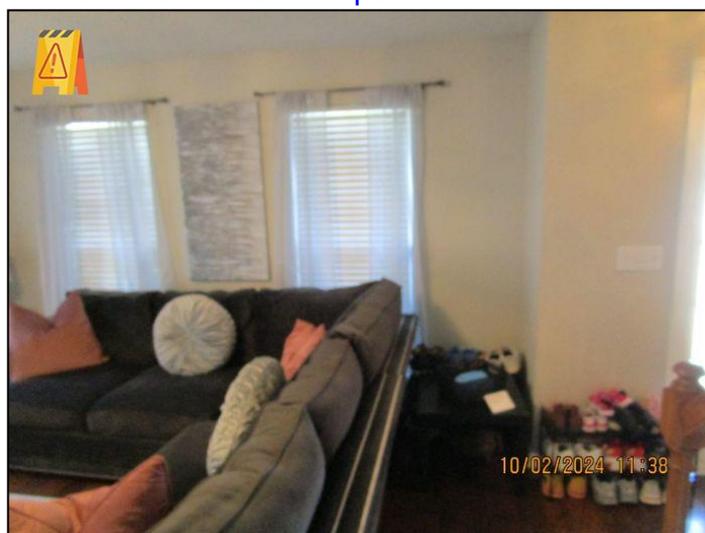
- **NOTE:** The inspector had limited visual/access of the floors/walls due to moderate to heavy volume of personal items stored at the time of inspection.

Limited Visual Due To Personal Belongings

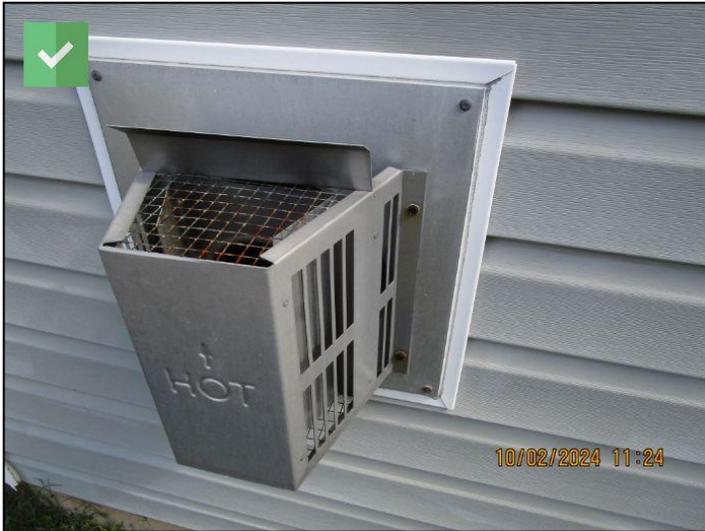
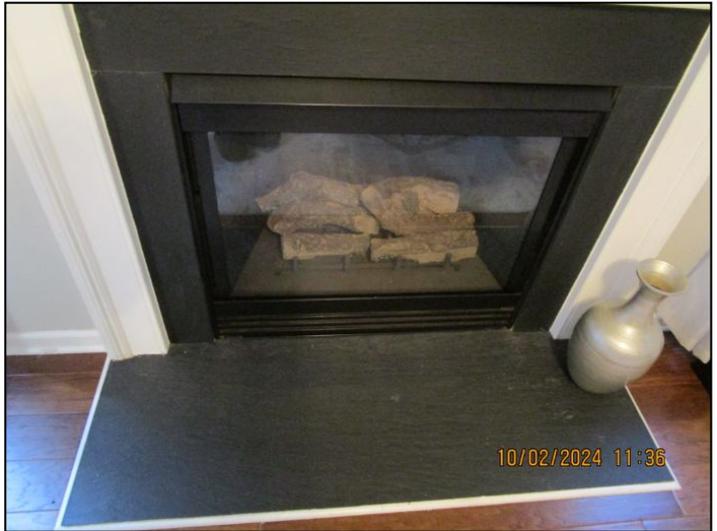
Gas Burning (Living Room)

- **NOTE:** Vent was installed at the time of inspection.
- **IMPROVE:** The gas fireplace was not tested as the gas valve was in the 'OFF' position at the time of inspection. Recommend a qualified fireplace specialist service/repair for proper function.

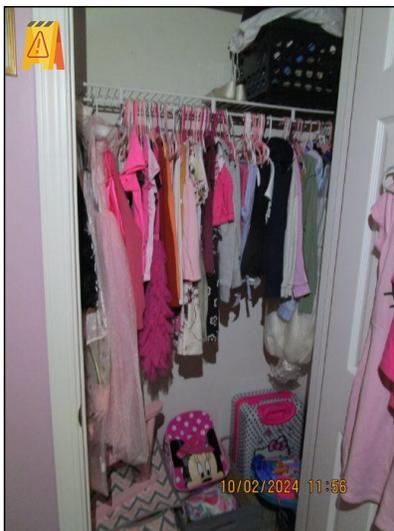
- **NOTE:** The inspector had limited visual/could not access the bedroom closet(s) due to stored personal items/insufficient space to move around in.

Limited Visual/Could Not Access

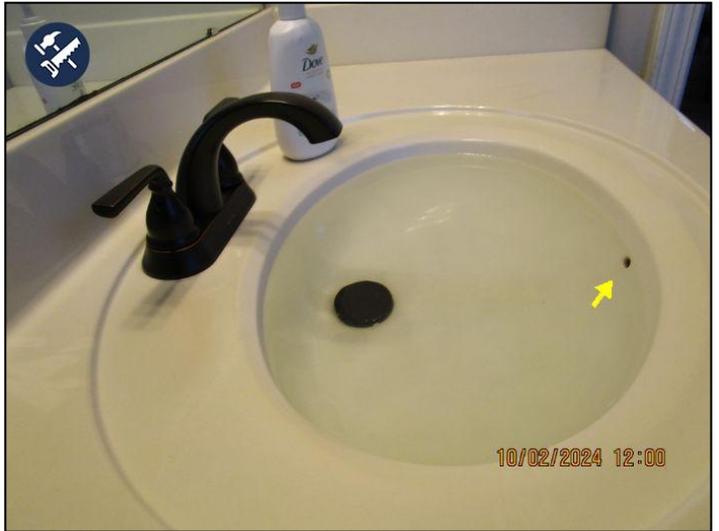
- **IMPROVE:** There was a slow drain observed at multiple bathroom sink overflow holes/lines at the time of inspection. Recommend a qualified individual clear the blockages for optimal function. If the issues continue, have a plumbing contractor further evaluate and repair as necessary.
- **REPAIR:** Bathroom sink was leaking from the overflow at the time of inspection. Recommend a qualified individual/plumbing contractor repair/replace the sink to avoid water overflow and/or damage to cabinets/building materials.

Clogged Overflow Drain (Primary Bathroom)

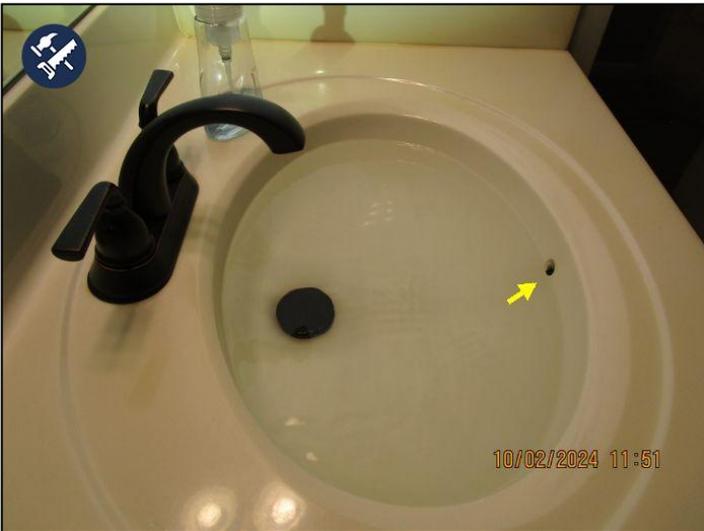
Clogged Overflow Drain (2nd Floor Guest Bathroom)

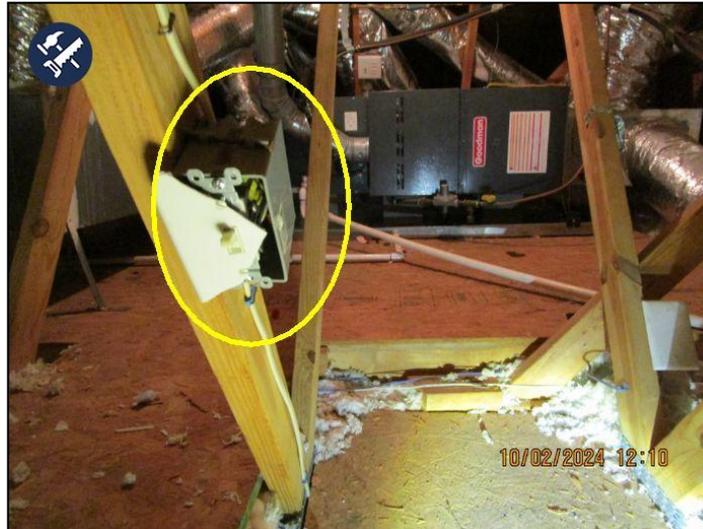
- **IMPROVE:** Damaged cover(s) noted in the attic. Recommend a qualified individual/electrical contractor repair/replace the cover(s) to prevent dust/debris from entering the electrical system.

Damaged Cover

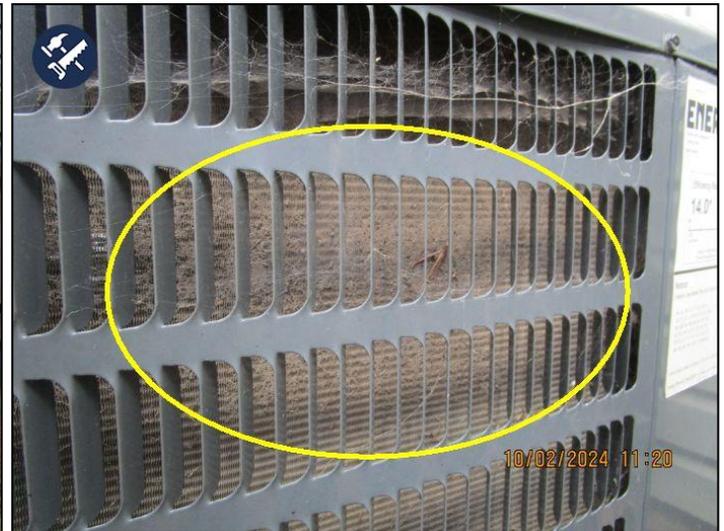
- **IMPROVE:** Dirty cooling fins noted on the compressor at the time of inspection. Recommend a qualified individual/HVAC specialist further evaluate and repair/clean the unit as necessary for optimal function.

Dirty Coil Fins

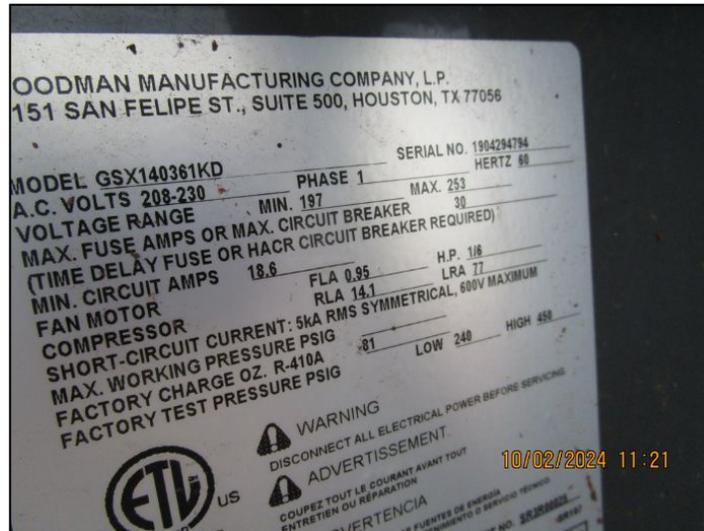
- **NOTE:** The Goodman unit is approximately 5 years old. The average lifespan of this system is 10-15 years depending on a number of factors.

2019 Goodman 3 Ton Unit

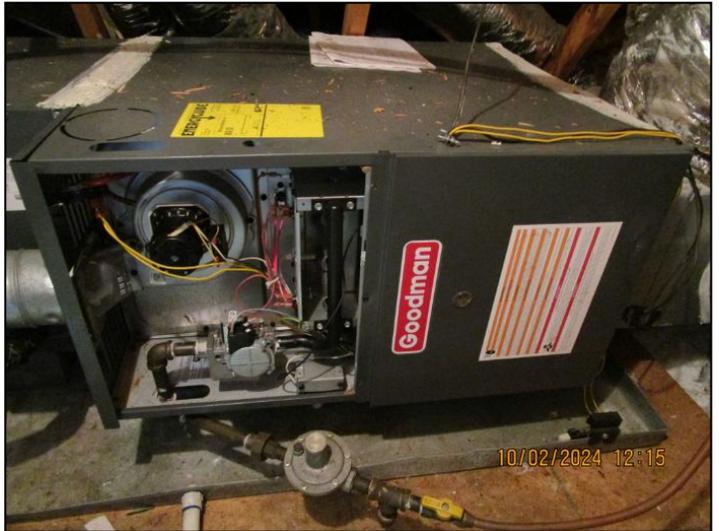
LOCATION: Attic

- **IMPROVE:** Gas Unit - Last service date is over one year ago, or is unable to be determined. Although this unit appears to be operating properly from controls, there are areas which cannot be seen without specialized equipment and training. One such area is the combustion chamber/heat exchanger where cold air blows across the 'fire box,' becoming the hot air that circulates throughout your home. During the life span of any furnace, this metal wall may develop a crack or a broken weld, allowing carbon monoxide to circulate throughout the home. This is why furnace specialists recommend a complete inspection annually; consider having the unit inspected by certified HVAC contractor.

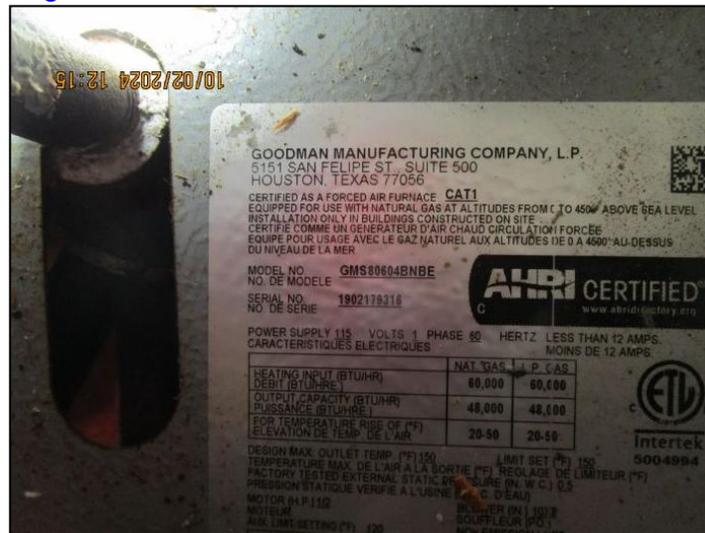
- NOTE: The Goodman unit is approximately 5 years old. The average lifespan of a unit of this type is 16-20 years depending on a number of factors. Recommend annual servicing by an HVAC specialist in order to prolong the life of the units.

2019 Goodman 3.5 Ton Unit

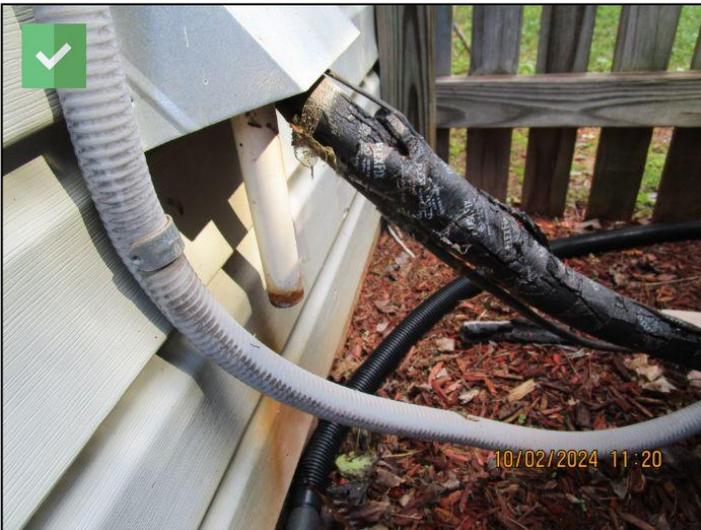
- **NOTE:** A condensate drain was present and routes to the exterior of the structure.
- **IMPROVE:** The condensate line plumbing trap was not insulated at the time of inspection. Recommend a qualified individual/HVAC contractor install insulation around the trap to prevent unwanted moisture issues.

Routes To Exterior

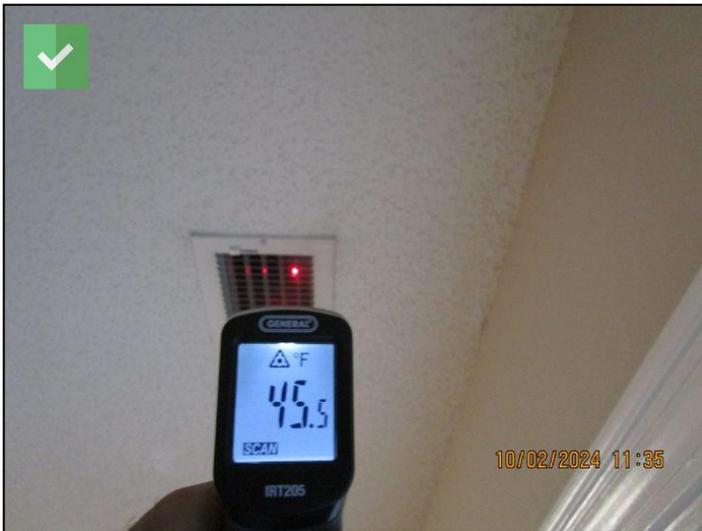
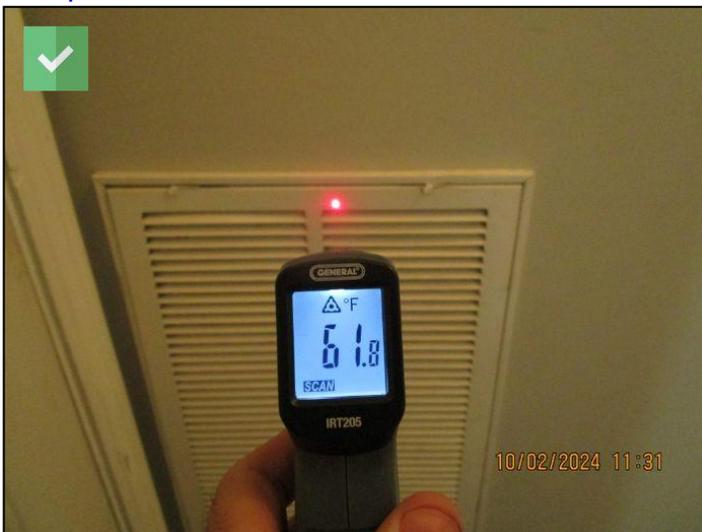
- **NOTE:** The typical temperature differential split between the supply and return air in an air conditioner of this type is 15-20 degrees F. This system responded and achieved an acceptable differential temperature.
- **NOTE:** Gas heating units (furnace) require a minimum 30-60 degrees rise in temperatures as comparing supply and return. This system responded and achieved an acceptable differential temperature.

A/C Differential 16.3 Degrees F

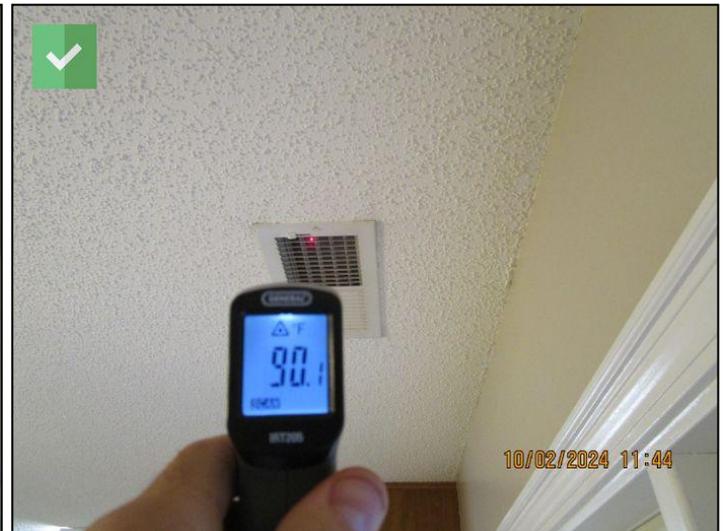
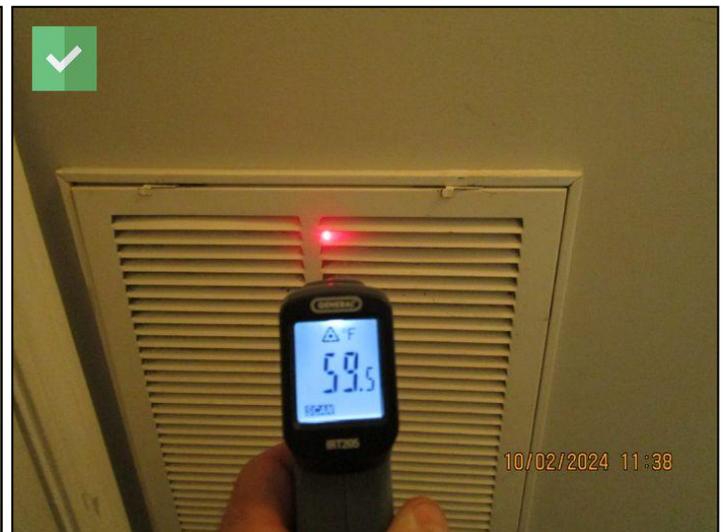
Heat Differential 30.6 Degrees F

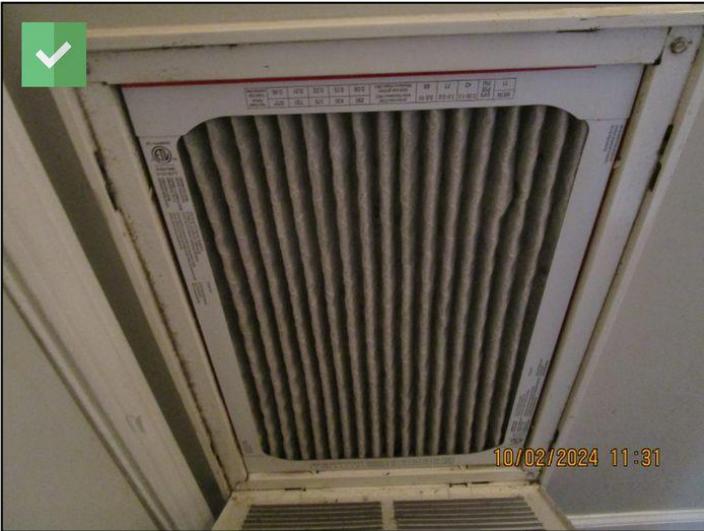
14x20x1

- IMPROVE: Filter(s)/grate(s) were dirty at the time of inspection. Filters help clean the house air, making the environment more pleasant. Filters also clean the air before it passes through the blower and heat exchanger. This helps to keep the furnace components working efficiently. Recommend a qualified individual clean the grate(s) and change the filter(s) periodically to ensure optimal function.

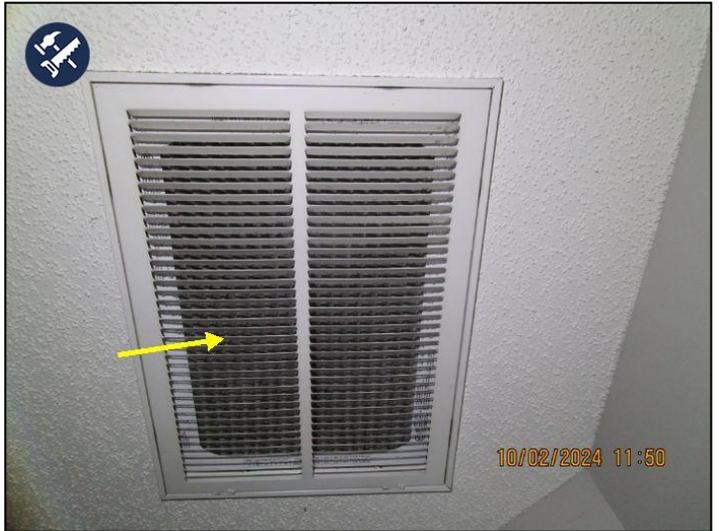
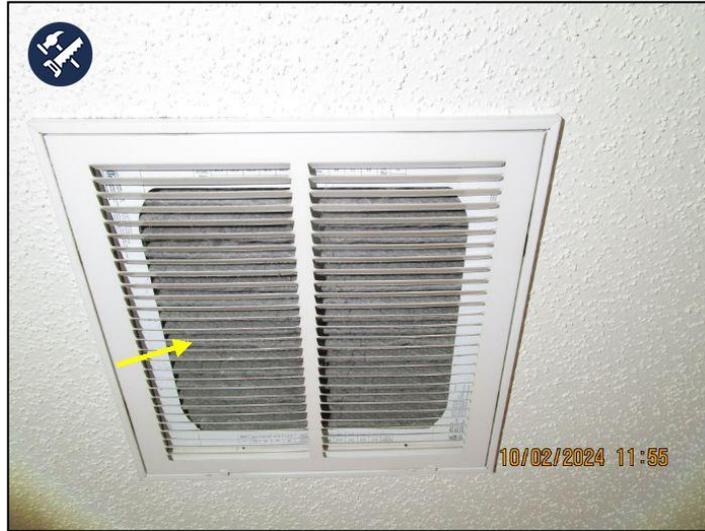
Dirty Filter(s)/Grate(s)
