Kempsey - Armidale Road Restoration

Arborist Report

Tree Assessment Report (Part A)

Kempsey to Armidale Road Recovery Program

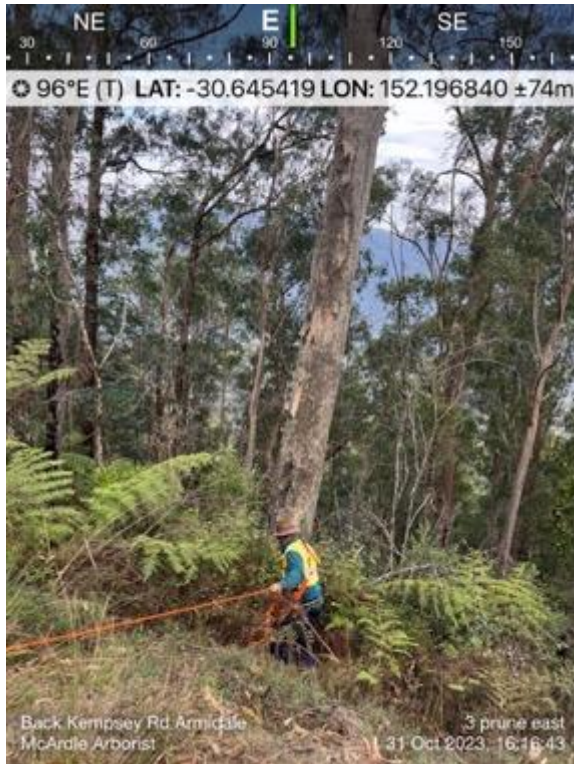
Plate 5: Tree 3, *Eucalyptus netriens* Prune dead wood to the East at 15 meters – heavy dead wood over site.

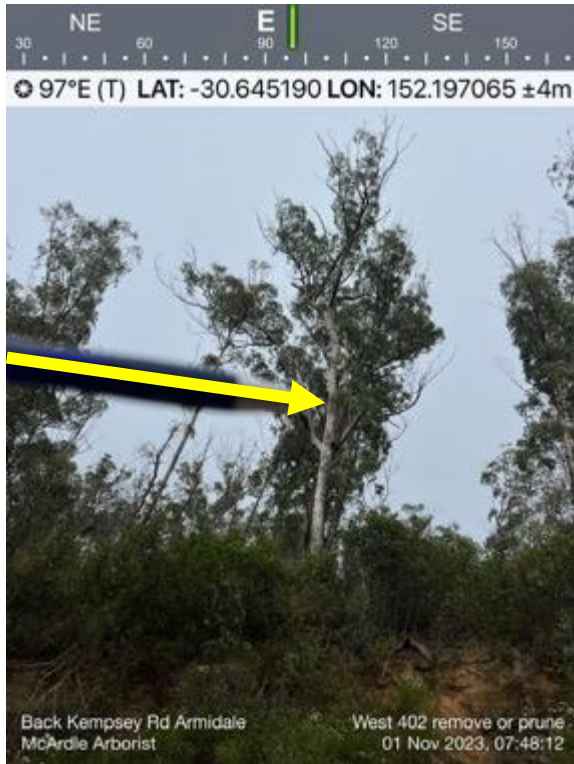
Plate 109: Tree 402, *Eucalyptus caliginosa*, Prune branches over work area or remove. Yellow arrow.
