## Building Survey Report

**Property Address:** 25 Anywhere Street  
Anytown  
BH50 1AA

**Chartered Building Surveyors**

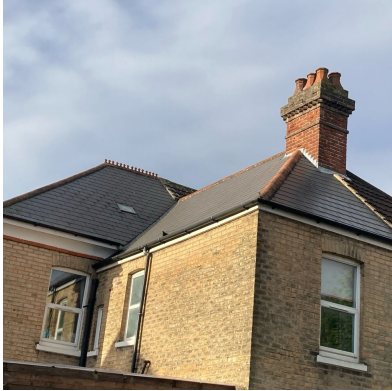
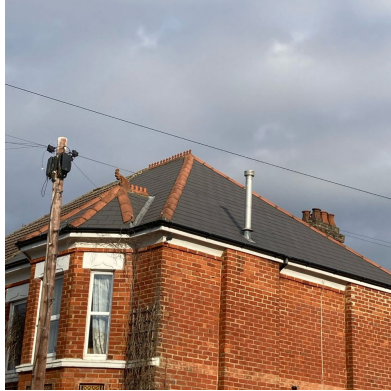
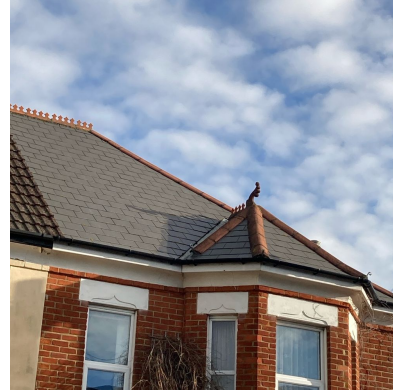
The roof covering has been replaced in the quite recent past.

The pitched roof coverings are in satisfactory condition.

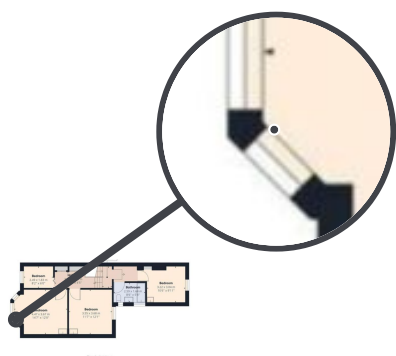
There are slightly elevated damp readings between the windows to this bay, and minor resultant damage to the decorations. You mentioned that you thought that there is a similar problem to the ground floor bay, but I found no elevated readings there.

I was not able to diagnose the cause of the elevated readings, but possible causes are a lack of a cavity tray over the windows and / or a missing vertical damp-proof course to the windows allowing water to bridge the cavity to the inner leaf.

I recommend that the area is inspected more closely from high level and consideration given to the provision of cavity trays over the windows, and the application of a breathable sealant to the brickwork around here. Alternatively/additionally, the internal plaster could be hacked off and replastered with a proprietary water-proof plaster or cavity membrane system (see section 5.5).

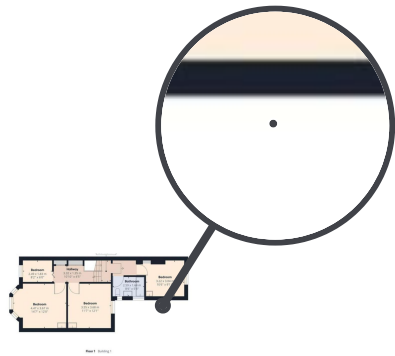
Further example of small area of eroded pointing.

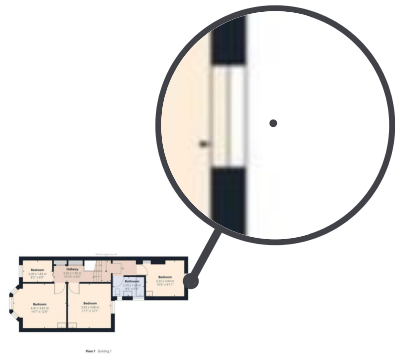
Small area of cracking through mortar joints.

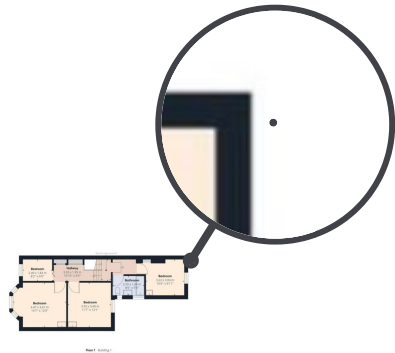
Short length of vertical cracking.

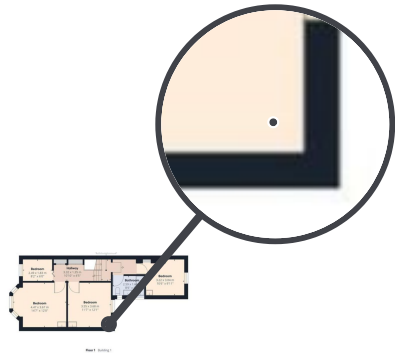
There is some discolouration here, but there were no elevated damp readings. It is possible that there is occasional dampness here. When work is being carried out to the external walls, I recommend that a couple of bricks are removed, and the cavity checked and cleared out as necessary.

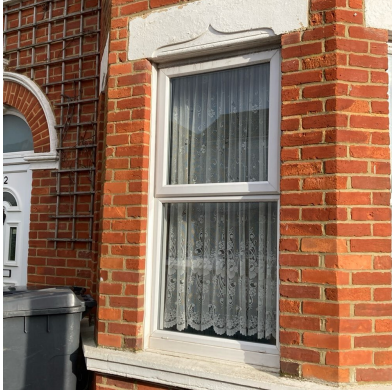
The windows are double glazed in PVC frames.

The windows are in satisfactory condition.

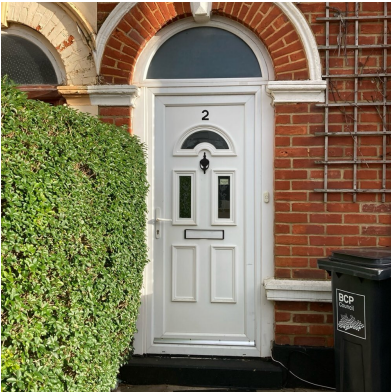
This door is made of PVC.  
This is in satisfactory condition.

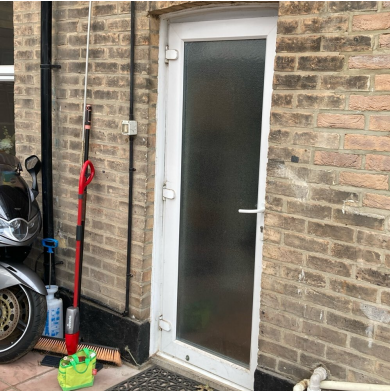
This door is made of PVC with double glazed panel(s).  
This is in satisfactory condition.

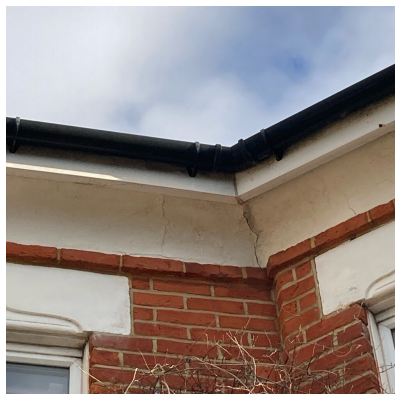
The external joinery includes fascias and soffits.

The external joinery is in satisfactory condition.

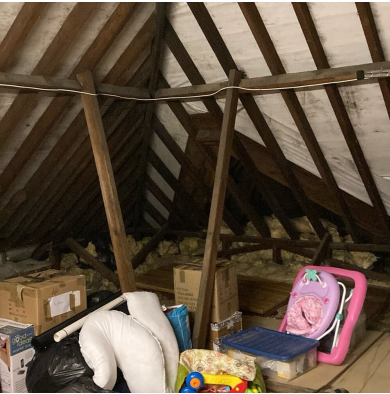
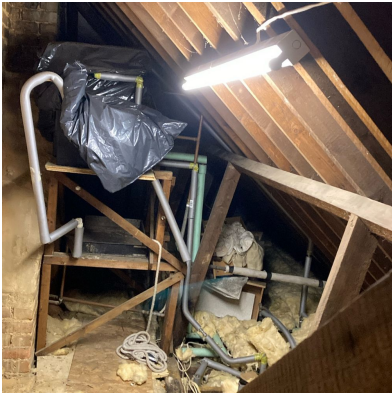
This chimney stack, where it has been removed to below roof level, has loose bricks. I recommend that this is made safe.

5.1 Roof structure: Repair chimney stack in roof space where bricks are loose.

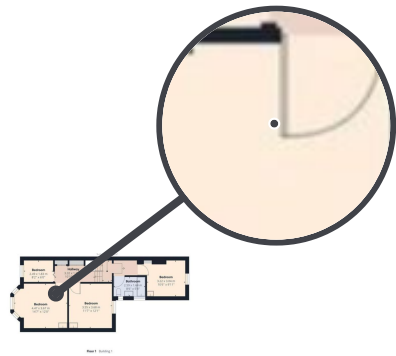
Example of hairline cracking.

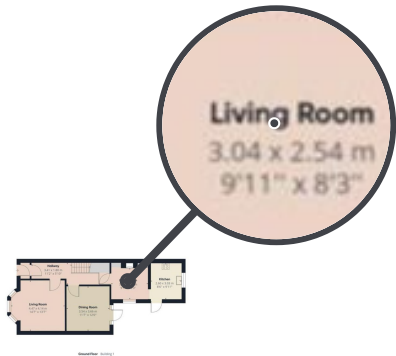
This ceiling has been lowered by a few inches. I couldn't see why, but it is possible that the original ceiling is in poor condition, or that there are services run within the void.

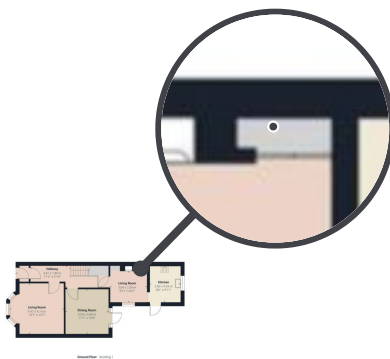
There is slight staining and slightly elevated damp readings here. I was not able to diagnose the cause of the elevated readings, but possible causes are sub-floor dampness or a current / old service leak. I recommend that the floorboards are lifted and the sub-floor timbers inspected, and all of the surrounding pipework is checked for a slight leak.

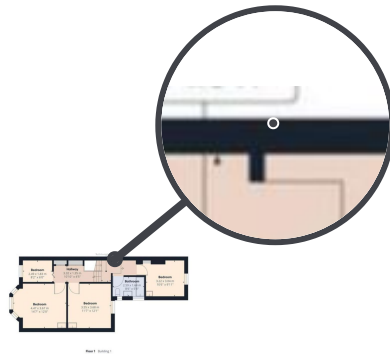
There is an old (repaired) vertical crack to the party wall in the roof space. In my opinion, no action is needed.

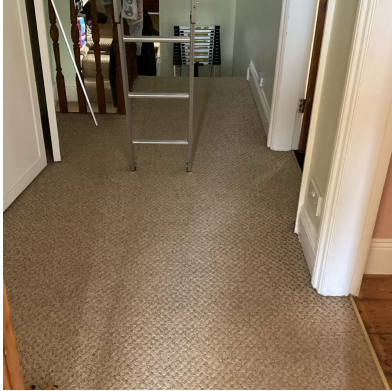
### Condition rating 1

The floors are in satisfactory condition.

Ground-floor timber floors require sub-floor vents to allow air to circulate beneath the floor. This prevents the build-up of condensation which can lead to timber decay (by way of wood-boring insects, wet rot or dry rot). Sub-floor vents are provided. These should not be obstructed.

If you decide to provide retrospective cavity wall insulation, and / or when work is being carried out to the external brickwork, I recommend that you check that the vents are sleeved through the cavity to the sub-floor.

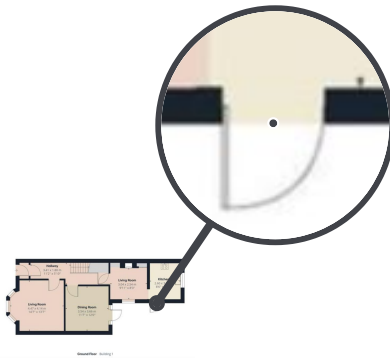
It is good practice for ground levels to be at least 150mm (6") below the internal floor level and damp-proof course (DPC), which helps to avoid dampness to the inside of external walls at low level. External ground levels are above this level outside the kitchen only, but this is common, and I found no evidence of any internal dampness as a result of this. Therefore, in my opinion, no action is needed in this regard, but if work is carried out to external hardlandscaping, I recommend that ground levels are lowered.

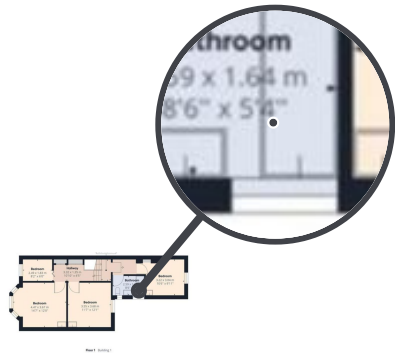
The floor is sloping here, but this is not uncommon in buildings of this age. In my opinion, no action is required, but it should be possible to level the floor if / when the floor covering and bathroom suite is replaced.

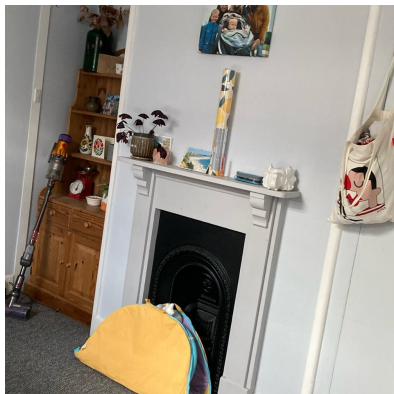
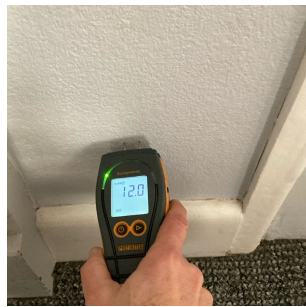
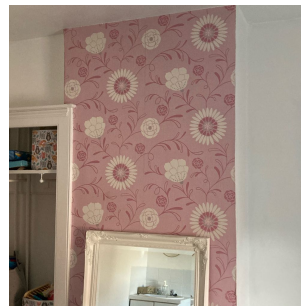
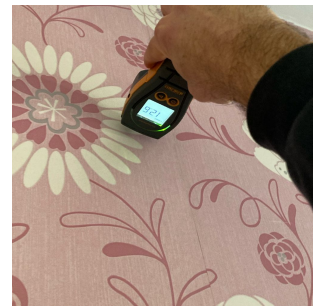
There is some slight dampness to the bottom of the chimney breast. This is quite common in older buildings and could be from dampness rising up from the ground through the hearth. It could also be due to a bridged cavity (as described in section 4.4) and / or water entering the cavity at high level (where the brickwork is in poor condition (see below)), and tracking down the cavity.

There is also slight dampness at the top of the chimney breast in the bedroom. In my opinion, this is likely to be caused by hygroscopic salts remaining in the brickwork and plaster originating from flue gases (with hygroscopic salts, moisture is attracted from the air into the plaster). I recommend that you remove the damp plaster and re-plaster with a proprietary salt retardant render/plaster, or apply a cavity membrane before plastering with plasterboard.

I recommend that you:

1. Carry out repairs to the brickwork as described elsewhere, and when this work is being carried out to the external walls, remove a couple of bricks, and check the cavity and clear out as necessary.
2. If the dampness persists, then the most cost effective solution might be to hack off the plaster and to replaster with a proprietary water-proof plaster or to line with a cavity membrane system.

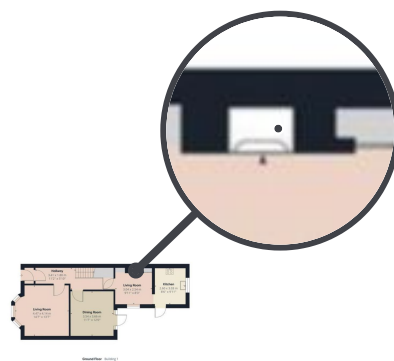
## Condition rating 1

There is a chimney breast here, continuing up through the room above, then joining to form the chimney stack above roof level.

The chimney breast is in satisfactory condition with no evidence of any movement or damp.

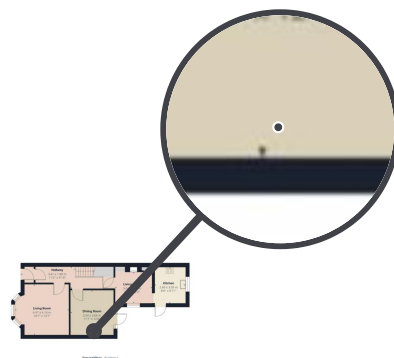
## Condition rating 1

There is a flush chimney breast here, continuing up through the room above. The chimney stack has been removed to below roof level.

The chimney breast is in satisfactory condition with no evidence of any movement or damp.

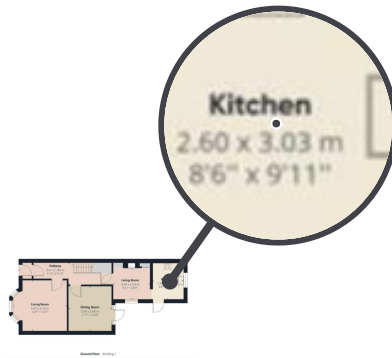
### Condition rating 1

The built-in fittings are in satisfactory condition.

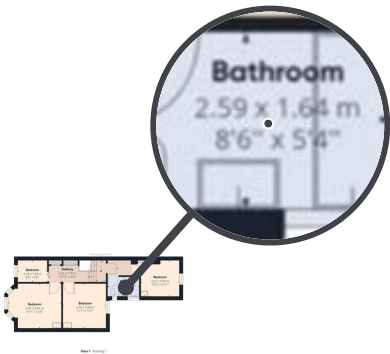
Condition rating 1

The bathroom fittings are in satisfactory condition.

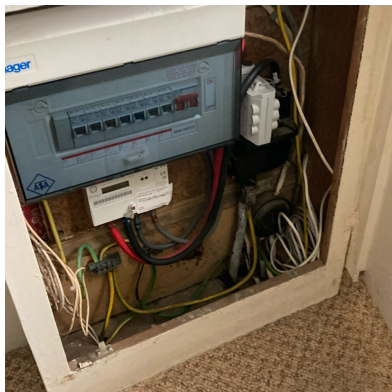
#### Condition rating 3

The consumer unit is of the modern type with a Residual Circuit Device and Miniature Circuit Breakers to provide protection. I saw nothing that concerned me, but I saw no evidence that the electrical system has been checked in the last ten years. You should ask your legal adviser to check for this (see Section 8), and if no such evidence is available, you should ask an appropriately qualified person to test the installation now.

**(Further investigation).**

6.1 Electricity: Obtain electricity certificate from the last 10 years.

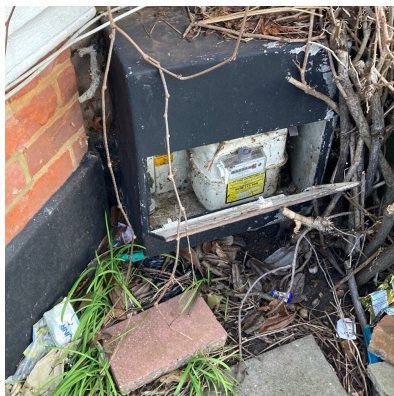
### Condition rating 3

I could see no features that concerned me. However, I saw no evidence that the gas installation has been inspected and tested in the last 12 months. You should ask your legal adviser to check for this (see Section 8), and if no such evidence is available, you should ask an appropriately qualified person to test the gas installation now.

6.2 Gas/oil: Obtain gas safety certificate and/or servicing records from the last 12 months.

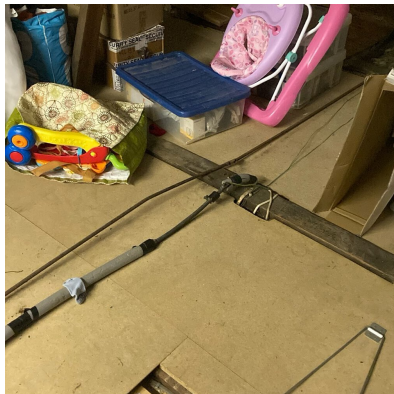
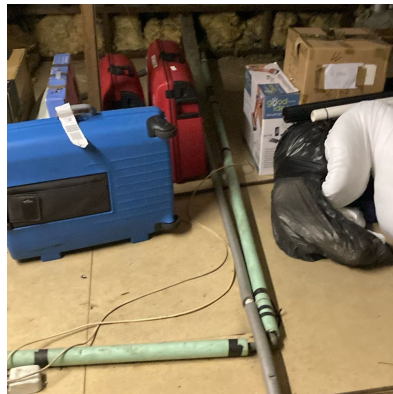
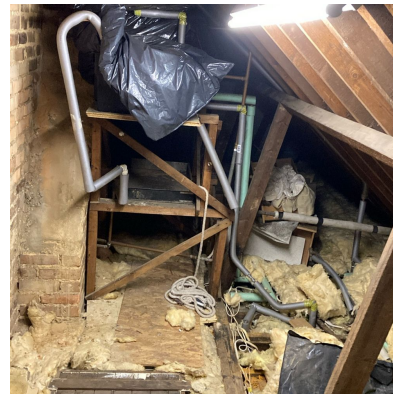
### Condition rating 2

I couldn't find the internal stop valve (these are often under the kitchen sink, but I couldn't see it here). It is important that there is an internal stop valve and that this is freely working so that the water can be quickly turned off in the event of a leak, or when maintenance work needs to be carried out to the plumbing system. If there is no internal stop valve, then you should have one installed.

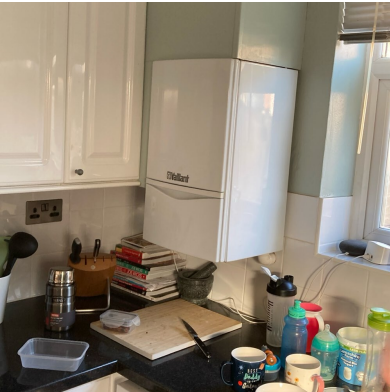
Condition rating 1

The property is heated by a fixed heating system consisting of a natural gas-fired boiler with radiators.

I saw nothing that concerned me about the main heating system.

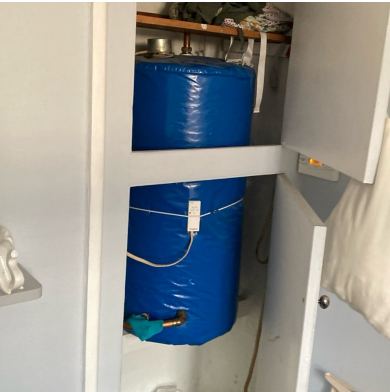
6.5 Water heating //

The hot water is provided by the main heating boiler and stored in a separate hot water storage cylinder or tank.

I saw nothing that concerned me, but the hot water cylinder might be considered on the small side for a property of this size. Some purchasers would choose to upgrade the hot water system, for example to a mains-pressured sealed hot water system. A cold water storage tank is not needed for this type of system.

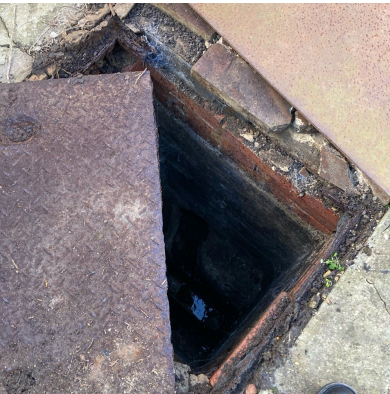
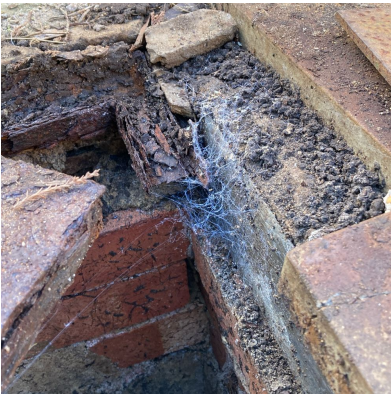
Additional Image 1

The manhole covers / frames are corroded and this could be a safety hazard. This / these should be replaced.

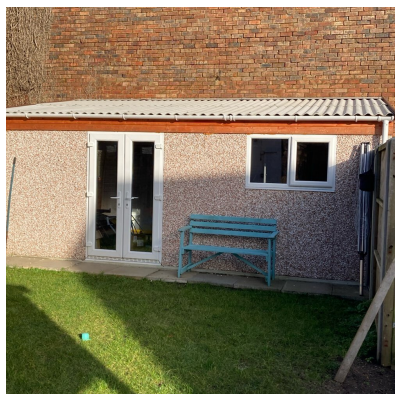
### 7.1 Garage //

There is a detached garage.

The garage is in satisfactory condition.
