Home Inspection Report

New Constrcution Sample

Wake Forest, NC 27587

Inspected on Mon, Aug 18, 2025 at 8:00 AM

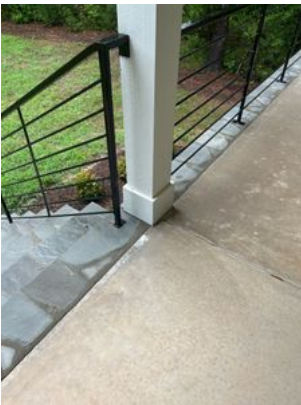
Exterior: Exterior Trim Material

A 1/2" gap is required between composite trim material and any concrete surface per manufacturer's installation instructions. Cutting any trim to meet this guideline is recommended to help reduce possible moisture related damage.

Properly flash and space at least 1/2" from any flatwork (such as porches, patios, decks, or driveways) or horizontal brick ledge. Prime and paint bottom edge before installing. Also all miter joints should be glued and caulked.

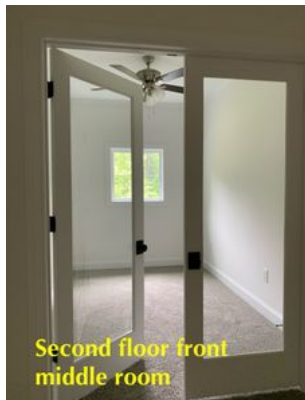
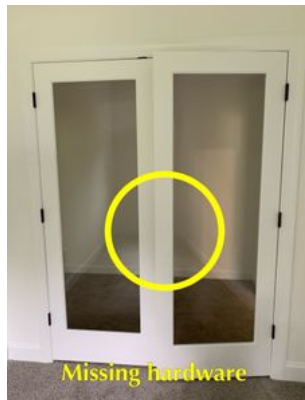
Door handles were not installed on the 2nd floor office doors.

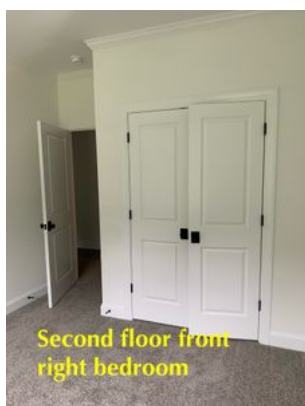
There was cosmetic closet door in the second floor front right bedroom.

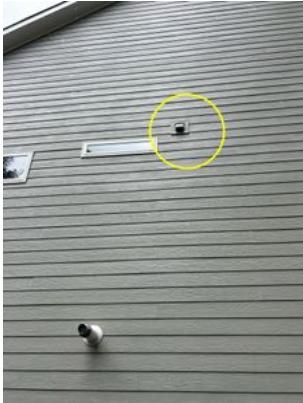
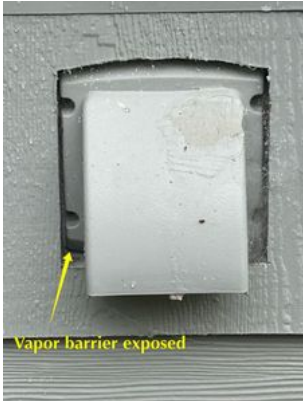
Sealing the gap between the exterior vent cap(s) and siding is recommended to prevent water entry behind the siding.

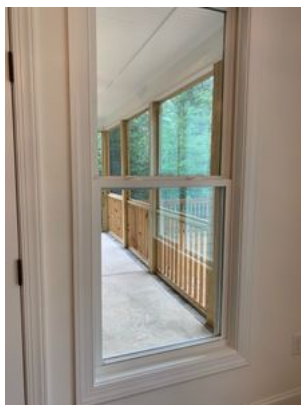
Multiple windows are loud when opened compared to other windows in the home. It is recommended to have a qualified professional make any adjustments needed to allow for easier function. (Photos may not be all inclusive)

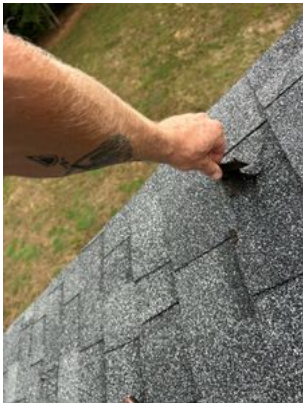
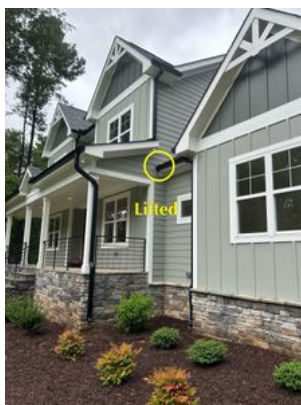
Multiple shingles were found to be damaged. Replacement of the affected shingles is recommended. Damage that compromises the protective granule layer and asphalt composition can lead to premature shingle failure, increasing the risk of water intrusion.

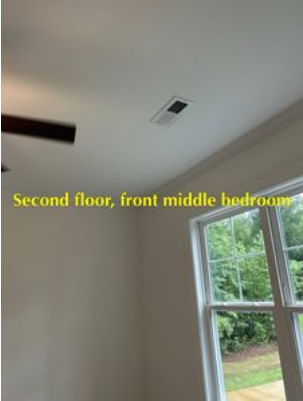
Second floor, front middle bedroom

Cosmetic defect at an HVAC supply diffuser. The ceiling paint will need to be touched up.

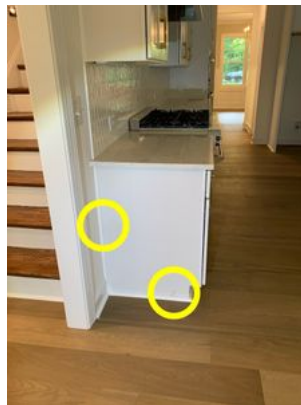
There were several areas of damaged finish on the kitchen cabinets.

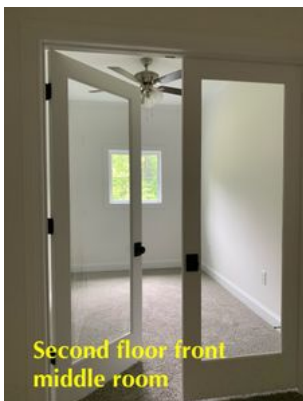
Comment 50 Deficiency

Door handles were not installed on the 2nd floor office doors.

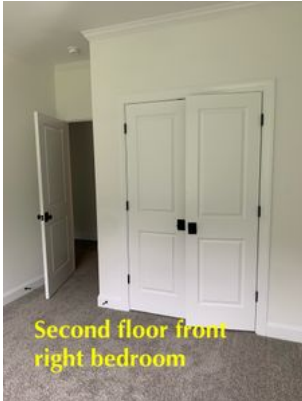
Comment 51

There was cosmetic closet door in the second floor front right bedroom.
