Home Inspection Report

123 Sample Report Dr
Raleigh, NC 27606

Inspected By: Stephen Pait, CMI- Lic # 4329 &
Septic Lic #72451

Inspected on Thu, Jan 2, 2025 at 8:00 AM

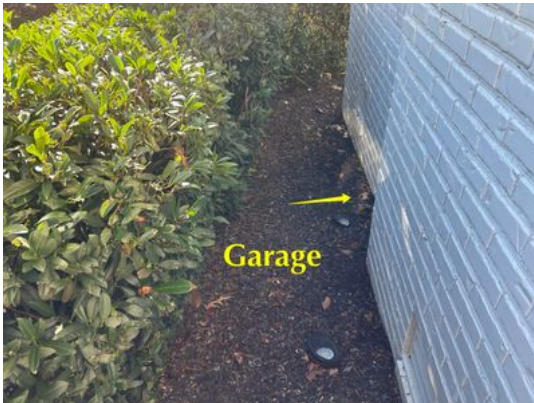
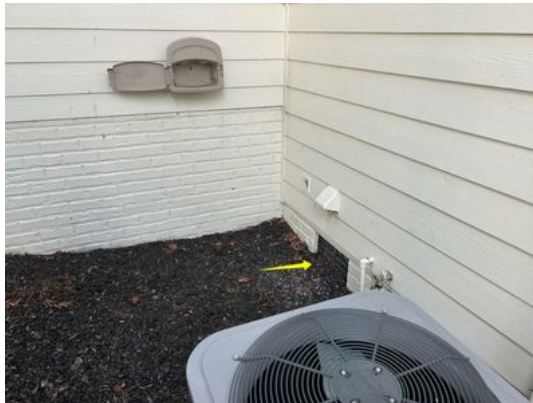
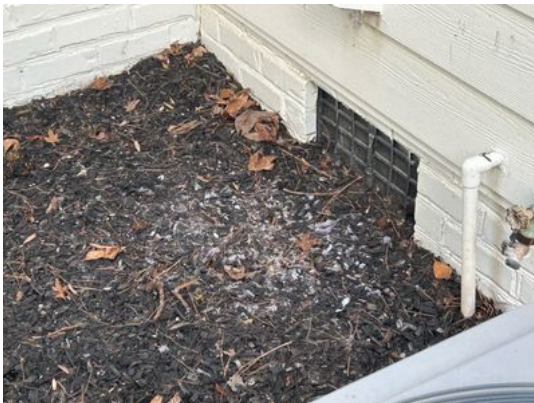
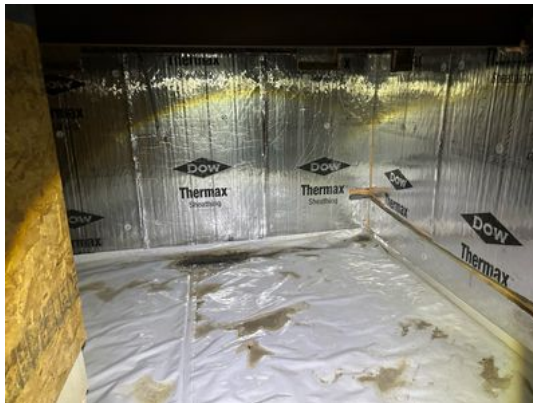
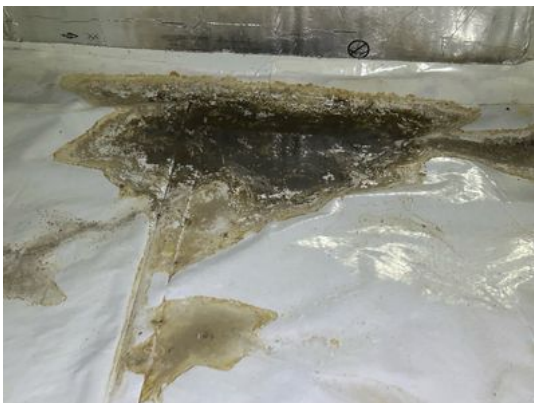
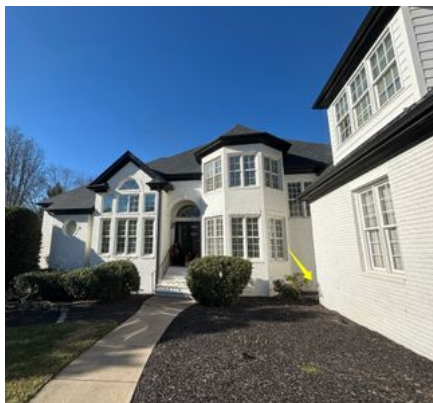
The site grading in multiple areas slopes toward the home or is not properly sloped away from the foundation. It is required that grading slopes away from the foundation 6 inches in the first 10 feet where possible. This will help reduce water intrusion into the foundation and deterioration of materials, as well as help reduce the promotion of foundation settlement . Raising the grade or sloping these areas is recommended.

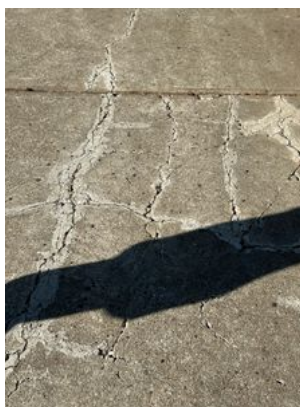
The driveway has a significant number of stress or settlement cracks. Over time these cracks could lead to lifting or settling of the driveway which will create walking hazards and issues with driving. Repairing any damaged areas is recommended by a qualified concrete contractor.

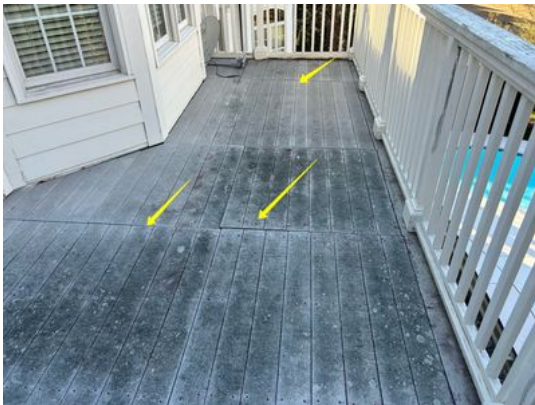
Multiple sections of the floating balcony deck were loose/lifted which creates a trip hazard. Repair is recommended by a qualified professional.

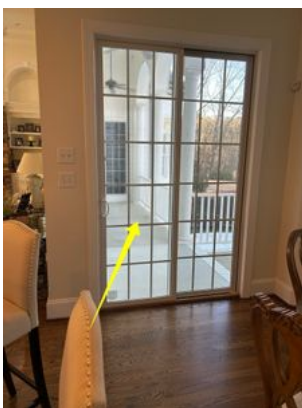
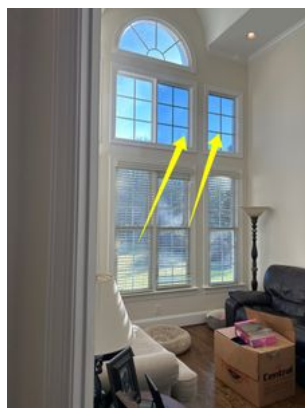
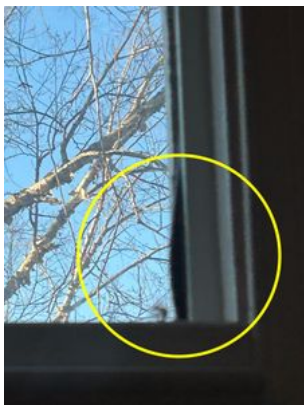
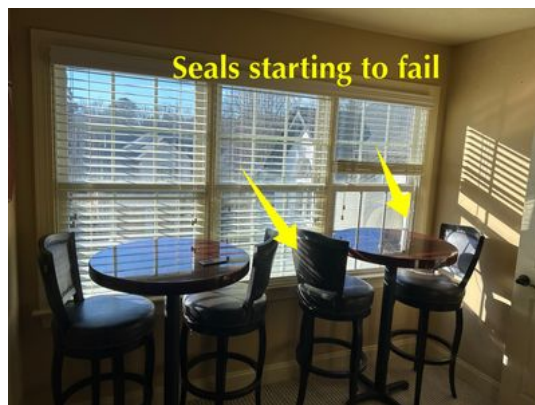
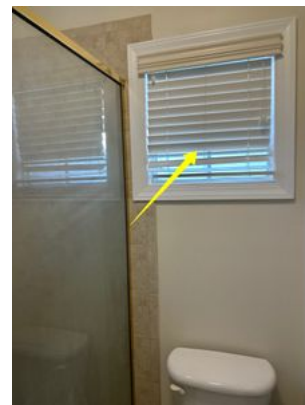
Comment 5 Deficiency

Hazing and moisture was observed in between multiple window panes. This is likely caused by deterioration of the low-e film and hermetic seal in between the window panes. Low-E is a film applied to the windows to help reduce solar heat gain. This condition may result in increased solar heat gain. It is recommended to consult with a qualified window repair professional to evaluate this condition and perform and necessary repairs or replacements.

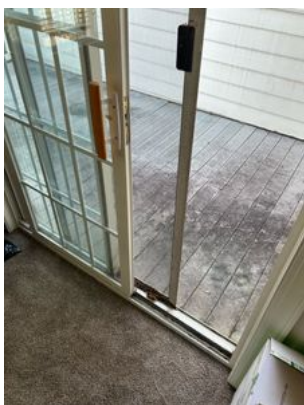
Comment 6 Information

Screen door would not function. (Debris)

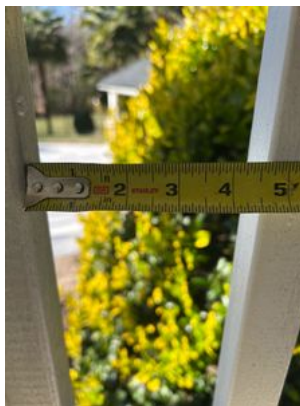
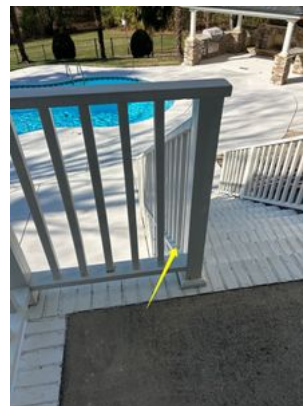
Comment 8
Deficiency

At several areas on the back porch, the spindle spacing does not meet current requirements. A 4" sphere should not pass between two spindles. This is considered a fall safety hazard. A qualified professional is recommended to repair the railing where needed. (Photos are not all inclusive)

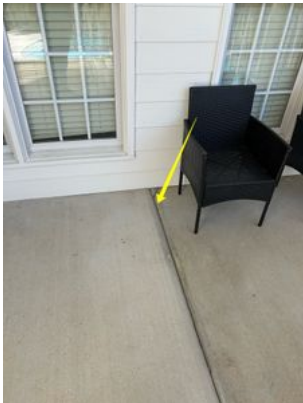
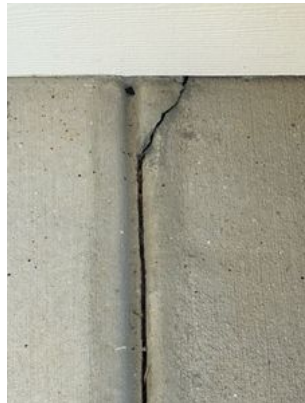
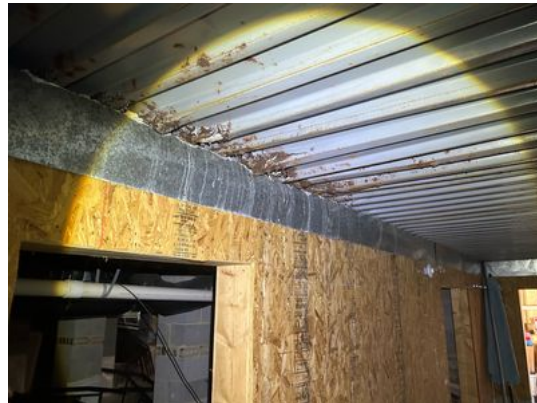
Comment 9
Deficiency

A qualified concrete contractor is recommended to evaluate the back porch concrete slab and corrugated form panels. The slab has settlement at a control joint which appears to promote water entry at the home's rim joist. This has led to deterioration of the metal forms and the concrete was brittle and breaking apart. (See video). Over time, this could lead to possible deterioration of the framing in this location.

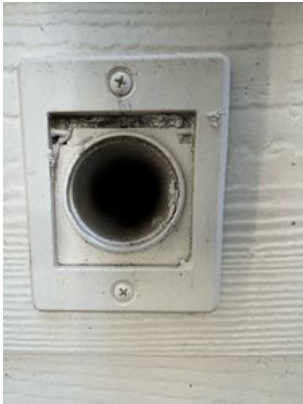
Central vacuum system (CVS): Testing the CVS is beyond the scope of a NC home inspector

Installing a cap on the back right exterior vent of the CVS is recommended to prevent possible pest entry.

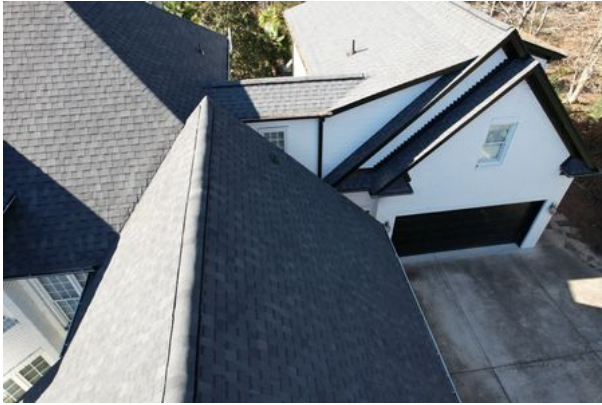
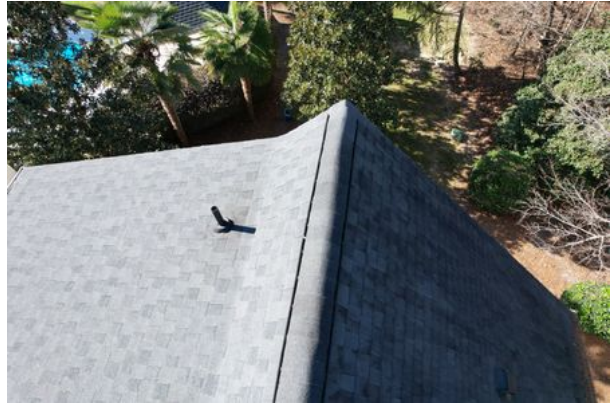
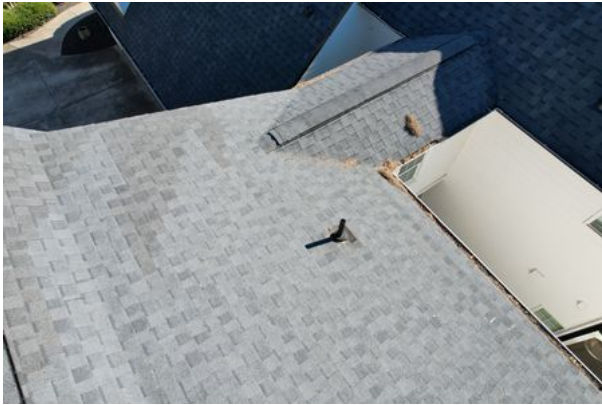
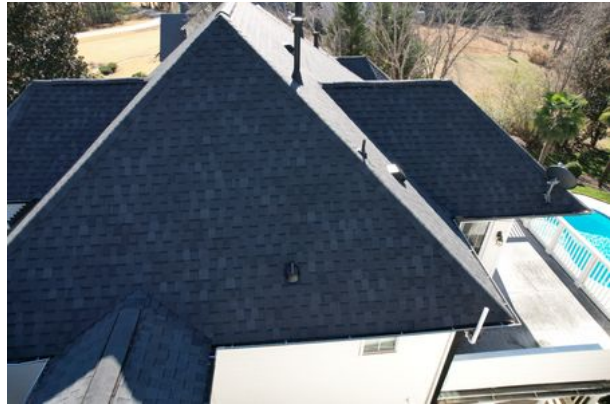
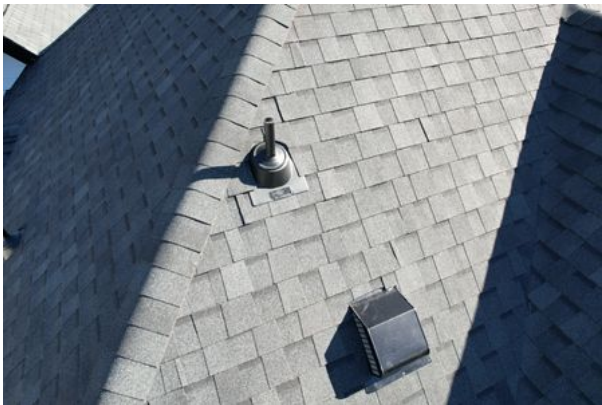
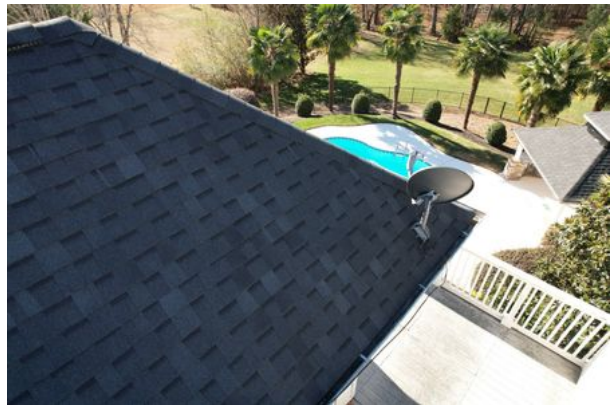
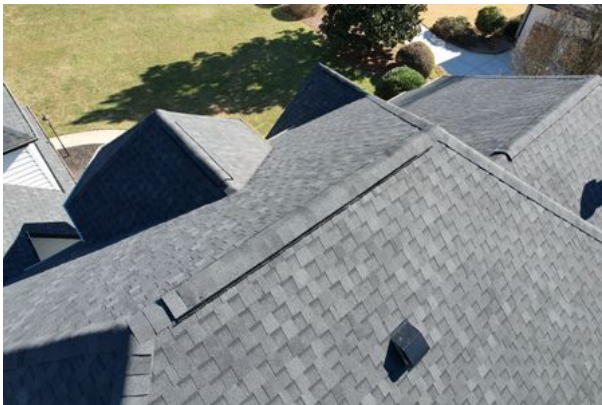
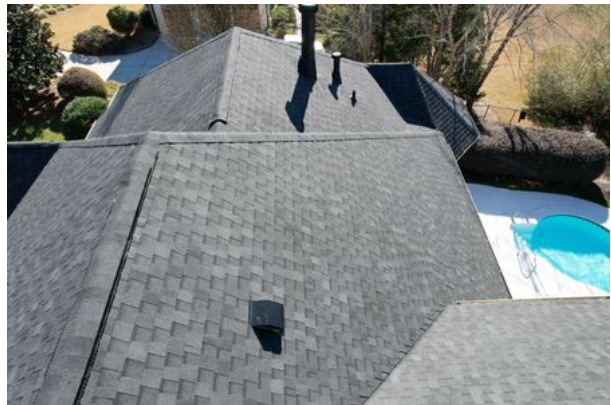
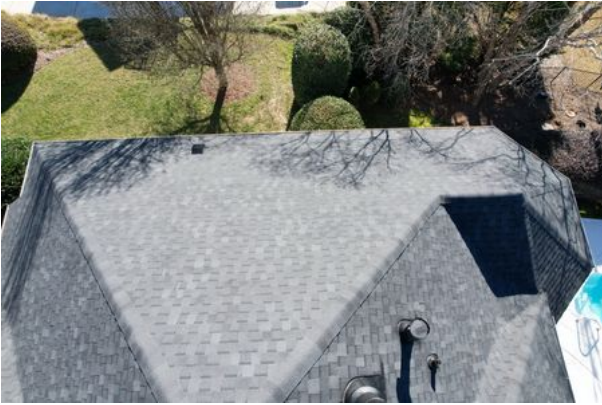
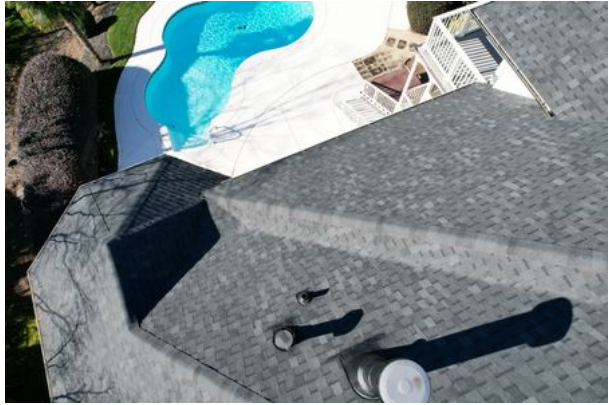
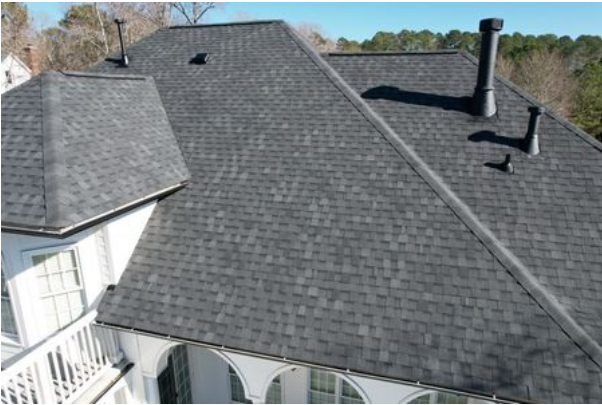
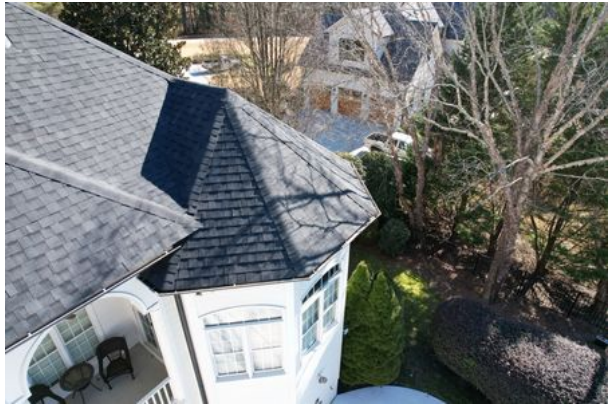
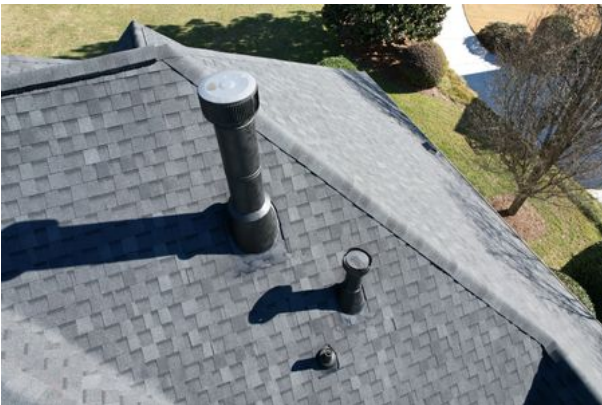
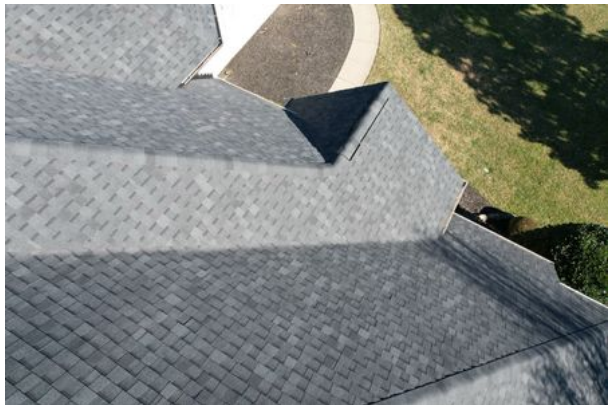
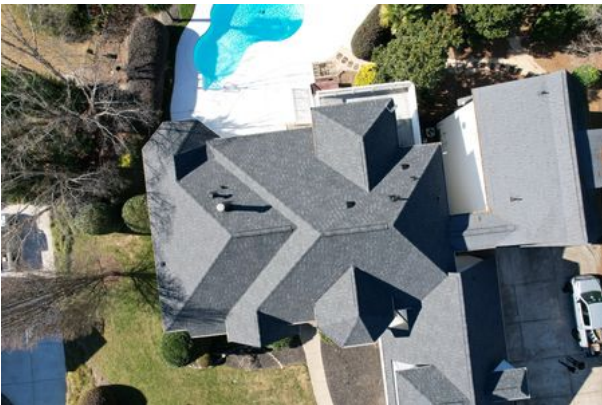
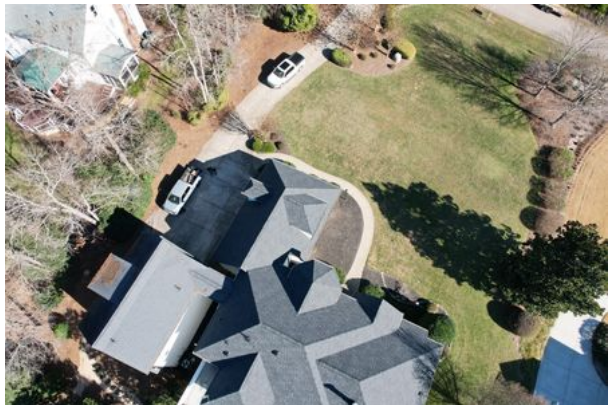
General Roof Photo(s)

There was debris from trees and surrounding vegetation on the roof. This can allow water to back up under the roofing materials and could lead to water entry and damage to surrounding components. Removal of the debris is recommended.

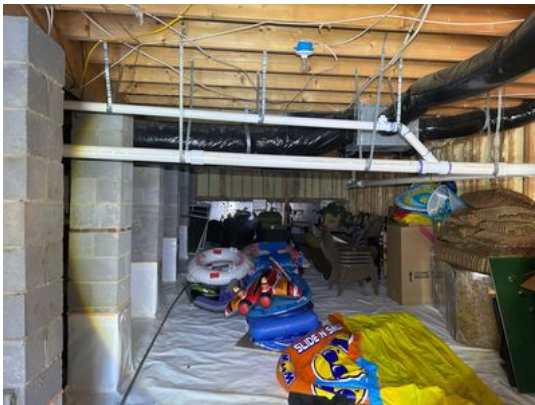
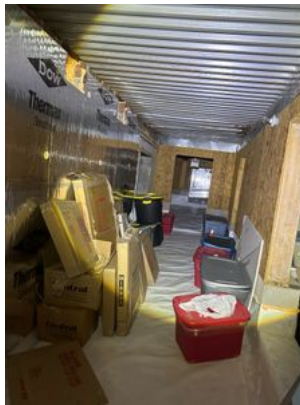
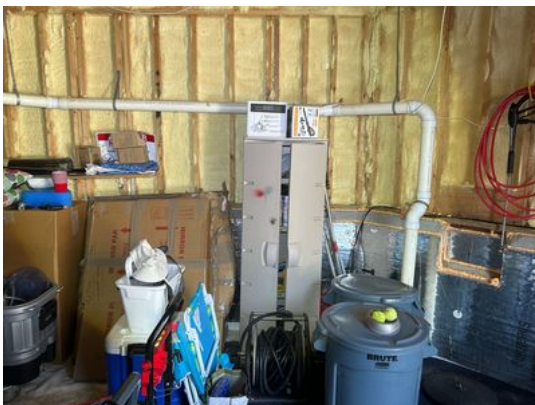
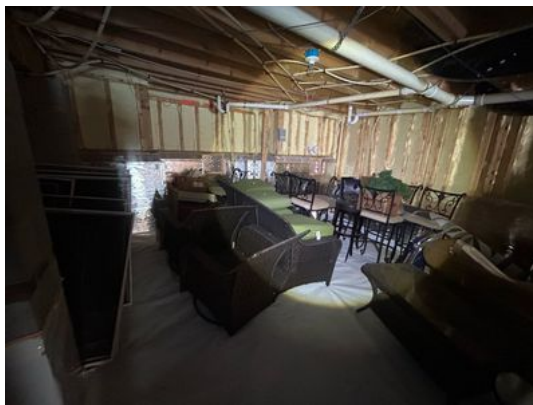
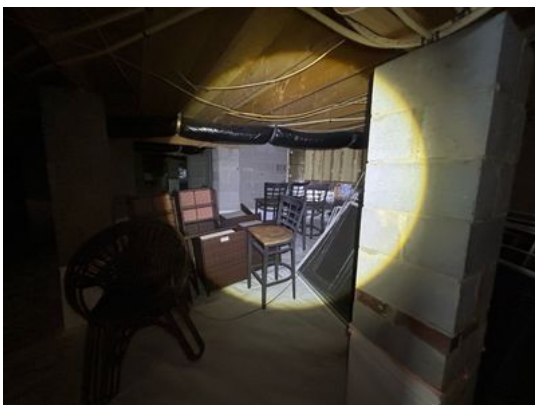
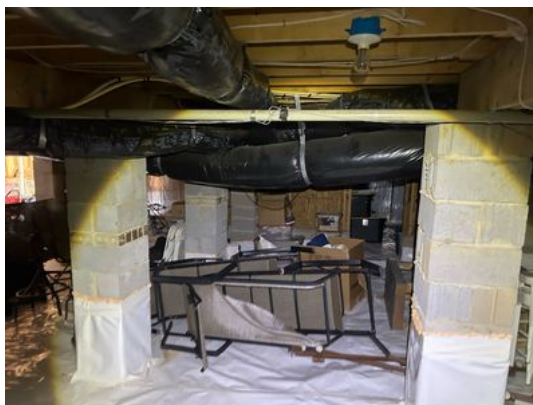
Comment 22 Information

This home has a sealed/encapsulated crawlspace which reduces the visibility of the foundation walls and piers. Additionally, portions of the foundation stem wall were not visible due to items being stored in the crawlspace.

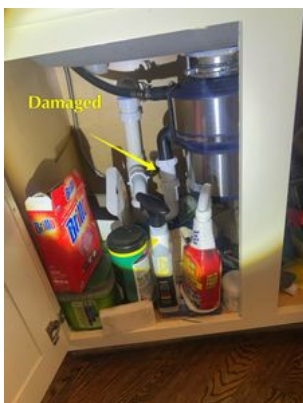
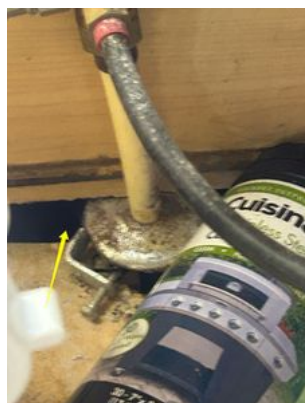
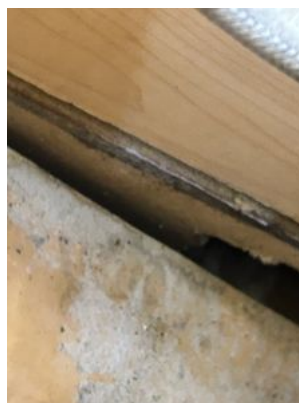
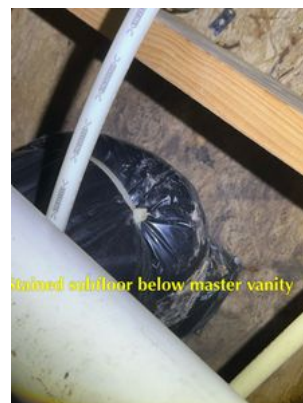
The subfloor at multiple hvac discharge boots was discolored and showed evidence of previous high moisture. Many times the air vents directly under the cabinet and is not in a chase or duct. The cool conditioned air leaves moisture under the cabinet base and this causes staining to the subfloor/base cabinet and sometimes damage to the base cabinet bottom panel. The subfloor was structurally sound in this location and moisture levels were normal at the time of inspection. The kitchen sink base cabinet was damaged and warm air was discharging inside the cabinet. A qualified contractor is recommended to evaluate the air discharge and repair the kitchen base cabinet to prevent further damage.

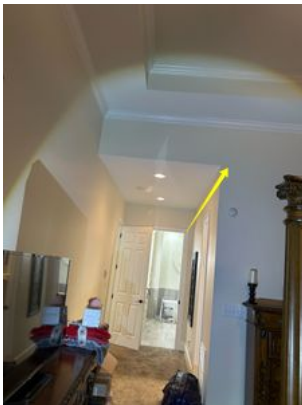
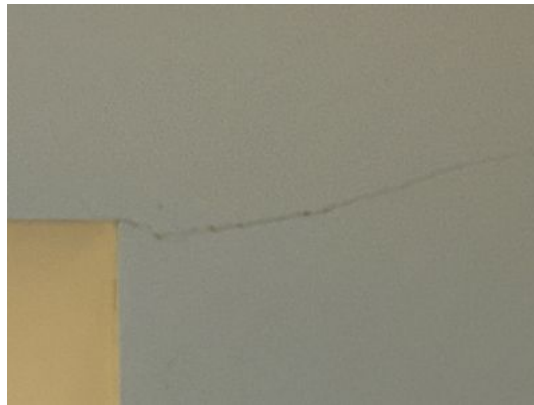
There is a diagonal crack in the sheetrock at a master bedroom wall. This type of crack is typically due to settlement. There were no signs of additional settlement to ceilings/floors/foundations below these locations. The crawlspace foundation was intact and in contact with the floor structure. This is most likely due to typical settlement.

As for what the cause of settlement here is from the from, that is unable to be determined and it is beyond the scope of a NC Licensed Home Inspector. To determine conclusively the causes or whether movement is progressive in nature or old and no longer occurring, such determination, if desired, would be provided by a licensed structural engineer.

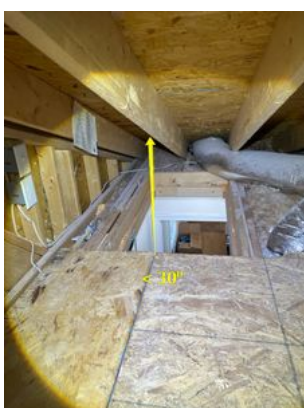
Comment 25 Information

The clearance height above the garage apartment attic access ladder may make it difficult for replacement of the HVAC air handler if needed. There was not 30" of headroom.

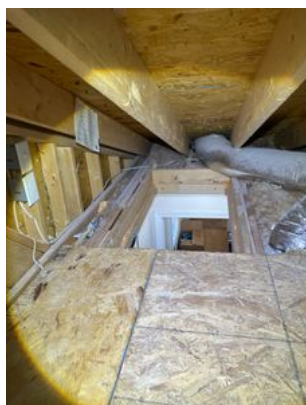
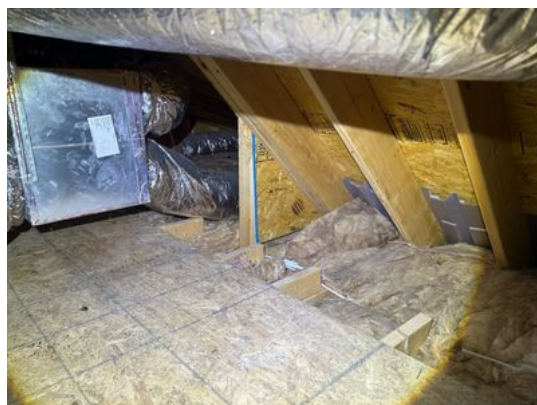
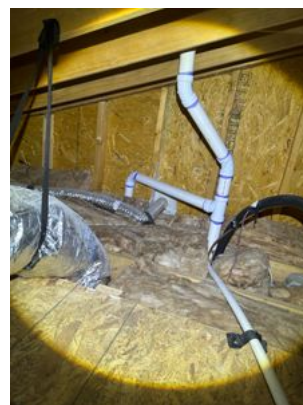
Apt-General Attic Photo(s)

Portions of the attic were unable to be inspected due to access restrictions due to mechanical equipment, roof geometry or personal belongings hindering visibility.

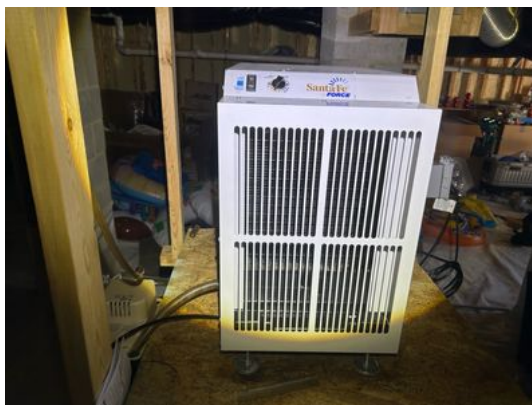
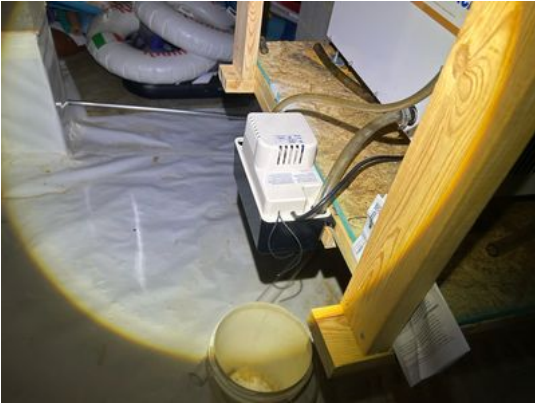
Comment 30 Information

There was a crawlspace dehumidifier. It is beyond the scope of a NC Licensed Home Inspector to determine if a dehumidifier is properly functioning. There was no water/condensation inside the condensate pump at the time of inspection but the system was on and running.

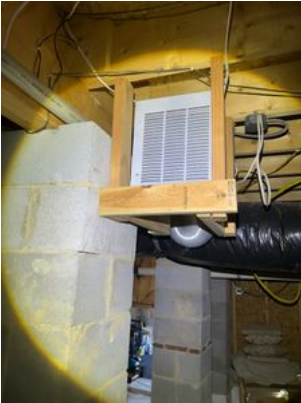
Comment 31
Information

Previous crawlspace vent no longer in use.

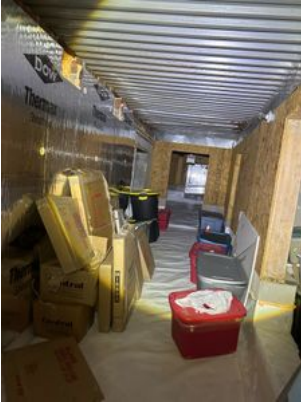
Comment 33
Information

Scrap wood and other organic materials have been left in the crawlspace. These items attract WDO (wood destroying organisms such as termites). Remove all excess debris from the crawlspace.

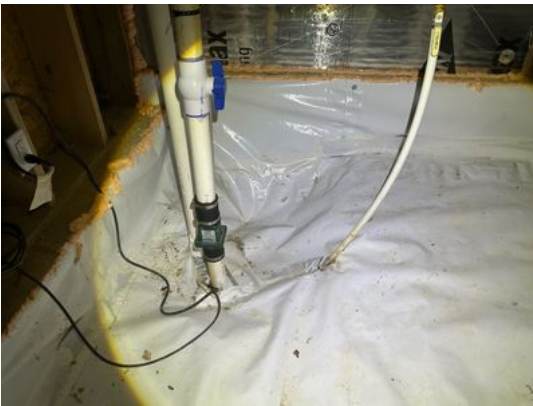
Comment 34
Information

There was a ground water water sump pump located in the crawlspace that was unable to be manually tested due to being covered with the vapor barrier. The final discharge location was not confirmed.

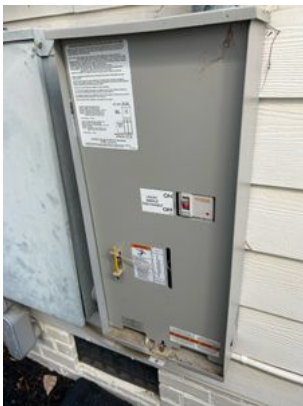
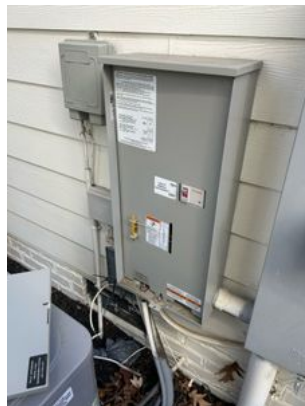
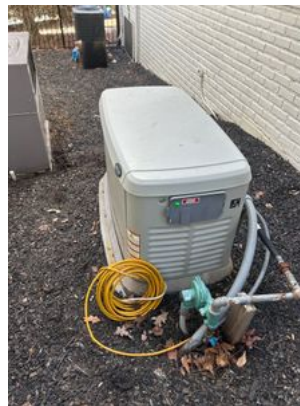
Comment 35 Information

Generators, their electrical panels, components and their installation are beyond the scope of the North Carolina home inspector. For a complete inspection of the system, contact a licensed electrician.

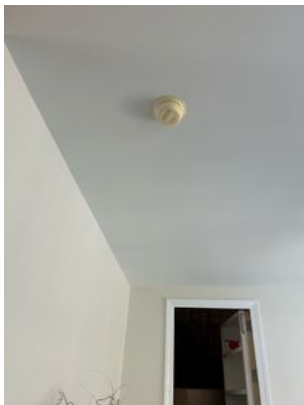
Comment 37 Deficiency

Hardwired smoke alarms are required to be connected to the home's electrical system and should set off every alarm in the home when tested. The garage apartment smoke alarms, when tested, did not set off the other alarms in the home which is a safety hazard. Additionally, multiple alarms in this home were past their useful life expectancy. Alarms should be replaced every 10 years. Further evaluation by licensed electrician is recommended.

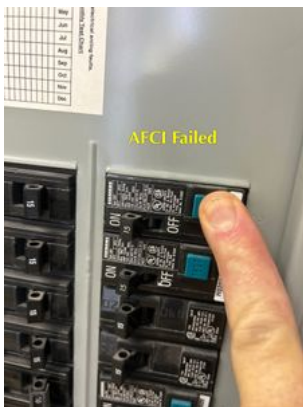
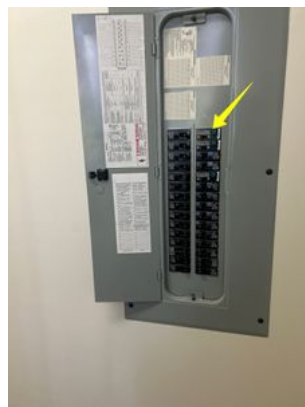
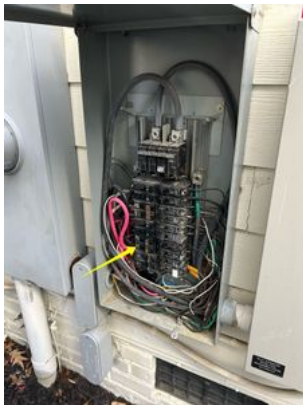
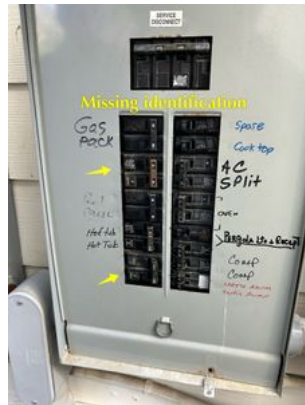
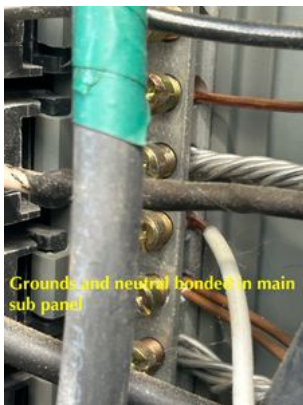
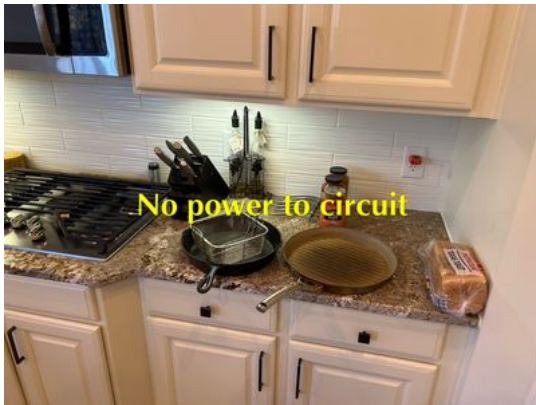
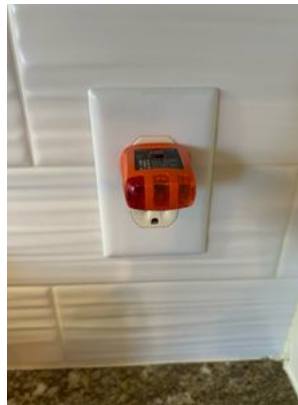
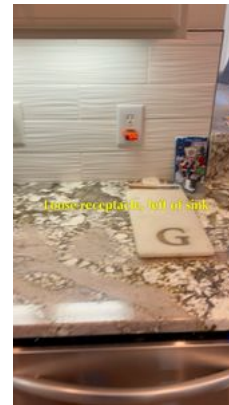
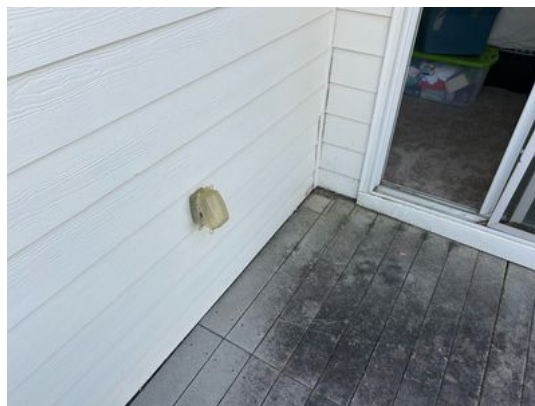
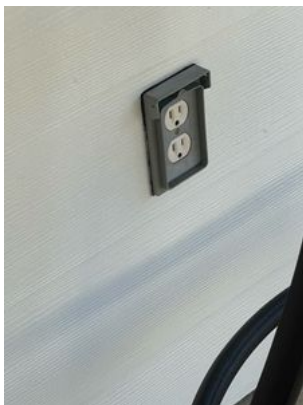
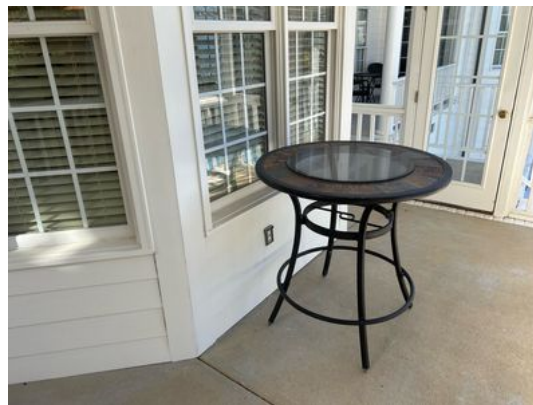
There were multiple deficiencies in the electrical system that should be evaluated/repair by a licensed electrician.

- An AFCI breaker failed to trip when tested in the laundry room sub panel. AFCI helps protect against potential fire hazards.
- A breaker was not properly seated on the bus bar in the exterior sub panel. This is a safety hazard that could lead to potential arcing or fire safety hazard.

- All electrical breakers are required to be properly identified on the legend attached to the panel. There were missing identifications on the exterior sub panel. This is a safety hazard.

- A large gauge conductor was installed in a 20A breaker in the exterior sub panel. A conductor too large to properly fit under a breaker terminal screw could lead to improper fit or needing to be modified to fit. Modified or improperly secured conductors can be a fire safety hazard. The max size wire gauge is typically stated by the manufacturer. The inspector was unable to confirm if the conductor had been modified. Typically a split bolt or wire nut is used in this application to downsize the conductor to fit the breaker.

- The exterior sub panel has a mismatching breaker. All breakers installed are required to be of the same type and manufacturer of the service panel. There are however some breakers that are suitable for replacement of certain breakers in certain panelboards. This information is provided by the breaker manufacturer. Improperly installed breakers can lead to voided warranty, failure or even fires.

- The GFCI receptacle to the right of the cooktop had no power and would not reset. Therefore, all receptacles on this circuit were unable to be tested. (Breakfast nook as well)

- The receptacle to the left of the kitchen sink was loose and should be properly secured to prevent possible loosening of the electrical conductor connections. Improperly/loosely connected wiring could result in arcing which can lead to possible fires. (Cover plate also broken)
- There was an open electrical junction box located in the right side of the crawlspace. All junction boxes should have a blank plate cover installed to prevent access to the electrical conductors.
- Replacing the missing exterior receptacle's weatherproof cover on the back side of the home and damaged cover on the balcony is recommended to prevent possible moisture entry which could lead to nuisance tripping of the GFCI receptacle and premature deterioration of the electrical components.

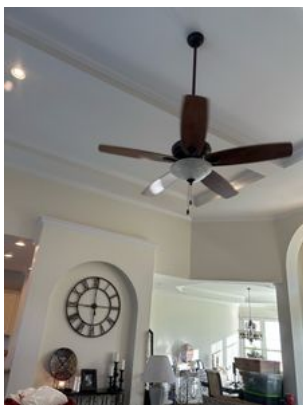
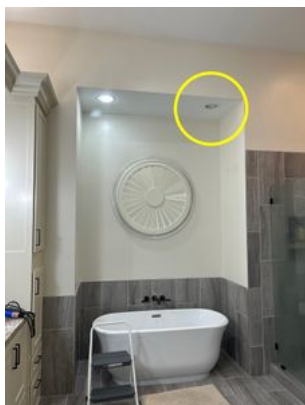
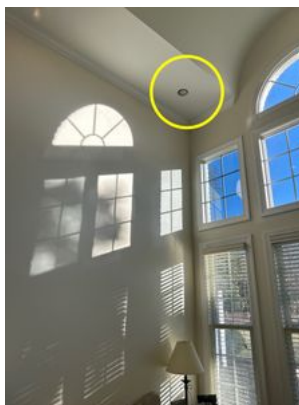
Comment 40
Deficiency

Multiple light fixtures would not illuminate using standard operating controls/switches. Replace the lightbulb and if issues continue, further evaluation by a licensed electrician is required. (Photos may not be all inclusive). Multiple fixtures has at least one bulb not functional.

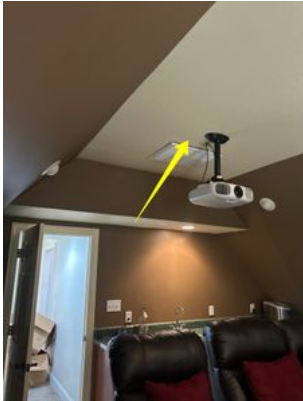
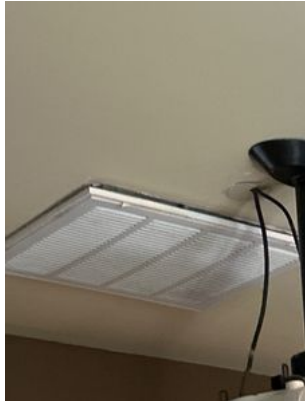
Secure the loose return register in the movie theatre room to prevent detachment.

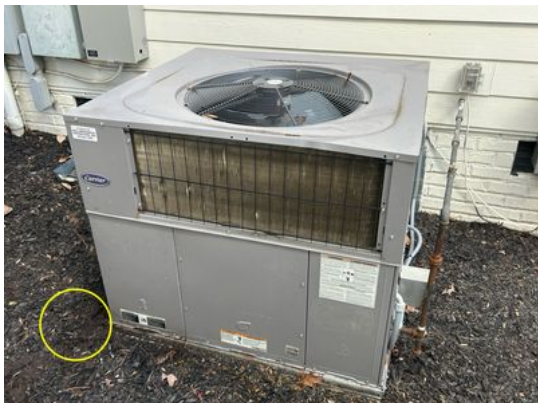
The HVAC condensate drain line should not be concealed underneath grade. The line should drain 6" +/- above grade to prevent it from being clogged which could lead to backups and leaking at the unit or nuisance shutoffs. Raise the drain line as needed to prevent blockage.

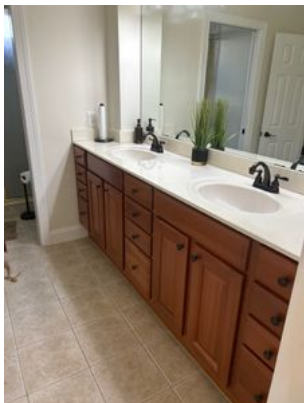
Comment 58 **Information**

Multiple pop up stoppers in bathroom lavatories will not hold water. Repair or replace to function as desired. (Photos are not all inclusive)

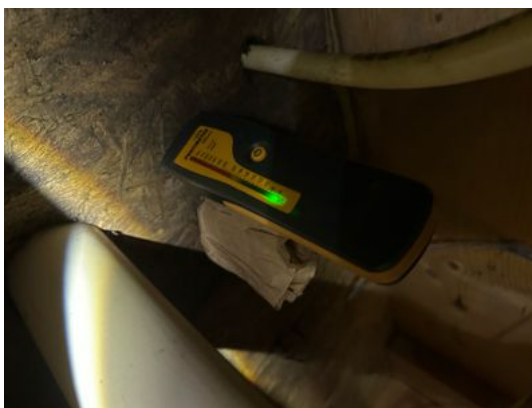
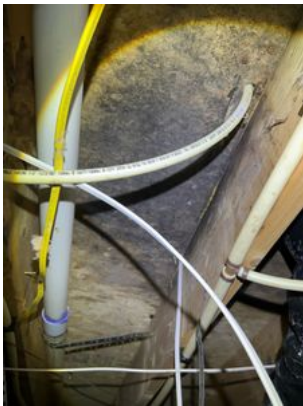
Comment 59 **Information**

There are signs of previous water stains to the subfloor and floor framing below the kitchen sink. There appears to be no active leak at the time of the inspection as all visible areas tested normal for moisture. If you have concerns, consult a licensed plumbing contractor.

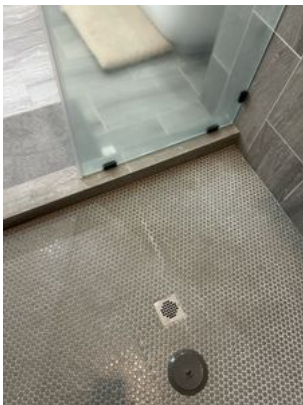
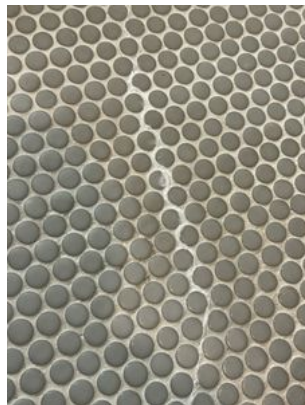
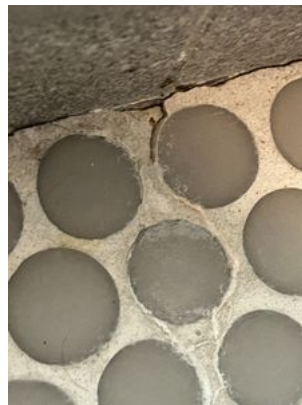
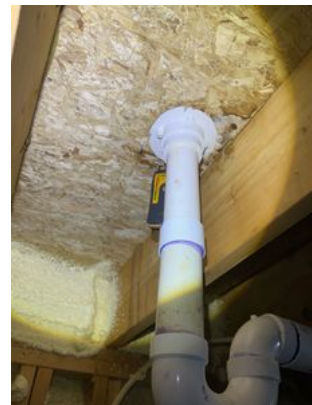
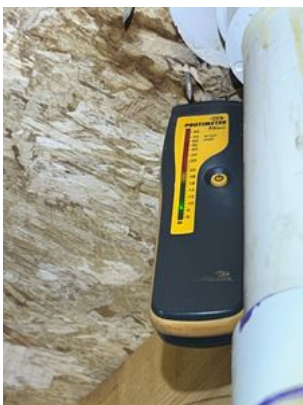
Comment 60
Information

The subfloor below the master shower showed signs of a previous leak and repairs to the shower floor. There were no signs of a leak at the time of the inspection. Consult the owner on any previous repairs and if you have concerns, further evaluation is recommended by a licensed plumbing contractor.

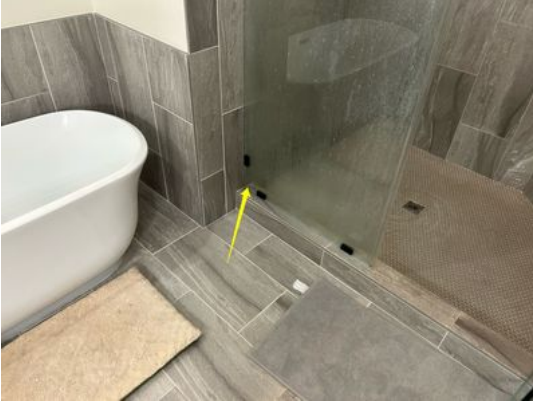
Comment 61 **Information**

Seal the master shower glass seam to prevent water from leaking onto the bathroom floor.

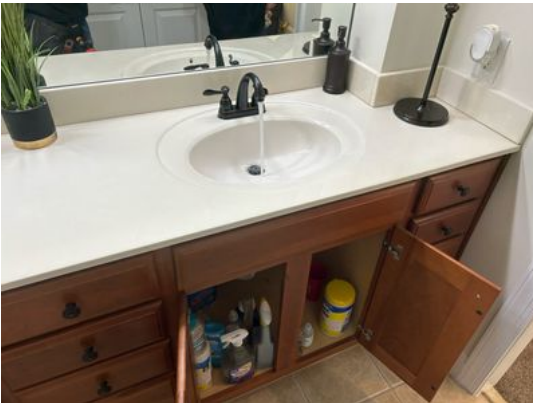
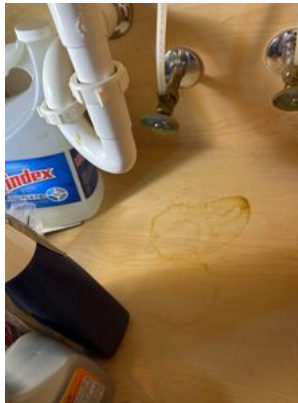
Comment 62 **Information**

A sink drain line showed signs of a previous leak. No visible active leaks were noticed during the inspection.

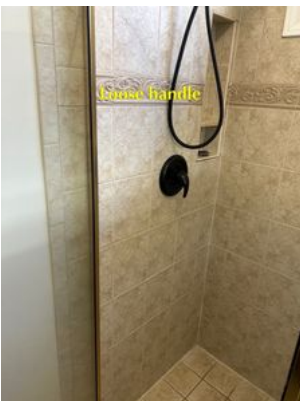
Comment 63 **Information**

The 2nd floor hallway shower valve handle was loose.

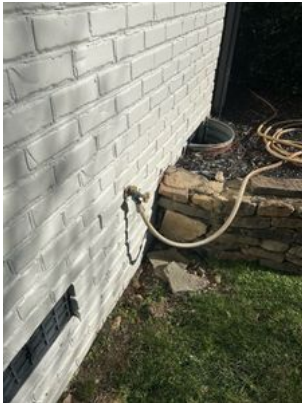
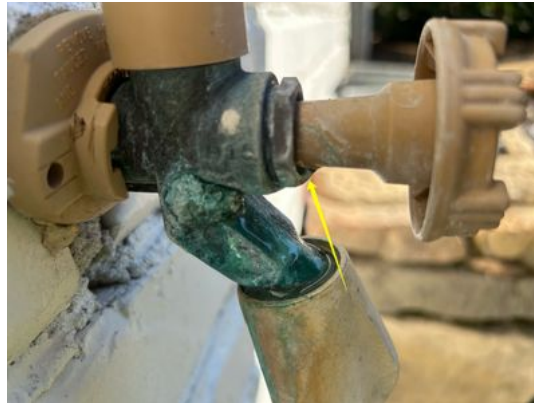
The left hose bib leaks at the valve stem when the valve is opened. Repair is recommended to prevent excess water loss and to prevent the leak from becoming greater.

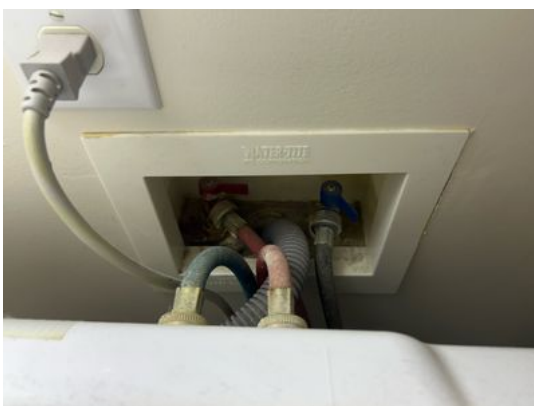
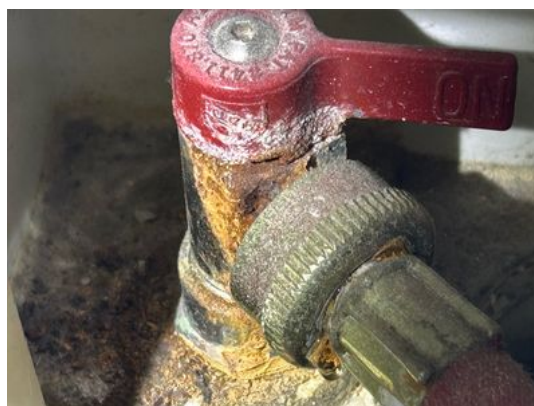
Corrosion and active leaking was observed on the hot water supply angle stop at the main house washer box. Replacement is recommended by qualified professional to prevent further deterioration or damage to surrounding components.

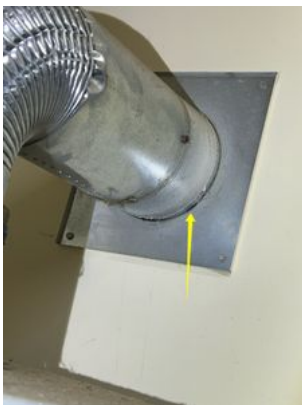
Comment 68 Deficiency

Fire caulking is required be installed at any location where the water heater vent stack protrudes through the garage sidewall/ceiling. This helps to prevent the possible spreading of a fire. Sealing the penetration is recommended with the appropriately rated sealant.

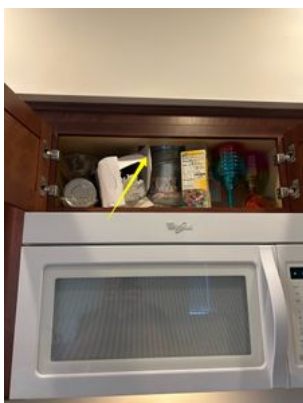
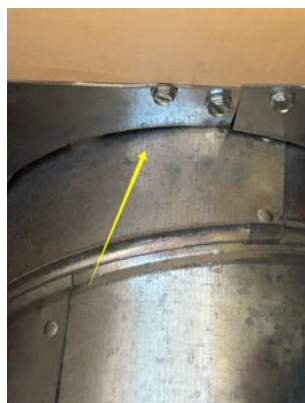
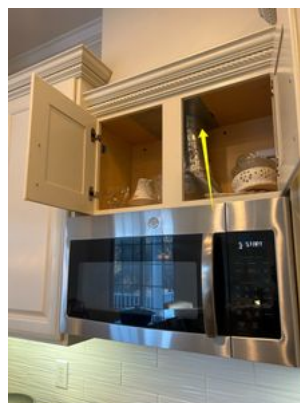
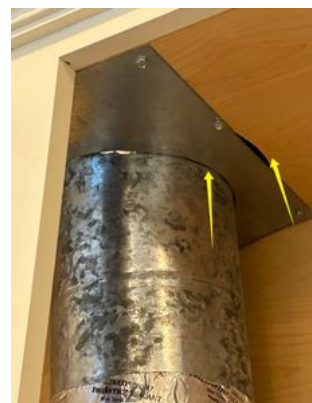
Comment 70 Information

Sealing the hood vent penetration, above the microwave, is recommended to prevent excess conditioned air loss and to prevent a possible fire draft.

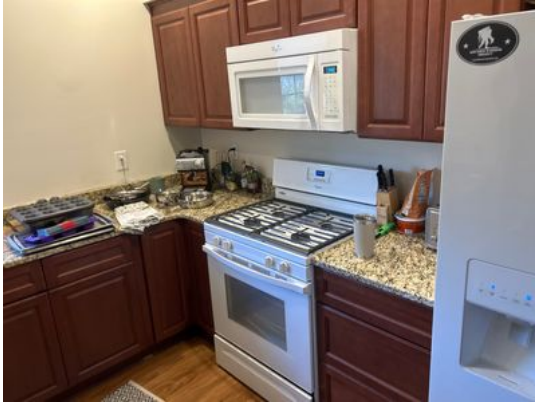
Comment 74 Information

The cabinets had no knobs or pulls.

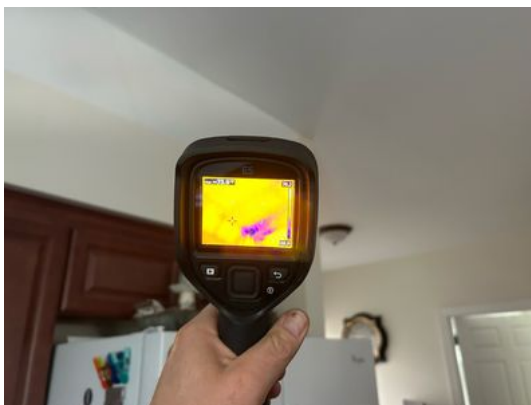
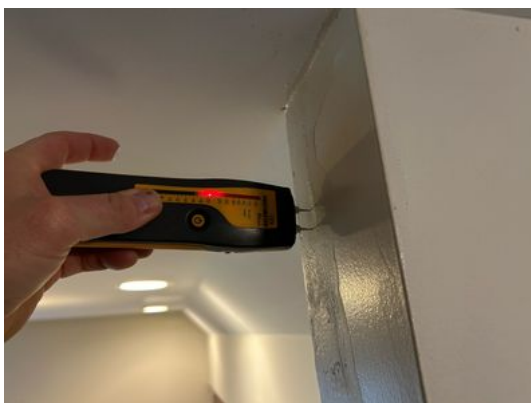
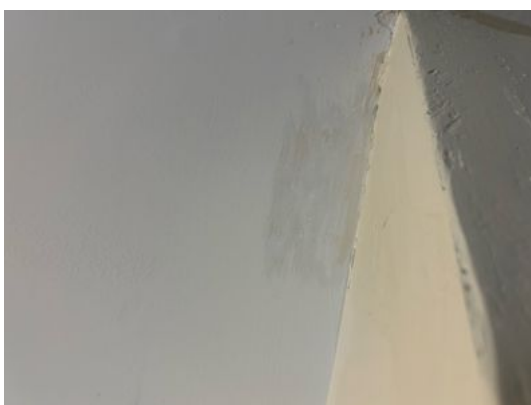
Elevated moisture levels were present on the garage apt walls, above the refrigerator. This appears to be a recent repair. It is recommended to consult the owner on any known repairs or current issues. If no information is available, further evaluation is recommended by a qualified professional.

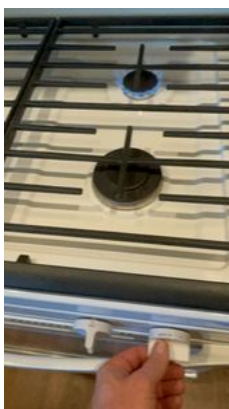
When turned to the low setting, the front left burner of the garage apartment range would go out, which is a safety hazard that could release gas into the home. Repair of the appliance is recommended by qualified appliance professional. See video.

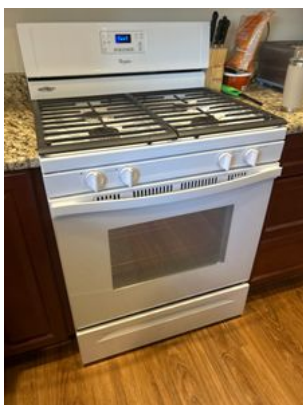
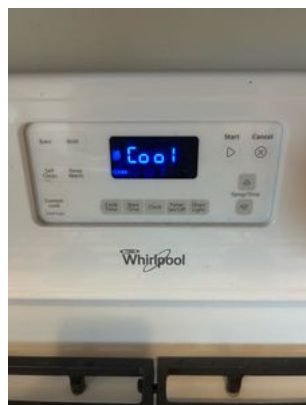
Comment 77

The garage apartment oven function was unable to be tested. The range was displaying “Cool” and the inspector was unable to get the oven to start and unable to get the “Cool” function off. Consult the owner on the function of the appliance and if information is not available, a qualified appliance professional is recommended for evaluation.

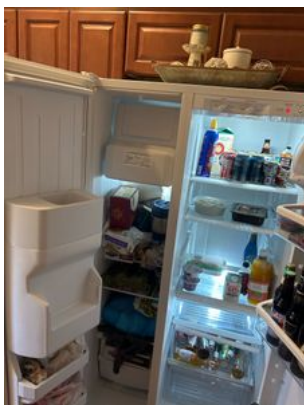
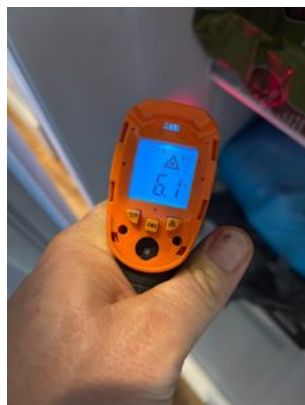
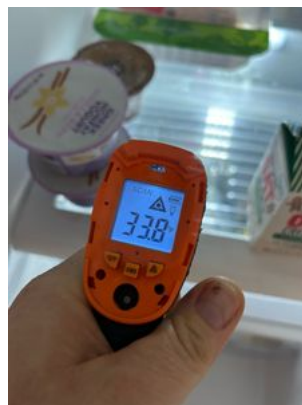
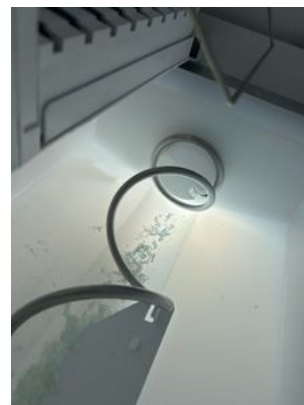
Comment 79
Information

There was no ice in the refrigerator dispenser at the time of the inspection. The water function was operational.

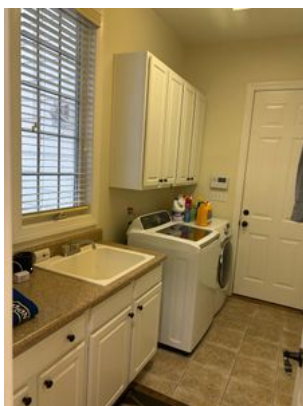
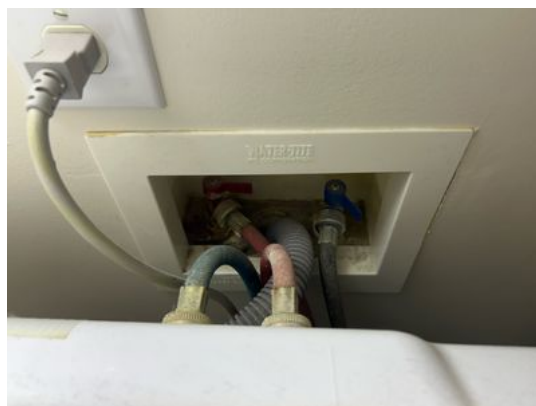
Comment 82 Information

Laundry room photos;

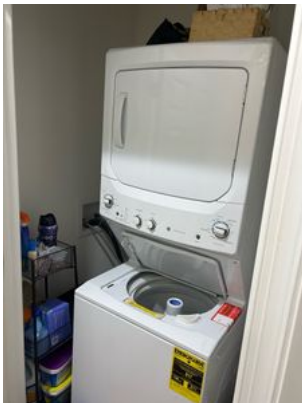
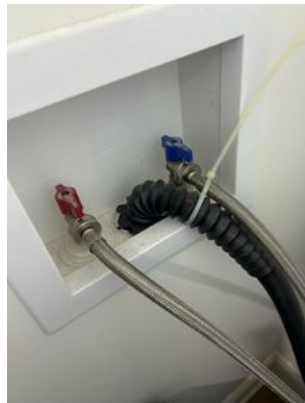
Comment 84 Information

Laundry room photos;

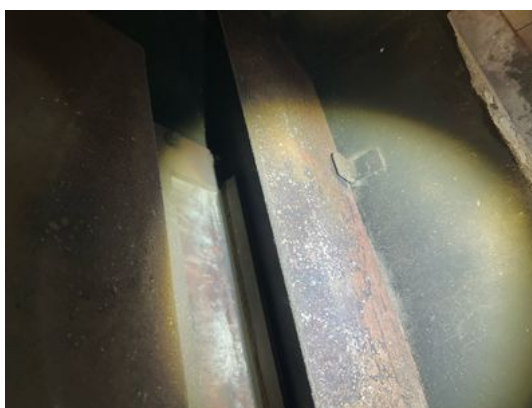
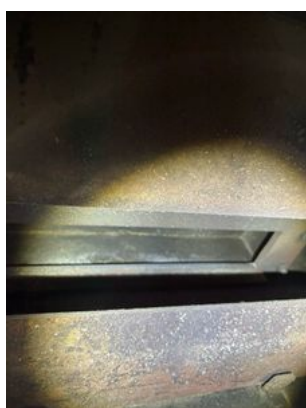
The wood burning stove and associated components should be properly inspected by a qualified professional before its first use to ensure safety and proper function. The system did appear to be in good condition and the damper was functional.
