Home Inspection Report

123 Sample Report Dr
Raleigh, NC 27606

Inspected By: Stephen Pait, CMI- Lic # 4329 &
Septic Lic #72451

Inspected on Thu, Jan 2, 2025 at 8:00 AM

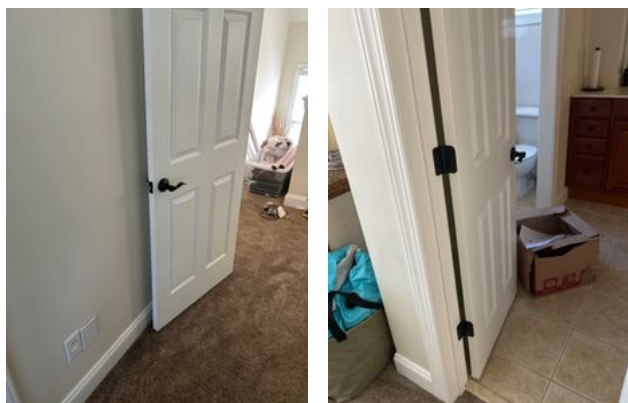
Comment 90
Information

There were no privacy knobs installed on multiple bedroom and bathroom doors throughout the home.

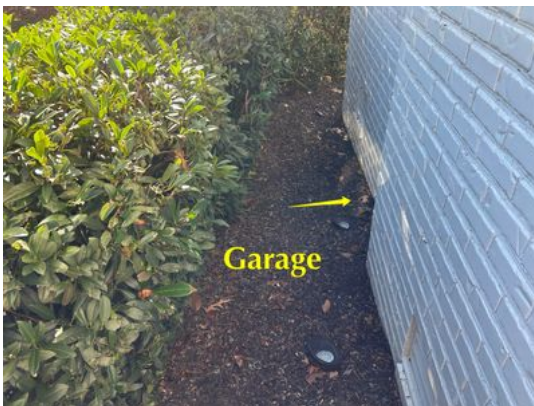
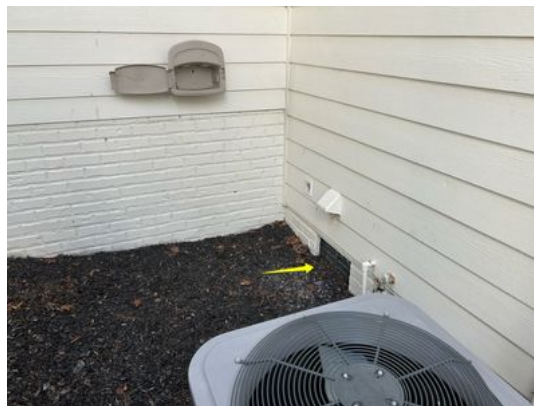
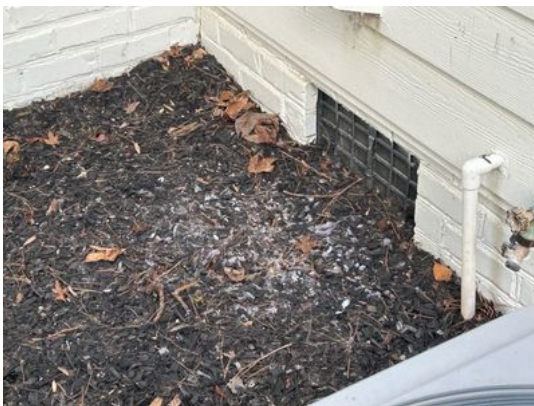
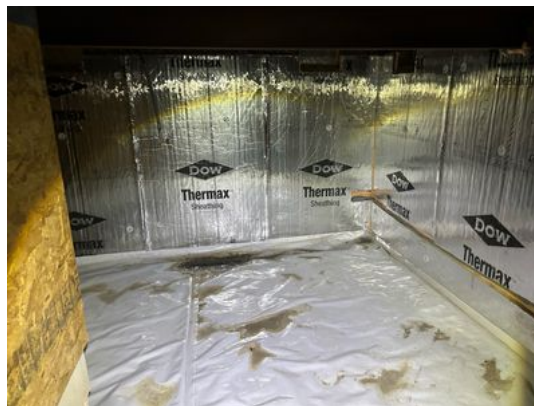
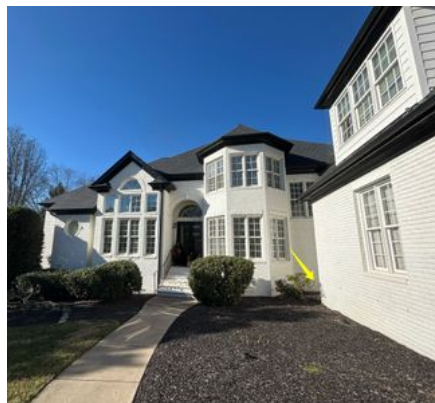
Site: Site Grading

The site grading in multiple areas slopes toward the home or is not properly sloped away from the foundation. It is required that grading slopes away from the foundation 6 inches in the first 10 feet where possible. This will help reduce water intrusion into the foundation and deterioration of materials, as well as help reduce the promotion of foundation settlement . Raising the grade or sloping these areas is recommended.

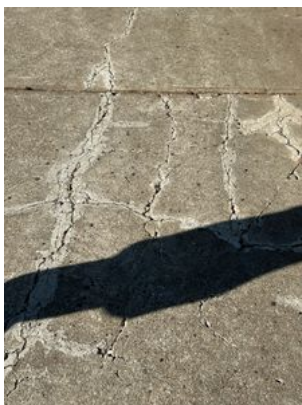
Site: Driveway

The driveway has a significant number of stress or settlement cracks. Over time these cracks could lead to lifting or settling of the driveway which will create walking hazards and issues with driving. Repairing any damaged areas is recommended by a qualified concrete contractor.

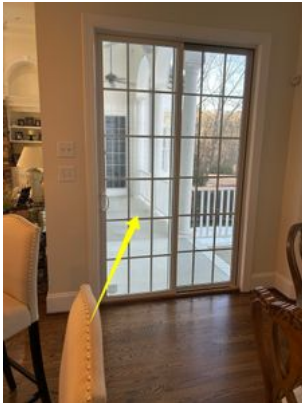
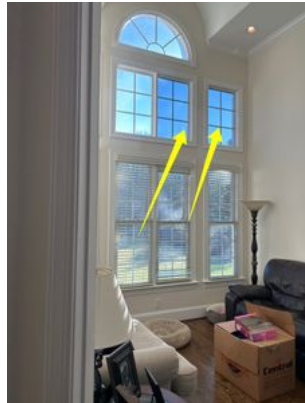
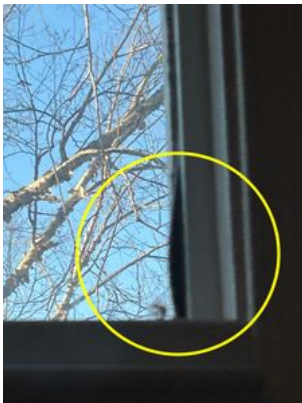
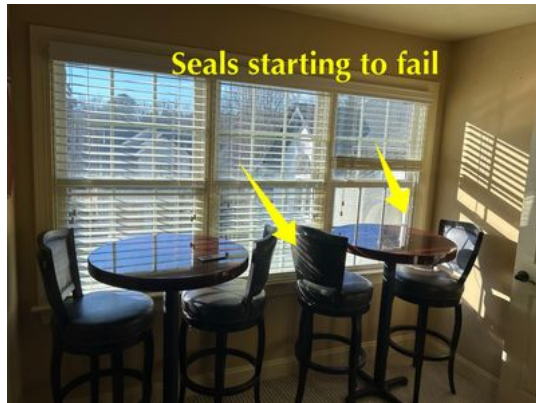
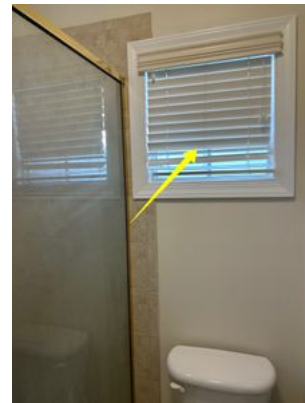
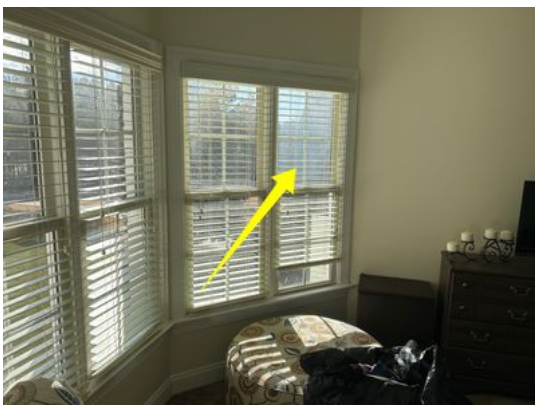
Exterior: Windows

Hazing and moisture was observed in between multiple window panes. This is likely caused by deterioration of the low-e film and hermetic seal in between the window panes. Low-E is a film applied to the windows to help reduce solar heat gain. This condition may result in increased solar heat gain. It is recommended to consult with a qualified window repair professional to evaluate this condition and perform and necessary repairs or replacements.

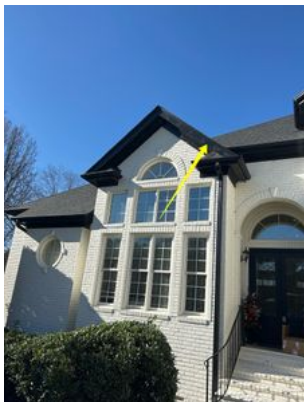
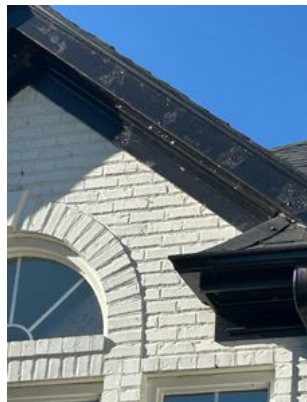
Paint was peeling at several locations on the front fascia. A qualified painting professional is recommended for repair to prevent further peeling and to ensure the material is properly sealed. Improperly sealed composite material can lead to premature deterioration.

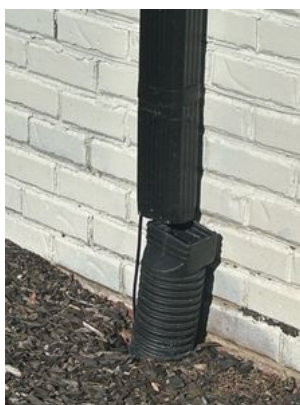
Comment 18

The gutters, in multiple locations, were filled with debris which will prevent water from exiting into the downspouts. This could cause water runoff in areas and present moisture related problems and lead to premature deterioration of the composite fascia. Ensure all gutter downspouts are properly connected to the corrugated drain lines and discharging away from the home. A qualified professional is recommended for repair. (Photos may not be all inclusive)

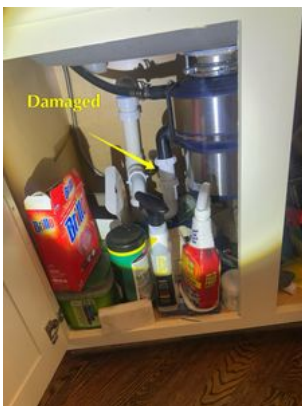
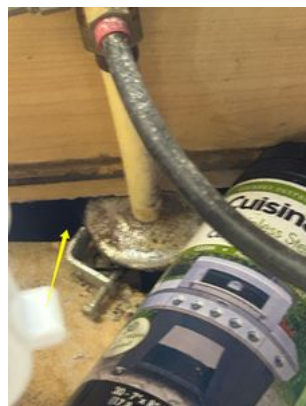
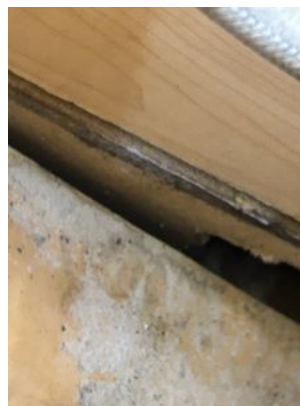
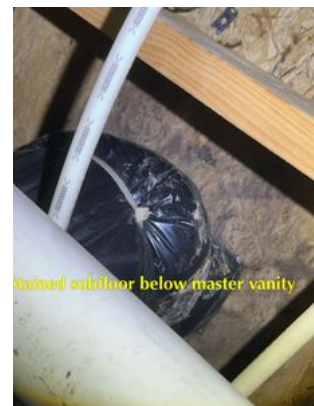
The subfloor at multiple hvac discharge boots was discolored and showed evidence of previous high moisture. Many times the air vents directly under the cabinet and is not in a chase or duct. The cool conditioned air leaves moisture under the cabinet base and this causes staining to the subfloor/base cabinet and sometimes damage to the base cabinet bottom panel. The subfloor was structurally sound in this location and moisture levels were normal at the time of inspection. The kitchen sink base cabinet was damaged and warm air was discharging inside the cabinet. A qualified contractor is recommended to evaluate the air discharge and repair the kitchen base cabinet to prevent further damage.

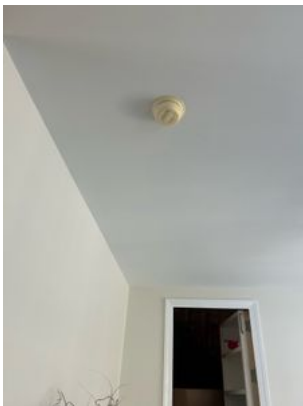
Comment 37

Hardwired smoke alarms are required to be connected to the home's electrical system and should set off every alarm in the home when tested. The garage apartment smoke alarms, when tested, did not set off the other alarms in the home which is a safety hazard. Additionally, multiple alarms in this home were past their useful life expectancy. Alarms should be replaced every 10 years. Further evaluation by licensed electrician is recommended.

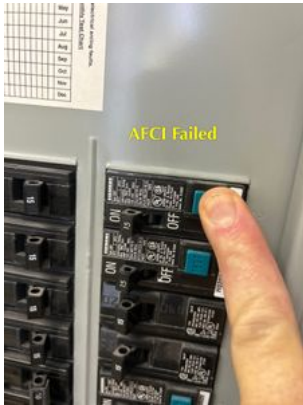
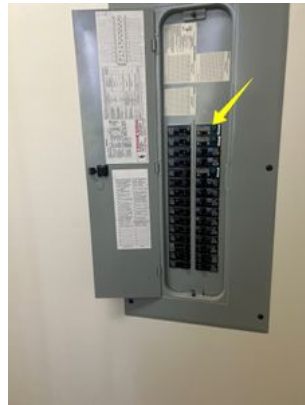
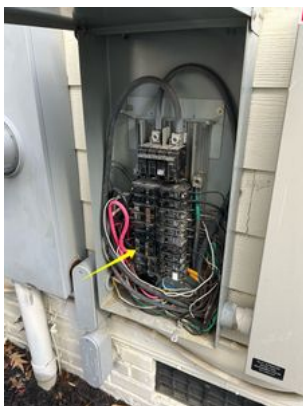
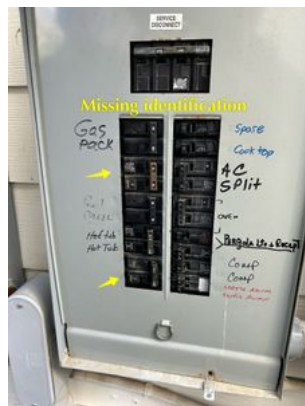
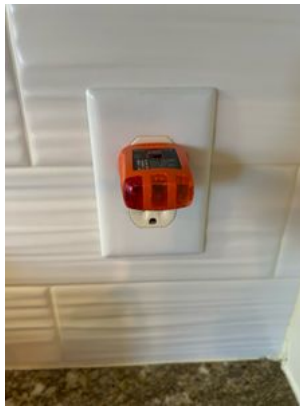
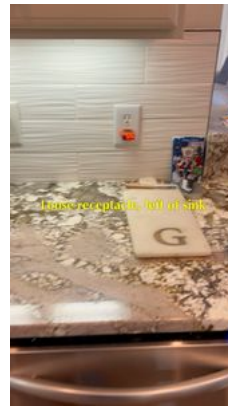
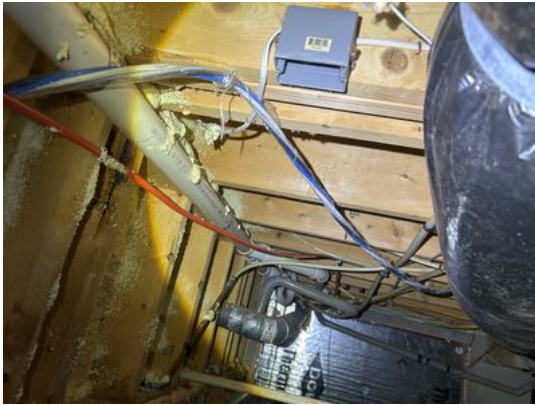
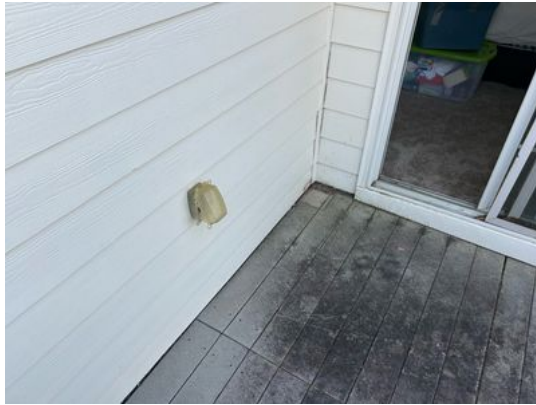
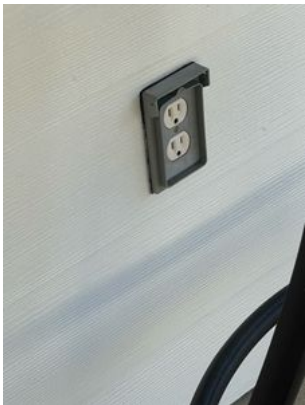
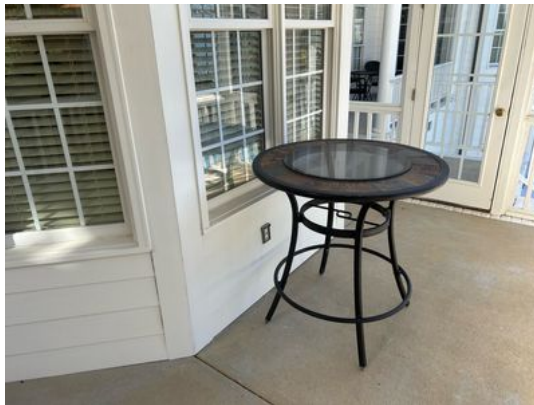
Comment 38

There were multiple deficiencies in the electrical system that should be evaluated/repair by a licensed electrician.

- An AFCI breaker failed to trip when tested in the laundry room sub panel. AFCI helps protect against potential fire hazards.
- A breaker was not properly seated on the bus bar in the exterior sub panel. This is a safety hazard that could lead to potential arcing or fire safety hazard.
- All electrical breakers are required to be properly identified on the legend attached to the panel. There were missing identifications on the exterior sub panel. This is a safety hazard.

- A large gauge conductor was installed in a 20A breaker in the exterior sub panel. A conductor too large to properly fit under a breaker terminal screw could lead to improper fit or needing to be modified to fit. Modified or improperly secured conductors can be a fire safety hazard. The max size wire gauge is typically stated by the manufacturer. The inspector was unable to confirm if the conductor had been modified. Typically a split bolt or wire nut is used in this application to downsize the conductor to fit the breaker.

- The exterior sub panel has a mismatching breaker. All breakers installed are required to be of the same type and manufacturer of the service panel. There are however some breakers that are suitable for replacement of certain breakers in certain panelboards. This information is provided by the breaker manufacturer. Improperly installed breakers can lead to voided warranty, failure or even fires.

- The receptacle to the left of the kitchen sink was loose and should be properly secured to prevent possible loosening of the electrical conductor connections. Improperly/loosely connected wiring could result in arcing which can lead to possible fires. (Cover plate also broken)

- There was an open electrical junction box located in the right side of the crawlspace. All junction boxes should have a blank plate cover installed to prevent access to the electrical conductors.

-Replacing the missing exterior receptacle's weatherproof cover on the back side of the home and damaged cover on the balcony is recommended to prevent possible moisture entry which could lead to nuisance tripping of the GFCI receptacle and premature deterioration of the electrical components.

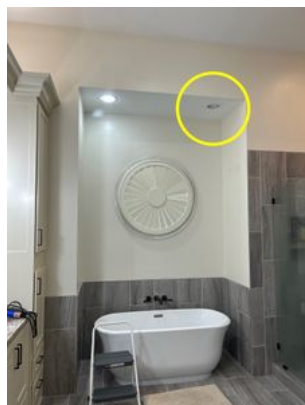
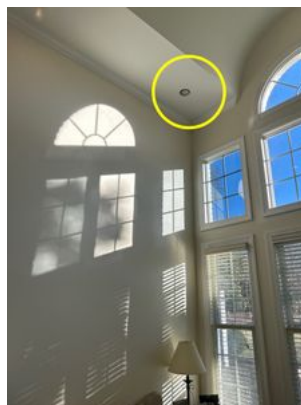
Comment 40

Multiple light fixtures would not illuminate using standard operating controls/switches. Replace the lightbulb and if issues continue, further evaluation by a licensed electrician is required. (Photos may not be all inclusive). Multiple fixtures has at least one bulb not functional.

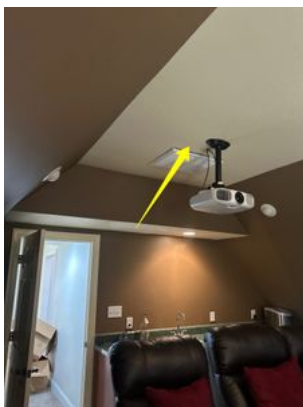
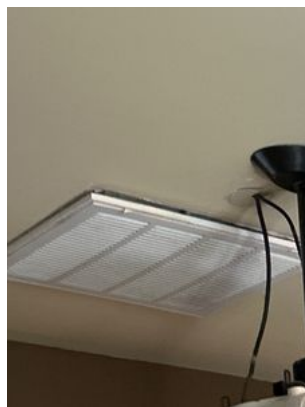
Comment 48

Secure the loose return register in the movie theatre room to prevent detachment.

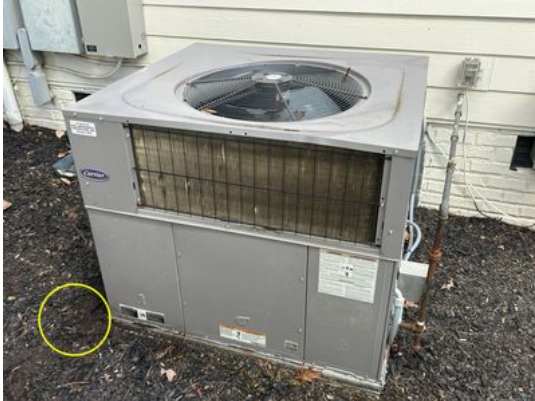
Comment 53

The HVAC condensate drain line should not be concealed underneath grade. The line should drain 6" +/- above grade to prevent it from being clogged which could lead to backups and leaking at the unit or nuisance shutoffs. Raise the drain line as needed to prevent blockage.

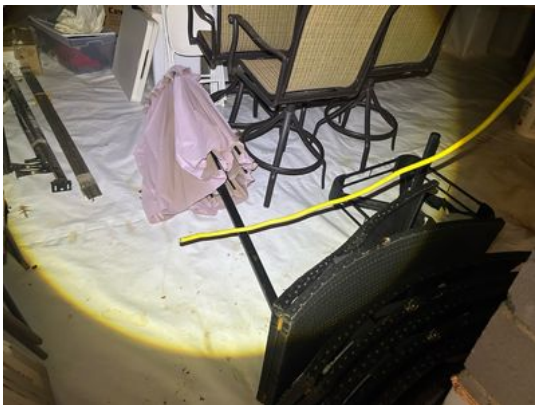
Comment 57

There was a disconnected/abandoned gas supply line in the crawlspace that should be properly capped or removed by a qualified professional. The inspector was unable to confirm if the line was disconnected at both ends. This could lead to possible gas leaks if the line is still active and a valve is opened. (Back left of crawlspace)

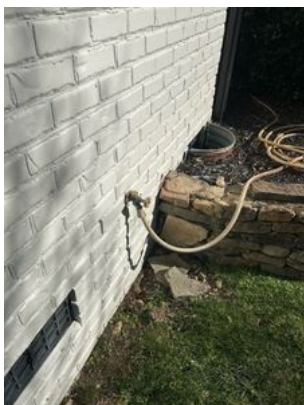
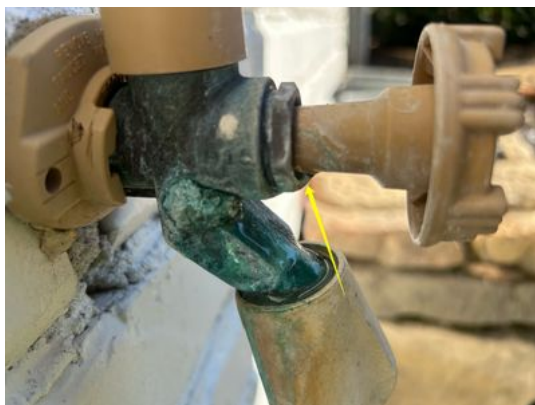
Comment 64

The left hose bib leaks at the valve stem when the valve is opened. Repair is recommended to prevent excess water loss and to prevent the leak from becoming greater.

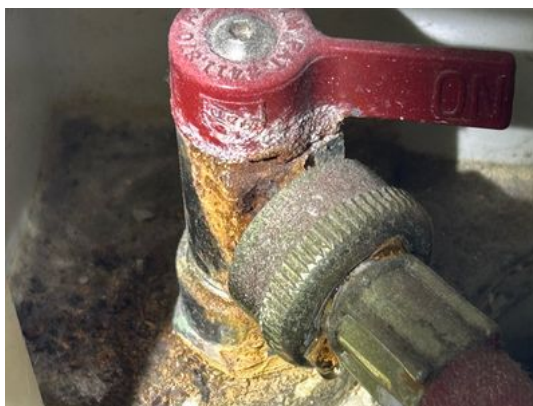
Comment 65

Corrosion and active leaking was observed on the hot water supply angle stop at the main house washer box. Replacement is recommended by qualified professional to prevent further deterioration or damage to surrounding components.

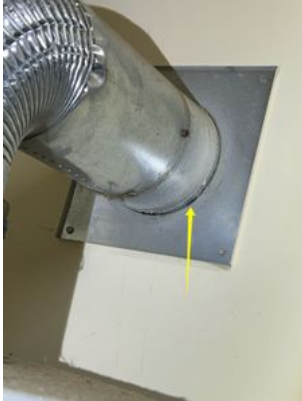
Comment 68

Fire caulking is required be installed at any location where the water heater vent stack protrudes through the garage sidewall/ceiling. This helps to prevent the possible spreading of a fire. Sealing the penetration is recommended with the appropriately rated sealant.

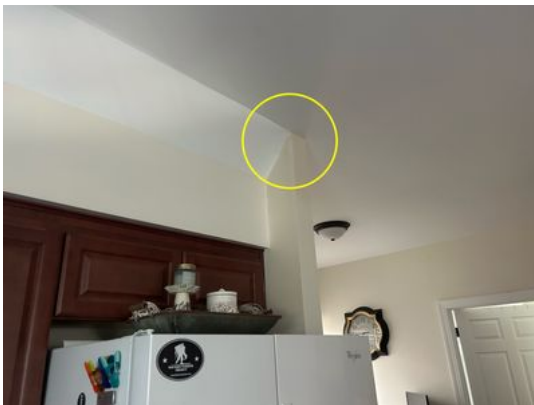
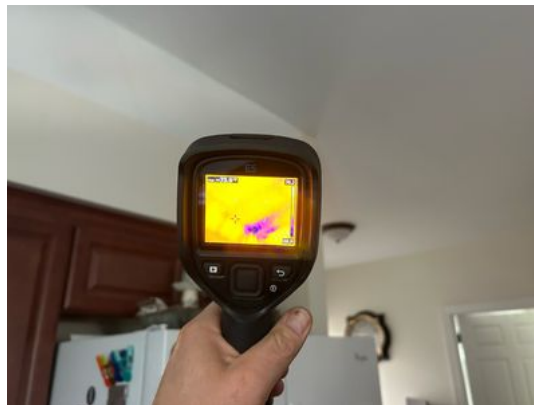
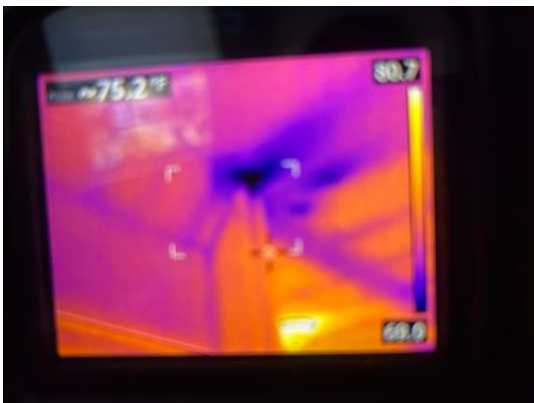
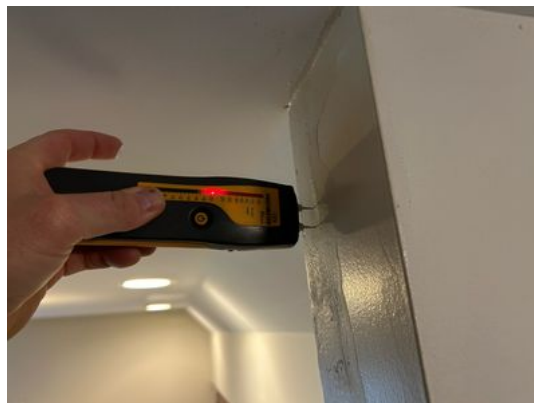
Comment 75

Elevated moisture levels were present on the garage apt walls, above the refrigerator. This appears to be a recent repair. It is recommended to consult the owner on any known repairs or current issues. If no information is available, further evaluation is recommended by a qualified professional.

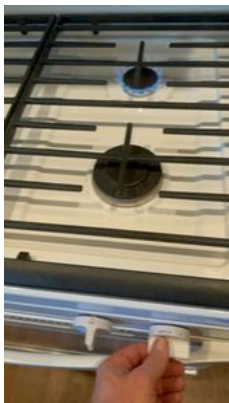
Comment 76

When turned to the low setting, the front left burner of the garage apartment range would go out, which is a safety hazard that could release gas into the home. Repair of the appliance is recommended by qualified appliance professional. See video.

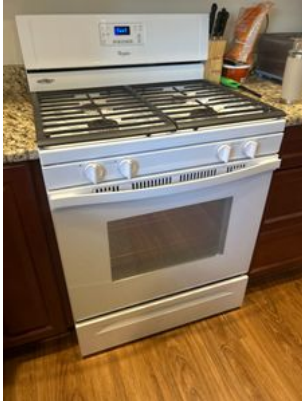
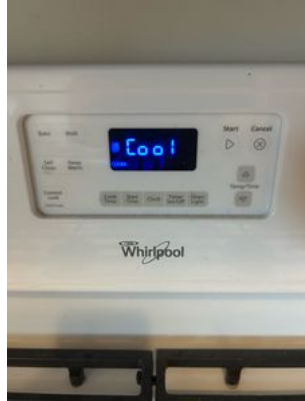
Comment 77

The garage apartment oven function was unable to be tested. The range was displaying “Cool” and the inspector was unable to get the oven to start and unable to get the “Cool” function off. Consult the owner on the function of the appliance and if information is not available, a qualified appliance professional is recommended for evaluation.
