## Home Inspection Report

### New Construction Sample

### Wake Forest, NC 27587

Inspected By: Stephen Pait, CMI- Lic # 4329 &  
Septic Lic #72451

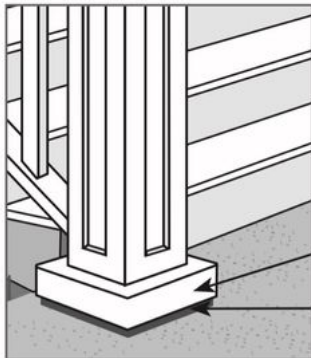
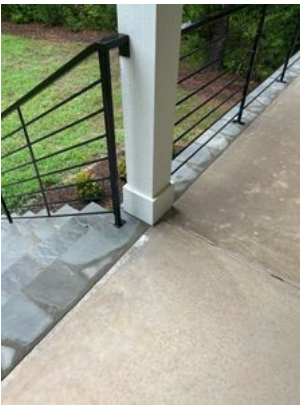
A 1/2" gap is required between composite trim material and any concrete surface per manufacturer's installation instructions. Cutting any trim to meet this guideline is recommended to help reduce possible moisture related damage.

Properly flash and space at least 1/2" from any flatwork (such as porches, patios, decks, or driveways) or horizontal brick ledge. Prime and paint bottom edge before installing. Also all miter joints should be glued and caulked.

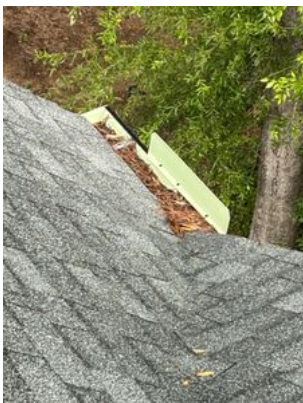
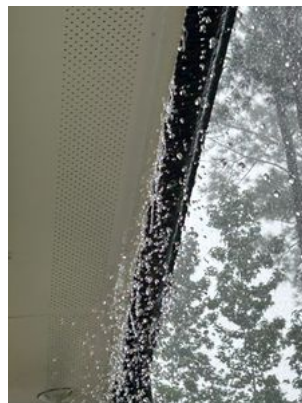
The gutters, in multiple locations, were filled with debris which will prevent water from exiting into the downspouts. This could cause water runoff in areas that could present moisture problems. Cleaning out the gutters and ensuring functional flow out of the downspouts is recommended.

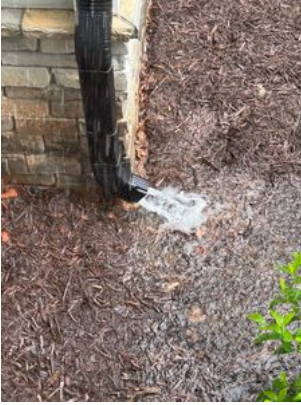
Gutter downspouts should direct water away from the foundation at least 6 feet to reduce the risk of water intrusion, soil erosion or foundation settlement/deterioration.

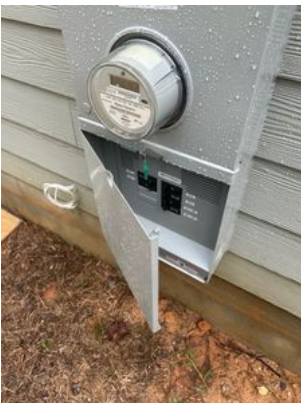
The main electrical panel door would not latch/shut.

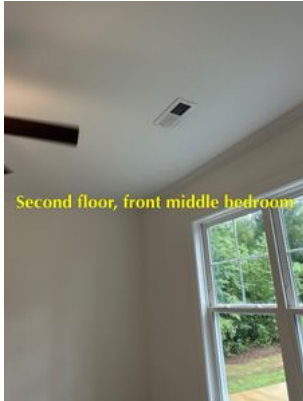
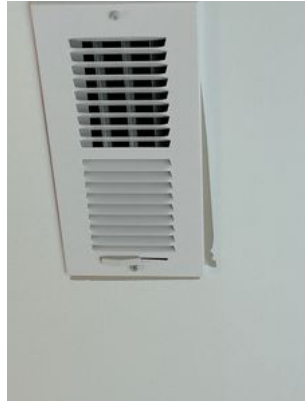
Cosmetic defect at an HVAC supply diffuser. The ceiling paint will need to be touched up.

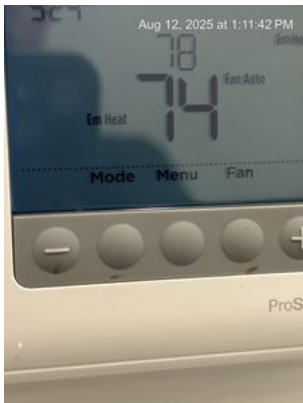
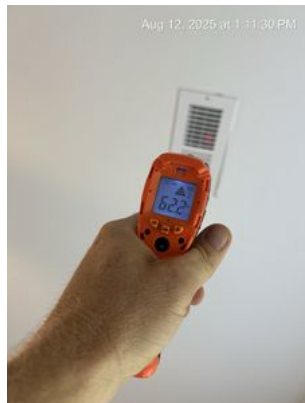
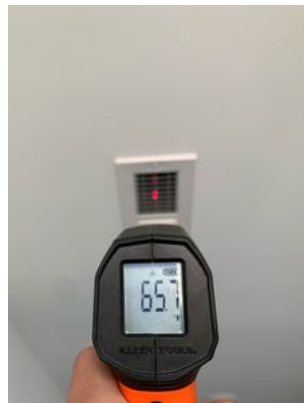
The auxiliary/emergency heat function of the heating system for the 2nd floor was not operating properly. This could result in inadequate heating during cold conditions. A licensed HVAC contractor is recommended for evaluation and repair.

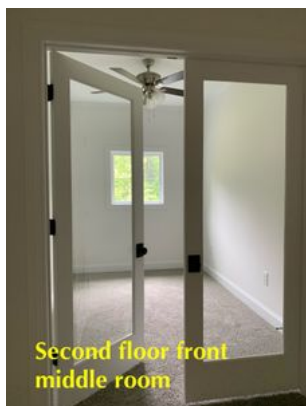
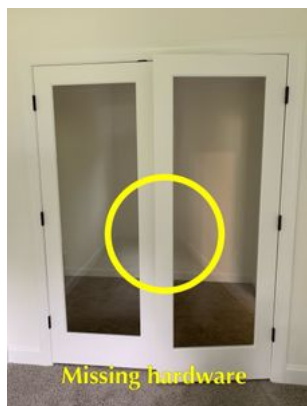
Door handles were not installed on the 2nd floor office doors.

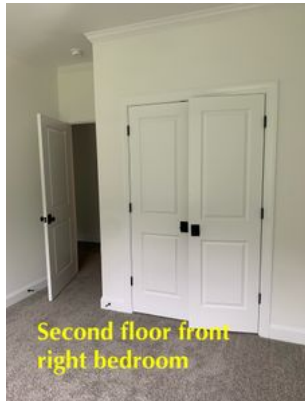
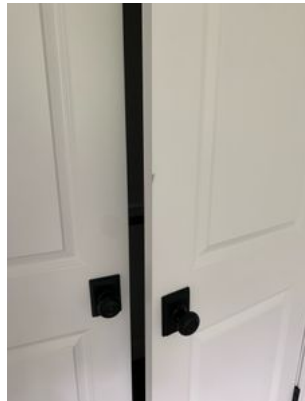
There was cosmetic closet door in the second floor front right bedroom.

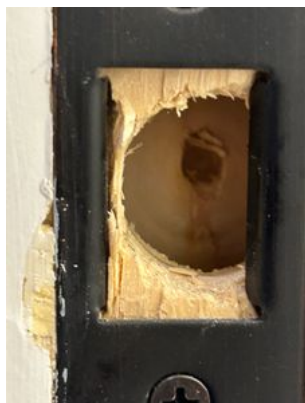
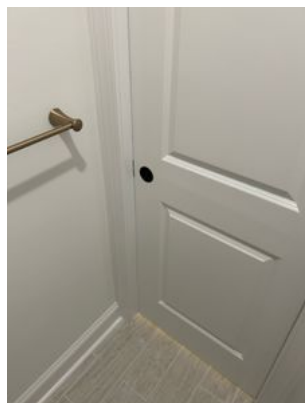
An interior door needs adjustment in order to function/latch properly. (2nd floor bathroom pocket door. Mortise incomplete, latch gets stuck)

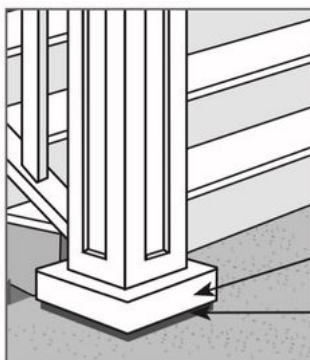
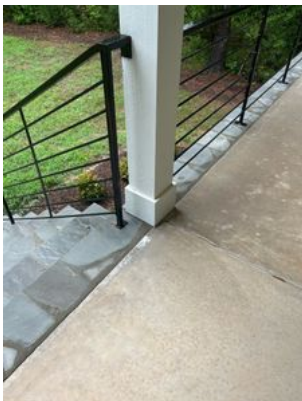
A 1/2" gap is required between composite trim material and any concrete surface per manufacturer's installation instructions. Cutting any trim to meet this guideline is recommended to help reduce possible moisture related damage.

Properly flash and space at least 1/2" from any flatwork (such as porches, patios, decks, or driveways) or horizontal brick ledge. Prime and paint bottom edge before installing. Also all miter joints should be glued and caulked.

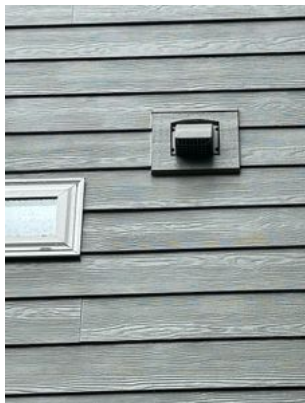
Sealing the gap between the exterior vent cap(s) and siding is recommended to prevent water entry behind the siding.

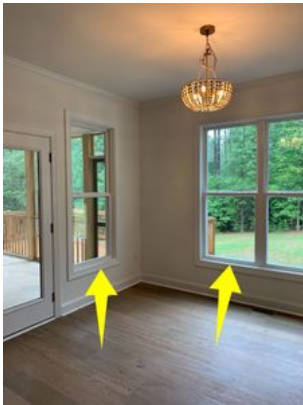
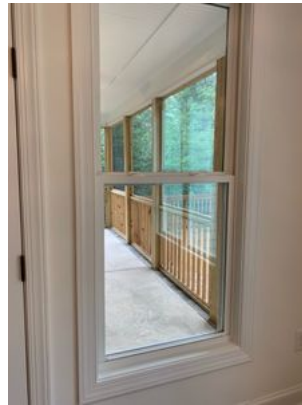
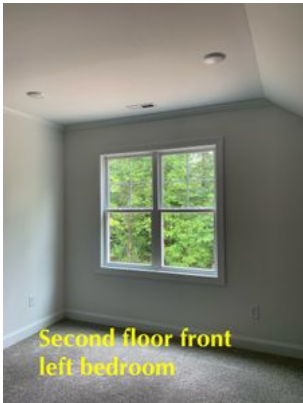
Multiple windows are loud when opened compared to other windows in the home. It is recommended to have a qualified professional make any adjustments needed to allow for easier function. (Photos may not be all inclusive)

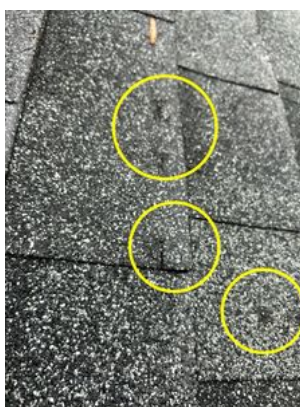
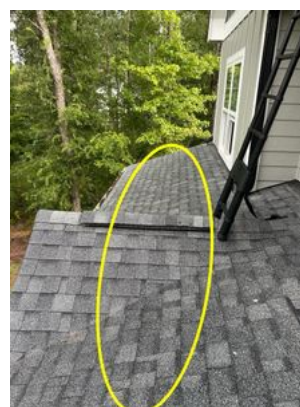
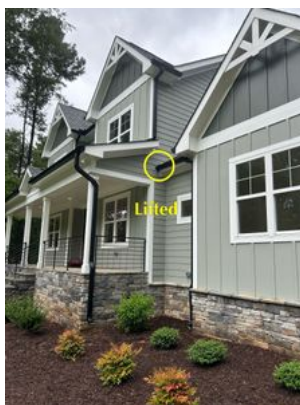
Multiple shingles were found to be damaged. Replacement of the affected shingles is recommended. Damage that compromises the protective granule layer and asphalt composition can lead to premature shingle failure, increasing the risk of water intrusion.

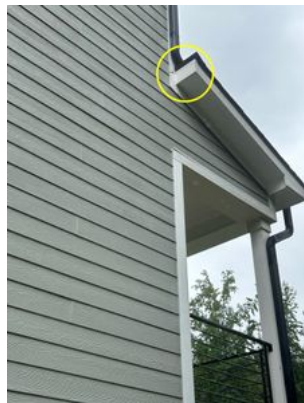
Flashing should be installed (or bent over the fascia) where the roof line extends beyond the main exterior wall of the home. Headwall flashing is installed in this location but water could enter behind the flashing and deteriorate the substrate. (Front porch)

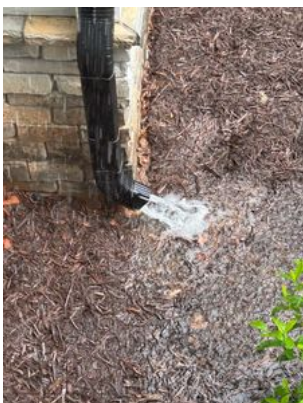
Gutter downspouts should direct water away from the foundation at least 6 feet to reduce the risk of water intrusion, soil erosion or foundation settlement/deterioration.

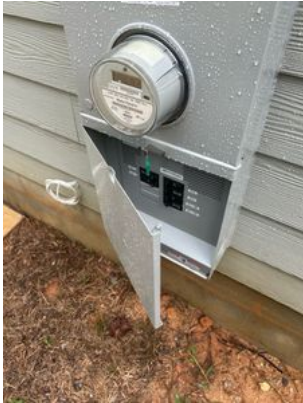
The main electrical panel door would not latch/shut.

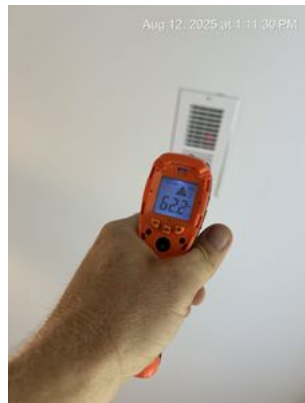
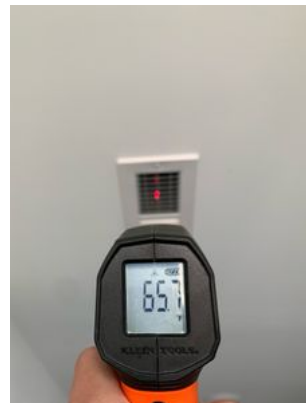
The auxiliary/emergency heat function of the heating system for the 2nd floor was not operating properly. This could result in inadequate heating during cold conditions. A licensed HVAC contractor is recommended for evaluation and repair.

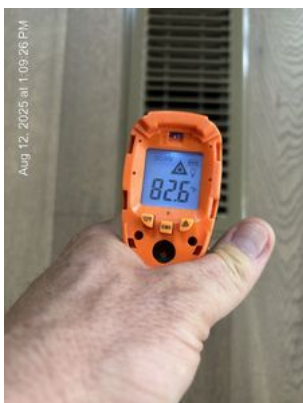
The heat pump was not tested due to outside temperatures being above 75° at the time of inspection, which is safe working temperature for heating equipment. The Emergency/Aux heat function was tested and was operational on the 1st floor.

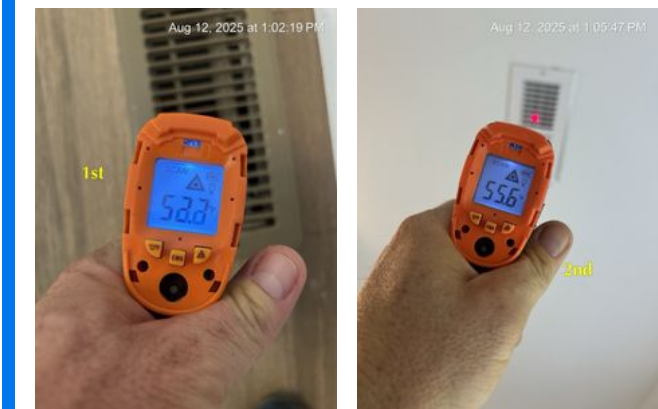
Approximate discharge temp. These temp readings are approximates and are simply to show if cool/warm air is discharging from the register.

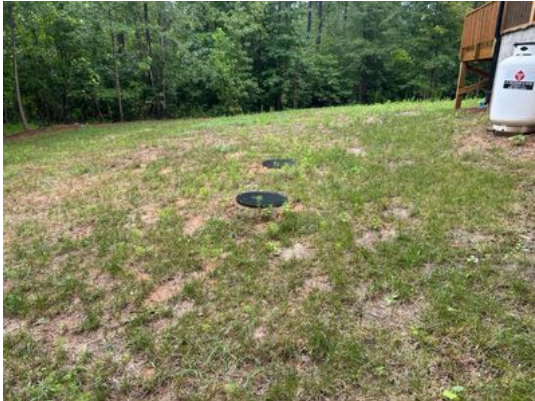
Septic tanks and any components are beyond the scope of a North Carolina Home Inspector.

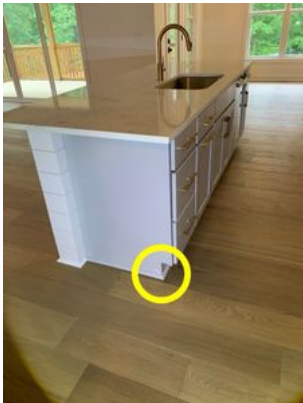
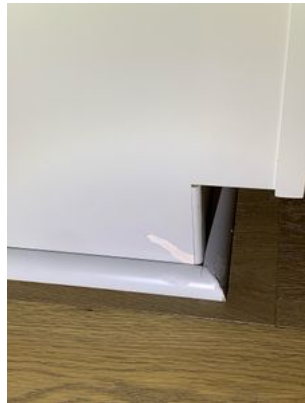
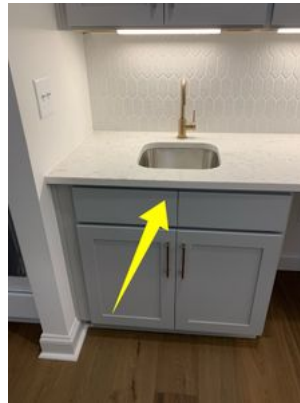
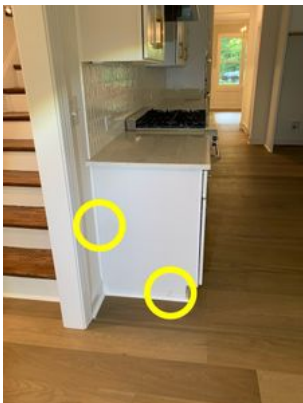
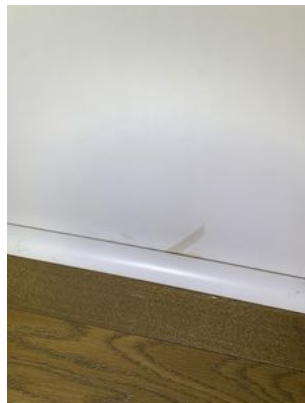
There were several areas of damaged finish on the kitchen cabinets.

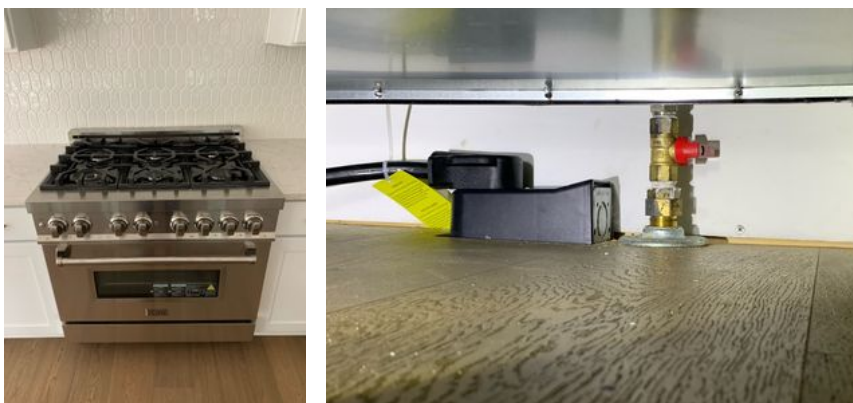
The kitchen range was unable to be inspected due the gas valve being off at the time of inspection.

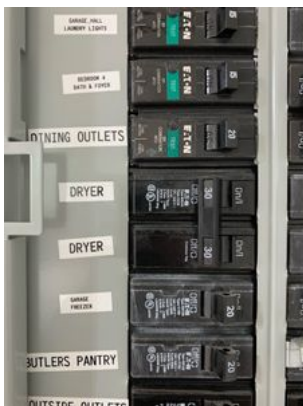
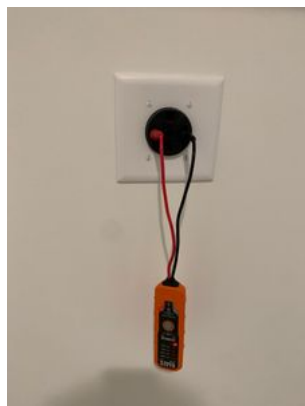
The dryer breaker was in the off, therefore the circuit was unable to be tested.

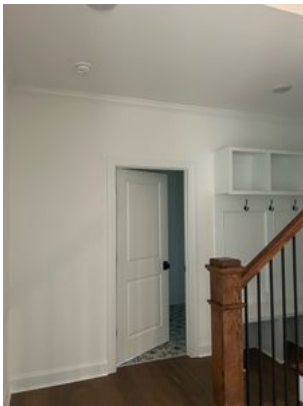
There was no opening observed for make up air in the laundry room. Where a closet/room is designed for the installation of a clothes dryer, an opening having an area of not less than 100 square inches shall be provided in the closet enclosure or makeup air shall be provided by other approved means. Consult the builder to determine if a transfer grill or jump duct should be installed for this application.

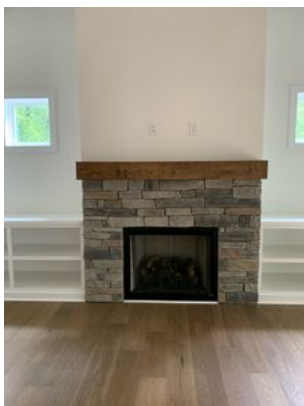
Fireplace would not ignite using standard operating controls.

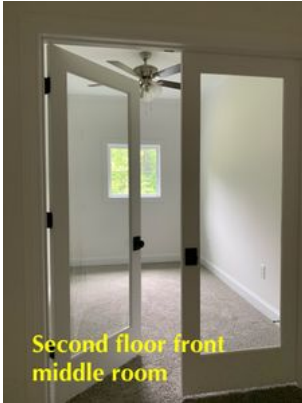
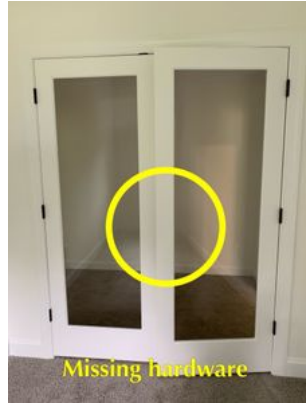
Door handles were not installed on the 2nd floor office doors.

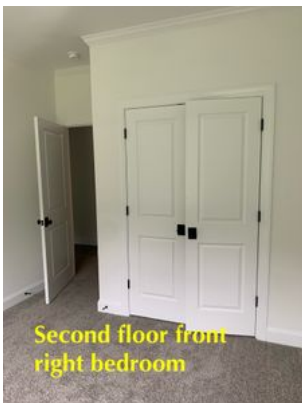
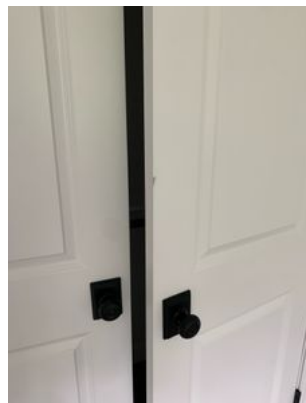
There was cosmetic closet door in the second floor front right bedroom.
