**Housing Authority of the City of Aurora  
REQUEST FOR QUALIFICATIONS NO. RFQ20261008  
ARCHITECTURAL DESIGN SERVICES**

**PROPERTY CONDITION REPORT  
TROLLEY PARK  
1445 DALLAS STREET  
AURORA, COLORADO 80010**

**D3G PROJECT NUMBER:  
2023-1793**

Property: Trolley Park  
1445 Dallas Street  
Aurora, Colorado 80010

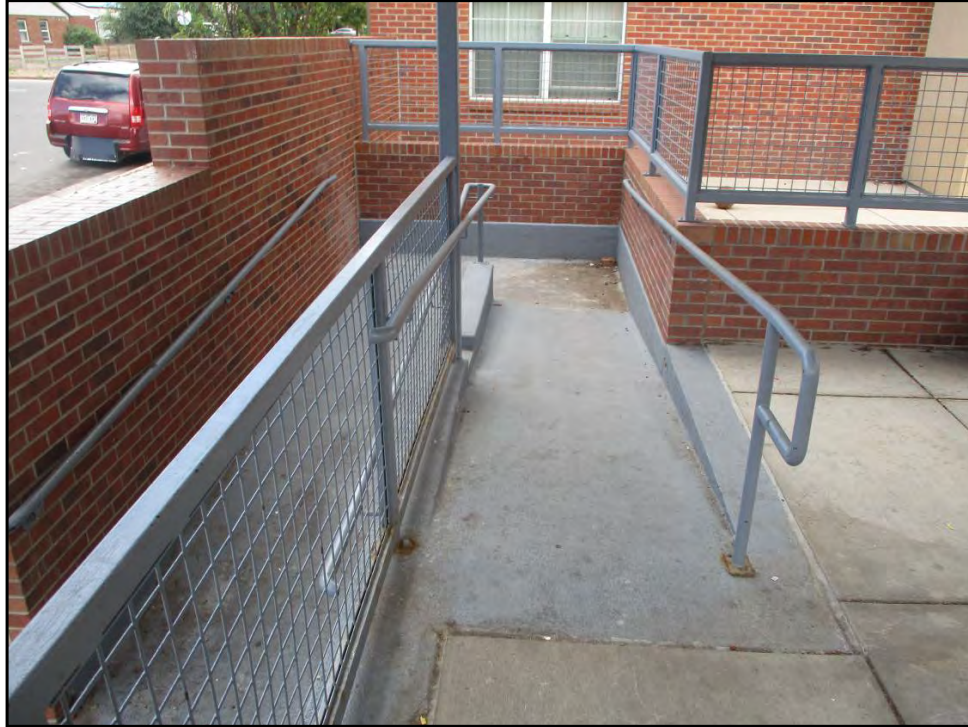
7: Ramp at primary pedestrian entrance

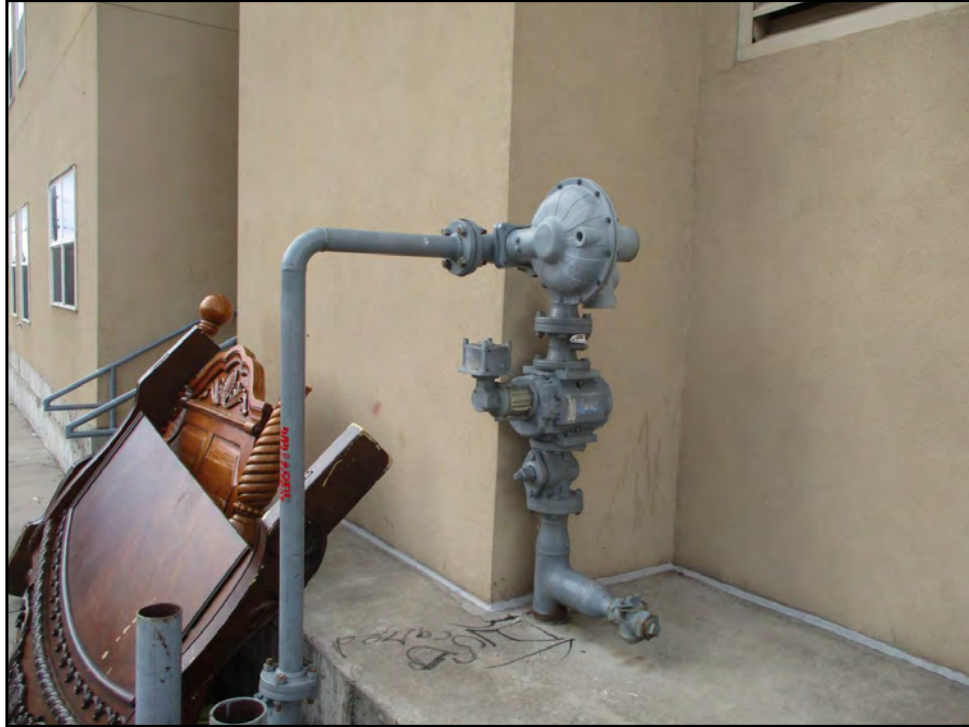
31: Main gas supply

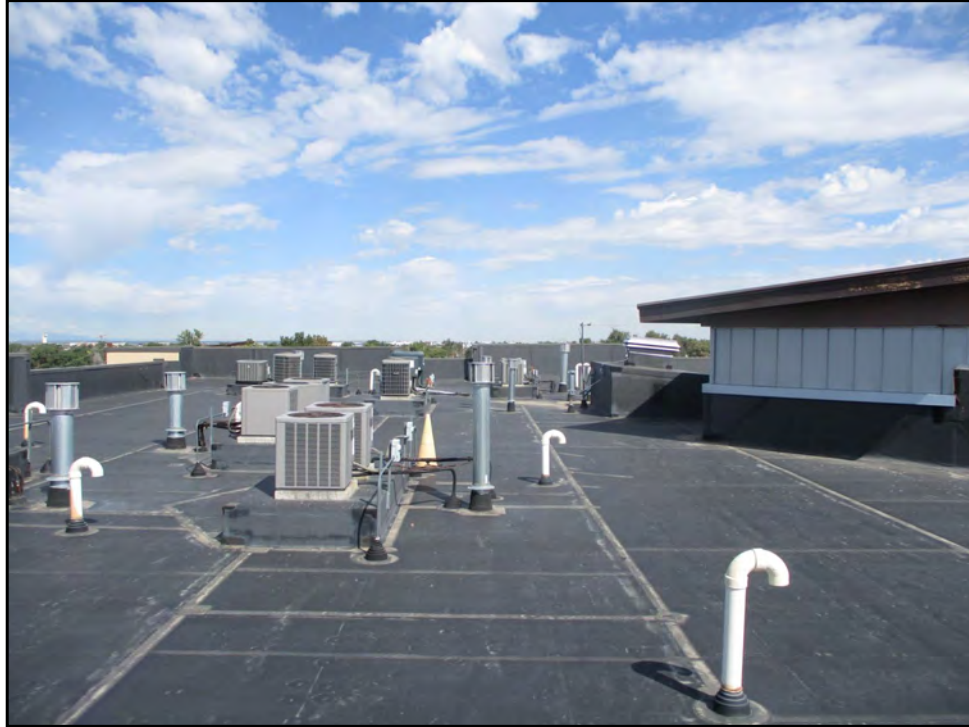
35: Roof profile and A/C equipment

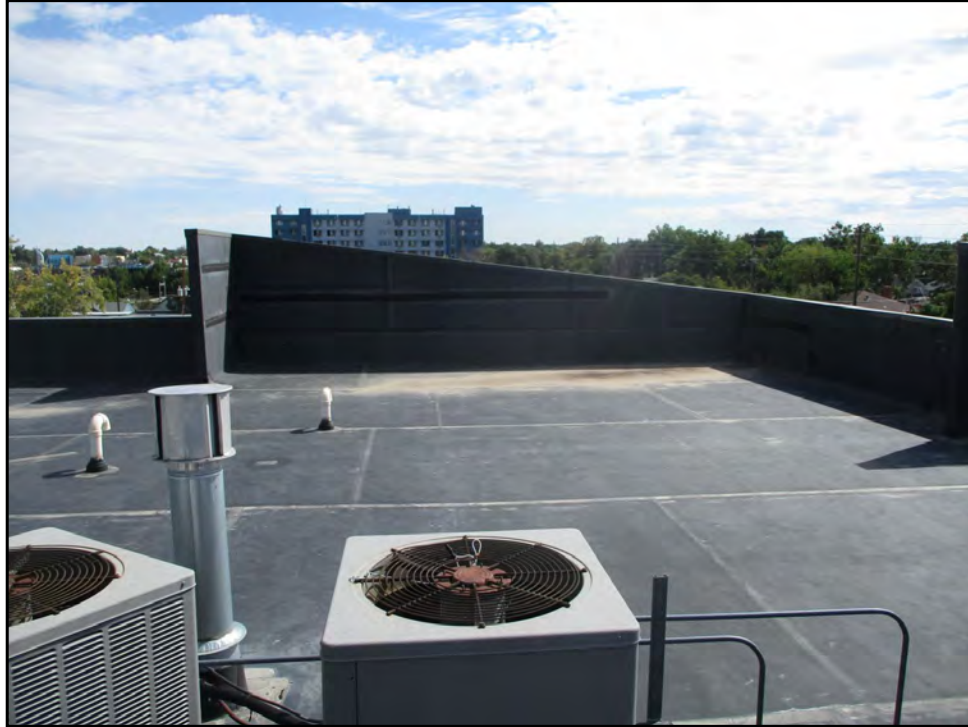
36: Roof profile and A/C equipment
