## Campus View COA *Harrisonburg, VA*

Report #: 35509-1  
Beginning: January 1, 2025  
Expires: December 31, 2025

# RESERVE STUDY Update "With-Site-Visit"

October 4, 2024

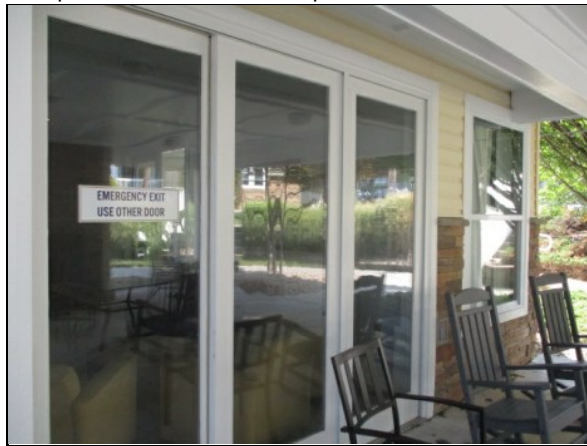
### Comp #: 2367 Windows & Doors - Replace

The windows and doors are in fair condition, showing normal signs of wear for their age, including more surface wear on the framework and hardware, but no advanced corrosion or other concerns. They remain functional and are aging normally, though more advanced technology may be available.

Unless otherwise noted, this component refers only to common exterior windows and doors. All are assumed to have been compliant with applicable building codes at time of installation. Inspect regularly for leaks and cracks around frame and repair as needed. Clean tracks and ensure hardware is functional to prevent accidental damage during opening/closing. With ordinary care and maintenance, useful life is typically long but often difficult to predict. Many factors affect useful life including quality of window currently installed, waterproofing details, exposure to wind and rain, etc. Individual windows and doors should be replaced as an Operating expense if damaged or broken. We recommend replacement at the approximate interval shown below based on consideration of installation/replacement dates, evident conditions, and/or our experience with similar Clients. Unless otherwise noted, cost estimates are based on replacement with current impact-resistant models.

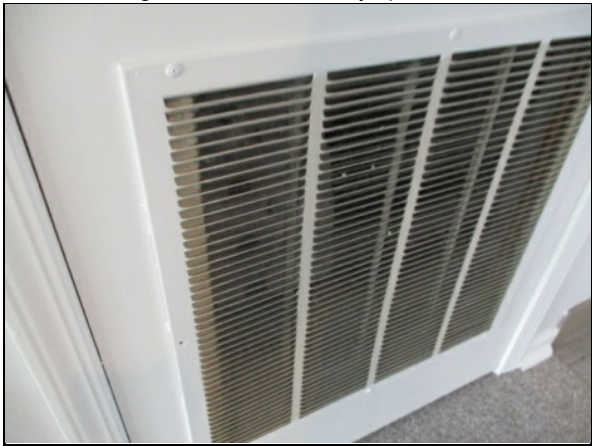
**Comp #: 2522 HVAC (Clubhouse) - Replace**

When exact replacement date is unknown or unreported, age of the system is derived by manufacturer's serial number or date shown on equipment unless otherwise noted. Life expectancy of HVAC systems can vary greatly depending on many factors including location of the property, level of preventive maintenance, manufacturer, etc. We recommend that routine repairs and maintenance such as filter replacement, system flushing, etc. be budgeted as an Operating expense. Useful life can often be extended with proactive service and maintenance. Unless otherwise noted, funding for system with same size/capacity as the current system. For split systems, we recommend budgeting to replace the entire system (condensing unit and air handler) together in order to obtain better unit pricing and ensure maximum efficiency, refrigerant compatibility, etc. If additional costs are expected during replacement, such as for system reconfiguration or expansion, ductwork repairs, electrical work, etc. costs should be re-evaluated and adjusted as needed during future Reserve Study updates.

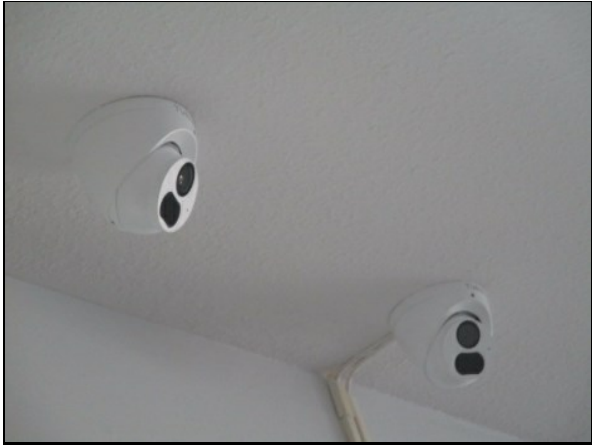
**Comp #: 2543 Security Cameras - Upgrade/Replace**

Security/surveillance systems should be monitored closely to ensure proper function. Whenever possible, camera locations should be protected and isolated to prevent tampering and/or theft. Typical modernization projects may include addition and/or replacement of cameras, recording equipment, monitors, software, etc. Unless otherwise noted, costs assume that existing wiring can be re-used and only the actual cameras and other equipment will be replaced. In many cases, replacement or modernization is warranted due to advancement in technology, not necessarily due to functional failure of the existing system. Keep track of any partial replacements and include cost history during future Reserve Study updates.

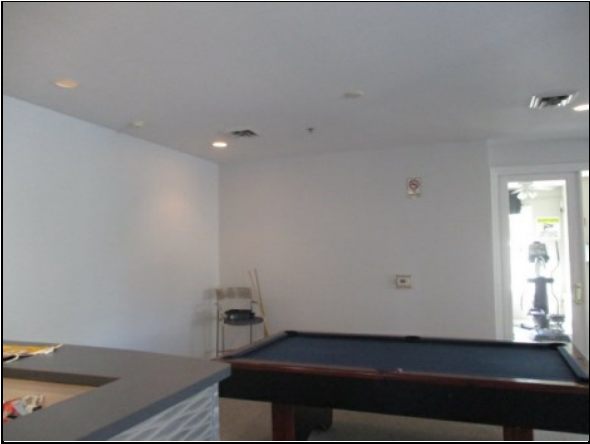
The interior areas are in good condition, exhibiting few significant marks, scuffs, or other aesthetic concerns. The color is consistent and compatible with other finishes and furnishings, maintaining high standards in the common areas.

Regular cycles of professional painting are recommended to maintain appearance. Small touch-up projects can be conducted as needed as a maintenance expense, but comprehensive painting of interior areas will restore a consistent look and quality to all areas. Best practice is to coordinate at same time as other interior projects (flooring, furnishings, lighting, etc.) whenever possible to minimize downtime and maintain consistent quality standard. Based on evident conditions and/or project history provided during this engagement, we recommend repainting at the approximate interval shown below. Unless otherwise noted, cost estimates below are intended for painting only and not inclusive of any extensive wall repairs/renovations (such as trim work, etc.).

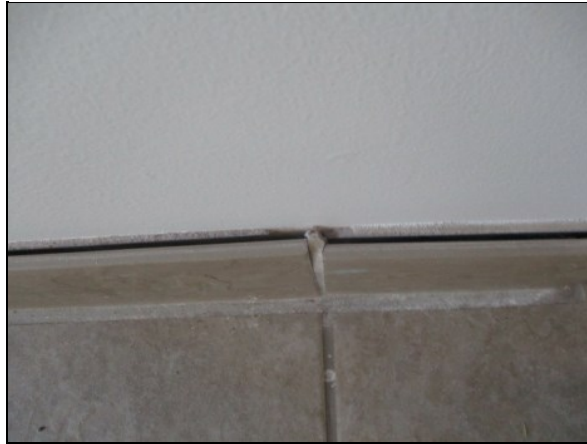
**Comp #: 2709 Tile Flooring - Replace**

The interior tile flooring is in fair condition, showing some routine signs of wear and age, possibly including sporadic cracks and damaged grout. The style remains appropriate, but the tile is showing more noticeable signs of deterioration.

As part of ongoing maintenance program, tile should be inspected regularly and damaged sections repaired/replaced as needed. Best practice is to keep a collection of replacement tiles on hand for partial replacements. With ordinary care and maintenance, tile in interior locations can last for an extended period of time, but replacement is often warranted eventually to enhance and restore aesthetic appeal throughout the common areas. Based on evident conditions, original installation, and project history provided by the Client, we recommend planning for replacement at the approximate interval shown below. Replacement costs can vary greatly depending on size, material, and design of tiles selected. Unless otherwise noted, cost estimates below assume replacement with similar quantity and quality as existing.
