O'BRIEN
BUILDING INSPECTIONS INC.

SB-721 INSPECTION REPORT

43726 Sunset Avenue

9/15/2025

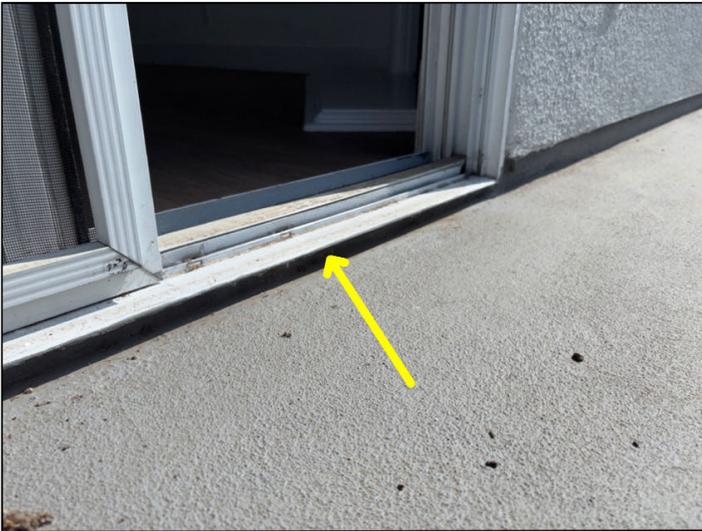
The slider door threshold at the #206 terrace is shown in this image. This is an example of a slider door threshold installed at the proper elevation above the exterior walking surface.

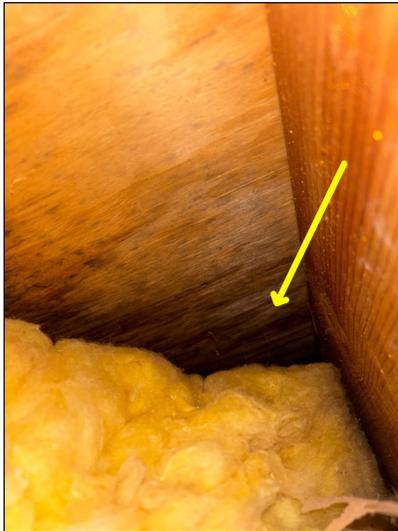
Dry water stains were not noted at the #207 framing where visible at #100.
