**Inspected For:  
Large 5000+ SF Home  
February 2, 2022**

# PROPERTY INSPECTION REPORT FORM

567 FM 1234, Millsap, TX 76000

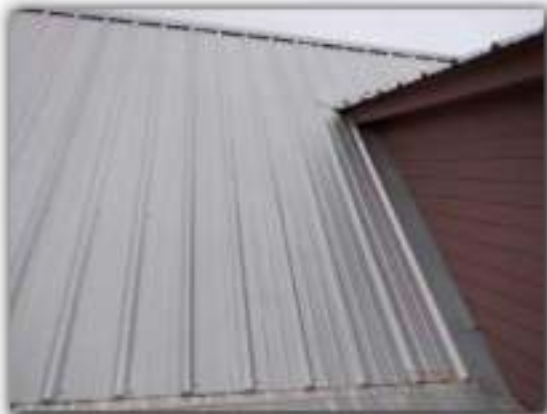
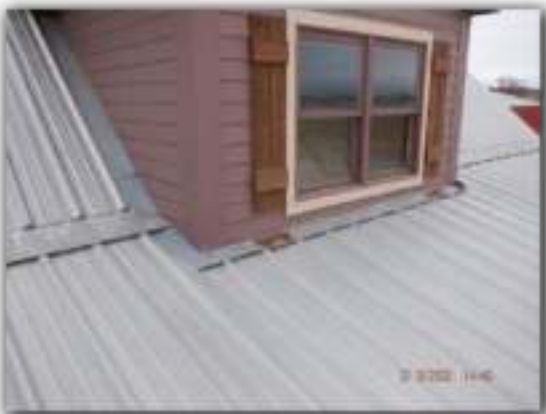
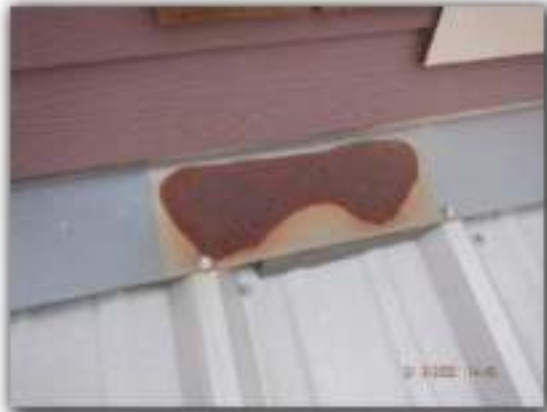
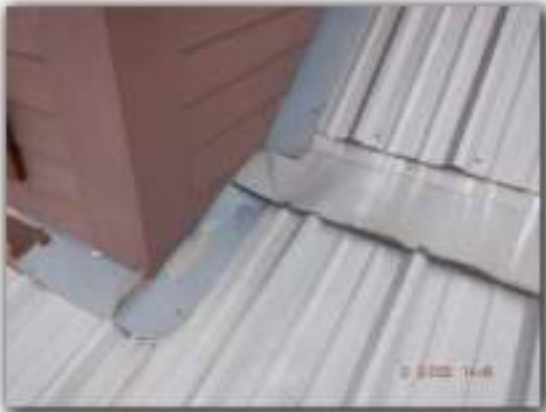
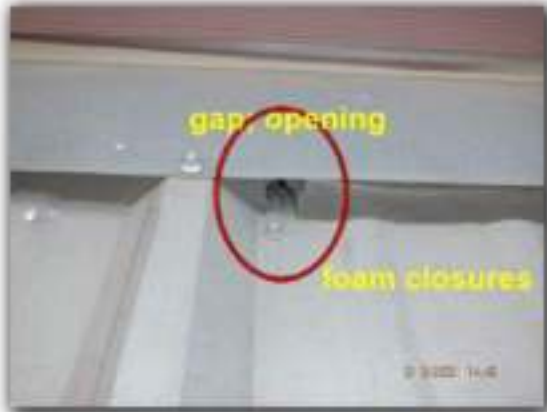
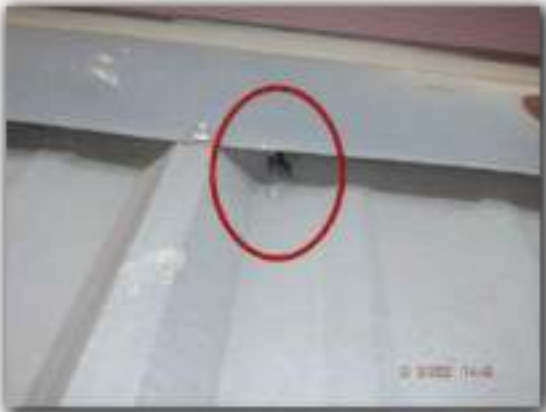
- Some of the roof fastener (screws) neoprene seals (rubber washers) were observed to be damaged or missing in various locations. This condition can allow for water intrusion. These fasteners should be checked every 2-years for deterioration; and repaired or replaced as necessary.

- One or more of the plumbing vent stacks do not have the proper flashing installed. They are caulked or sealed rather than having the appropriate flashing installed.

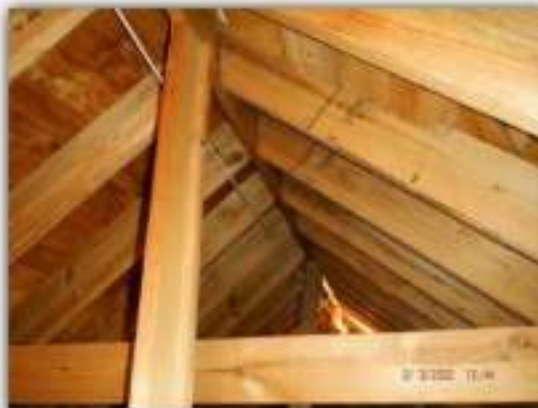
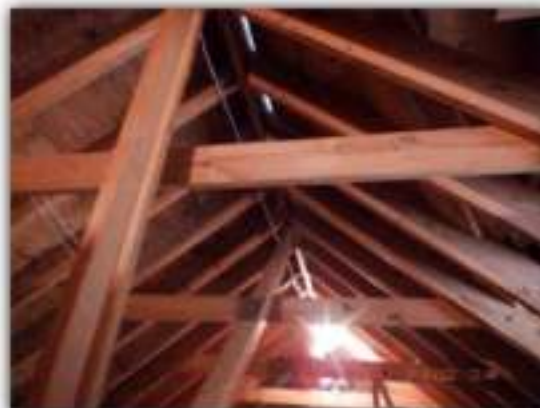
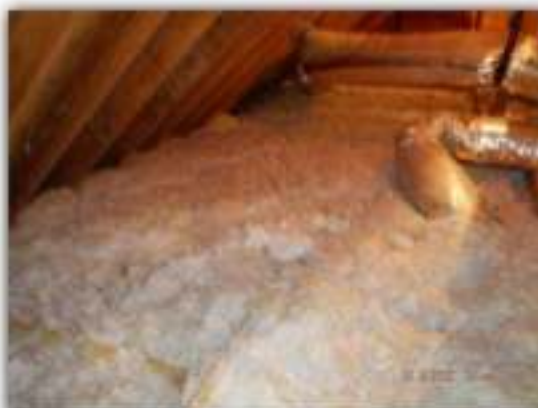
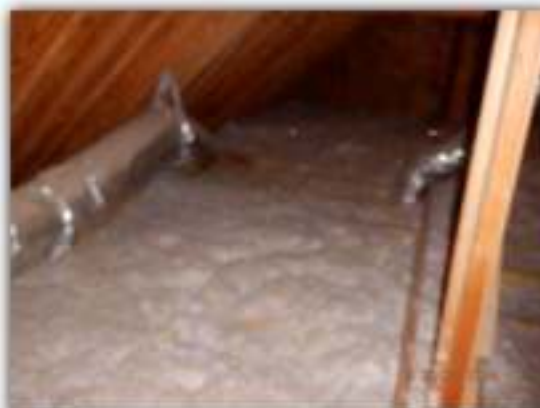
### Attic Insulation

All visible and accessible components were found to be performing and in satisfactory condition on the day of the inspection.

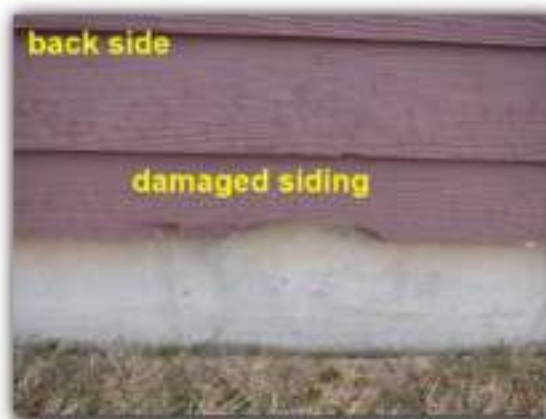
#### Exterior Walls & Surfaces

- The siding material was observed to be damaged in one or more areas around the structure; mainly observed on the back side.
- Mortar cracks were observed in the exterior masonry veneer in one or more locations around the structure. This is a common condition and does not appear to be significant at this time; however, it does imply that some movement of the structure has occurred.
- Caulking improvements are recommended for the area between the exterior veneer and one or more of the window and/or door frames. It is recommended to use elastomeric caulking.

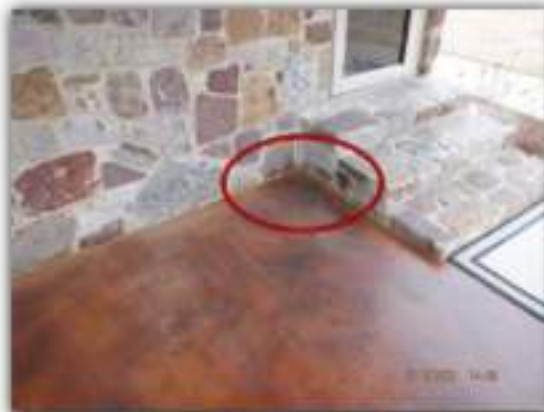
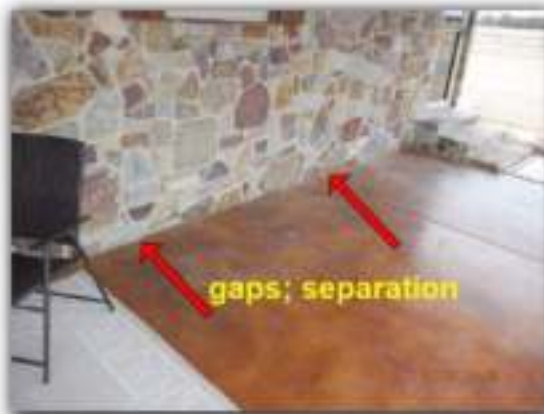
- The front porch appears to have settled somewhat; visibly at the front left side/corner. Recommend further evaluation to determine the cause and possible remedy if necessary.
- There were several areas observed where the concrete porches have gaps or openings at the foundation; these areas need to be properly sealed to keep out unwanted water intrusion to the basement area.

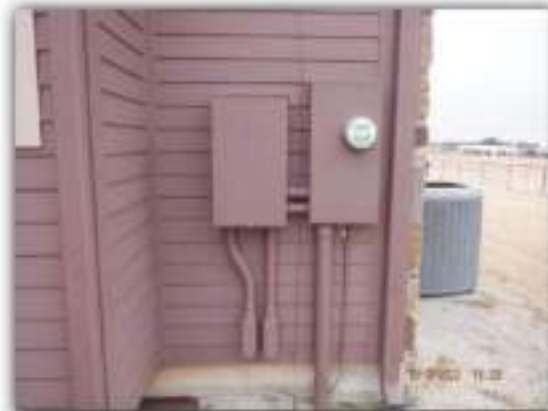
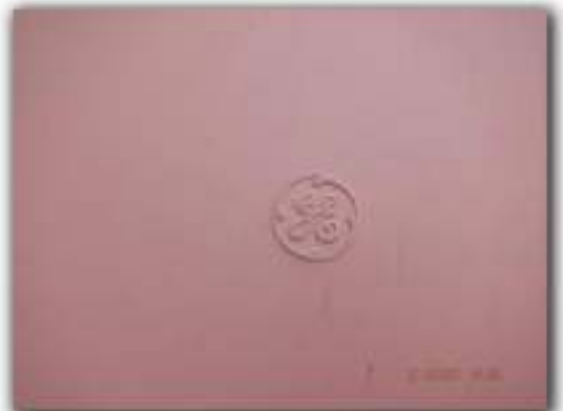
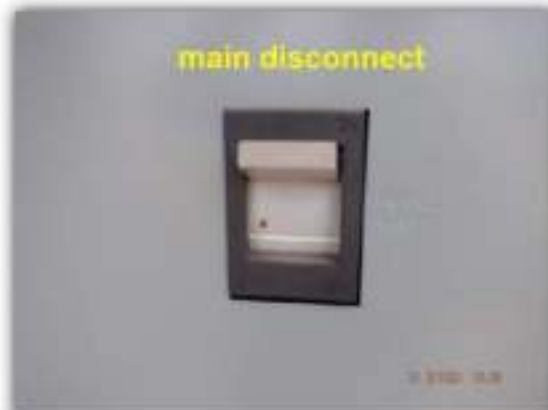
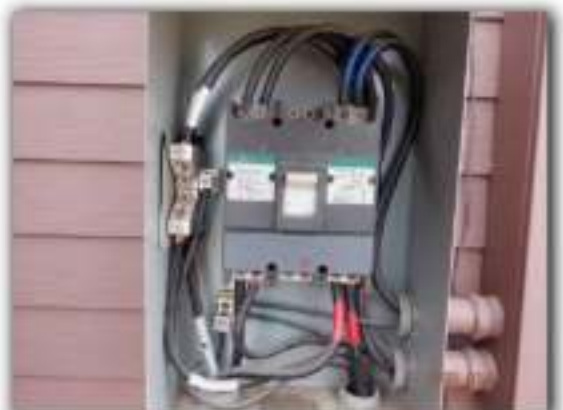
#### Service Entrance

All components were found to be performing and in satisfactory condition on the day of the inspection.

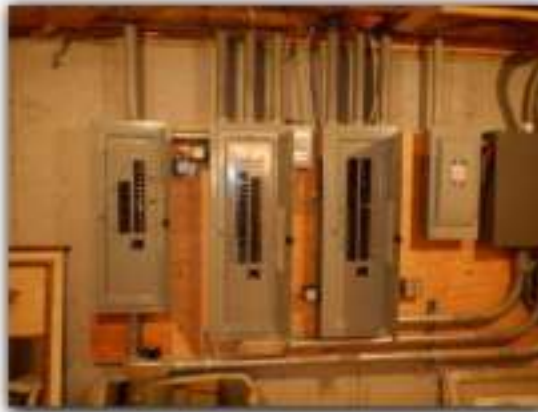
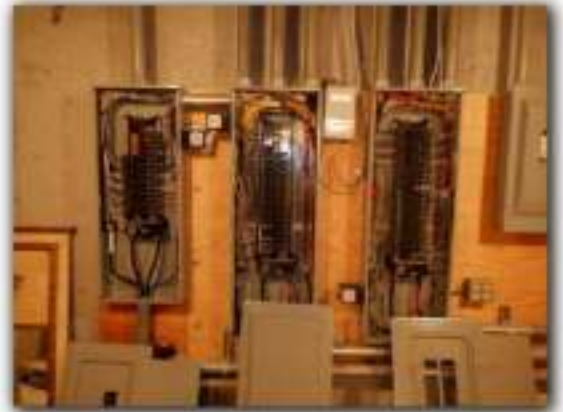
Cabinet Manufacturer: Murray

All components were found to be performing and in satisfactory condition on the day of the inspection.

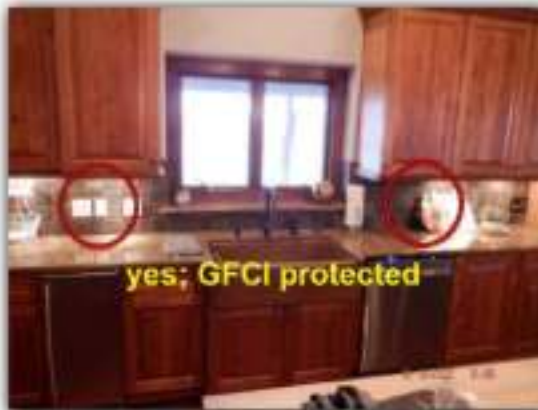
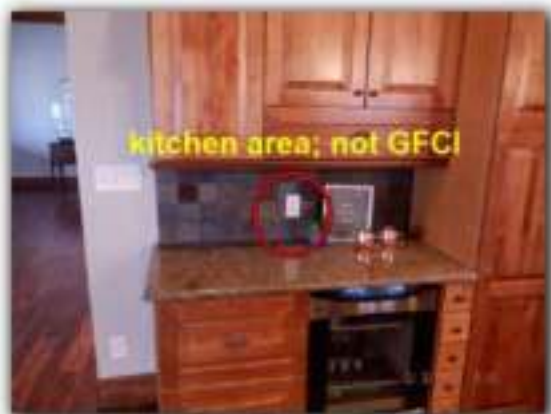
#### Receptacle Outlets

- Not all of the kitchen counter top receptacles appear to be connected to a ground fault circuit interrupter (GFCI) device. Under current electrical standards, all of the kitchen counter top receptacles should have GFCI protection.
- **Note:** Some of the receptacles in the home were inaccessible and could not be reached for inspection due to personal effects, heavy storage, furniture or conditions outside the control of the inspector.

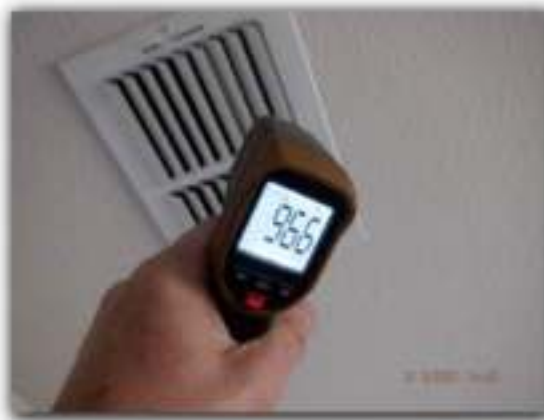
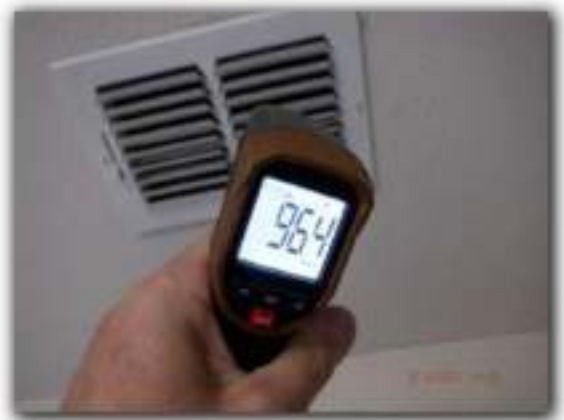
*Approximate System Age:* 2019

This component appears to be performing adequately at the time of this inspection. It is achieving an operation, function, or configuration consistent with accepted industry practices for its age.

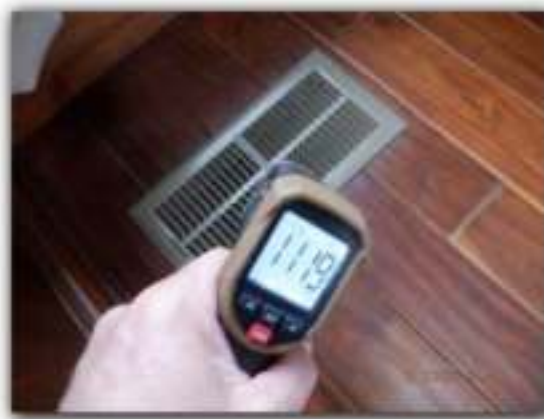
**Zoned / Bedrooms Heating System** – *Energy Source:* Heat-pump with electric heat strip backup

*Approximate System Age:* 2008

This component appears to be performing adequately at the time of this inspection. It is achieving an operation, function, or configuration consistent with accepted industry practices for its age.

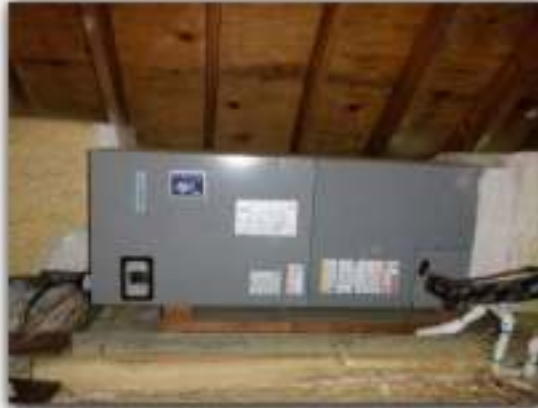
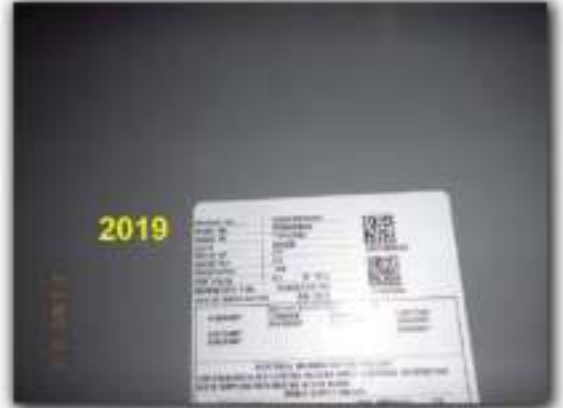
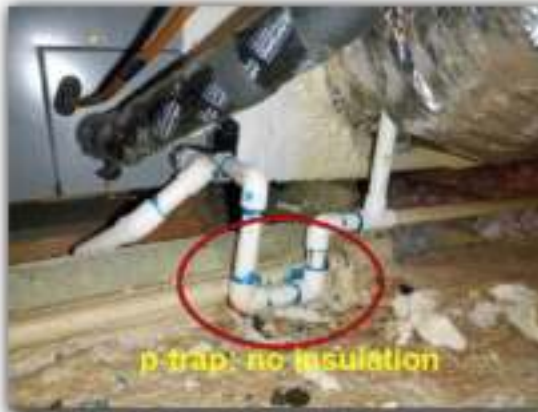
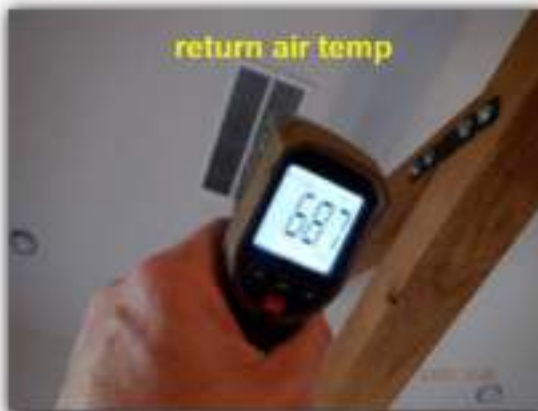
- The auxiliary/secondary drain pan under the indoor coil housing of the cooling system has some water staining and/or rust build-up. This would indicate that the pan has held water in the past and should be closely monitored. It is recommended to have the cooling system further evaluated and serviced.
- Note: The auxiliary/secondary drain pan under the coil housing should be free of all debris. The debris in the pan could clog the drain line and cause water to leak to the interior of the house.

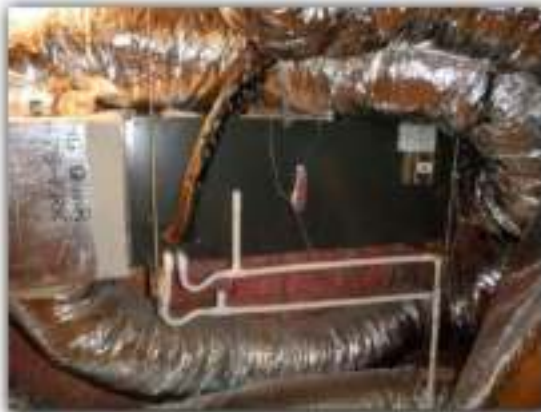
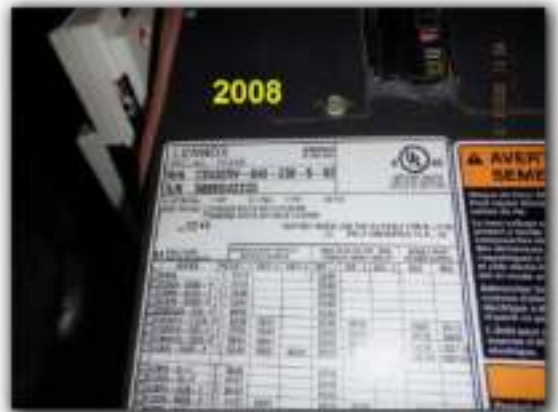
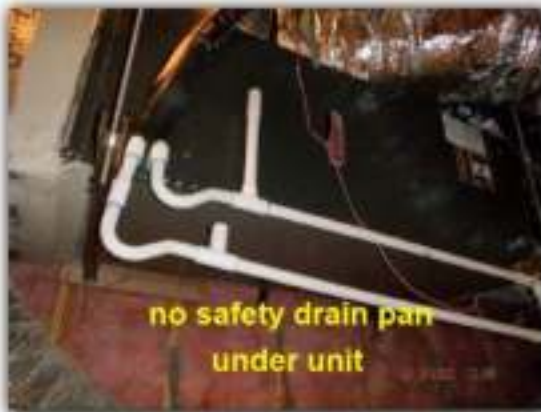
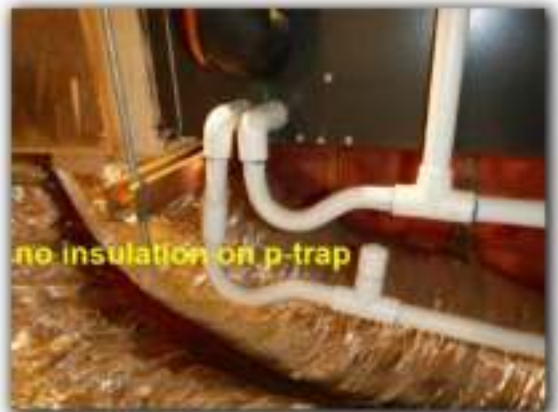
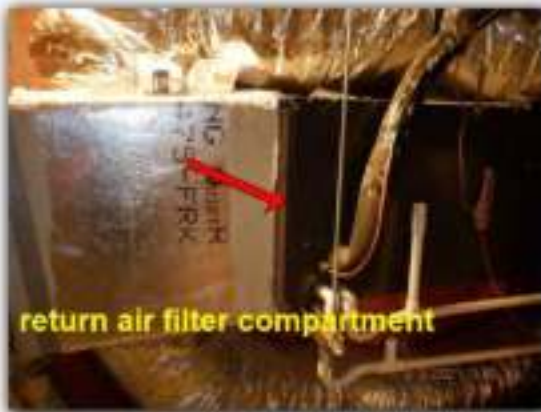
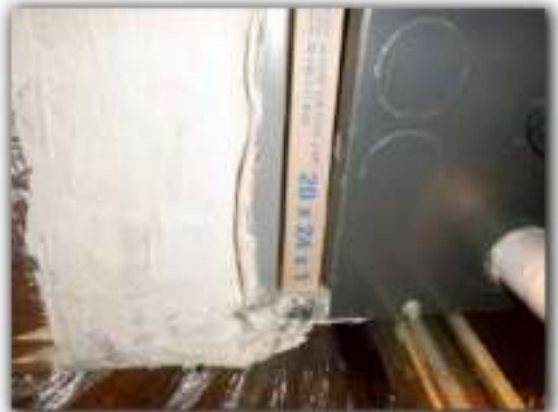
- The HVAC unit in the basement area is not equipped with an auxiliary/secondary condensate drain pan. It is recommended that an auxiliary condensate drain pan, with a secondary drain line, be installed under the attic mounted unit to help prevent possible water damage.
- There is no insulation on the condensation drain line "p-trap"; there should be insulation through and just beyond the p-trap section of the PVC drain line to help prevent sweating or condensation from dripping or collecting onto the attic floor.
- The copper refrigerant line appears to be condensating or leaking water unto the basement floor. This should be further investigated and repaired or corrected as necessary.

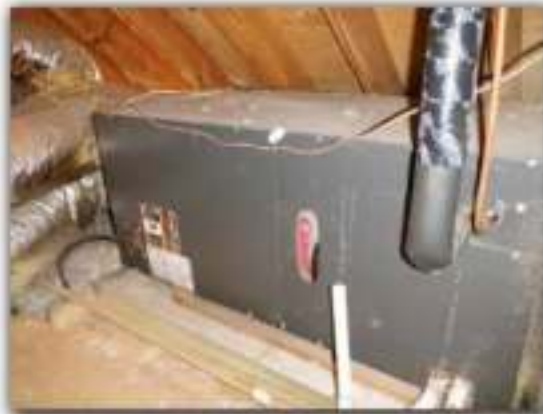
#### Inside Unit:

- There is no insulation on the condensation drain line "p-trap"; there should be insulation through and just beyond the p-trap section of the PVC drain line to help prevent sweating or condensation from dripping or collecting onto the attic floor.
- The auxiliary/secondary drain pan under the indoor coil housing of the cooling system has some water staining and/or rust build-up. This would indicate that the pan has held water in the past and should be closely monitored. It is recommended to have the cooling system further evaluated and serviced.
- Note: The auxiliary/secondary drain pan under the coil housing should be free of all debris. The debris in the pan could clog the drain line and cause water to leak to the interior of the house.

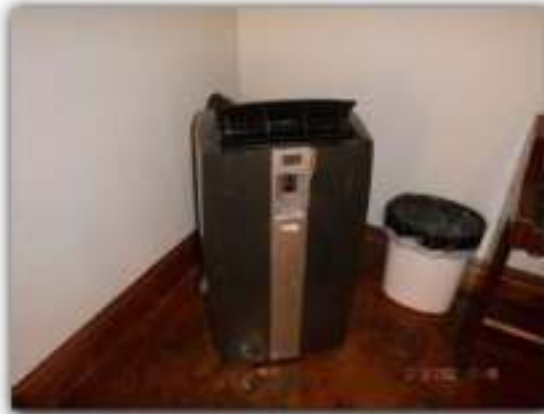
#### Basement - Portable Cooling Unit

- The basement portable cooling system exhaust duct vents into the equipment room and not to the exterior.

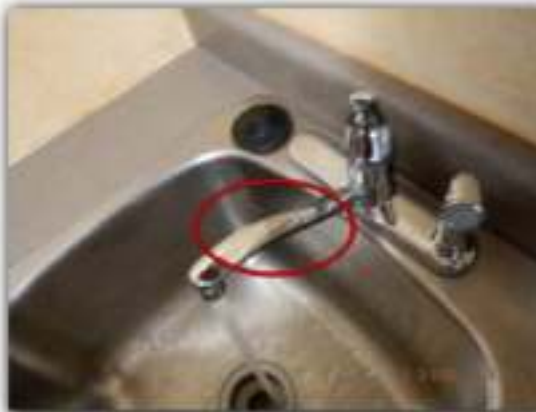
##### Laundry Sink

- The faucet fixture was rusted or damaged and leaking at the fill spout; recommend replacement.

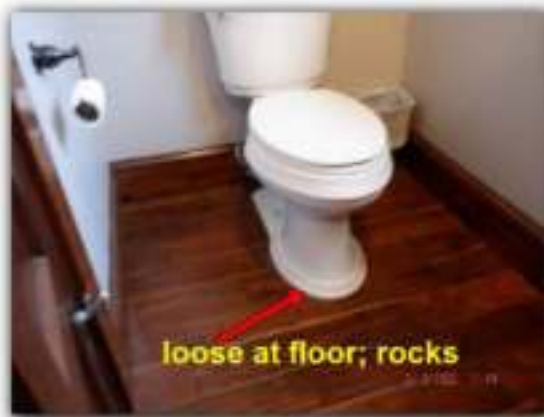
#### Powder or Half Bath

- The commode is loose at the floor mount; it tends to slide side to side or rock back and forth.

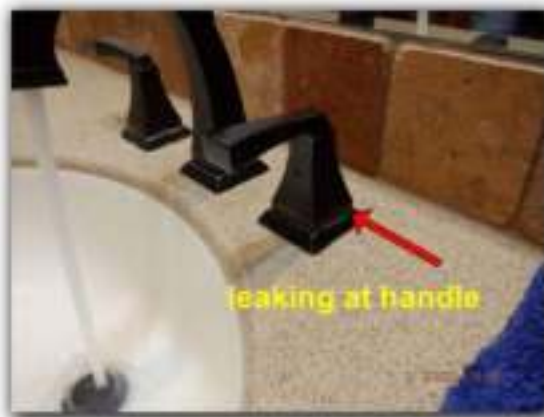
#### Primary Bathroom

- The "his" lavatory sink faucet leaks at the handle(s) when on.

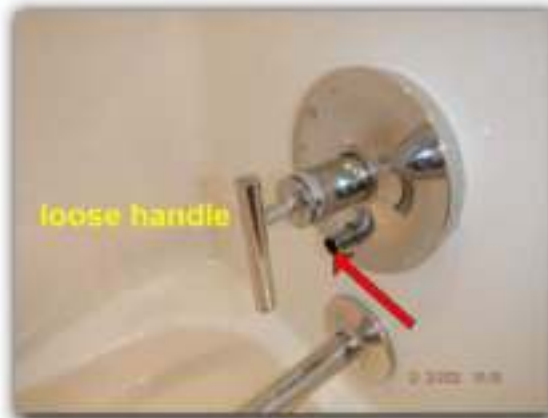
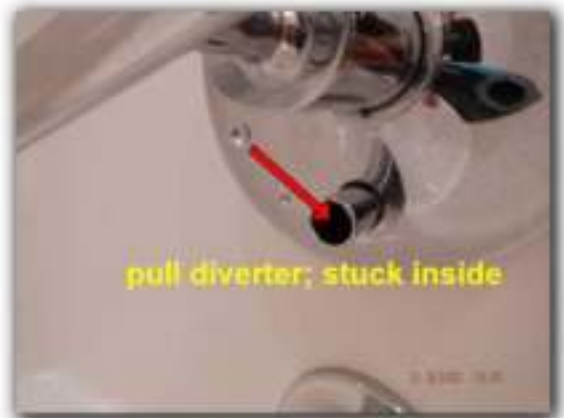
#### Hall Bathroom

- One or more of the bathtub faucet assembly components were observed loose.
- The bathtub shower head diverter is not functioning properly; it is stuck inside and cannot turn on shower head.

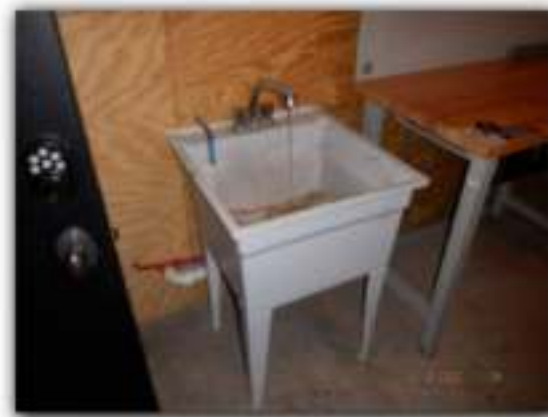
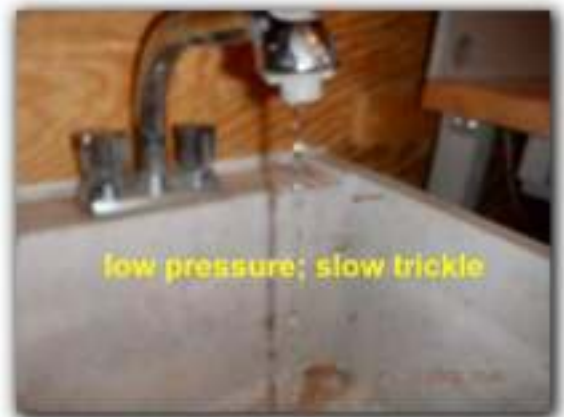
#### Basement Utility Sink

- The plumbing faucet has little to no water pressure, suggesting a possible blockage or obstruction may exist.

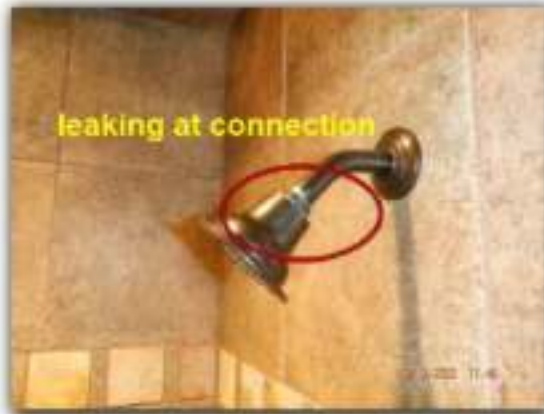
#### Basement Bathroom

- The shower head is leaking and/or may be damaged; repair or replace as necessary.

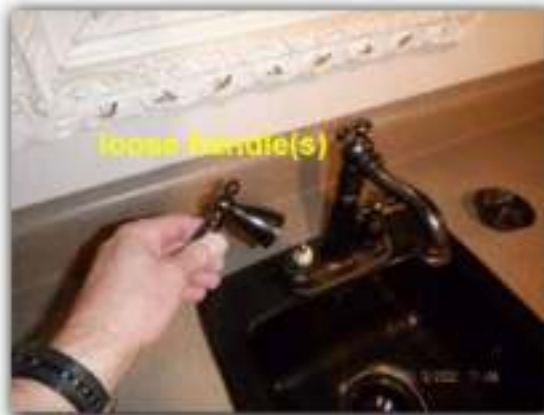
#### Wet Bar Sink

- One or more of the faucet handles were observed loose, damaged or missing.

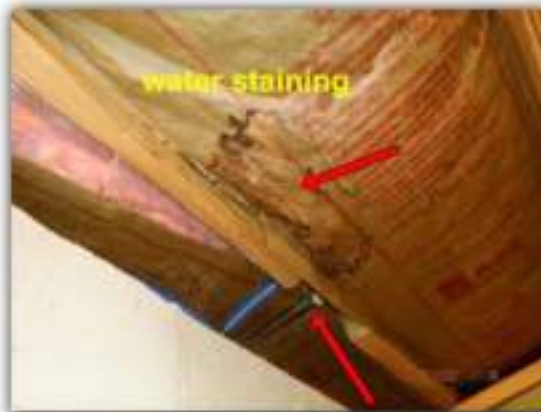
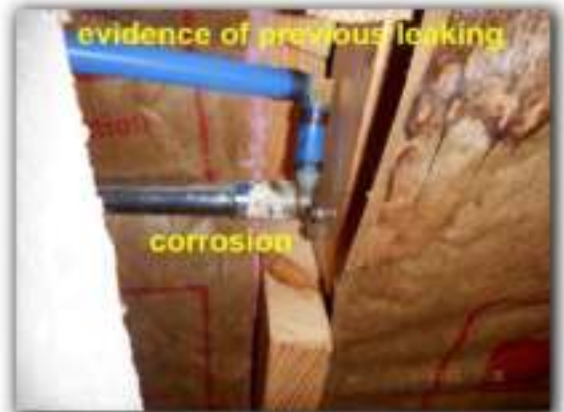
#### Water Supply

- One or more of the water supply lines or pipe fittings were observed leaking or corroded from previous leaking in the basement small hidden room at the bottom of the stairs. The cause and remedy should be further evaluated and corrected as necessary.

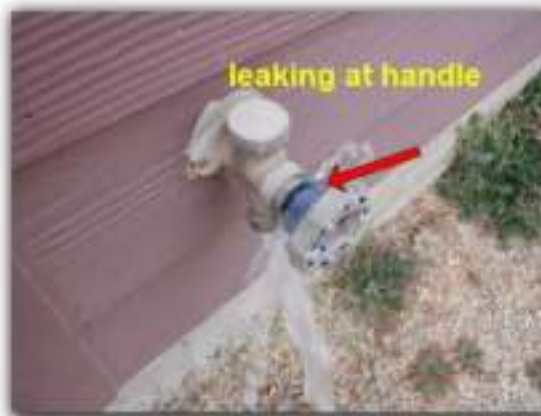
#### Exterior Faucets/Fixtures

- The exterior water hose bibb (faucet) is leaking at the handle when operated on the back side of the structure.

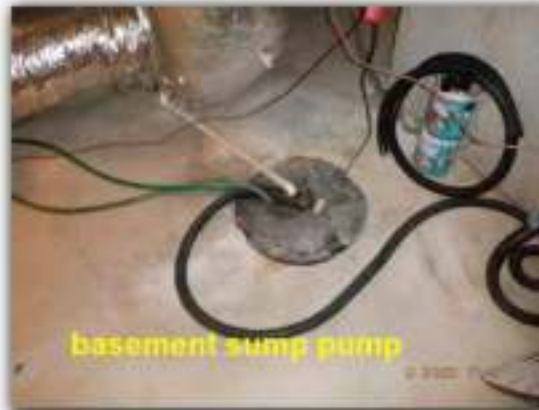
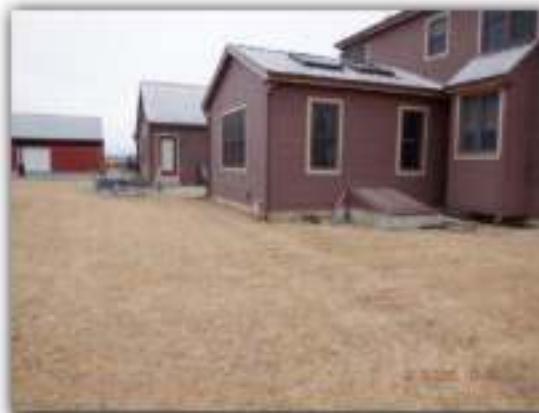
- The PVC drain piping for the sump pump is exposed on the back side of the structure; and showing signs of deterioration. Also, the drain piping is not the correct type of material; appears that some is for electrical use. It is recommended to replace at least this section of exposed drain piping.
- It should be noted that it appears the sump pump is draining to the exterior or out gray water and not into the main sanitary sewer system. This is not considered acceptable practice any longer.

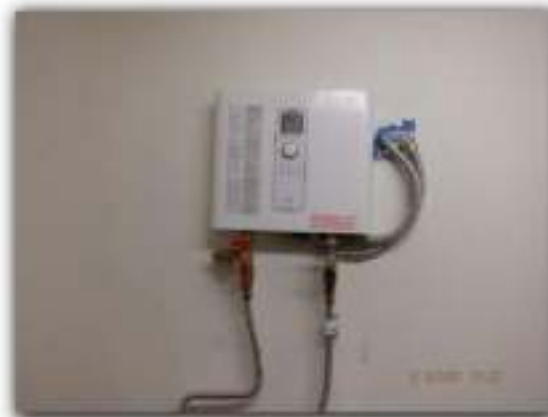
**Water Heater #2** – *Energy Source:* **Electric**  
*Location:* **Basement Closet**  
*Approximate Capacity:* **Tankless Water Heater**  
*Approximate Age:* **Unable To Determine**  
*Brand Name:* **Stibel Eltron**

- There is no temperature and pressure relief valve (TPR) discharge pipe in place at the time of this inspection. For safety reasons, it is recommended that a TPR valve discharge pipe be installed. Under current building standards, the discharge pipe should run downward to the exterior of the structure, turn downward, and terminate within 6-inches of the ground.
- There is no safety or emergency drain pan installed under the water heater. Current building standards require a drain pan under all water heaters. However, not all municipalities enforce this requirement for units installed in garages.

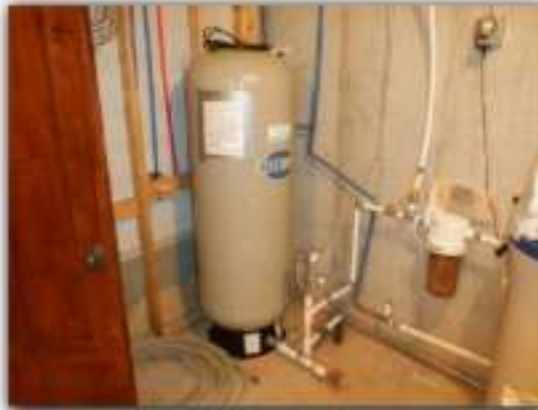
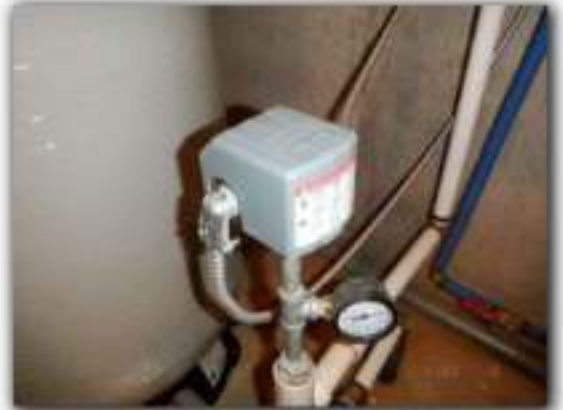
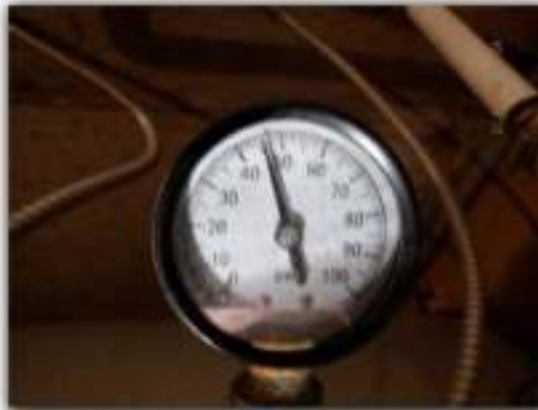
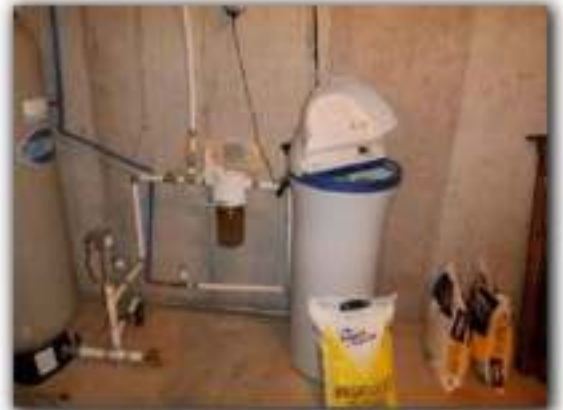
A visual inspection of the above-ground components only was conducted attempting to locate and identify the storage tank, pressure switch, control panel and well head. If there are concerns related to the overall condition of the well and equipment, a well specialist should be contacted for further evaluation.

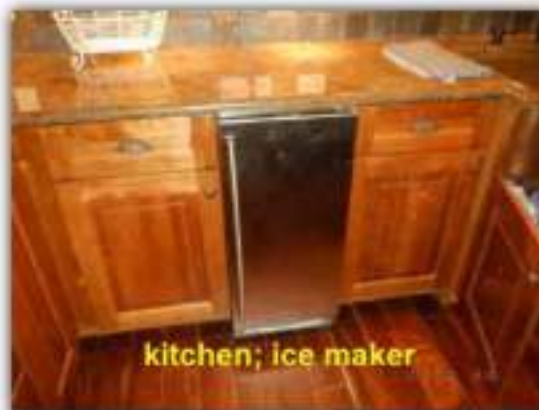
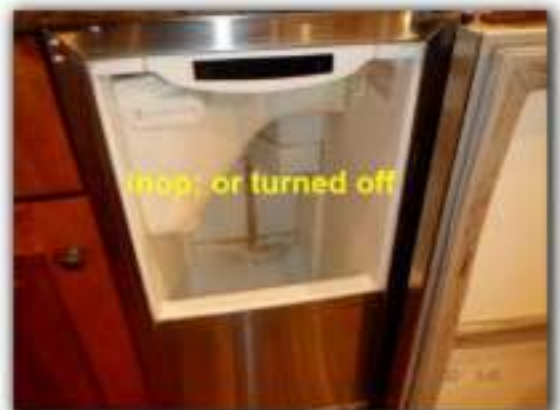
- This appliance appears to be inoperative at the time of the inspection. The cause and remedy should be further evaluated.

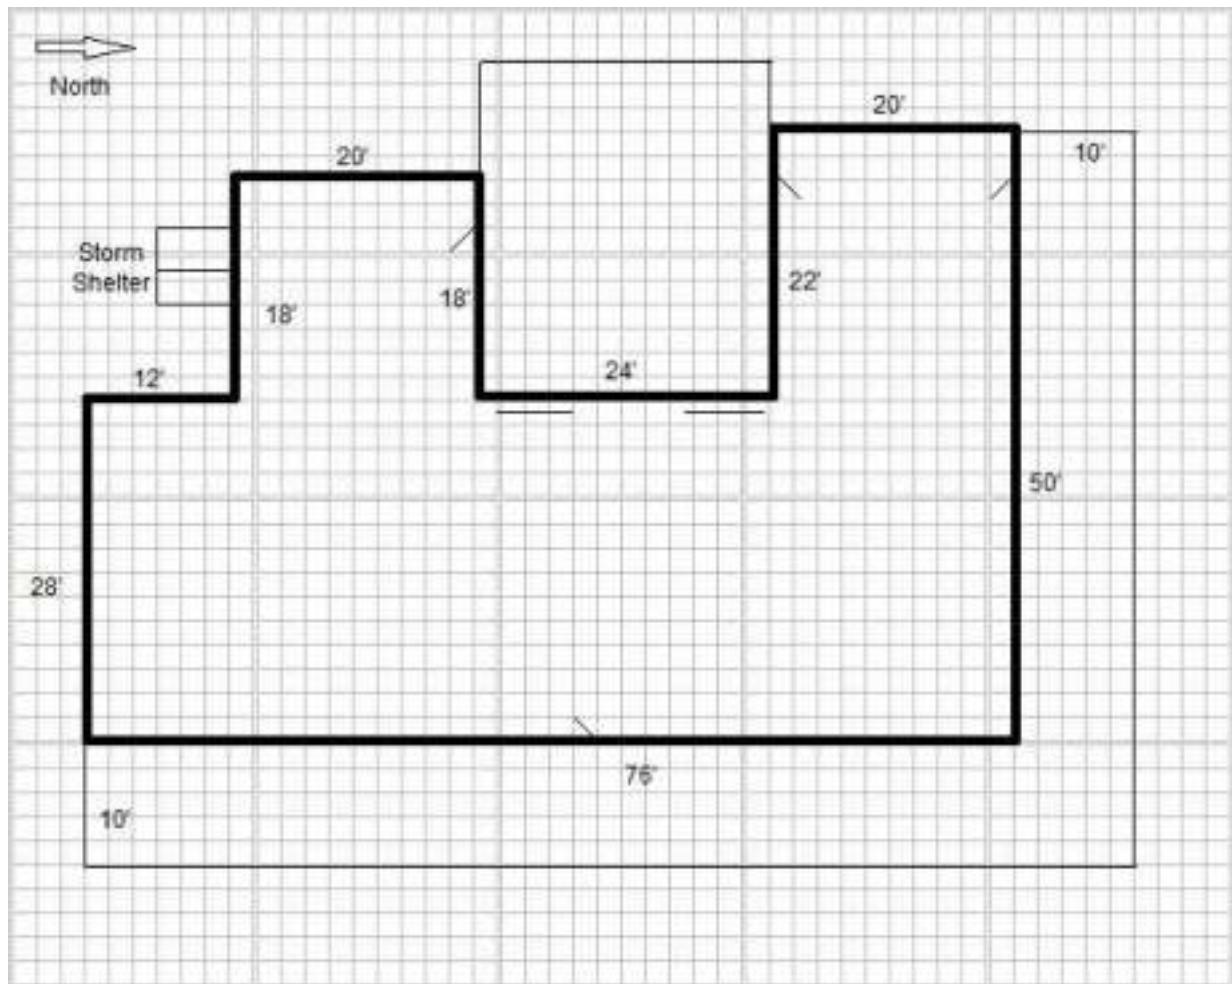
**Diagram of Structure(s) Inspected**

Additional Comments There is no visible evidence of wood destroying insects found at the time of this inspection. \_\_\_\_\_
