Inspection Report

0 Elm St
Danvers MA

Omega Home Inspections, LLC

Date: 3/18/2020	Time: 12:45 PM - 04:15 PM	Report ID: 2020SampleSF
Property: 0 Elm St Danvers MA	Customer: Bob Smith	Real Estate Professional:

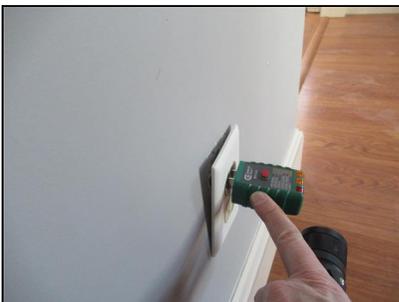
+ 7.3 (3) There was a loose electric receptacle at the corner of the living room wall. All receptacles should be properly affixed to the wall. I recommend that a licensed electrician properly secure this receptacle.

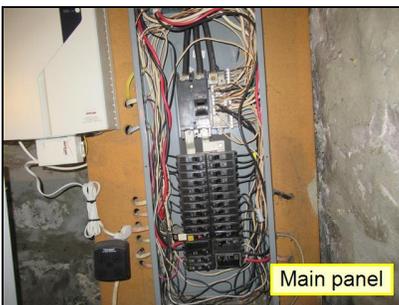
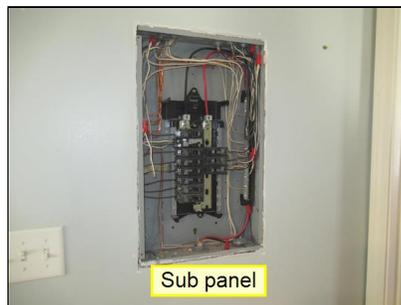
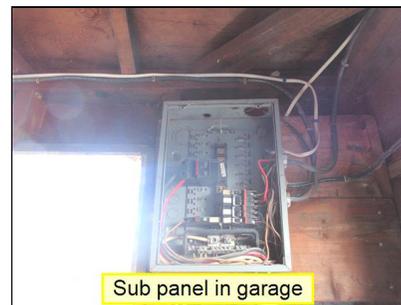
7.6 The main panel was located at the front corner of the basement. There was a sub panel located in the hallway off of the kitchen and one in the garage. This is for your information.

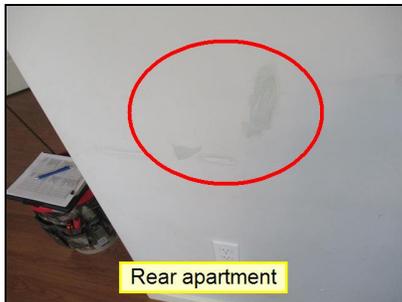
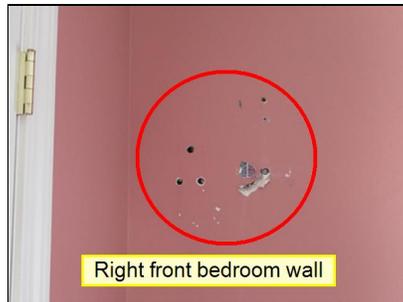
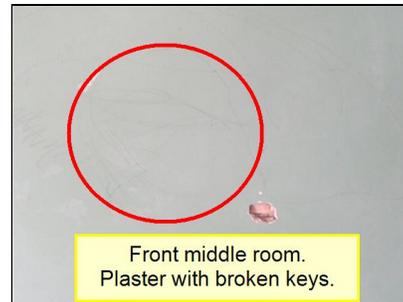
8.0 (1) There were some damaged wall surfaces in several of the rooms. The plaster is pulling away from the lath behind the wall at the front middle room on the second floor. This happens when the plaster 'keys' break at the back side of the lath. I recommend the damaged areas be filled with drywall compound for holes in the gypsum board walls, and then sanded, primed and painted. I recommend watching "tips on how to repair plaster walls", which can be found at the "This Old House" link here: <https://www.thisoldhouse.com/walls/21133086/how-to-repair-plaster-walls>

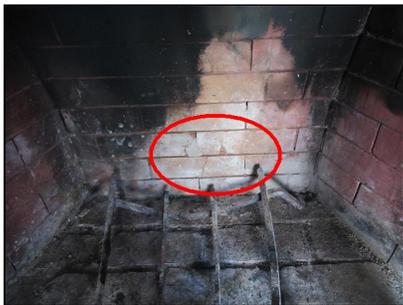
+ 9.0 There was deteriorated masonry at the back of the firebox as well as some missing mortar in the fireplace. I recommend that a qualified chimney sweep repair this masonry. Recommended accreditations for chimney sweeps; CSIA Chimney Sweep Institute of America and NFI National Fire Place Institute.
