Broken Head Quarry

Enforceable Undertaking Progress Report  
Report #6 – January 2019

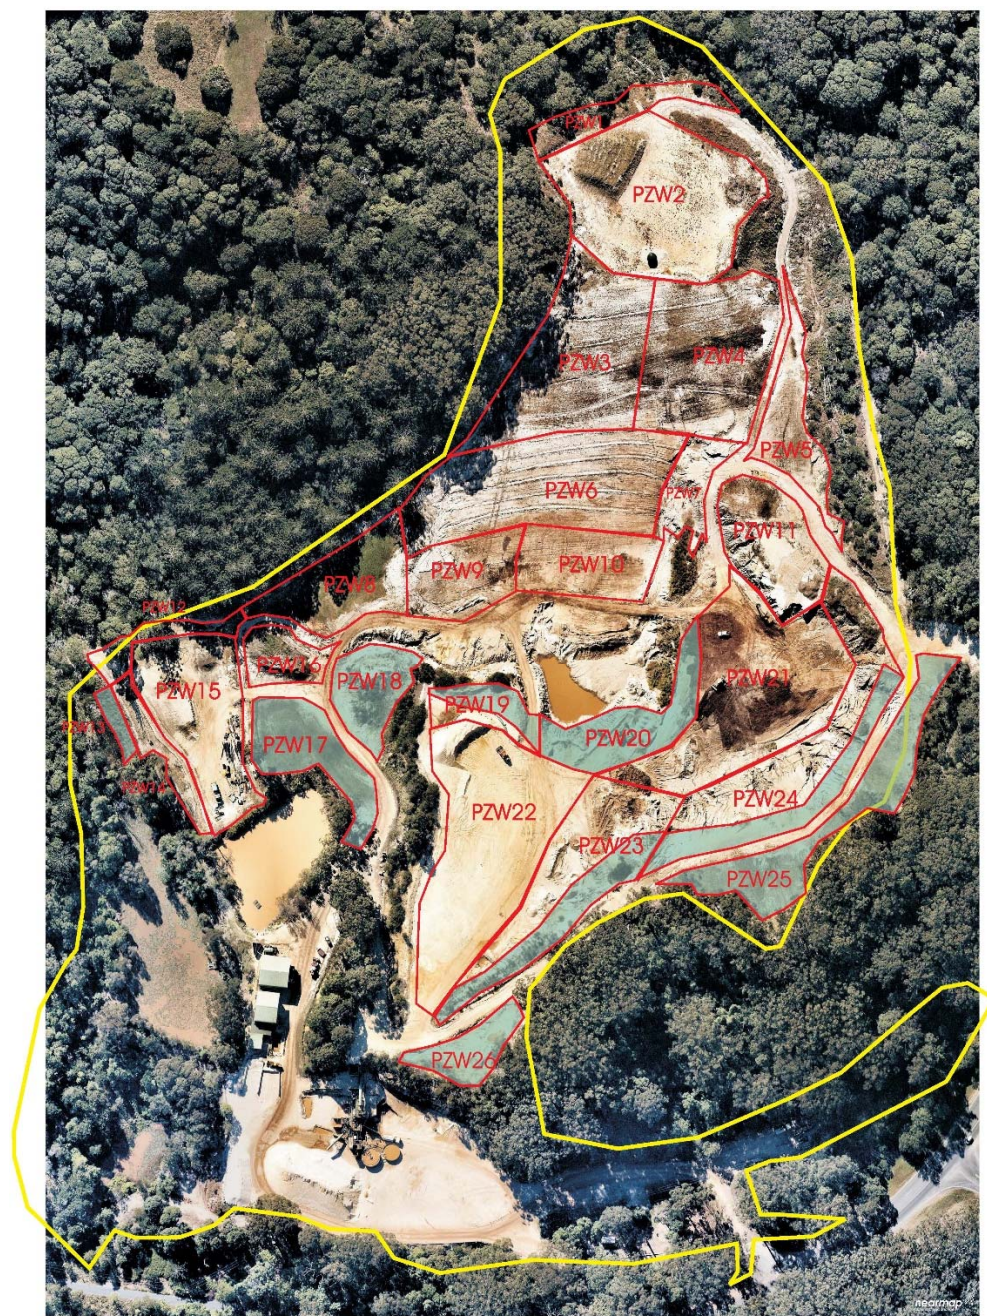
Planting will be undertaken in areas PZW13 (batter above the Lilypond), PZW17 (grassed area above Process Pond), PZW18 (grassed area below Central Dam wall), part of PZW19 (south west bank of the Central Dam), PZW20 (South Bank of Central Dam, including rehabilitated watercourse), upper part of PZW23 (batter west of Westside upper access trail), part of PZW24 (plateau west of Westside upper access trail), PZW25 (area between Westside upper access trail and the limit of extraction) and PZW26 (Area above washplant dump point). Those areas are as reported in Report #5 and are marked in green on the plan of instructions provided to the contractor following:

Figure 1 – Proposed planting areas March 2019

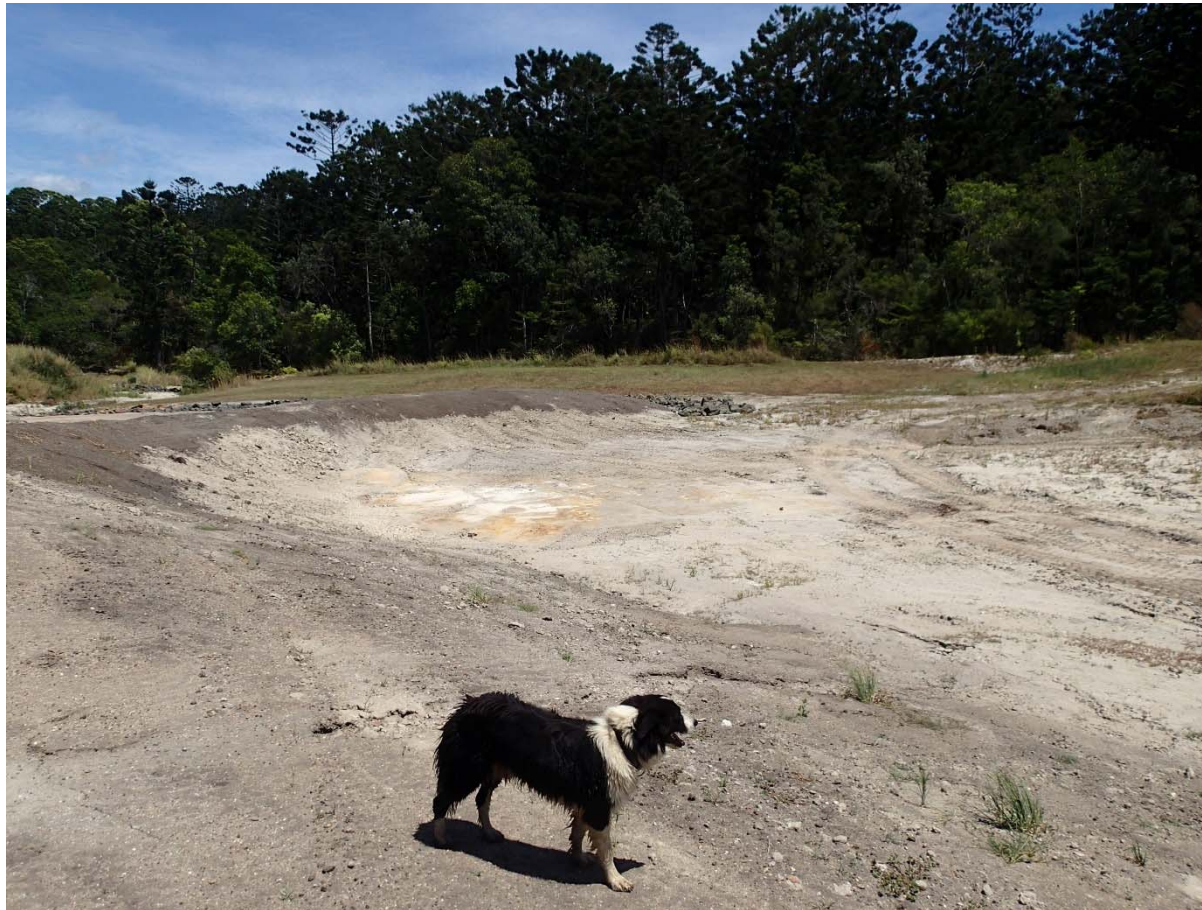
Area PZW11 was completely reprofiled and its final batter shape created and topsoil applied. Grass was not seeded due to unsuitable weather conditions over January 2019, meaning it was unlikely that any germination would be successful. Grass will be seeded when weather conditions are more conducive.

**Figure 14 – PZW11 looking north from PZW24 at top of new drain**
