Broken Head Quarry

Enforceable Undertaking Progress Report

Report #8 – March 2019

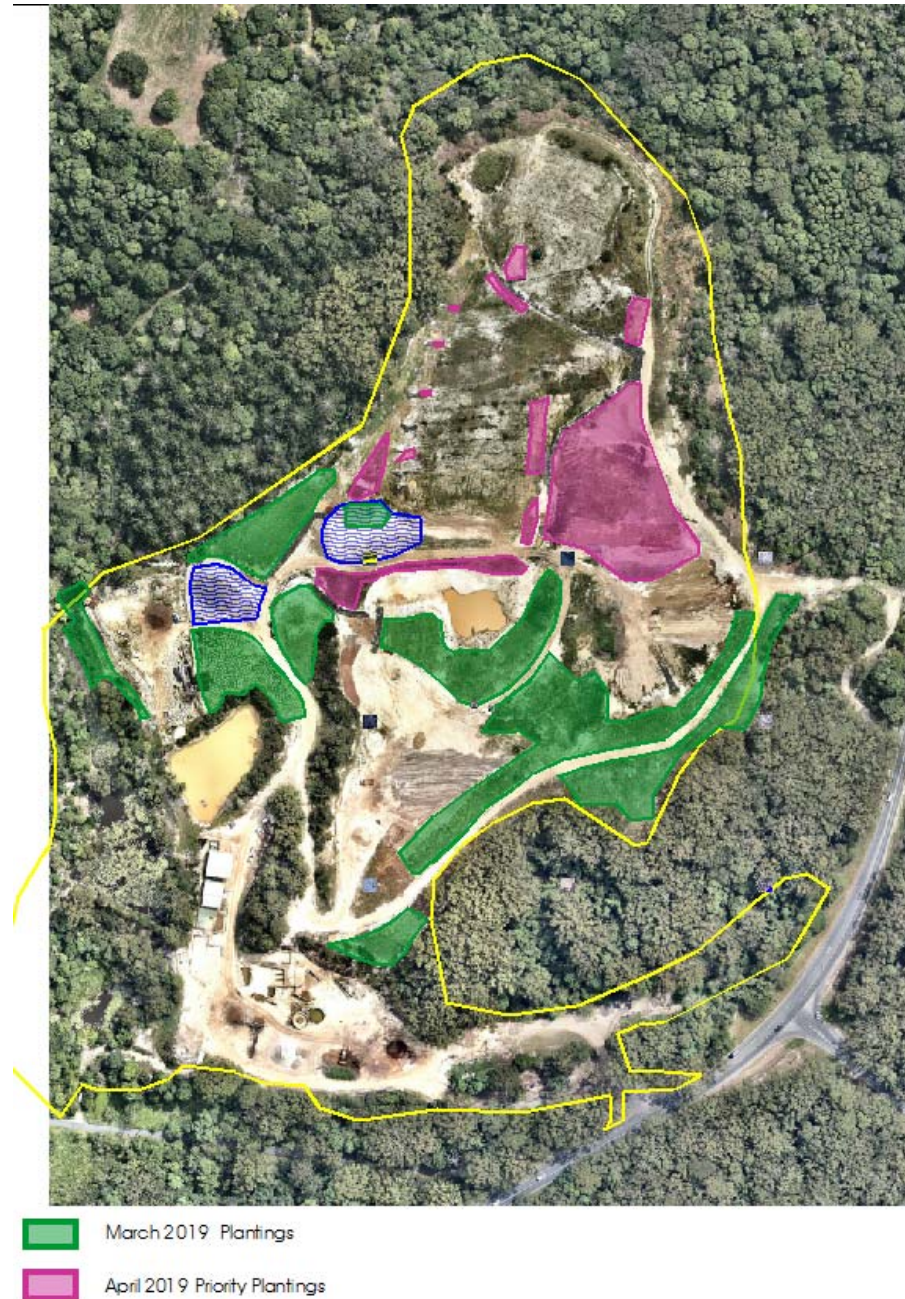
**Figure 3 – Westside March 2019 plantings and April 2019 planned plantings**

Extensive planting work was undertaken on the Westside during March 2019 in the areas shown shaded in green in **Figure 3**, comprising areas PZW8, PZW13, PZW14, PZW17, PZW18, PZW19, PZW20, PZW21, PZW23, PZW24, PZW25 and PZW26. Planting comprised approximately 5,000 plants over a period of about 3 weeks.

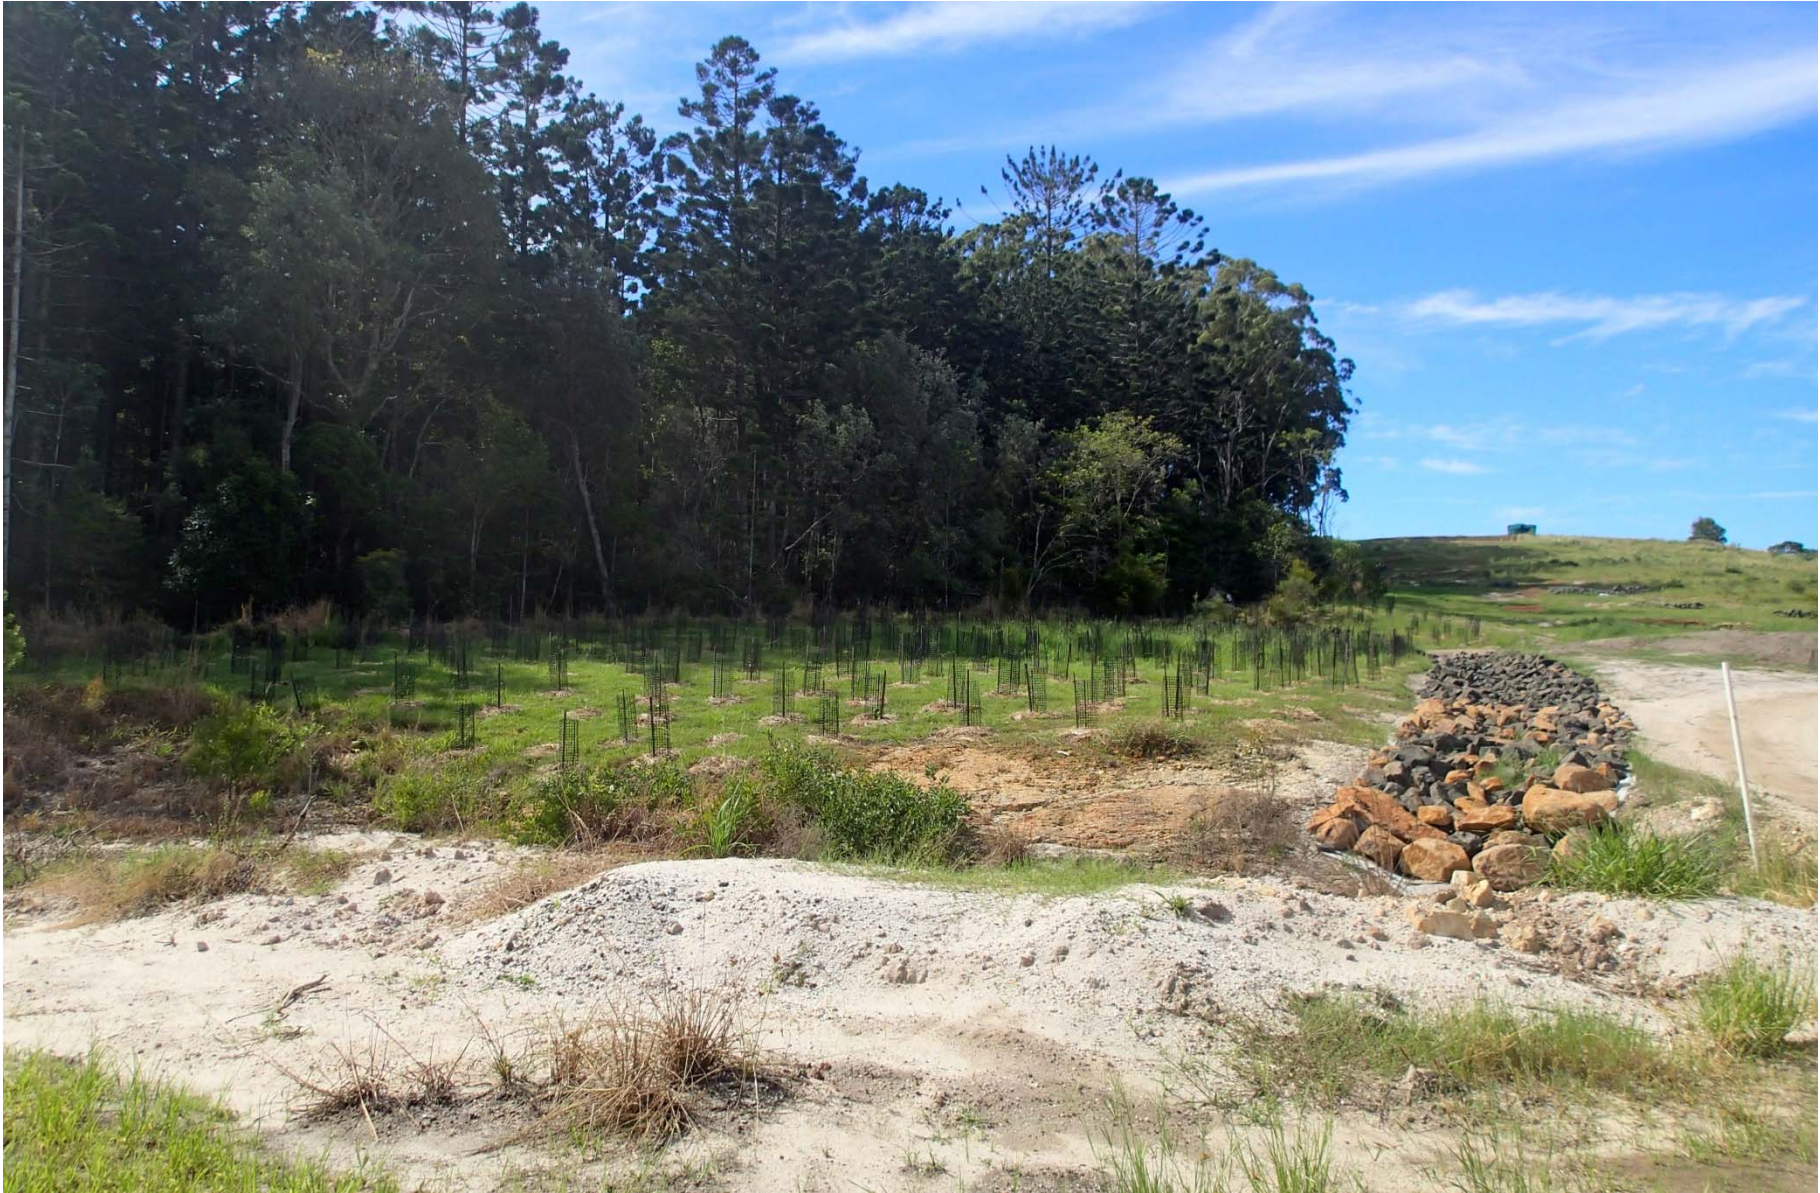
**Figure 28 – Plantings on PZW8 viewed from Cutoff drain looking north**

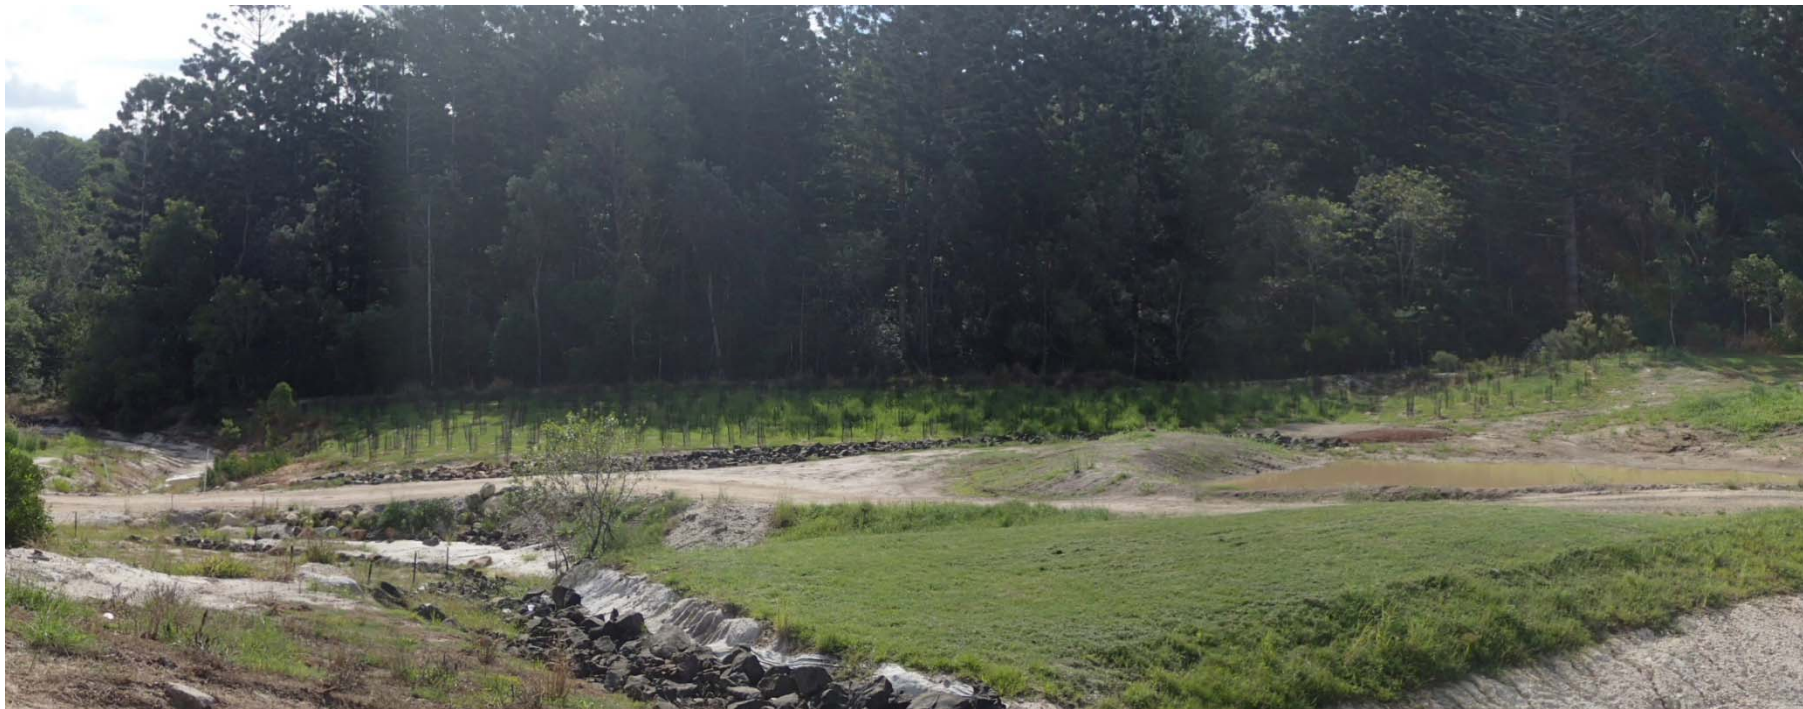
**Figure 29 – Plantings on PZW8 viewed from east of Central Dam looking west**

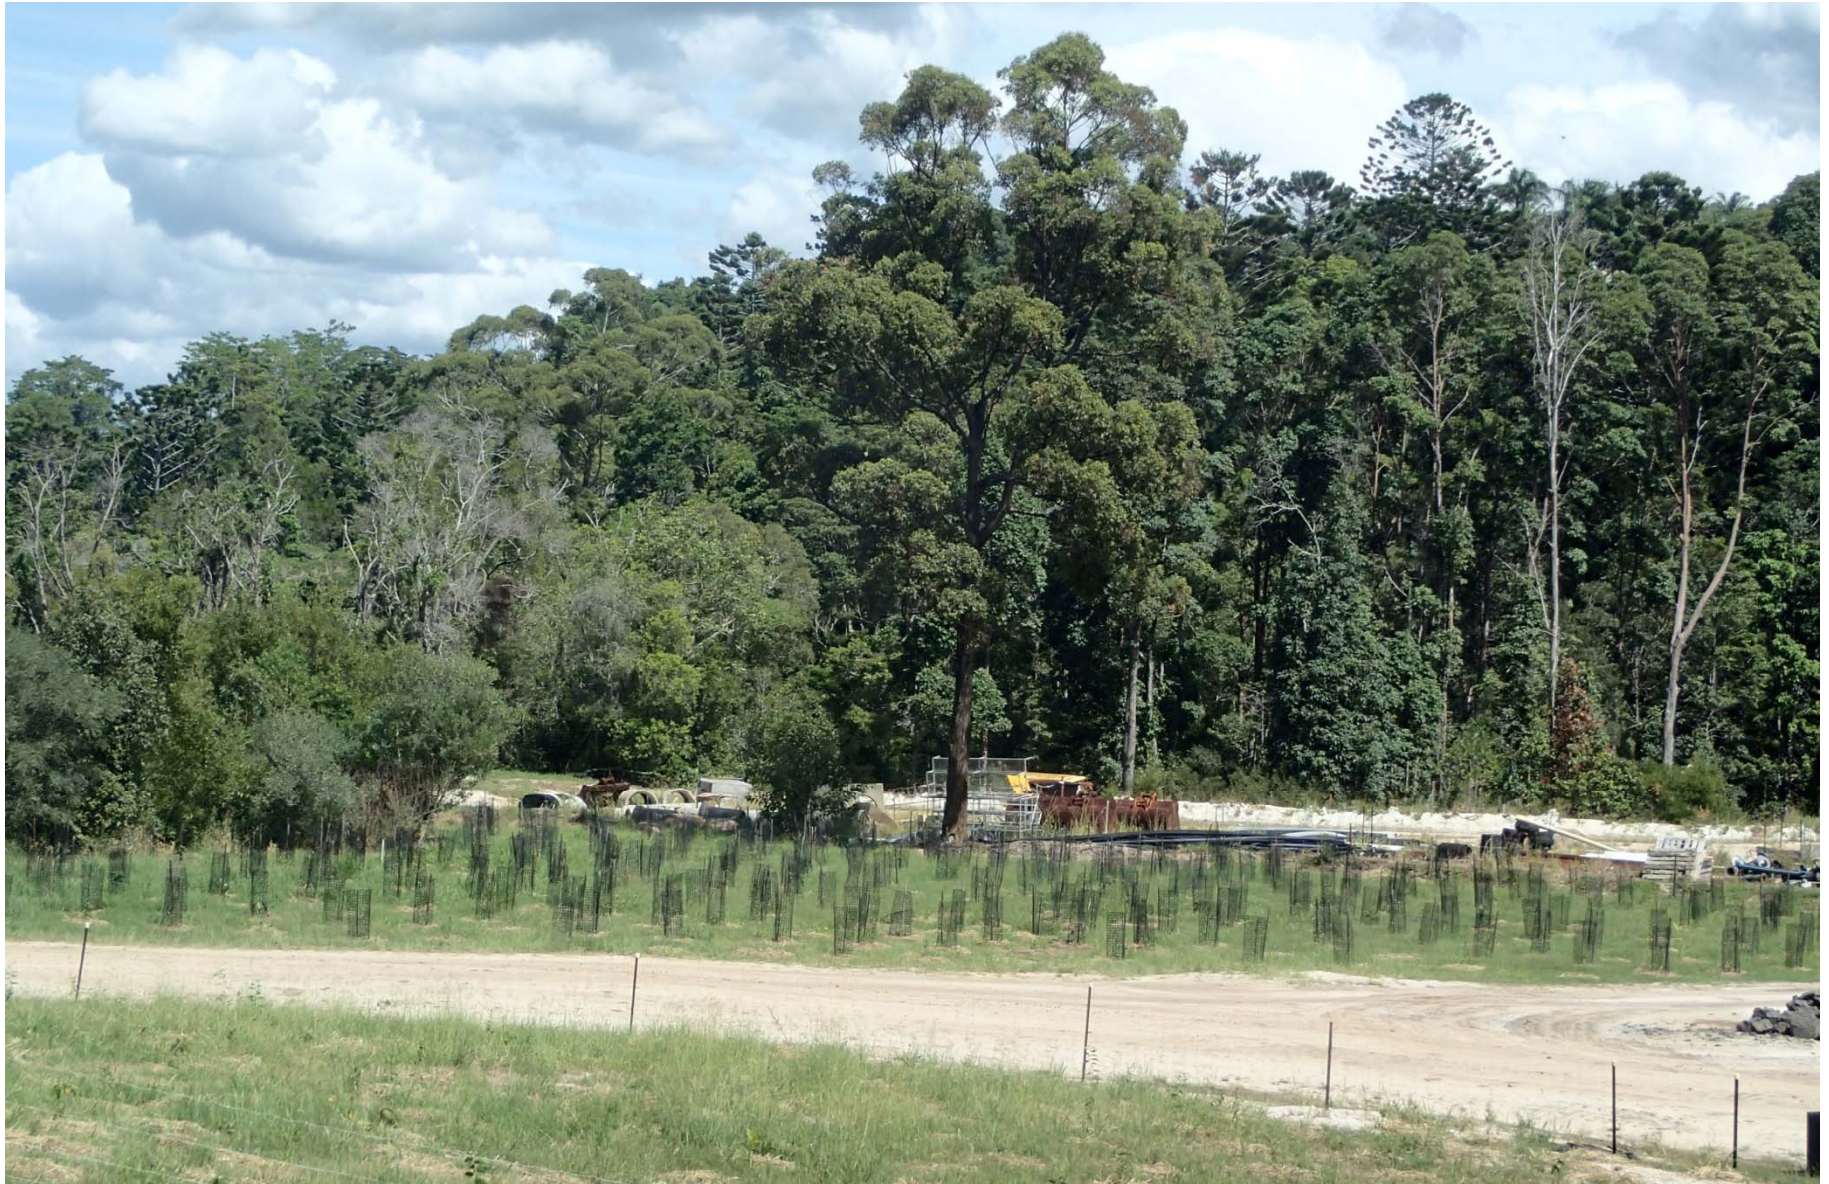
**Figure 32 – PZW17 plantings viewed from PZW18 looking west**

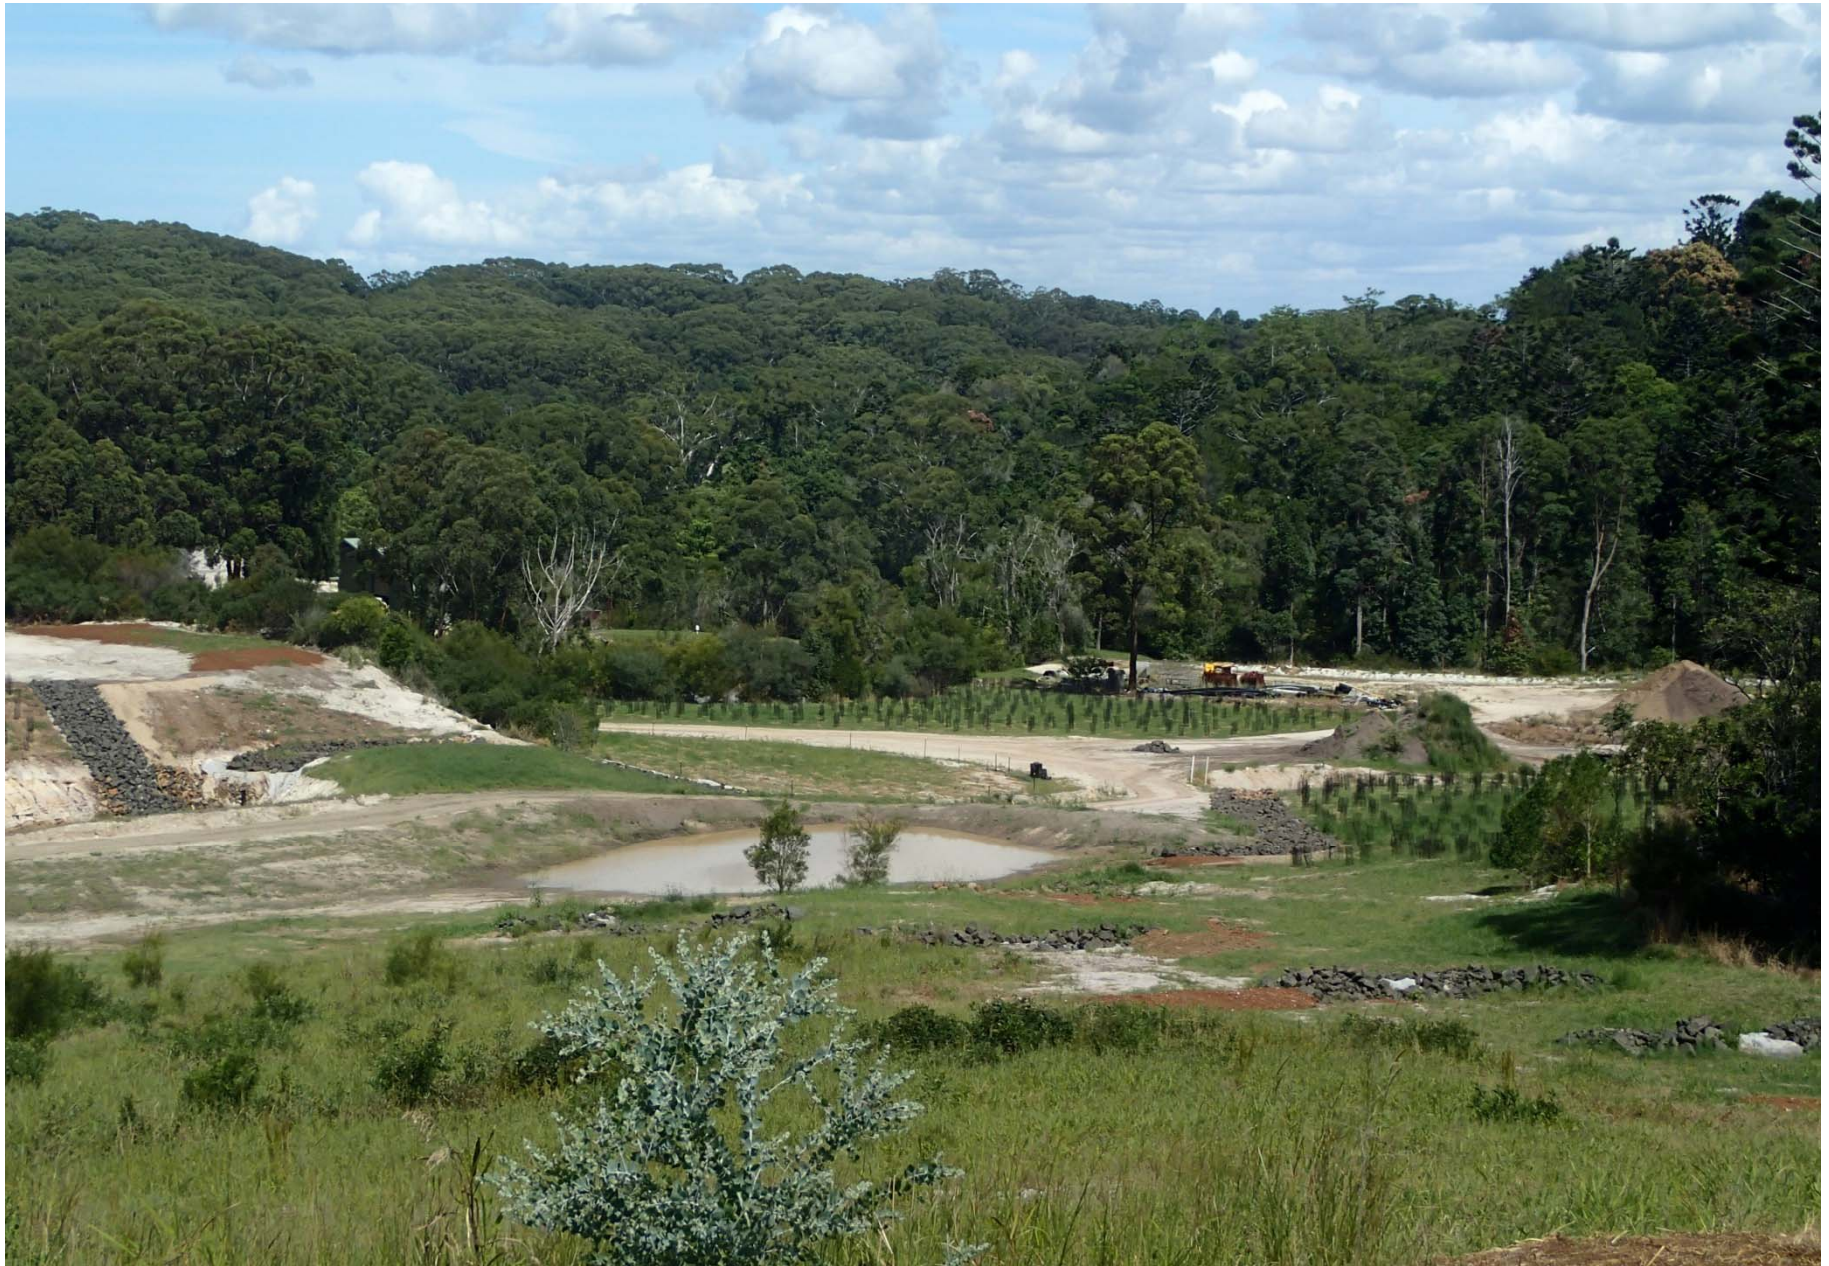
**Figure 33 – PZW17, PZW18 and PZW8 plantings viewed from PZW2 looking southwest**

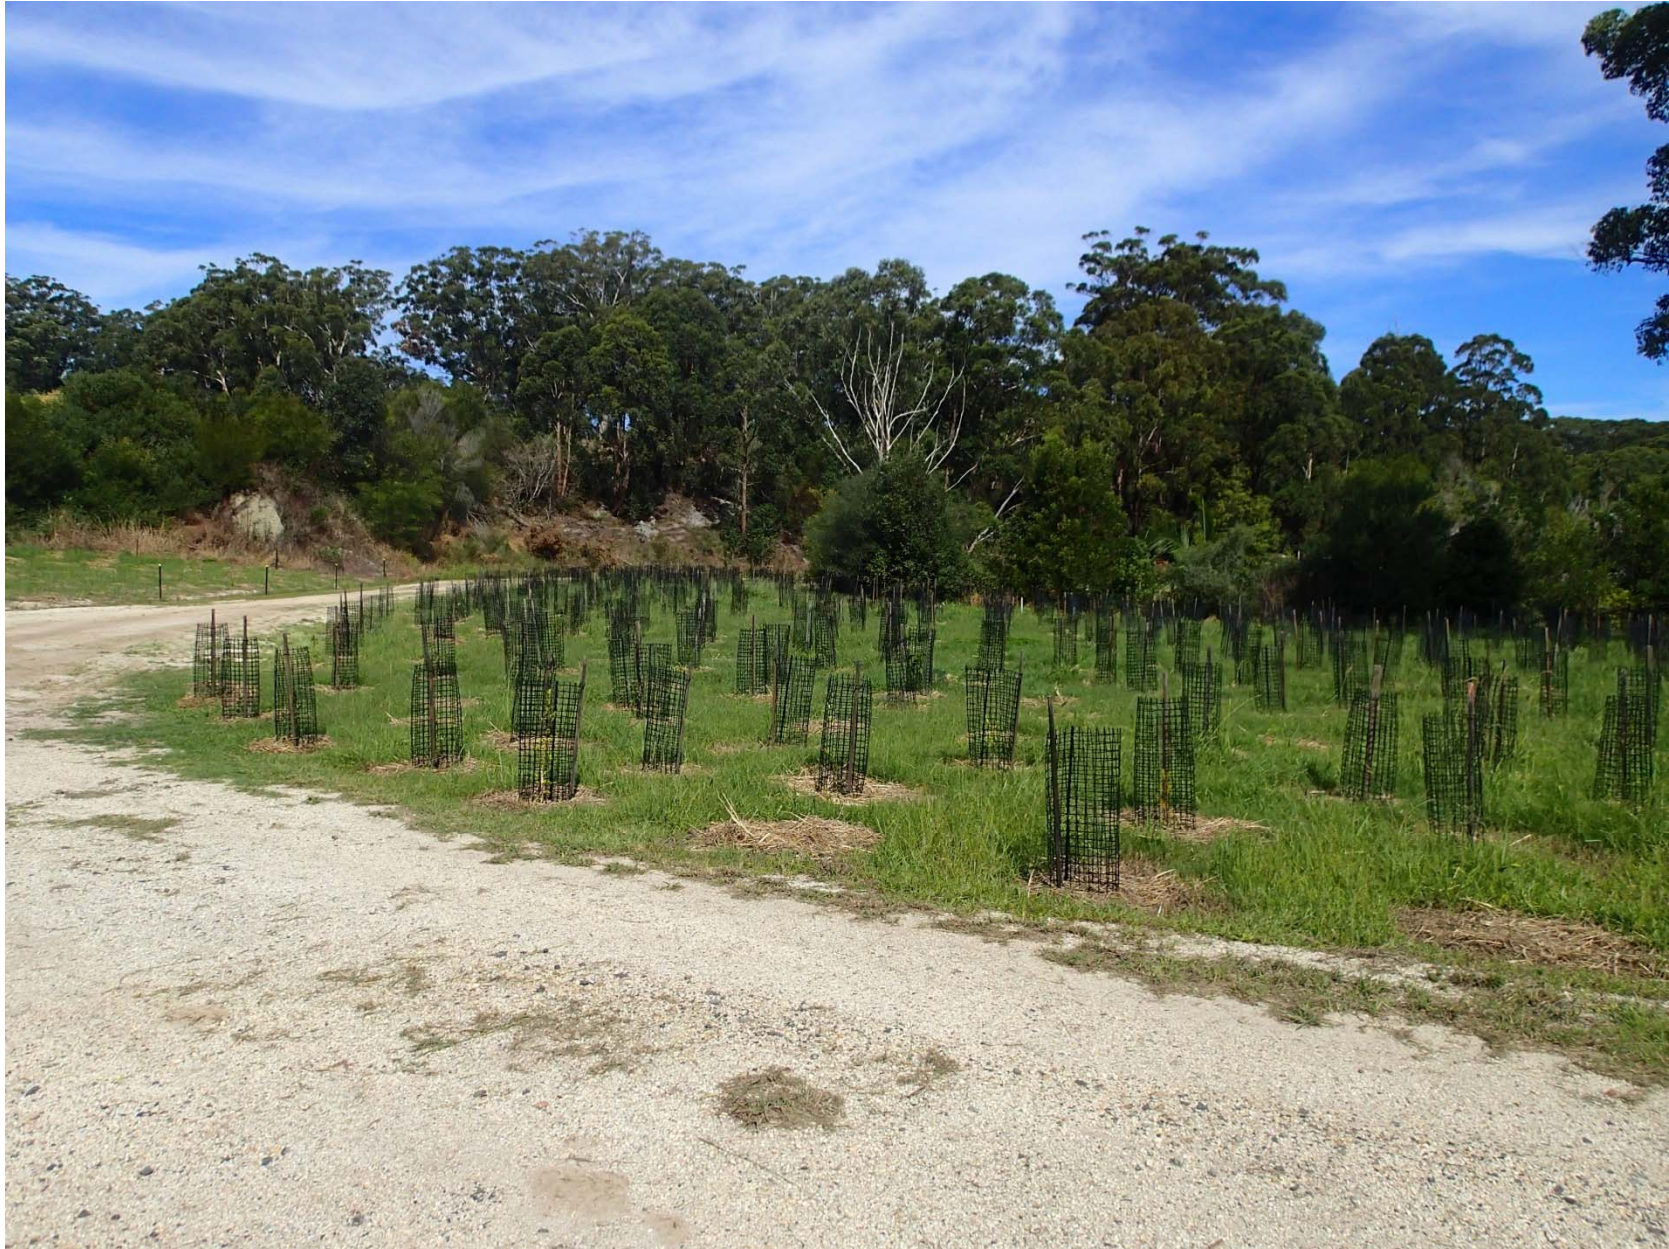
**Figure 34 – PZW17 plantings viewed from access road to PZW15 looking southeast**

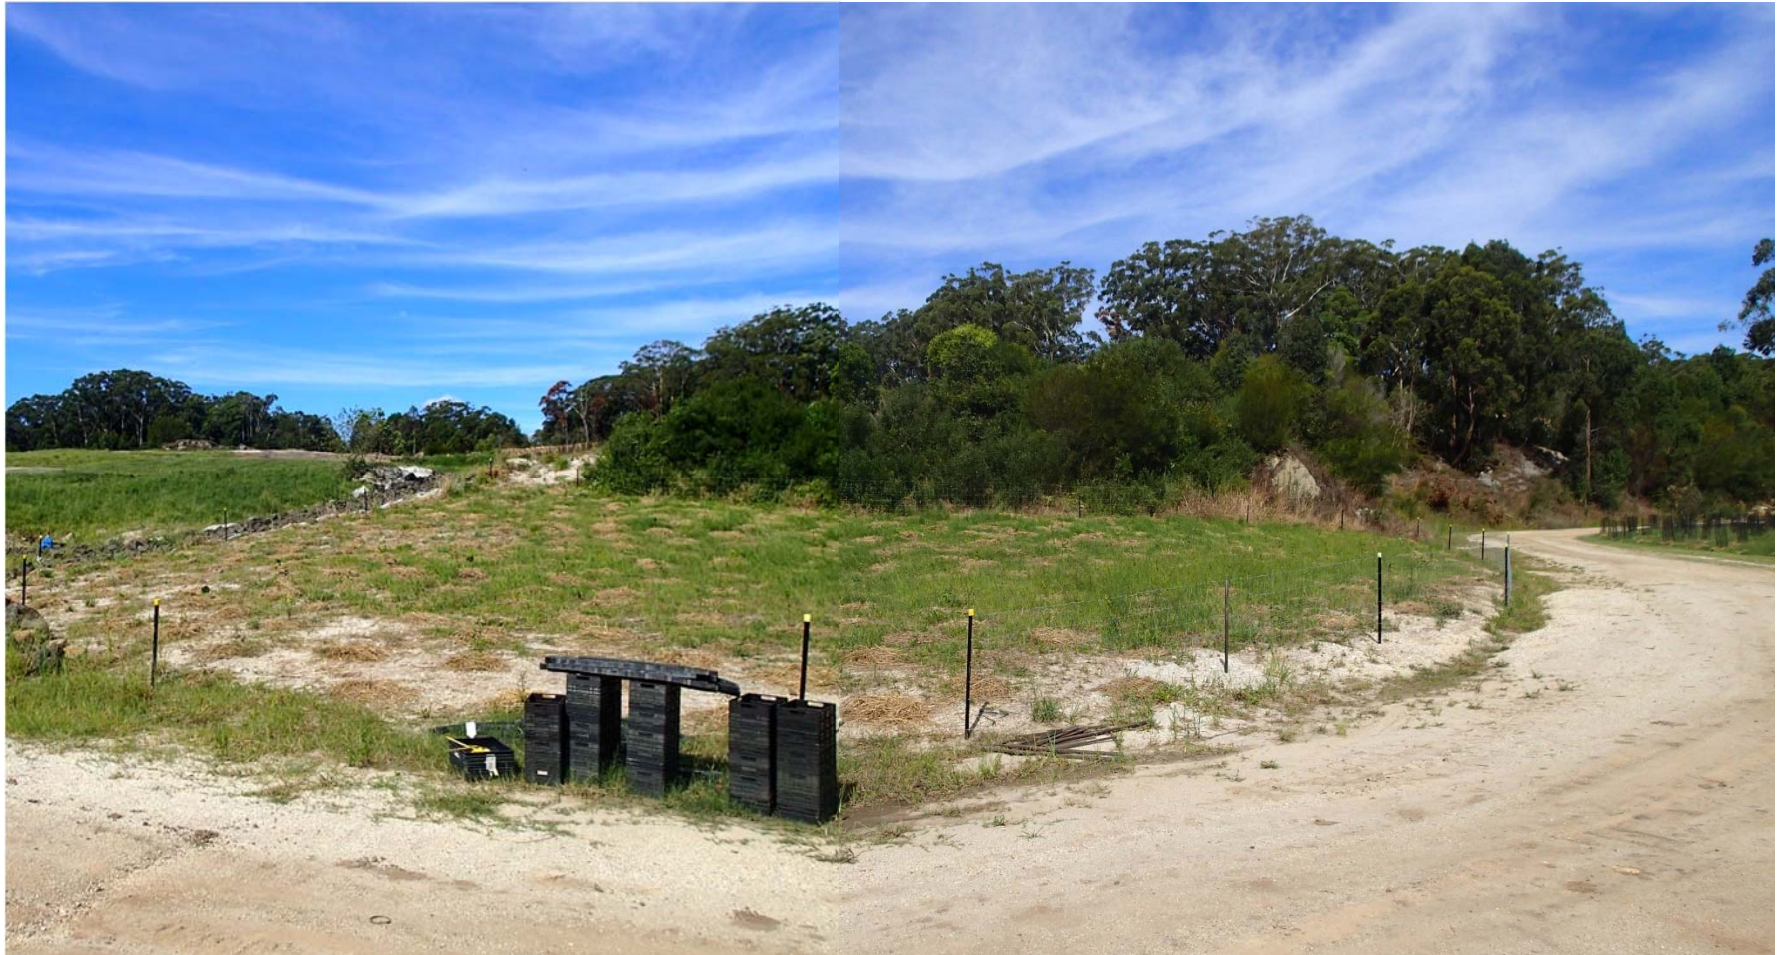
Area PZW18 was planted in the same density as the remaining plants except wallaby screens were not used, instead a wallaby exclusion fence was erected around the area. Accordingly it is more difficult to see the plantings than with respect to other areas.

**Figure 35 – PZW18 viewed from Central Dam access road looking east (montage of 2 photos)**

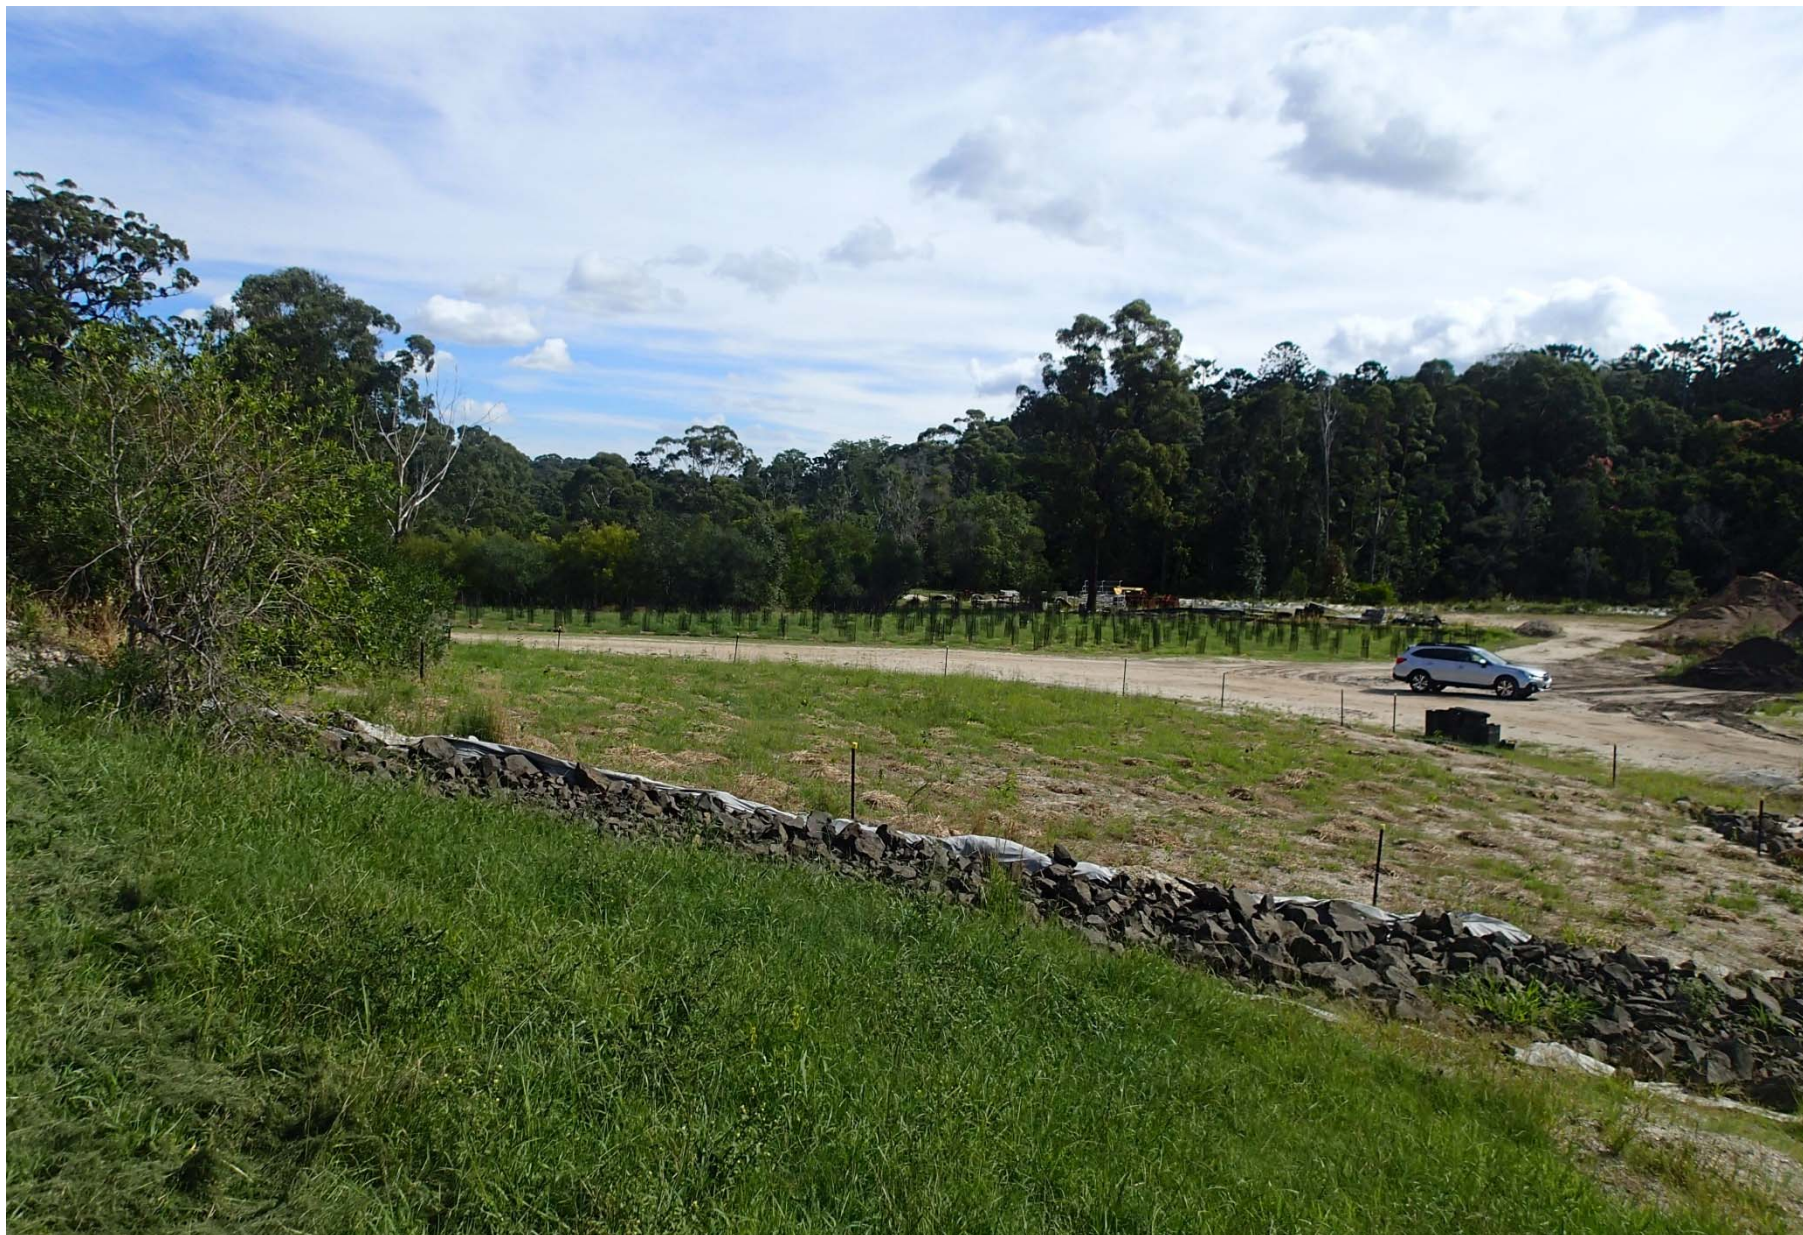
**Figure 36 – PZW18 (foreground) and PZW17 (rear) plantings viewed from Central Dam wall looking west**

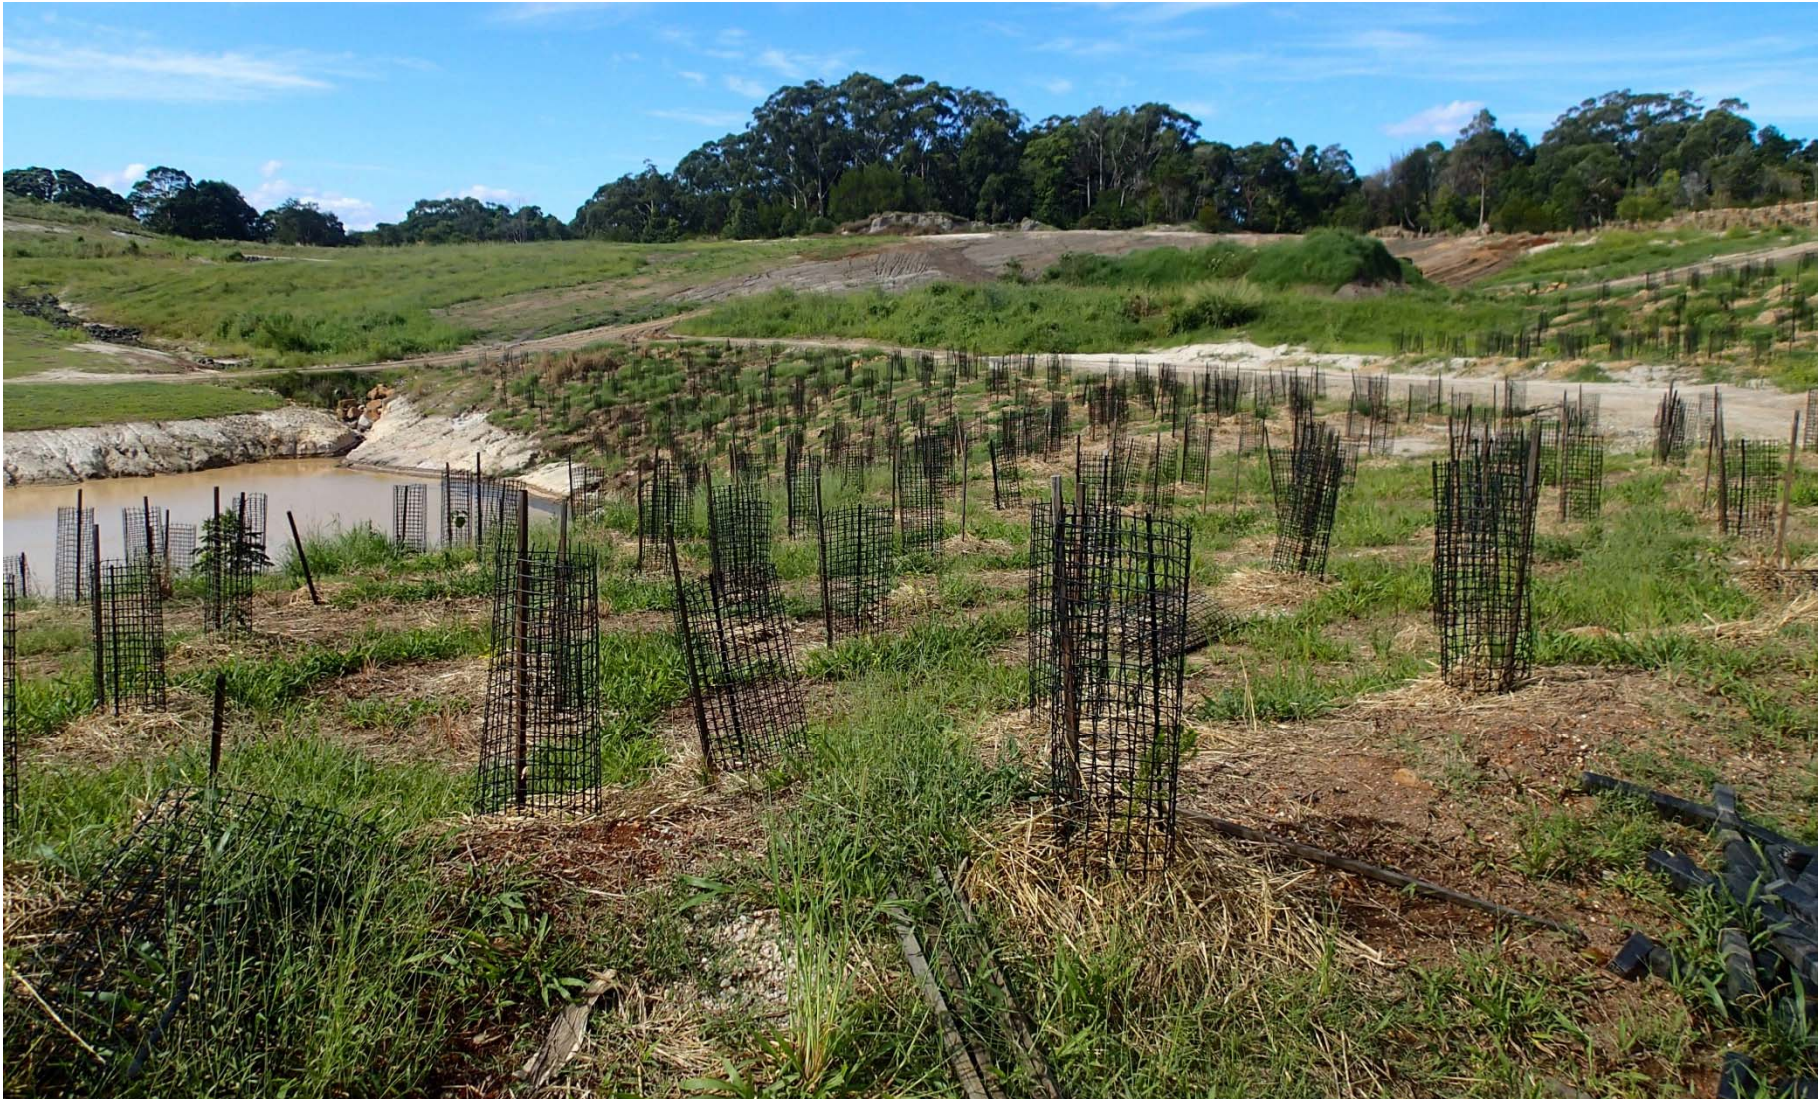
Half of PZW19 (east of the new rock-lined chute) was planted in March 2019, but the area west of the new rock-lined chute has not been planted so as to allow access for the reforming of the Central Dam spillway as discussed in Report #7.

**Figure 37 – PZW19 planting viewed from top of new rock-lined chute to Central Dam, looking northeast**

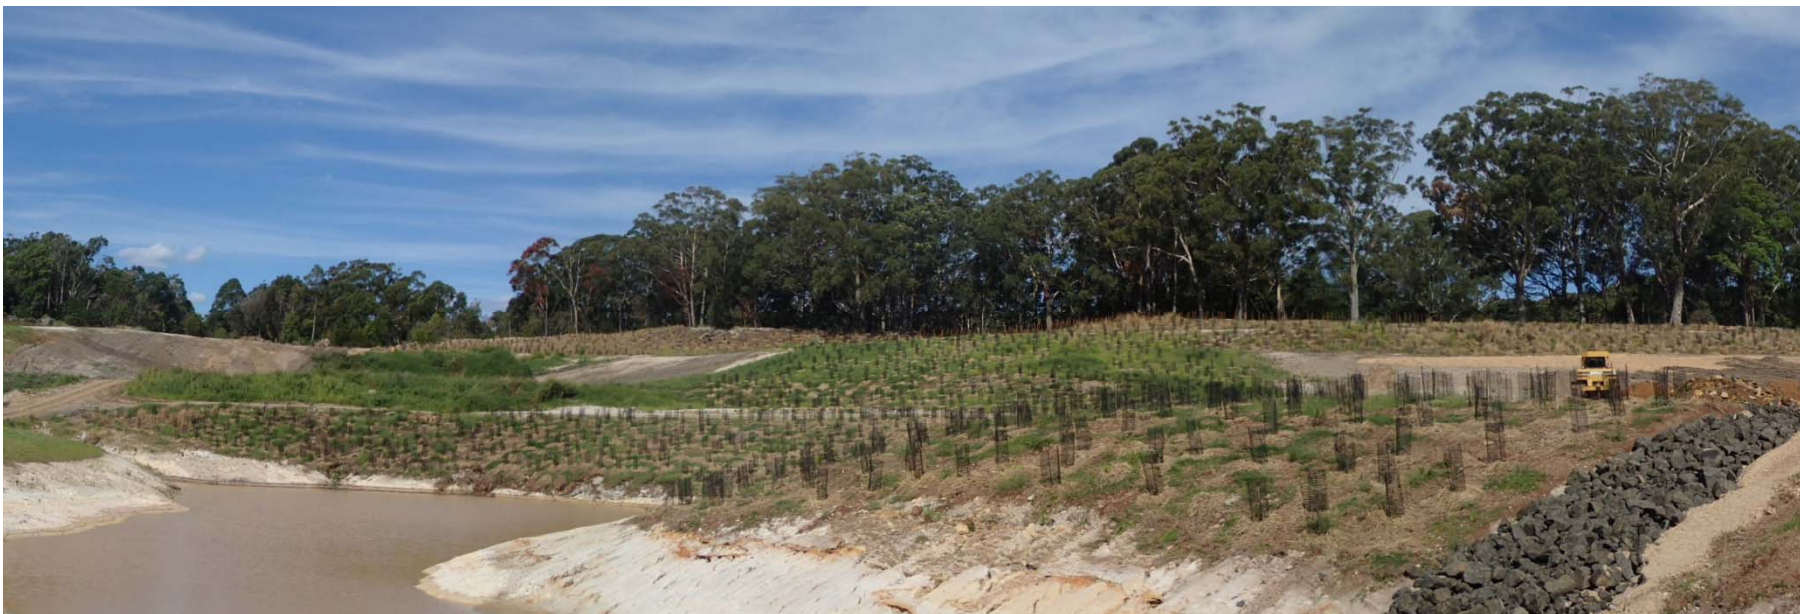
**Figure 38 – PZW19 planting (foreground) and PZW20 planting (rear left) and PZW21 planting (rear central) and PZW23 planting (rear right) viewed from Central Dam wall looking east**

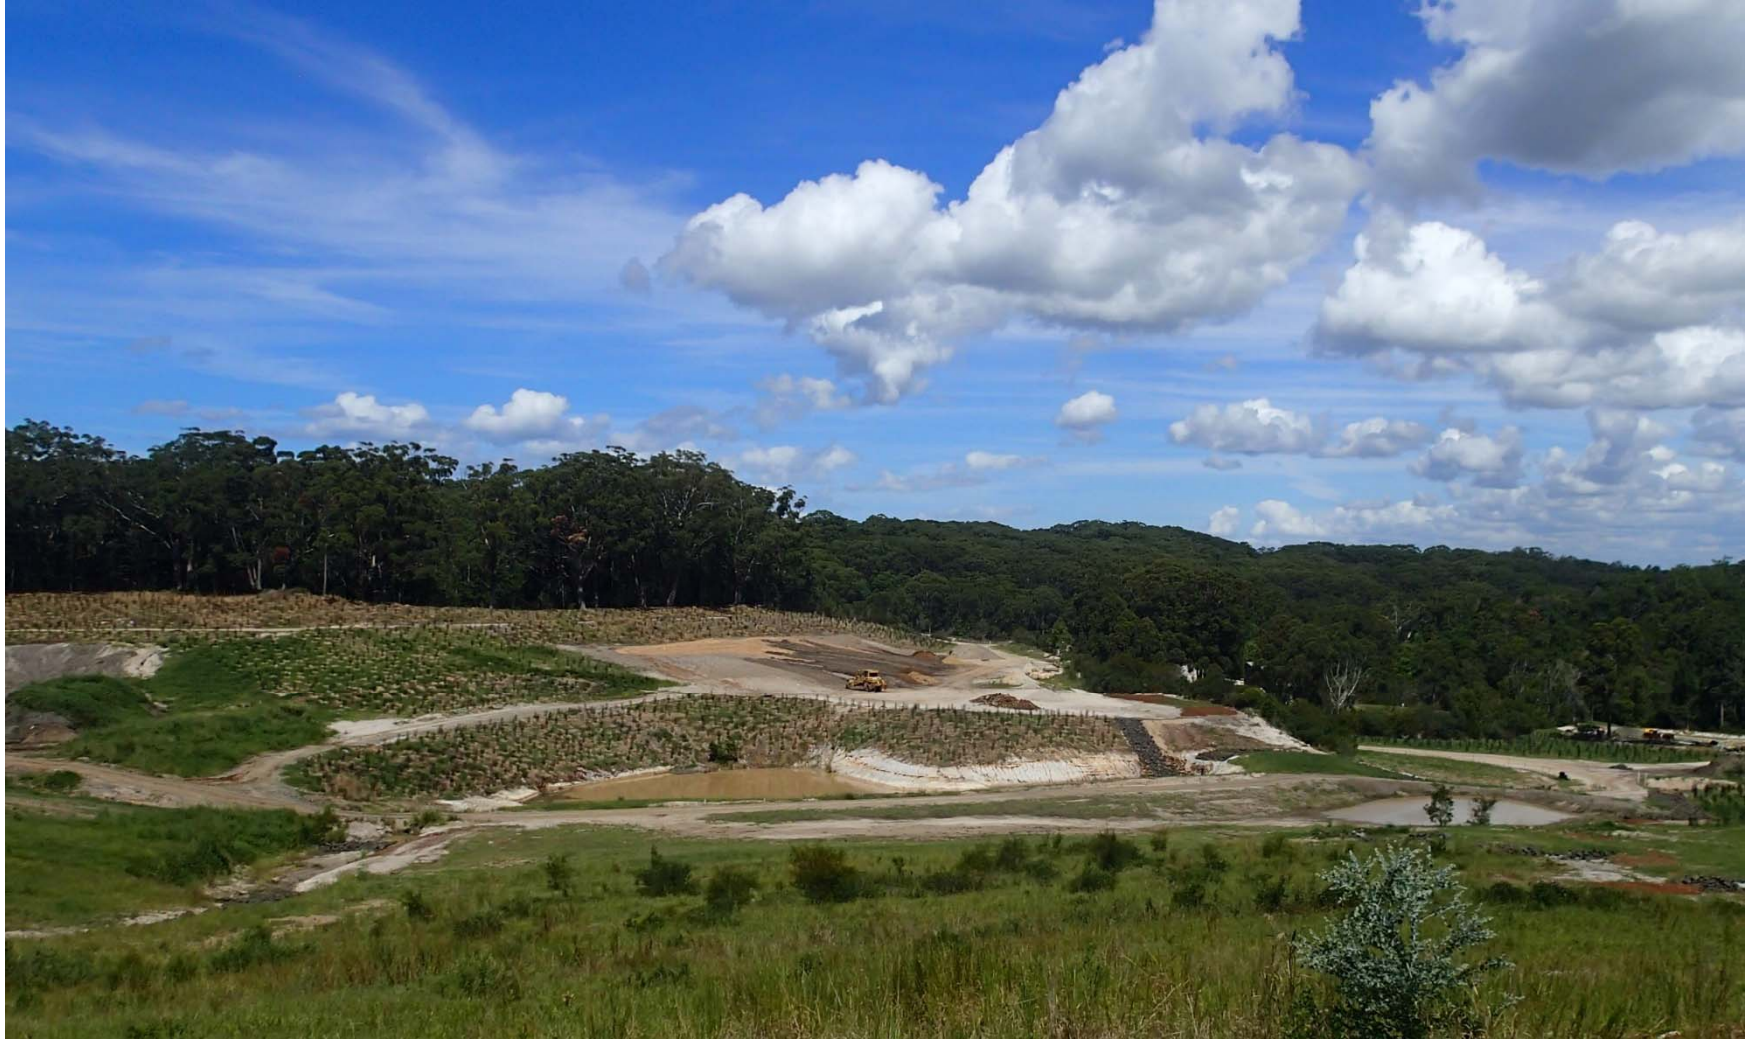
**Figure 39 – PZW20 planting (foreground left) and PZW19 planting (foreground right) and PZW21 planting (rear central left), PZW24 and PZW25 planting (rear left) PZW23 planting (rear right) viewed from PZW2 looking south**

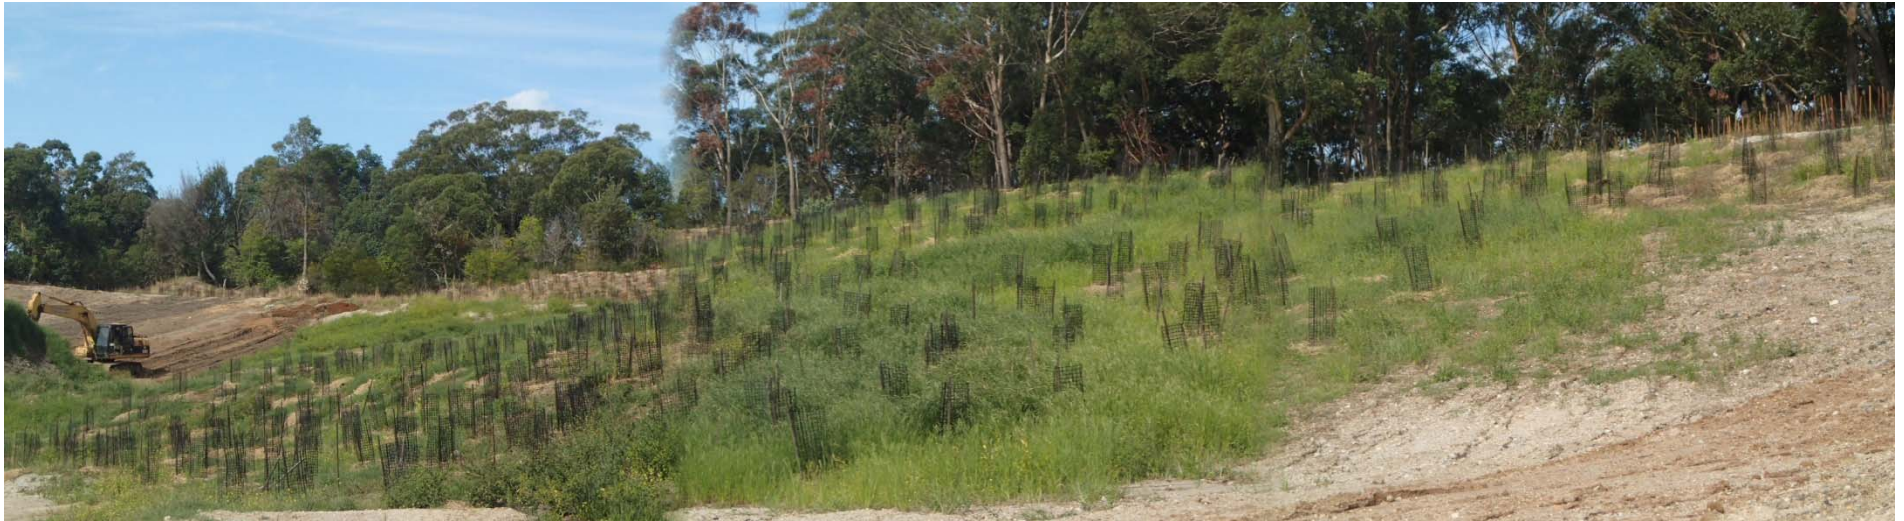
The western part of PZW21 was planted during March 2019. The remainder of PZW21 was still being landformed during the month and was therefore not able to be planted.

**Figure 40 – PZW21 planting viewed from PZW22 looking east**

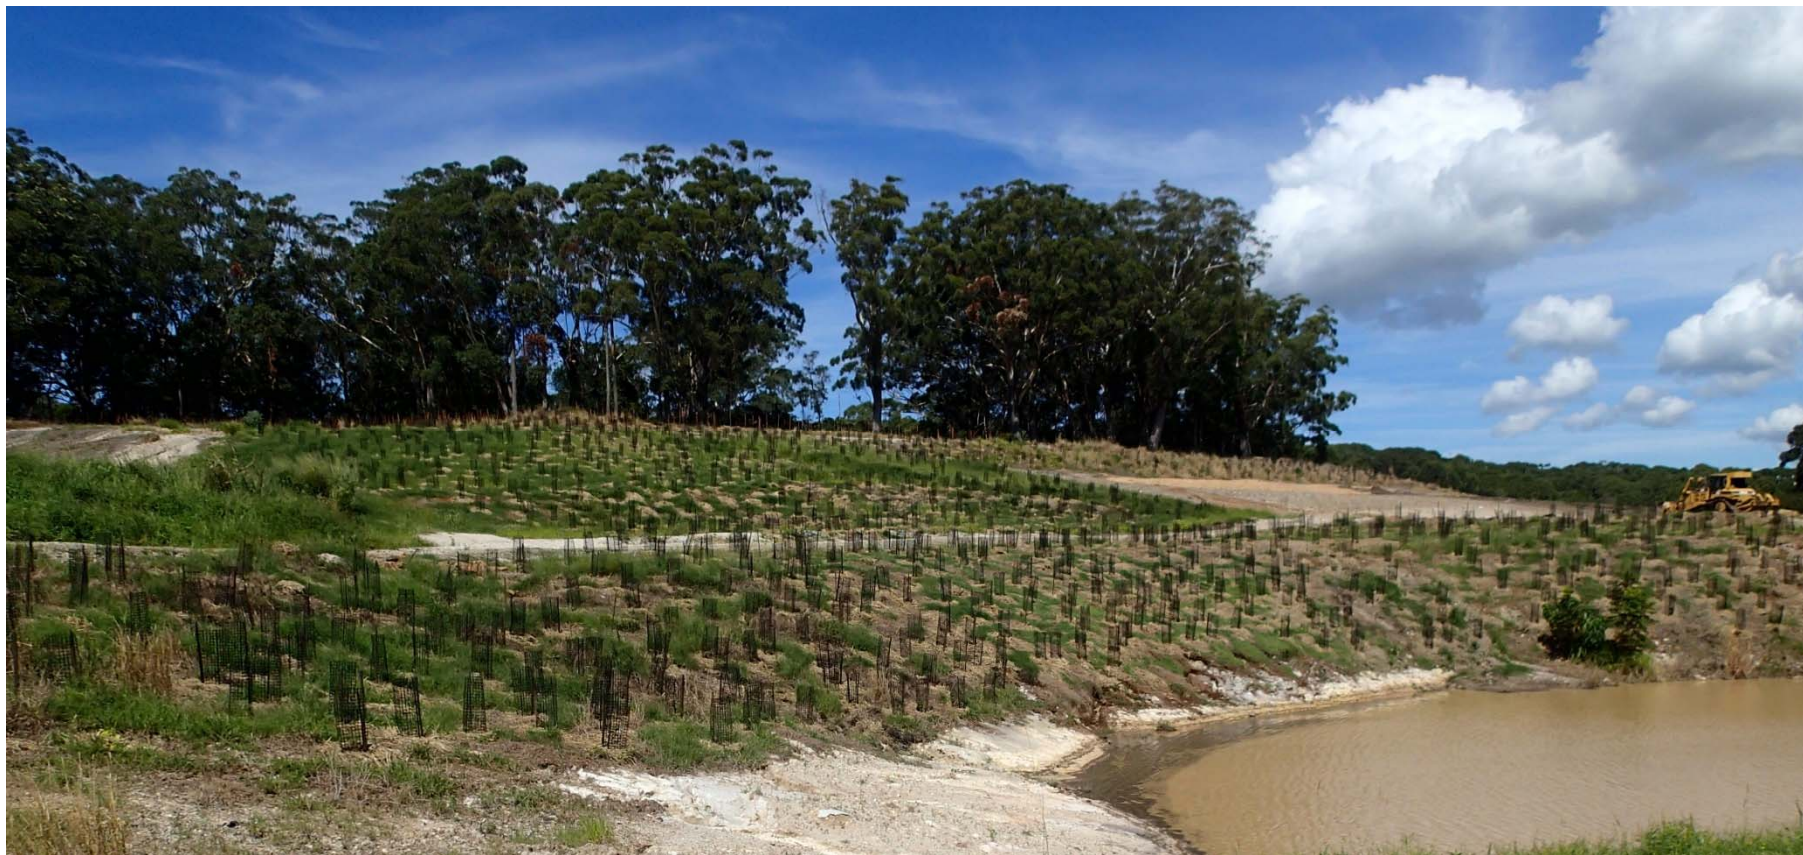
**Figure 41 – PZW21 plantings (rear) and PZW20 plantings (foreground) viewed from Central Dam bypass road next to PZW10**
