Broken Head Quarry

Enforceable Undertaking Progress Report

Report #8 – March 2019

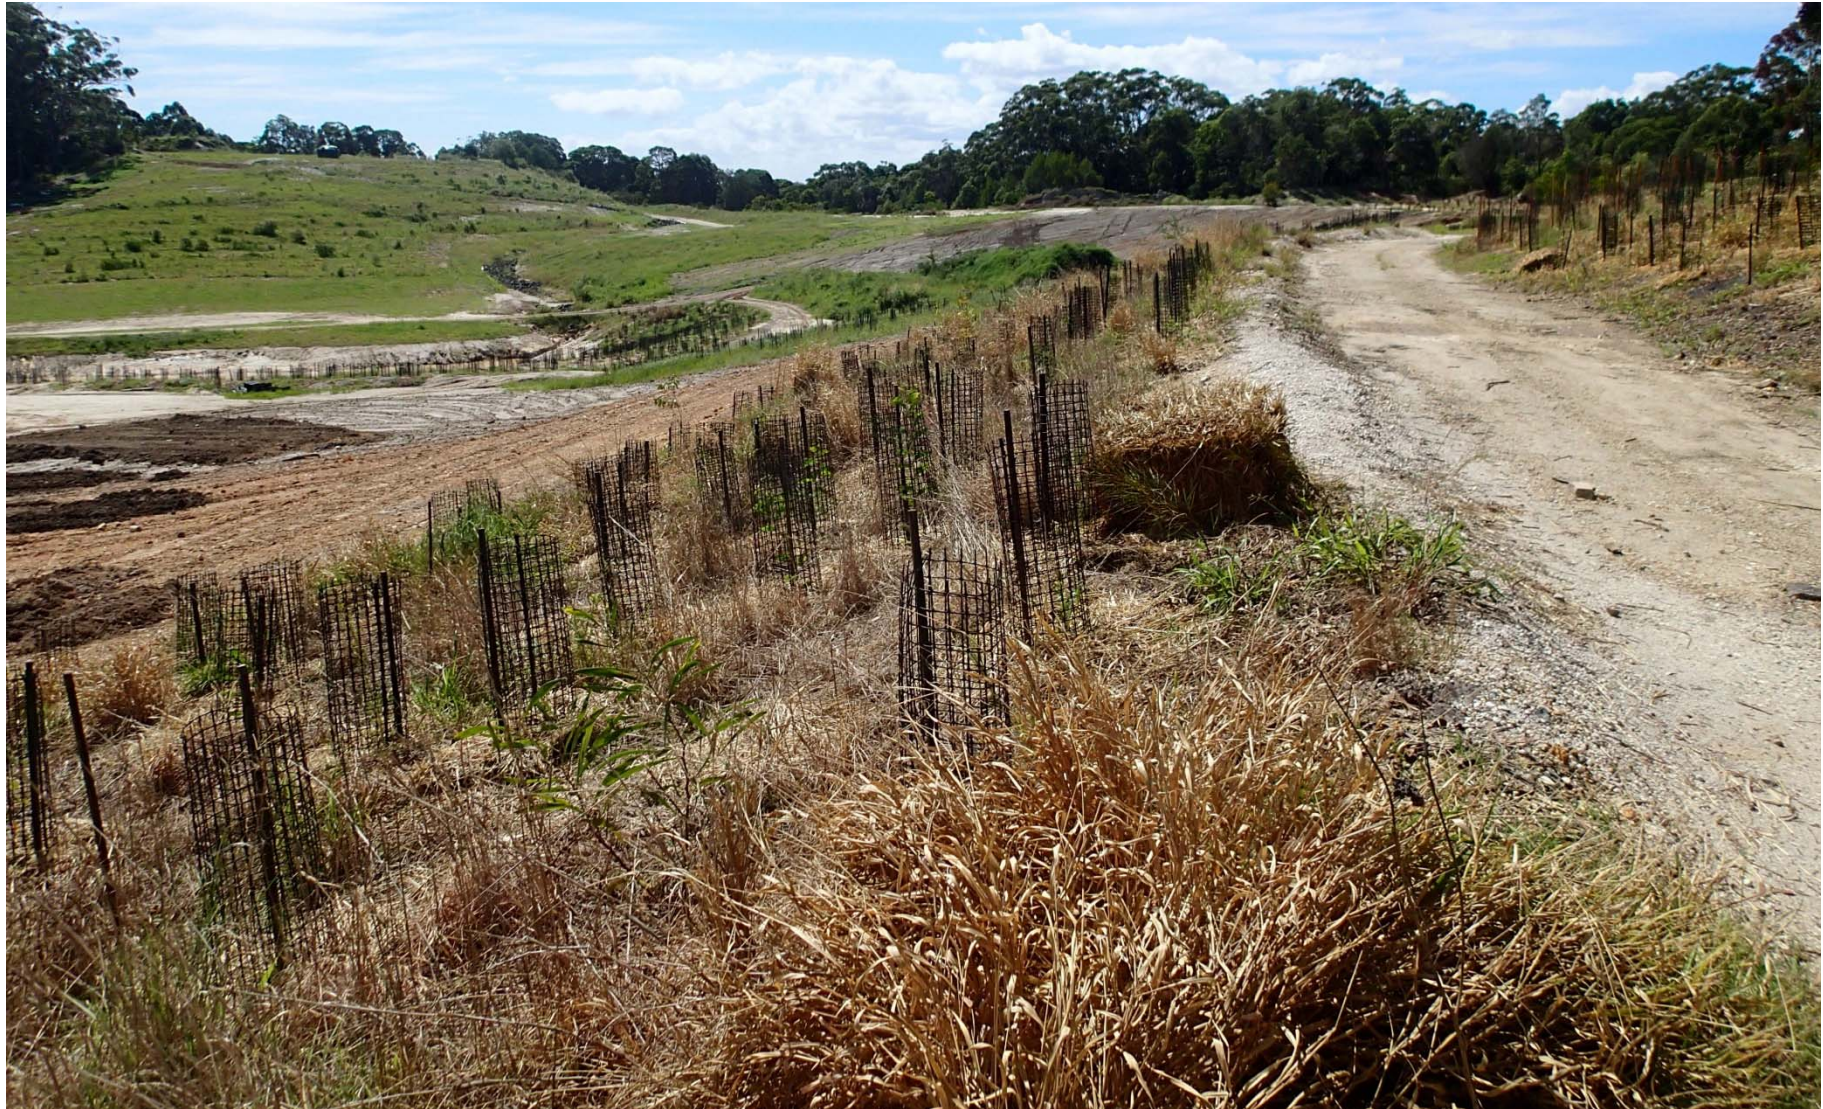
The upper half of PZW23, where the January 2018 hydromulched grass struck and still stands, was planted in March 2019. (The area below in PZW223 and PZW22 was being landformed during the month and could not be planted).

**Figure 42 – PZW23 plantings viewed from upper access road looking northeast. PZW25 plantings at right of shot**

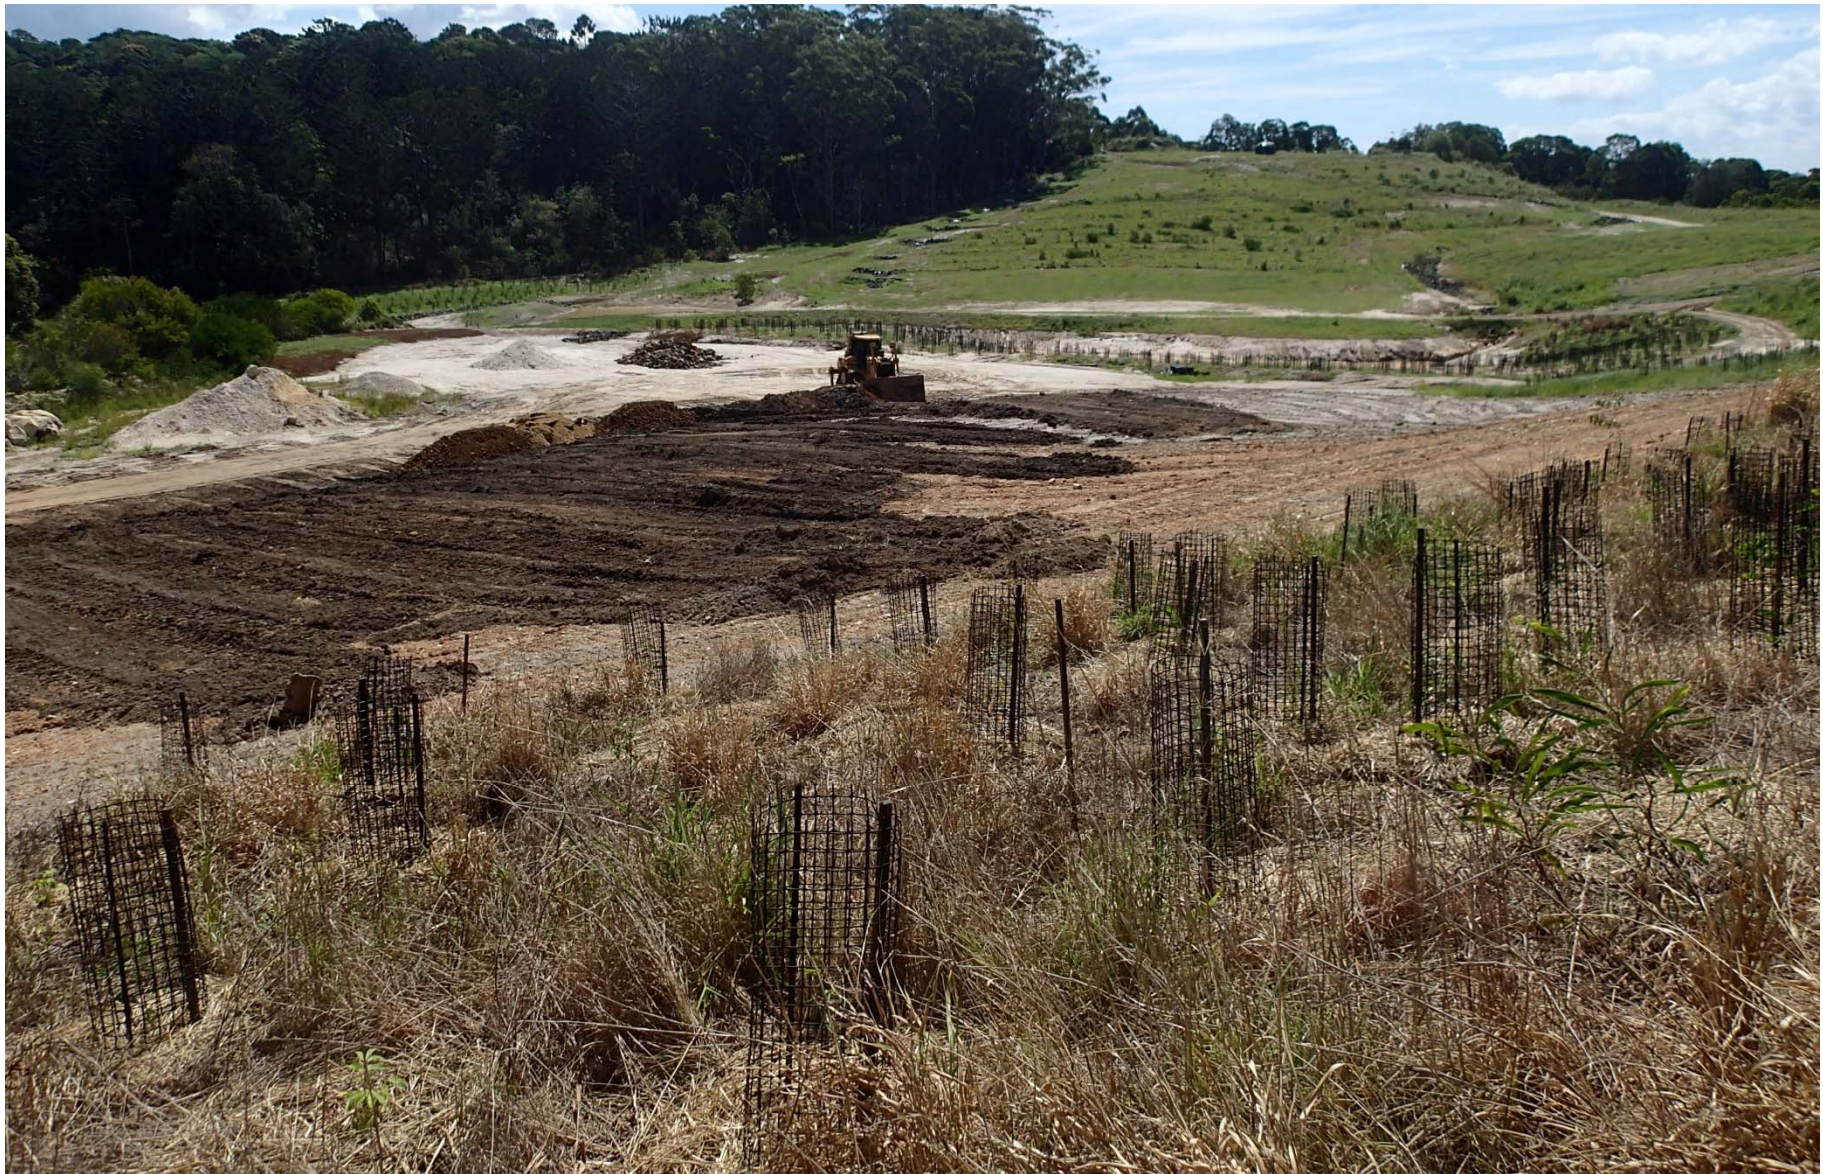
**Figure 43 – PZW23 plantings viewed from upper access road looking north**

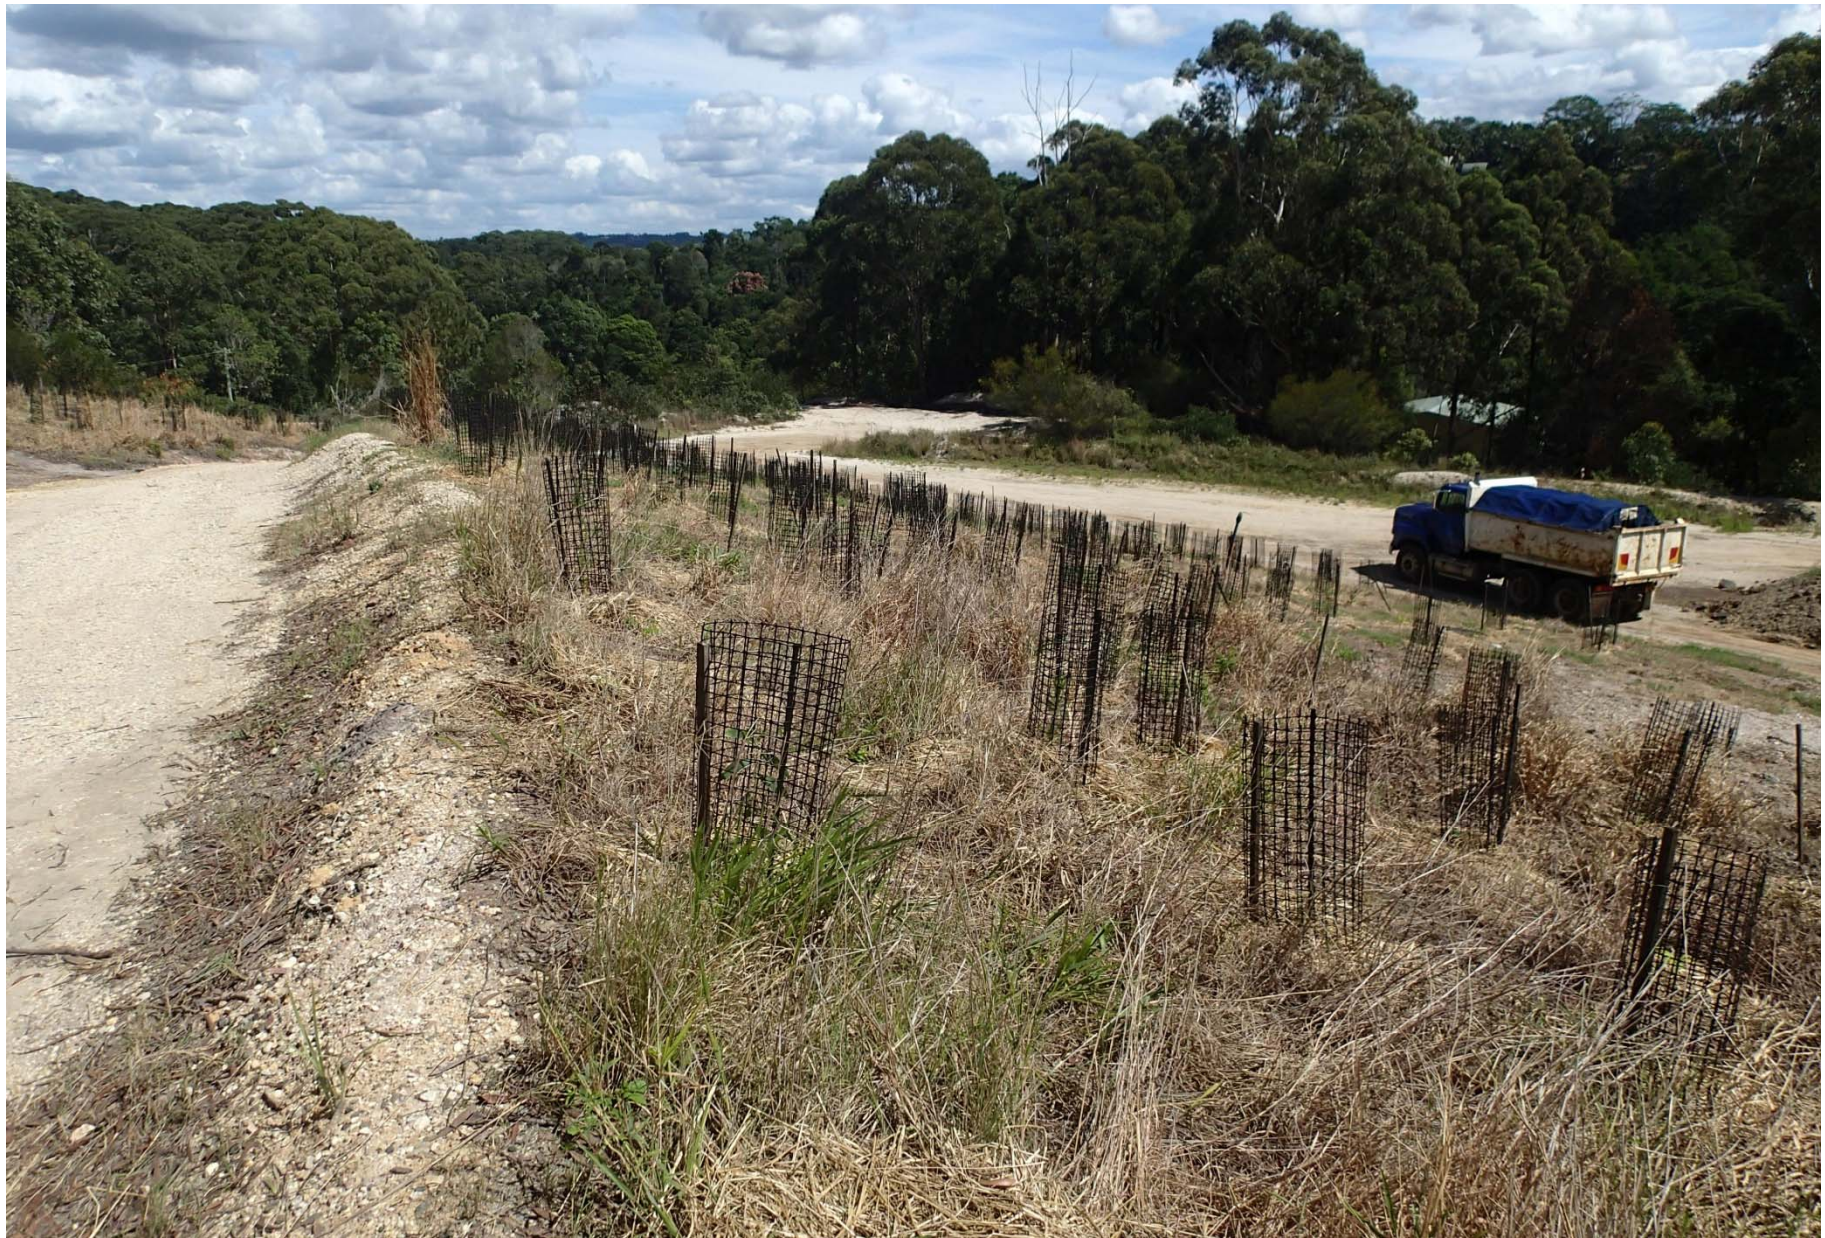
**Figure 44 – PZW23 plantings viewed from upper access road looking southwest. PZW26 plantings in rear of shot**

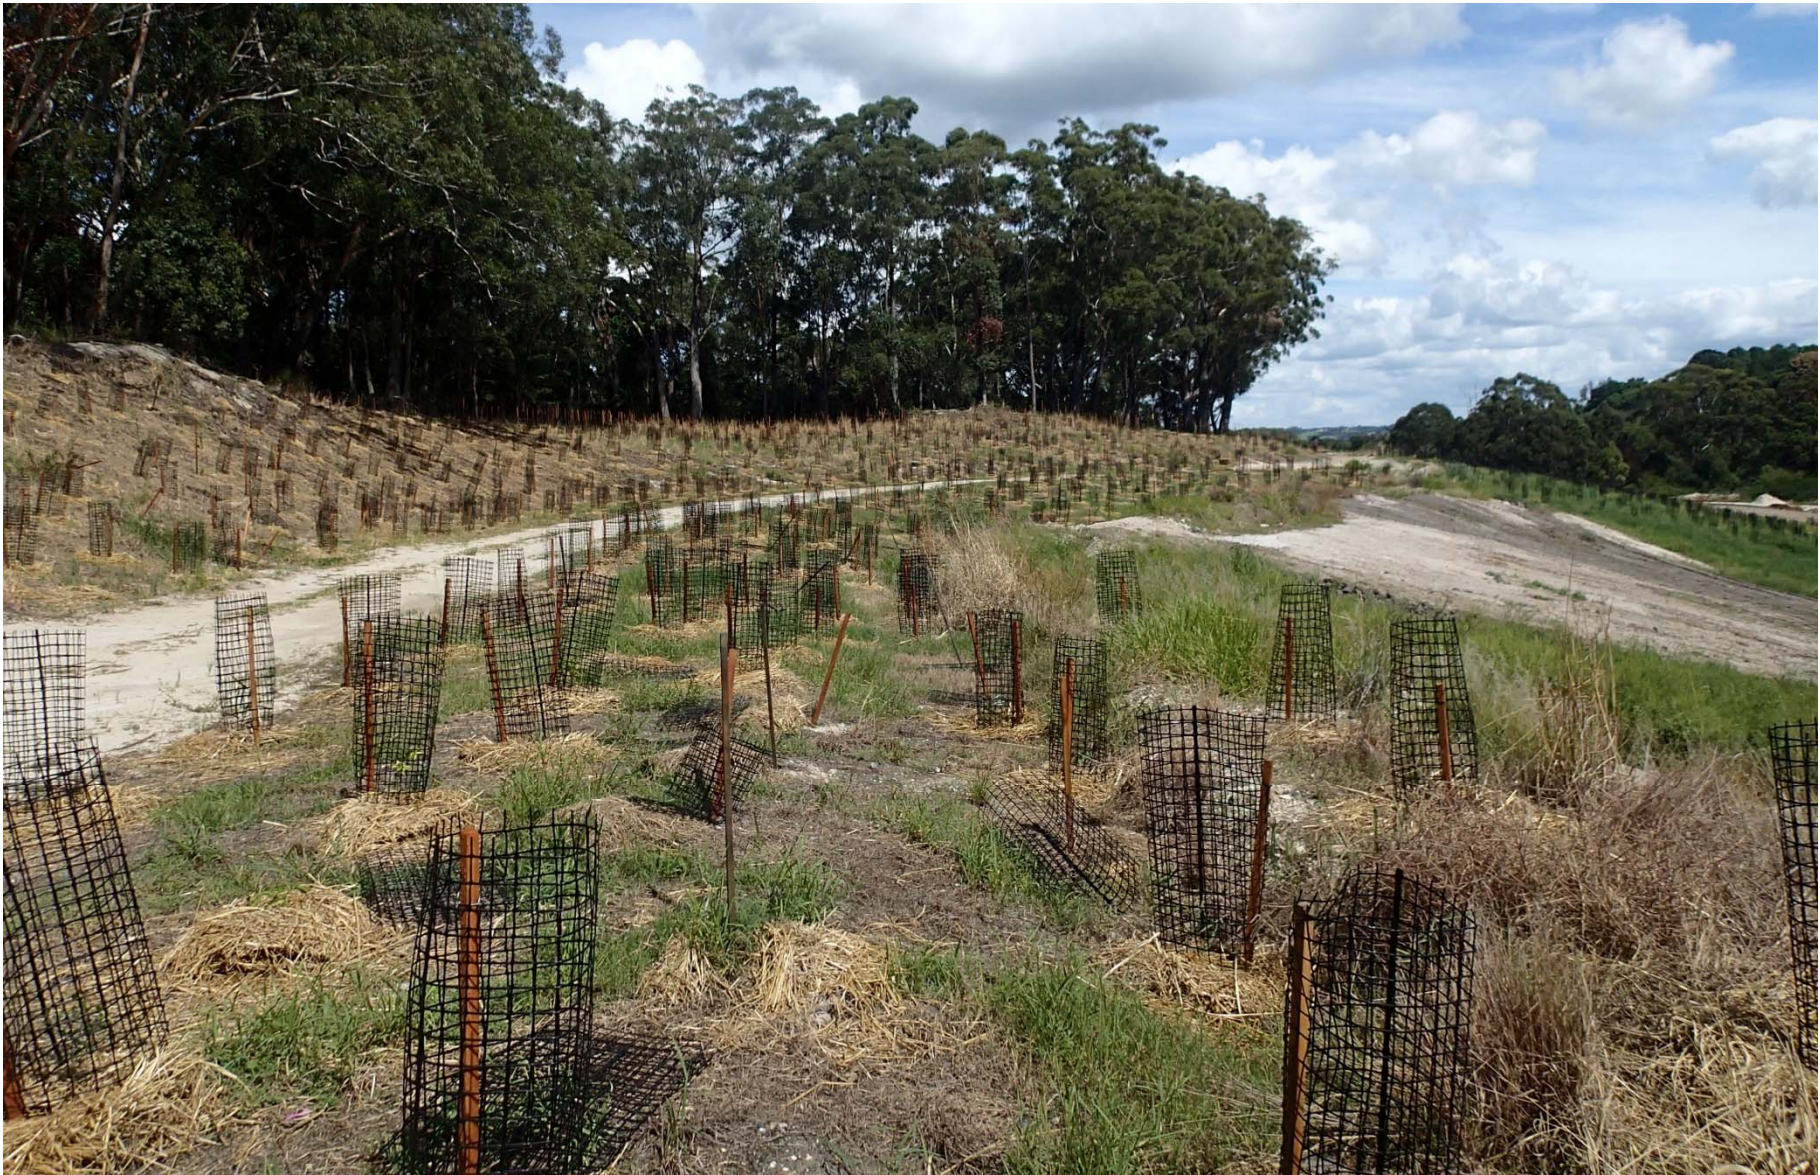
All of Area PZW24 was planted during March 2019.

**Figure 45 – PZW24 (foreground) and PZW25 (rear) viewed from upper access road looking south. Note locations for future blackbutt planting**

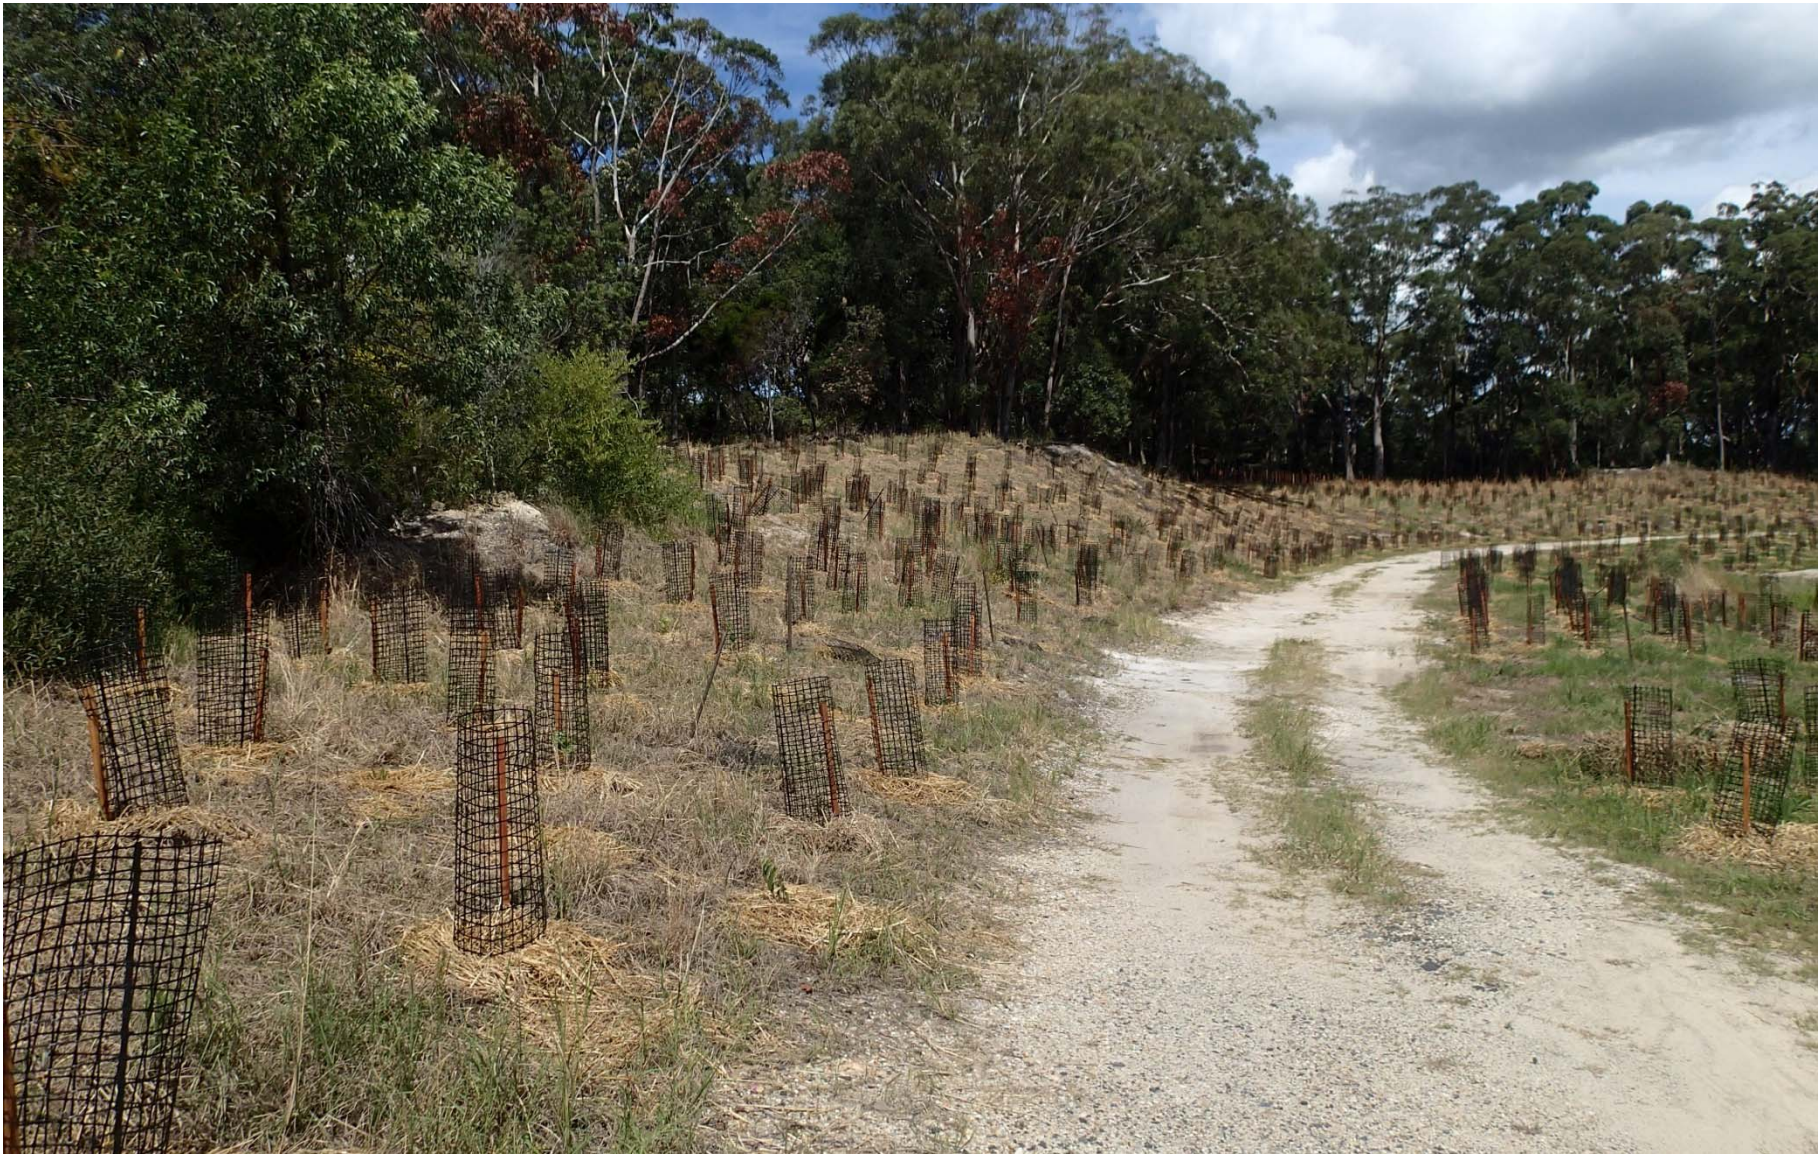
All of Area PZW25 was planted during March 2019.

**Figure 46 – PZW25 plantings viewed from upper access road looking south**

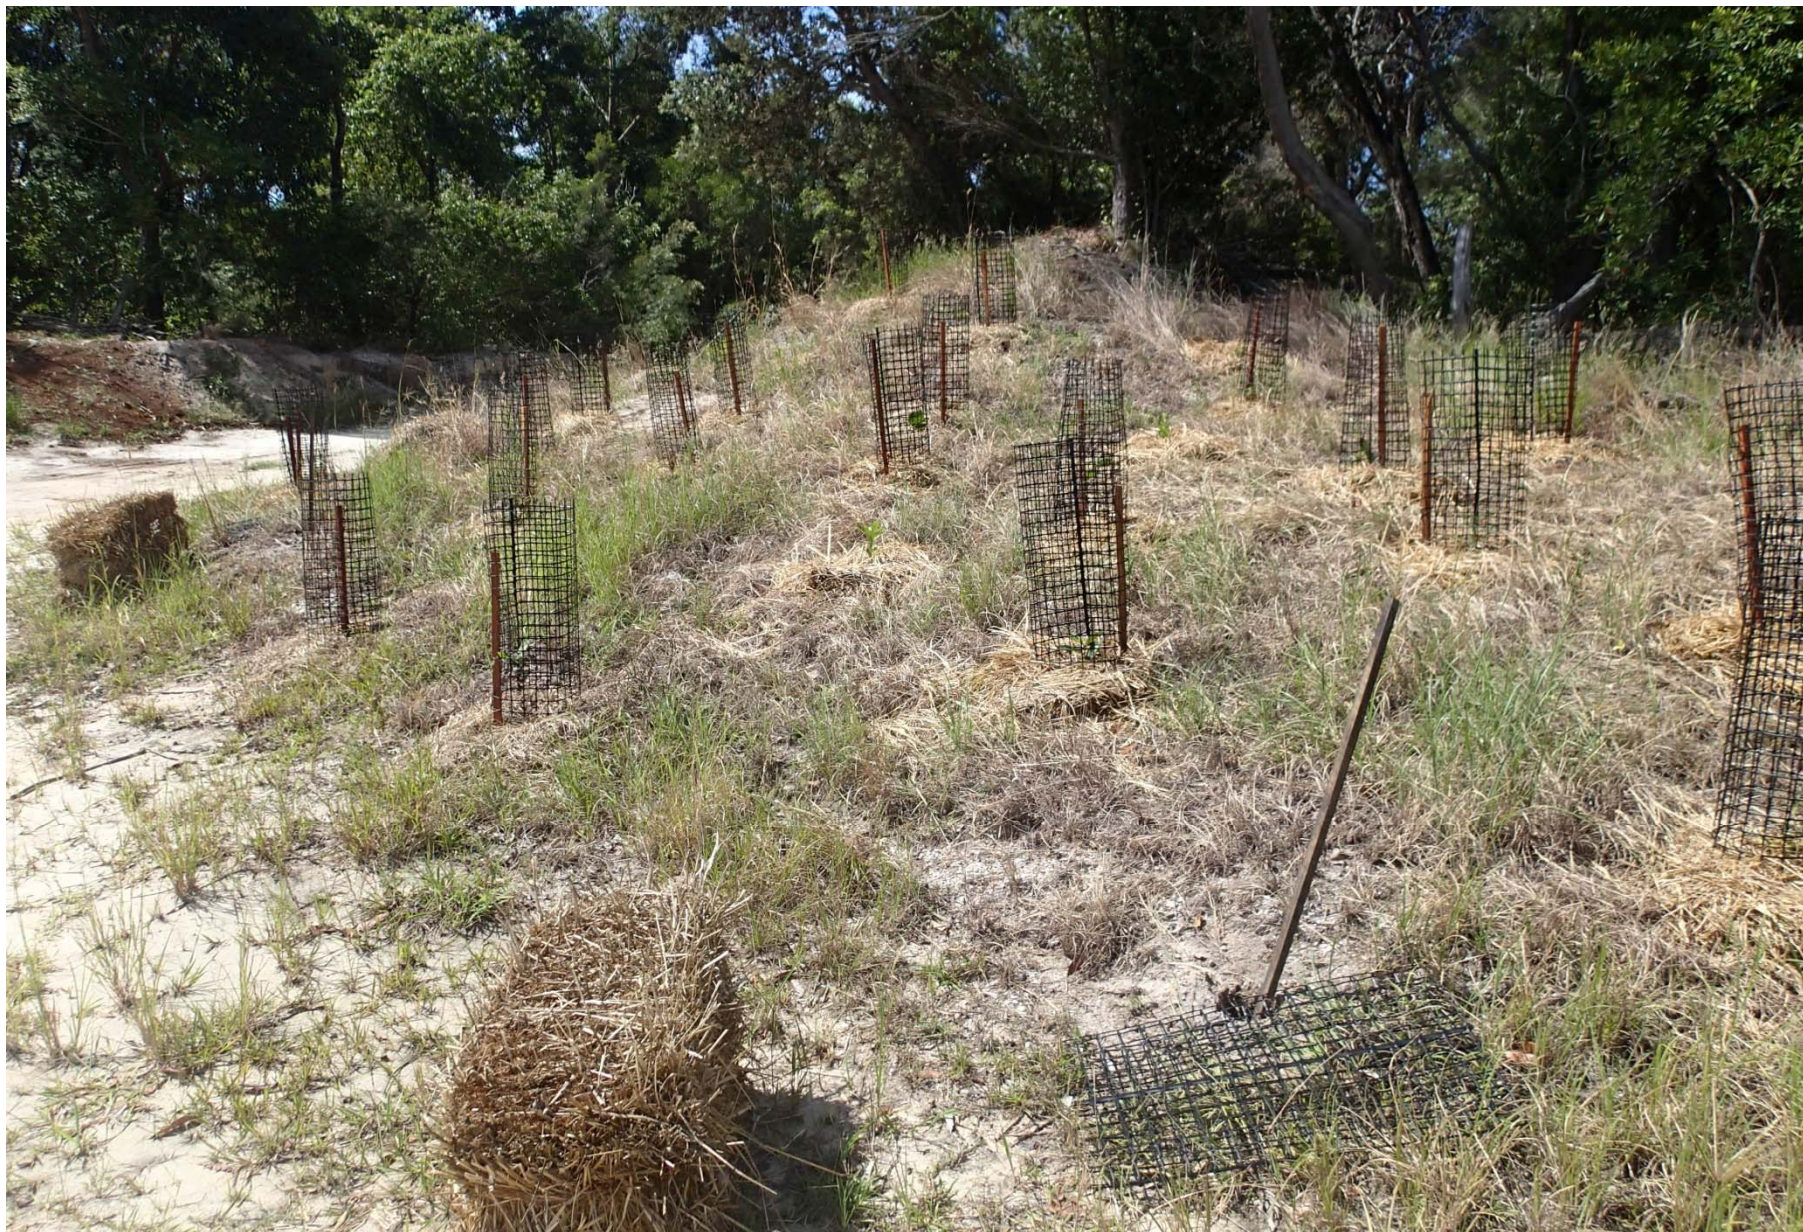
**Figure 47 – PZW25 plantings viewed from near crest of Westside haul road looking north. Future blackbutt location marked**

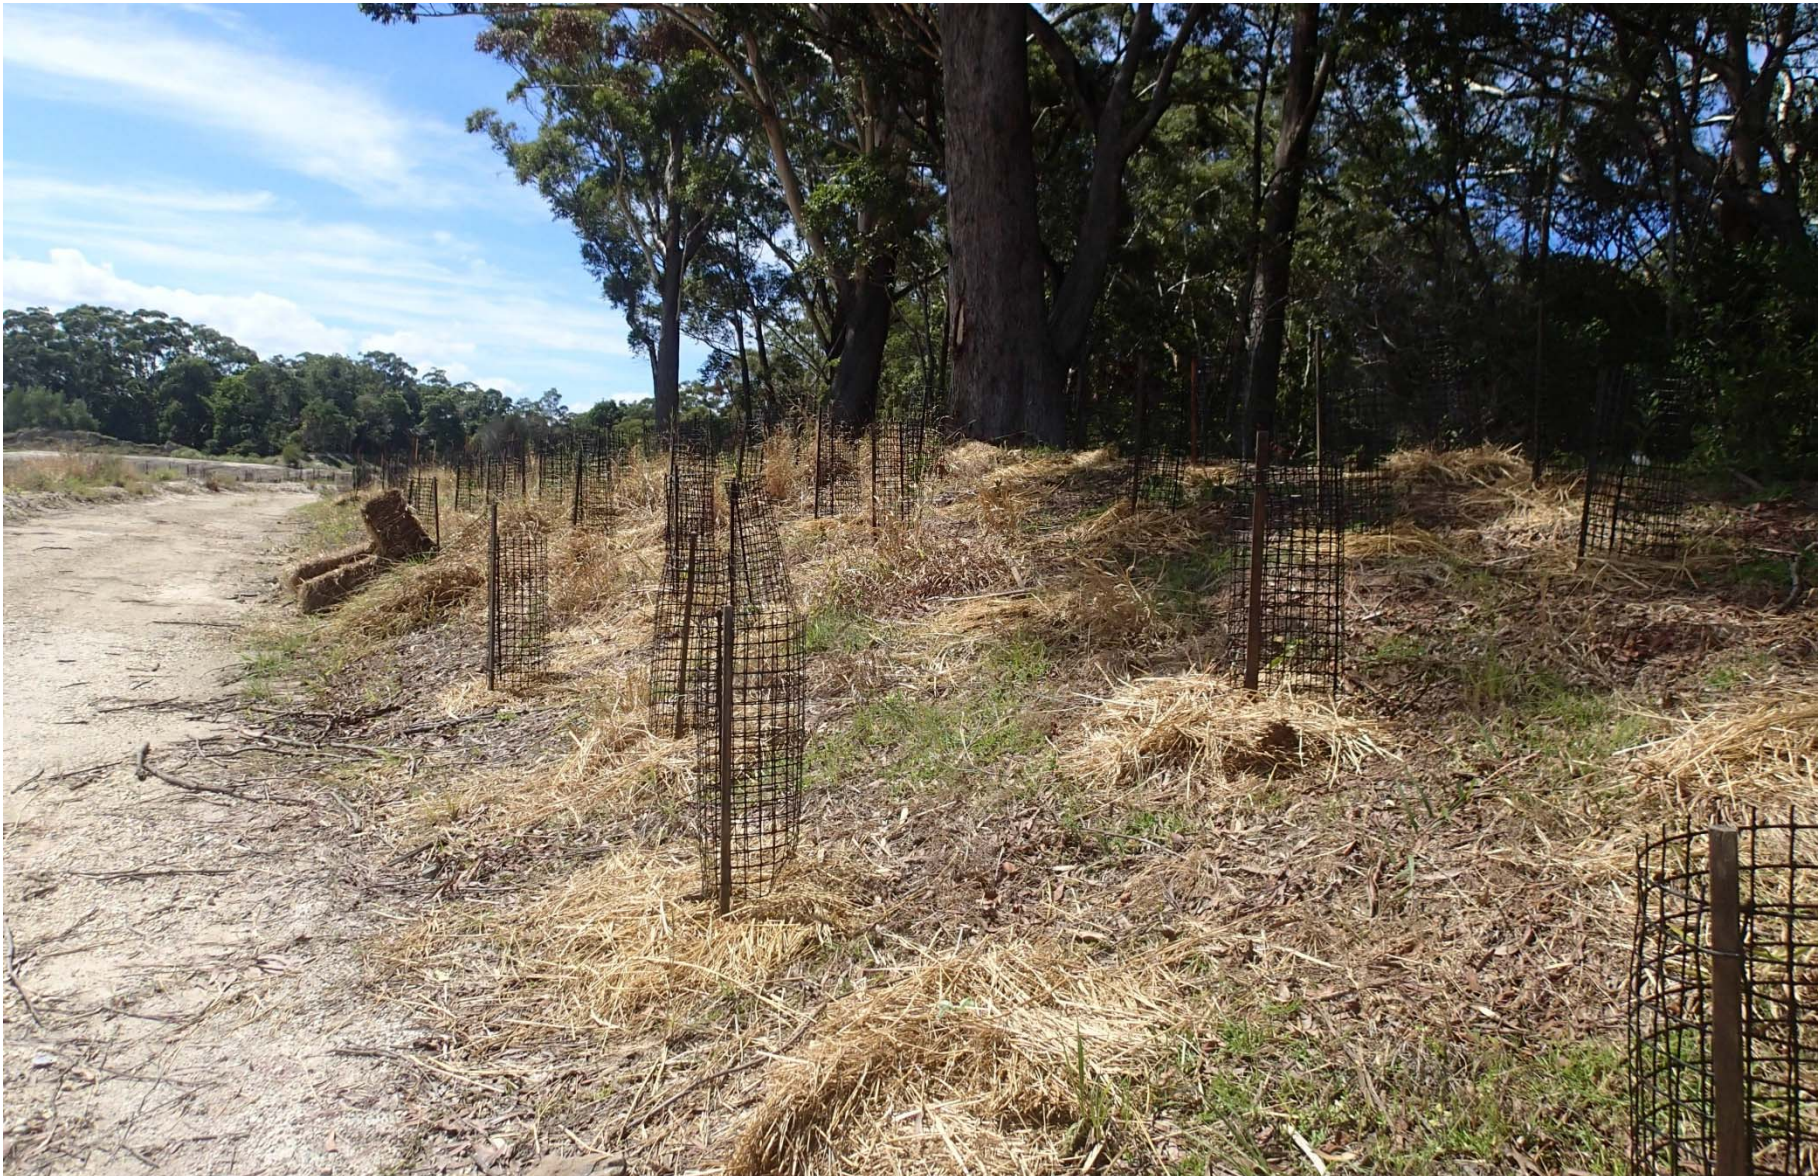
Figure 48 – PZW26 plantings looking north

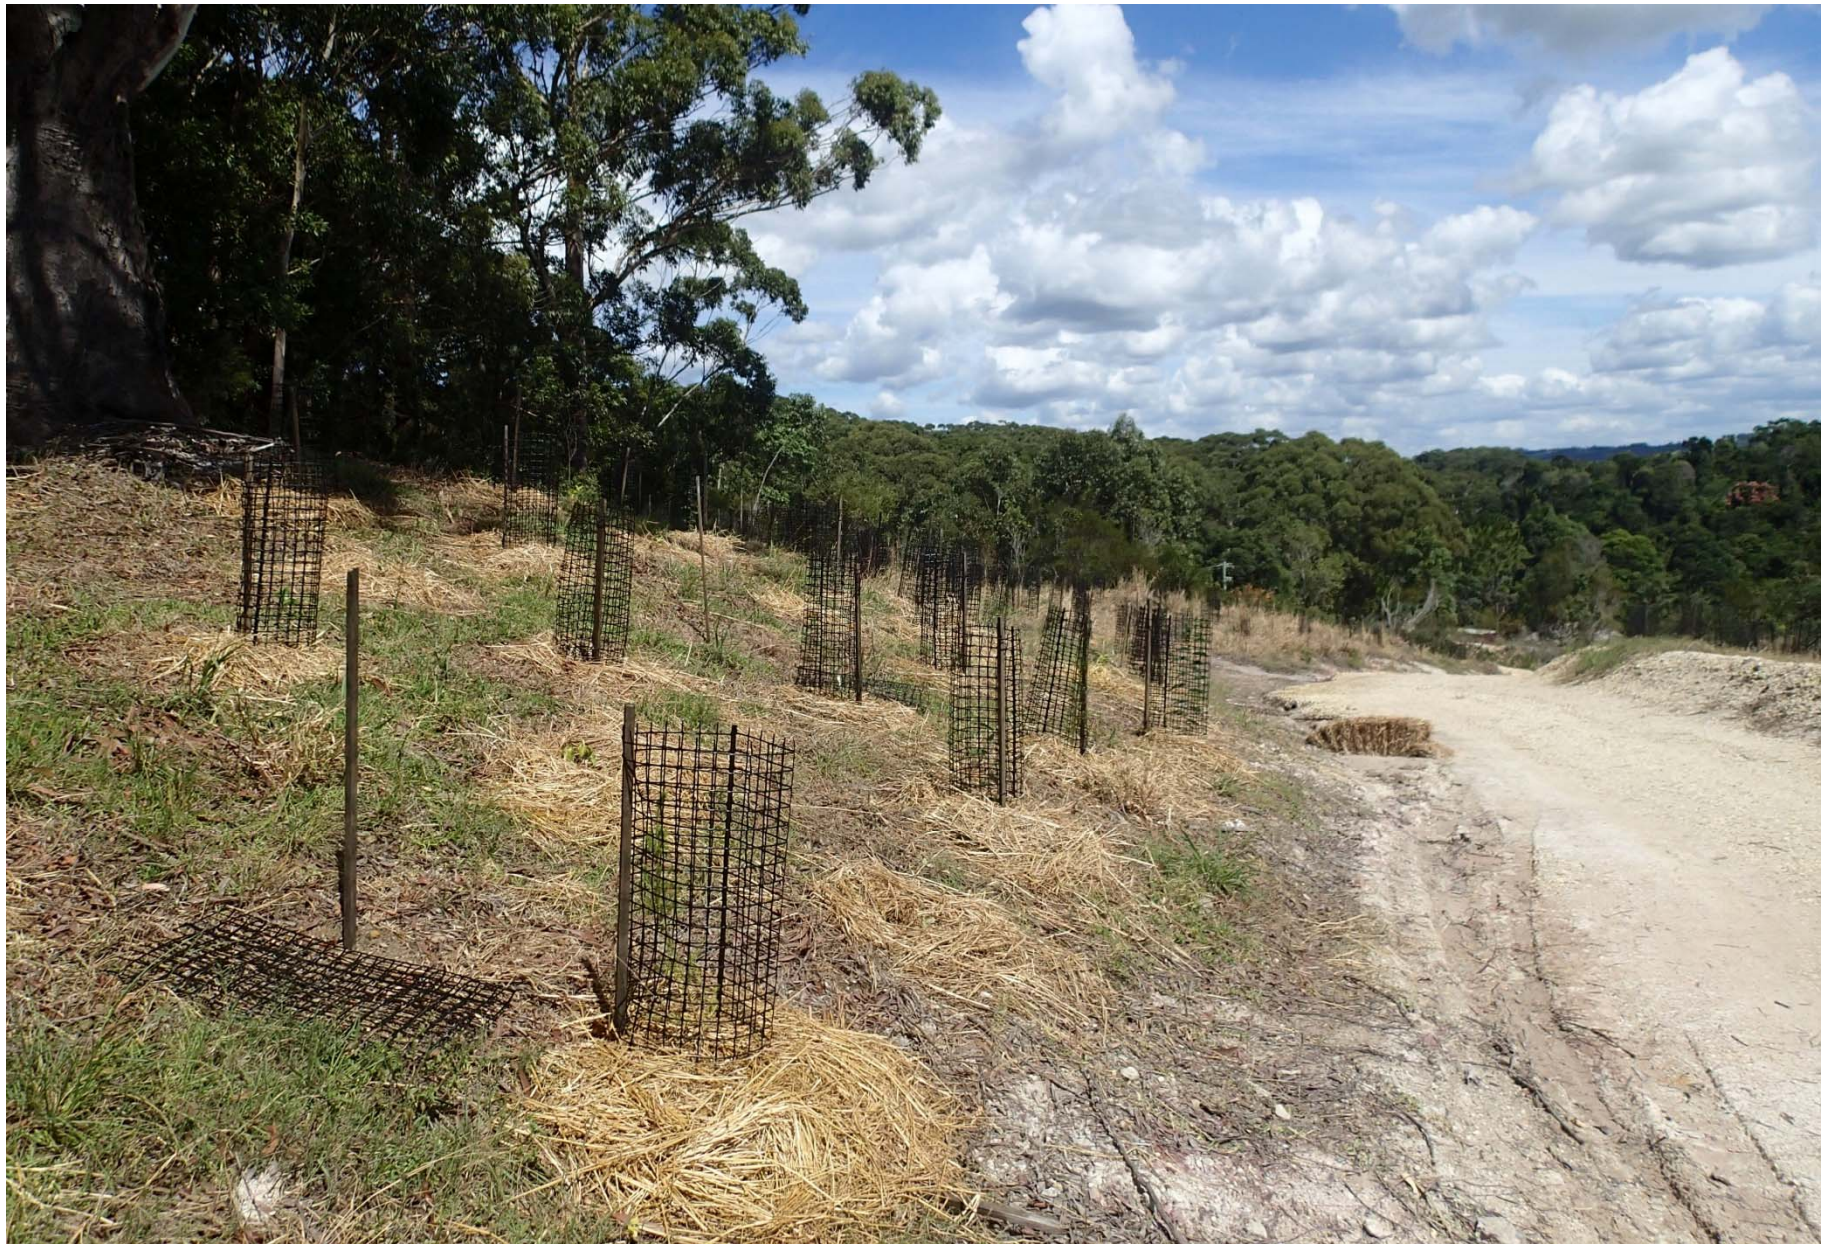
**Figure 49 – PZW26 plantings looking south. Future blackbutt locations marked**
