December 7, 2021

**RE: Forensic Engineering Report – Wind Damage  
Newnan Presbyterian Church  
38 Greenville St. S  
Newnan, GA 30263**

Per your request, Shields Engineering Group, Inc. performed a forensic engineering inspection at the Newnan Presbyterian Church at the address above. The Church purportedly sustained damage as a direct result from high winds from a tornado that passed through Newnan on March 26, 2021. This investigation was conducted on November 9<sup>th</sup>, 2021, by Martin Shields, P.E. and Ava Shields of SEG.

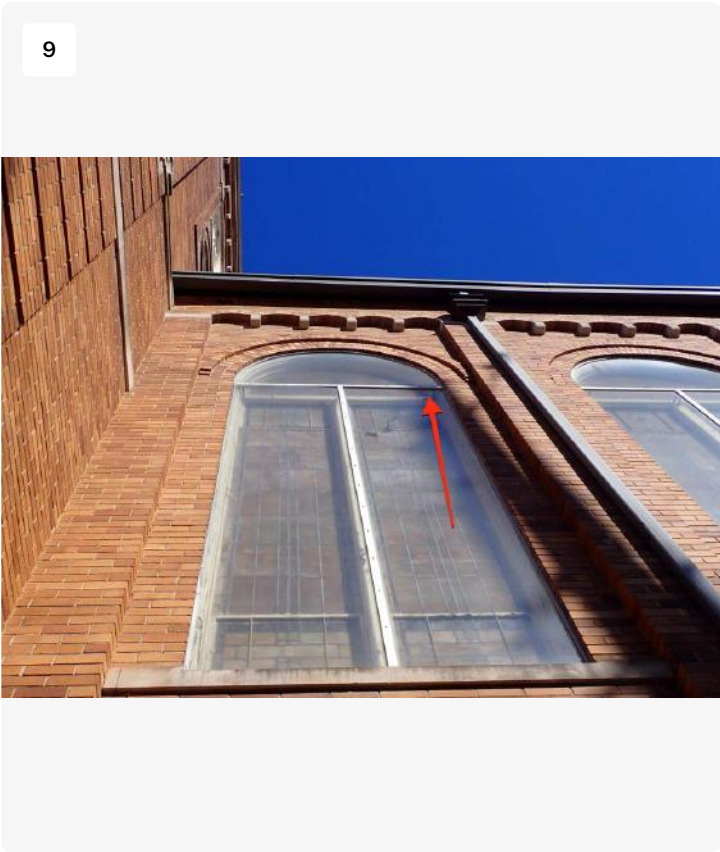
Displaced metal window frame

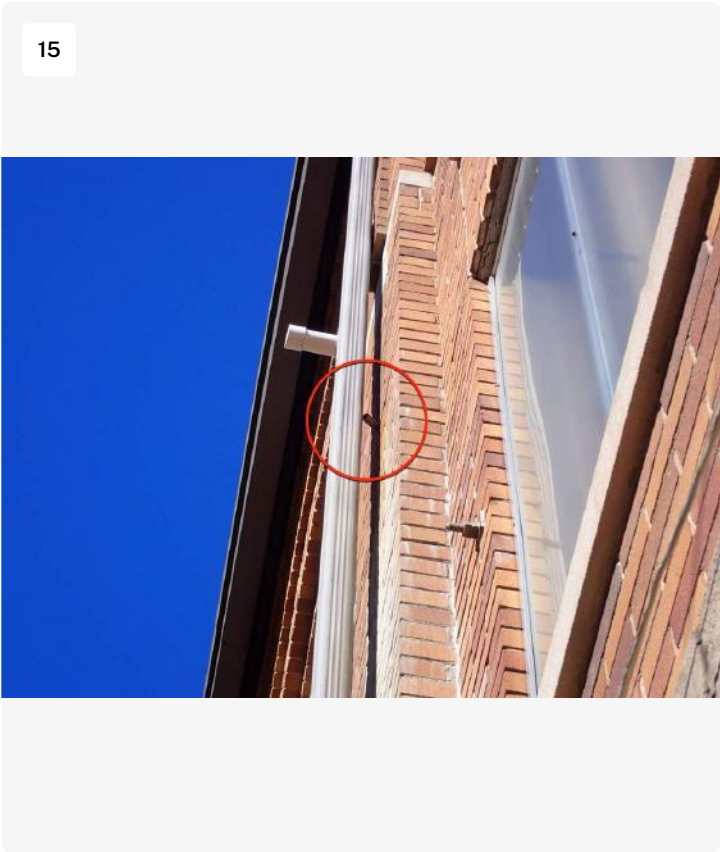
Unknown water line discharge

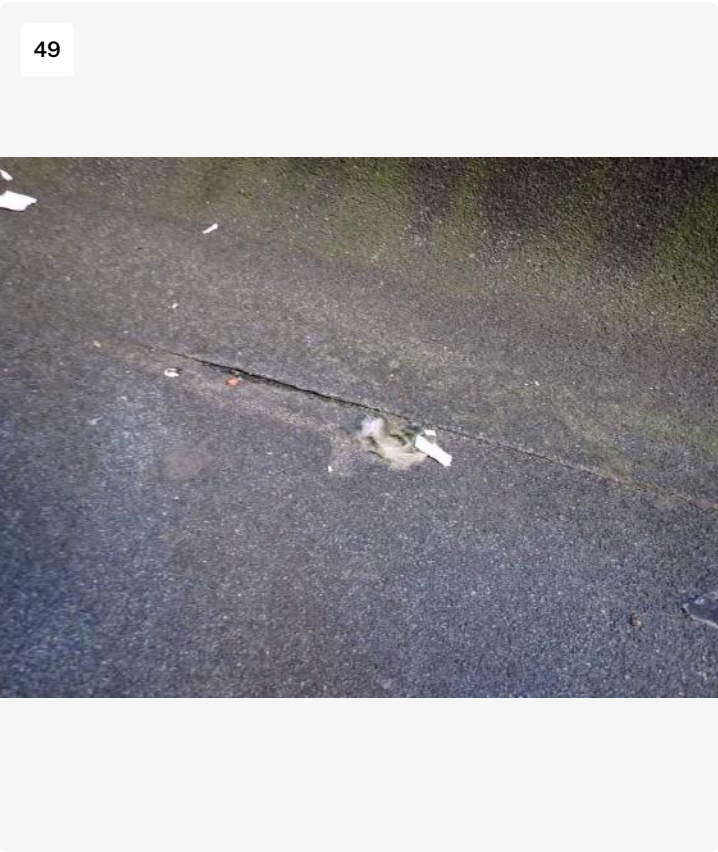
Minor uplift on lap seam

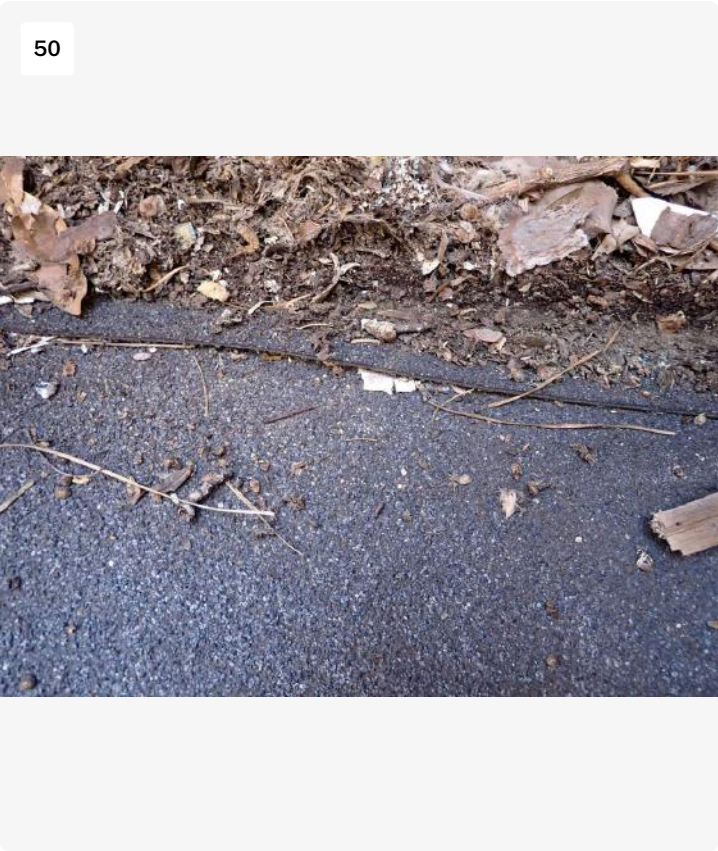
Uplifted lap seam and wind-borne debris

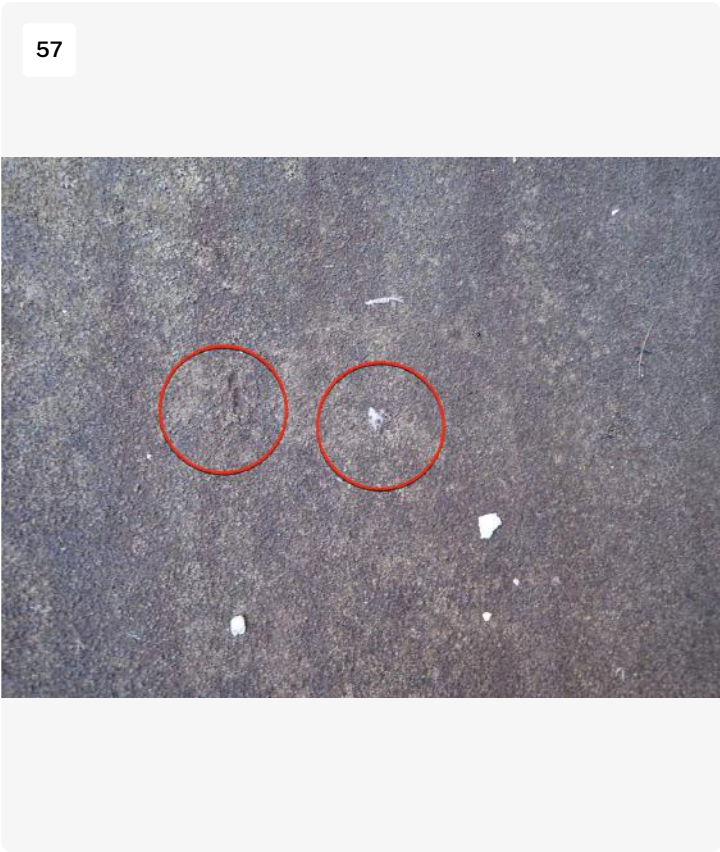
Abrasions in mod-bit from fallen tiles

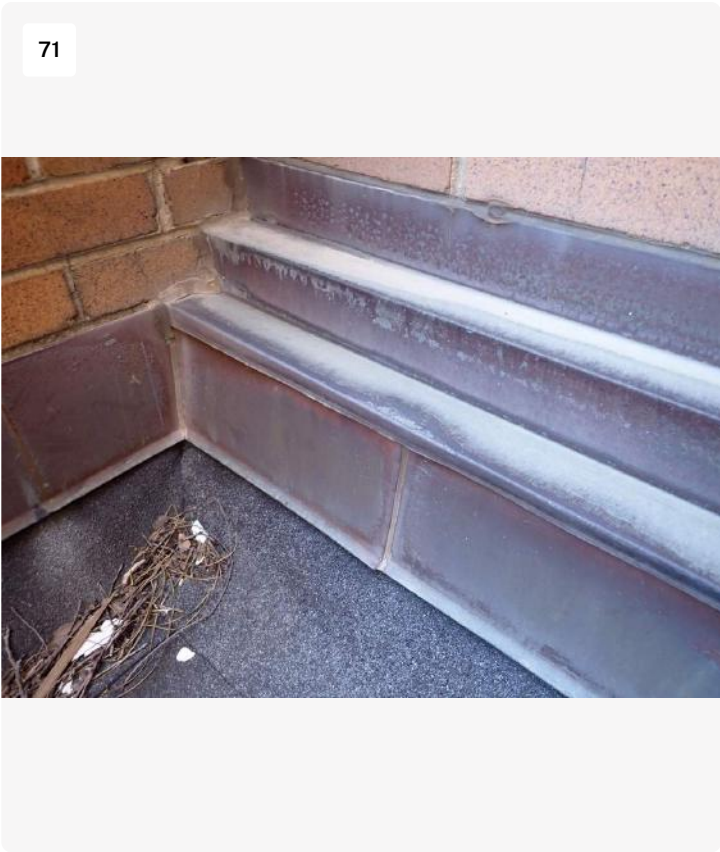
Copper counter flashing

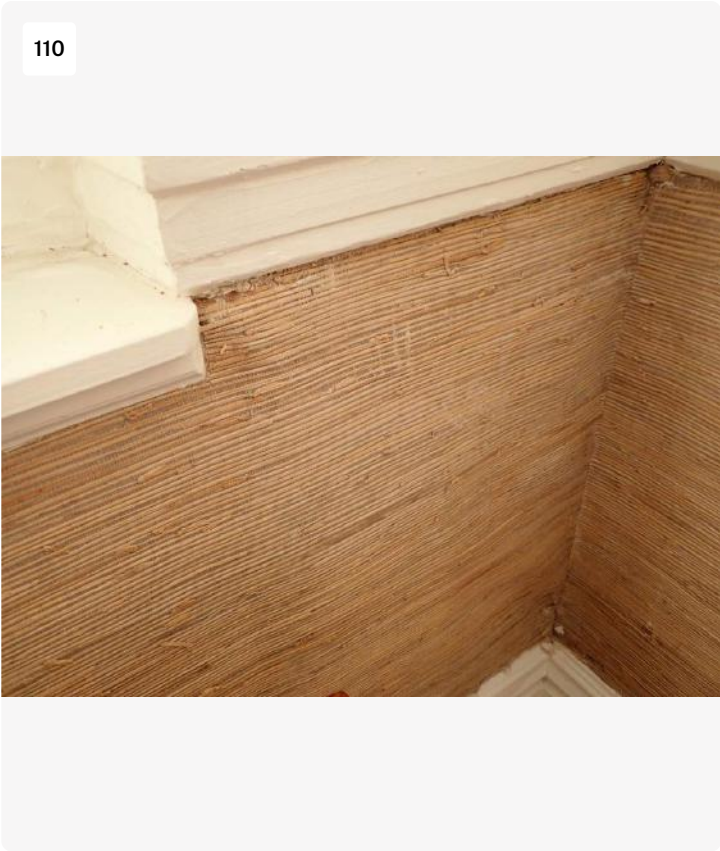
Water intrusion behind wallpaper

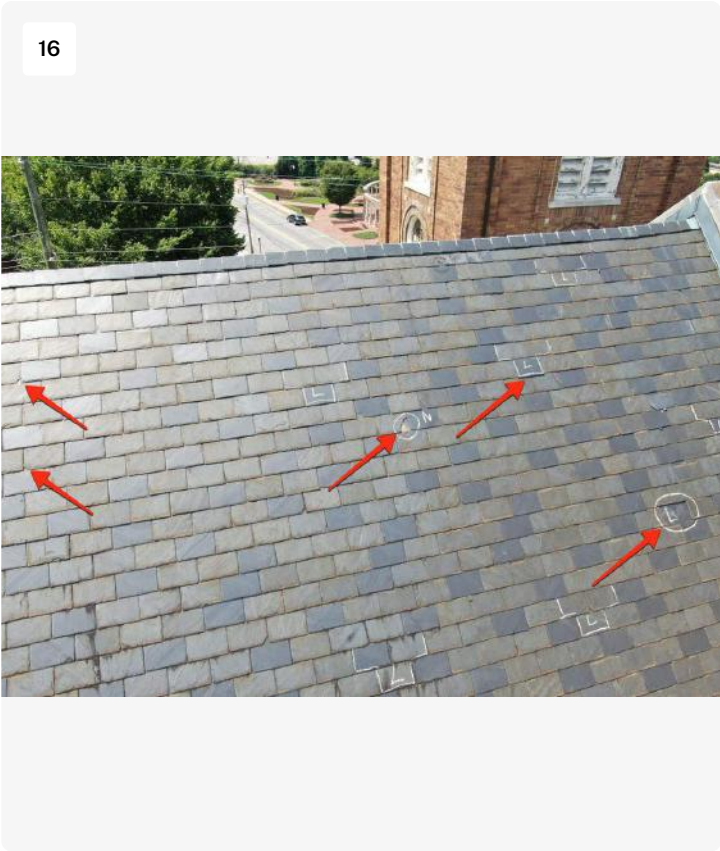
Cracked and displaced tiles

1. The slate tiles should be removed and replaced on both the north and south slopes. If economically feasible and if replacement tiles are available to match, the intact tiles can be removed and re-attached, after the replacement of the old/damaged roofing felt. Several items to note if the intact tiles are going to be re-used: 1) A breakage factor must be included as approximately 10 to 15% of the intact tiles will be broken, and 2) many of the intact tiles are currently chipped and have small cracks – these tiles cannot be re-used per IBC codes.

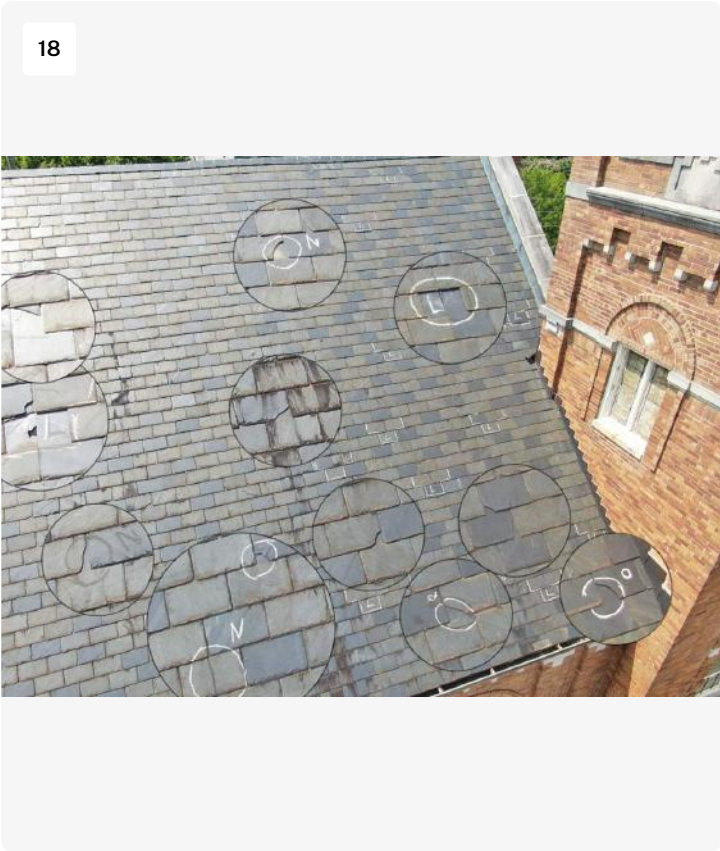
Missing, cracked and displaced tiles

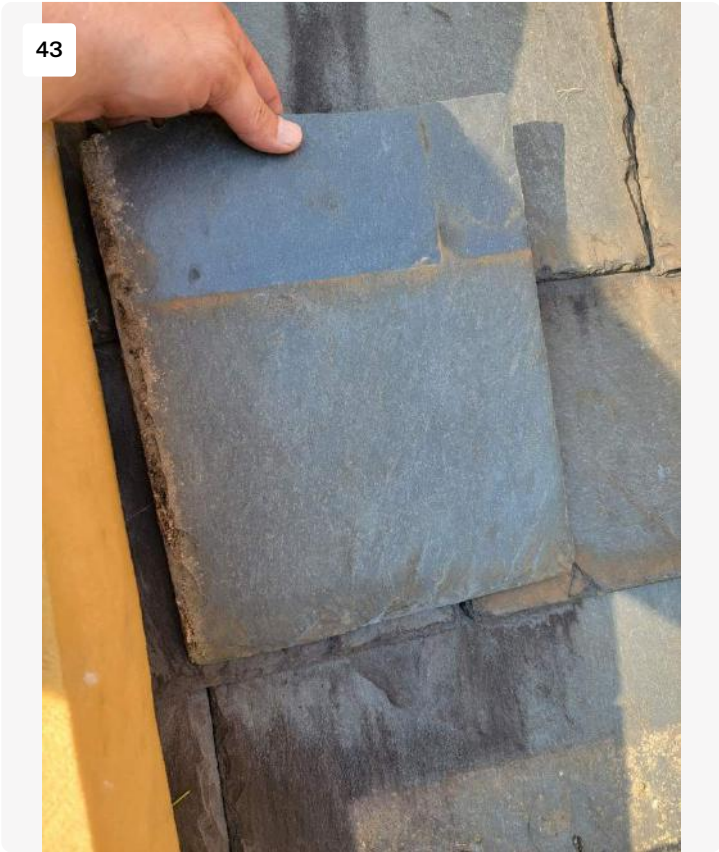
Displaced slate tile
