Ohio Asphalt Paving Conference

Local Government Strategies for Building and Maintaining Asphalt Pavement: A Case Study

February 1, 2023

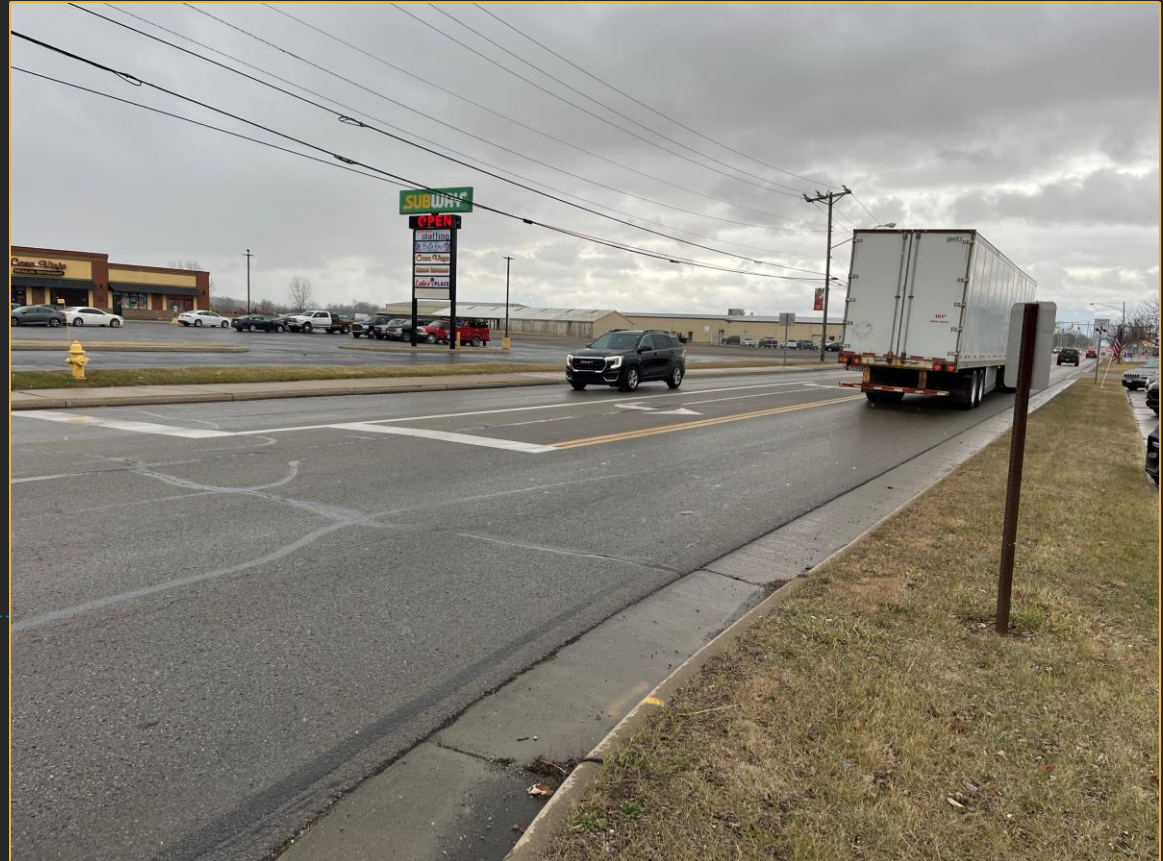
RUTTING

S. Defiance Street (SR66) – Built 1993

- 4000 LF, 36' wide, C/G
- 3" Surface (441 Type1H) on 10" Asphalt Base (301) on Subgrade
- Arterial – Commercial District
 - ADT 8,800

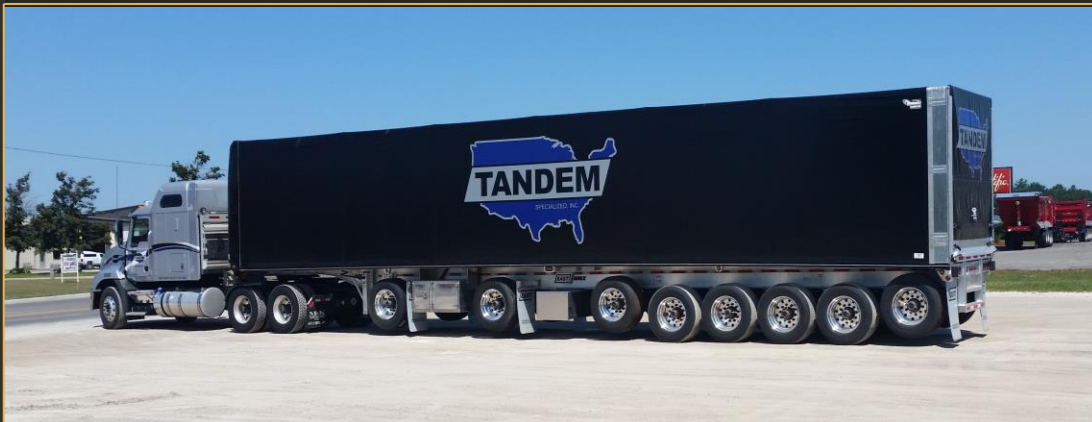
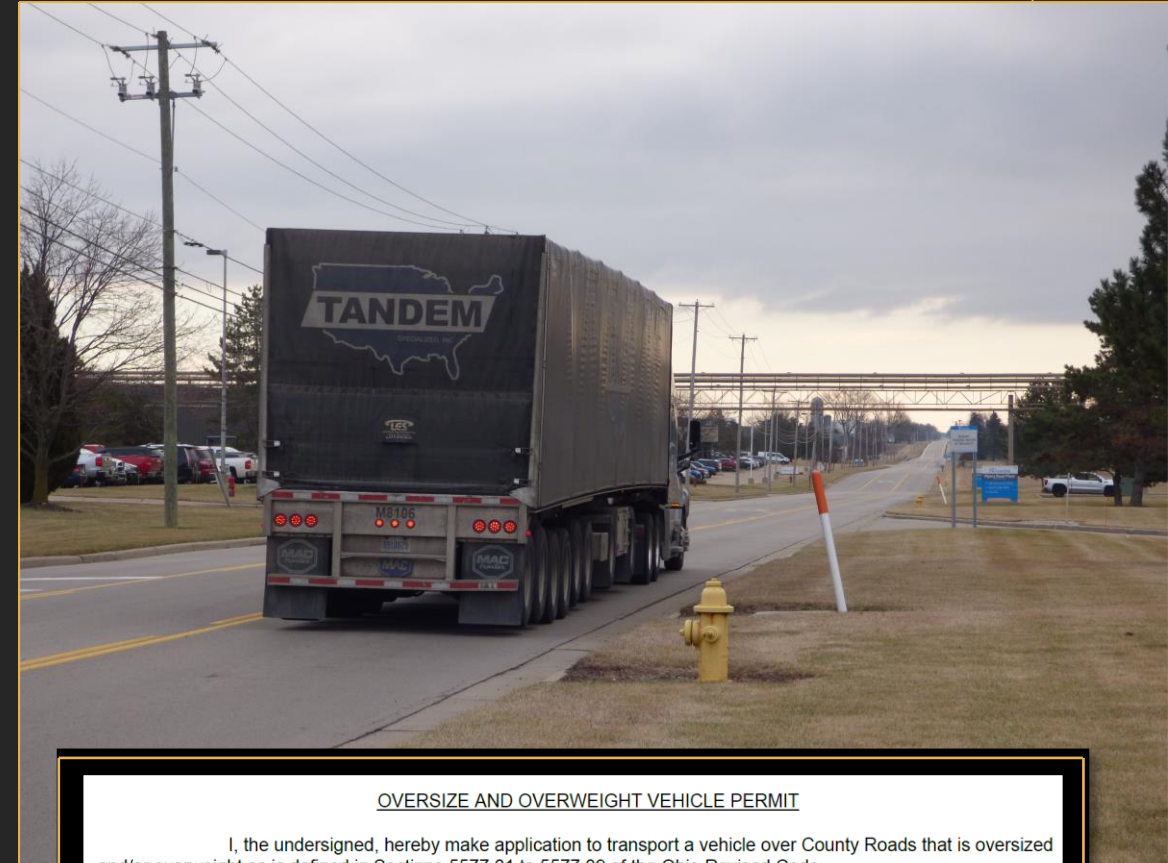
RUTTING

West Barre Road – Built 1994

- 6000+ LF, 36' wide, C/G
- 2-1/2" Surface on 10-1/2" Asph. Base on Subgrade
- Major Collector – Heavy Industry
 - ADT 6,000

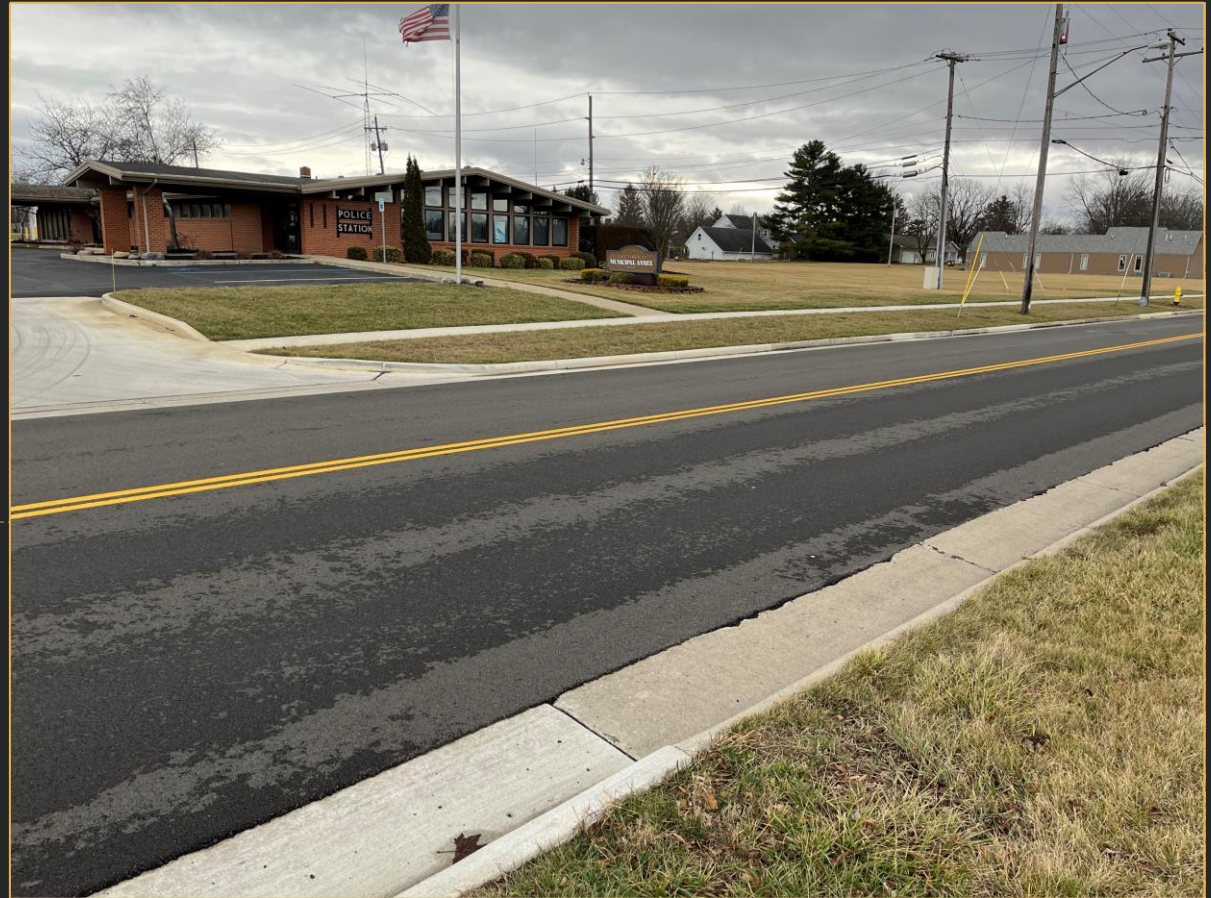
LONGITUDINAL & FATIGUE CRACKING

East Lutz Road – Built 1971

- 5000 LF, 26' wide, C/G
- 5" Asph. on 12" Agg. Base
- Major Collector
 - ADT 2,600
- Truck Traffic

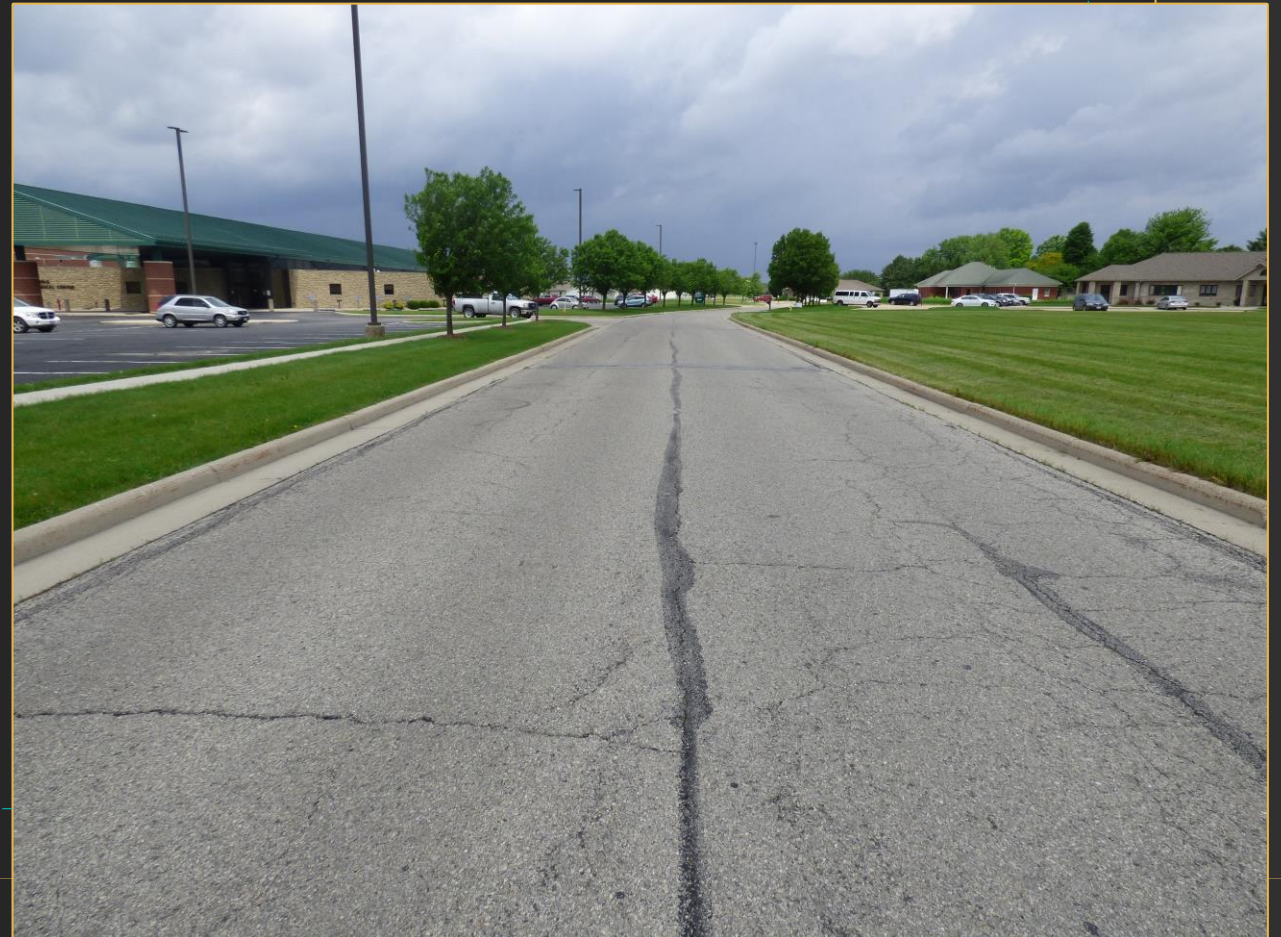
THERMAL & REFLECTIVE CRACKING

West Field Drive – Built 1994 & 1998

- 2000 LF, 24' wide, C/G
- 1994 – 2-1/2" on 5-1/2" on Dirt
- 1998 – 3" on 3" on 8" on GSF
- Local Street
- Commercial & Residential Area, Archbold Medical Group

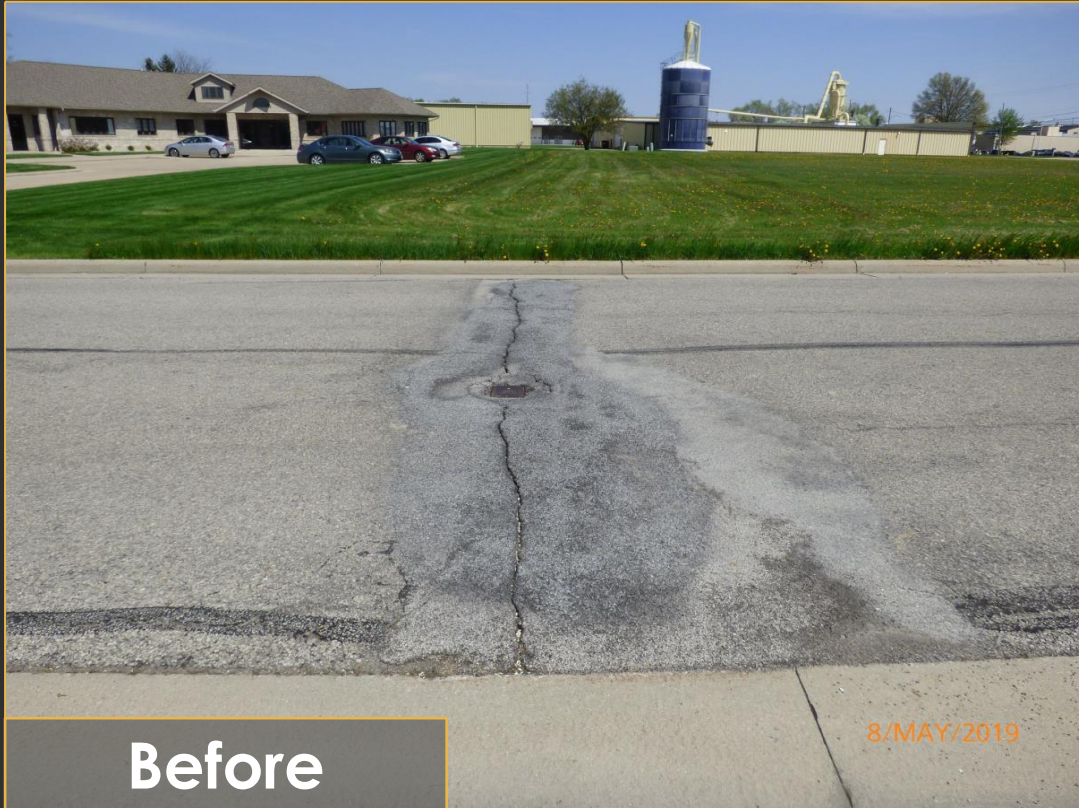
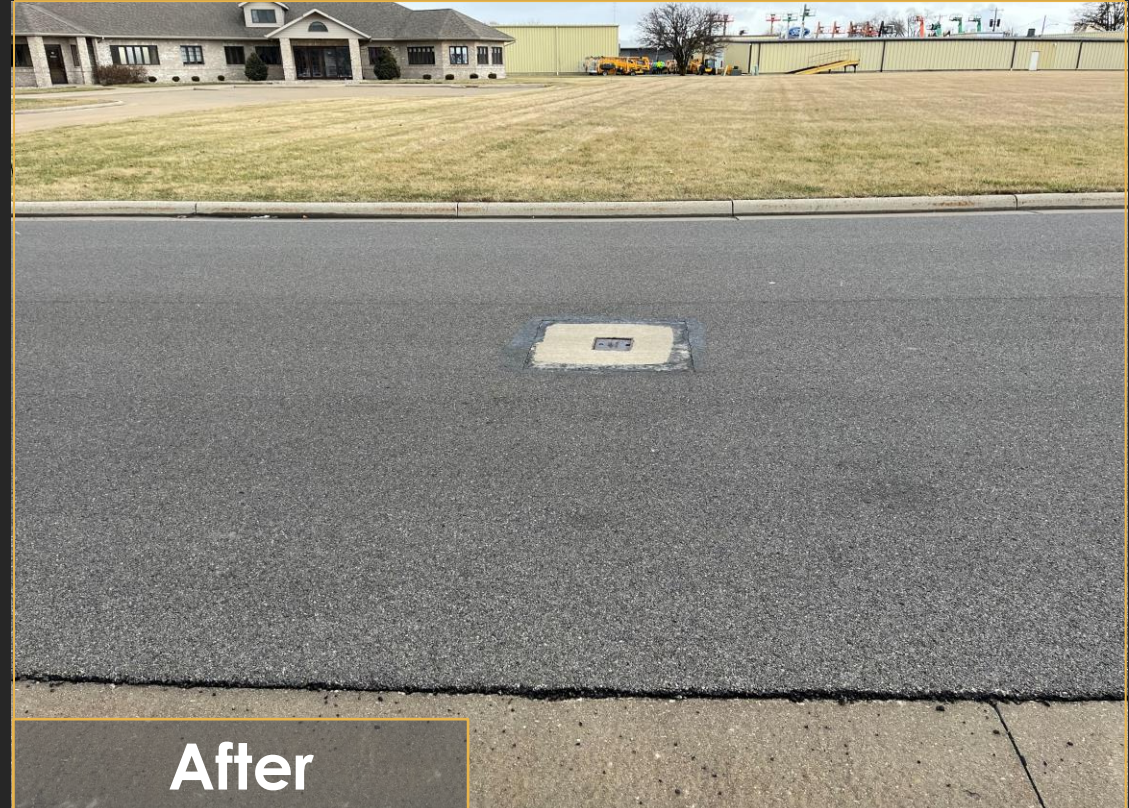
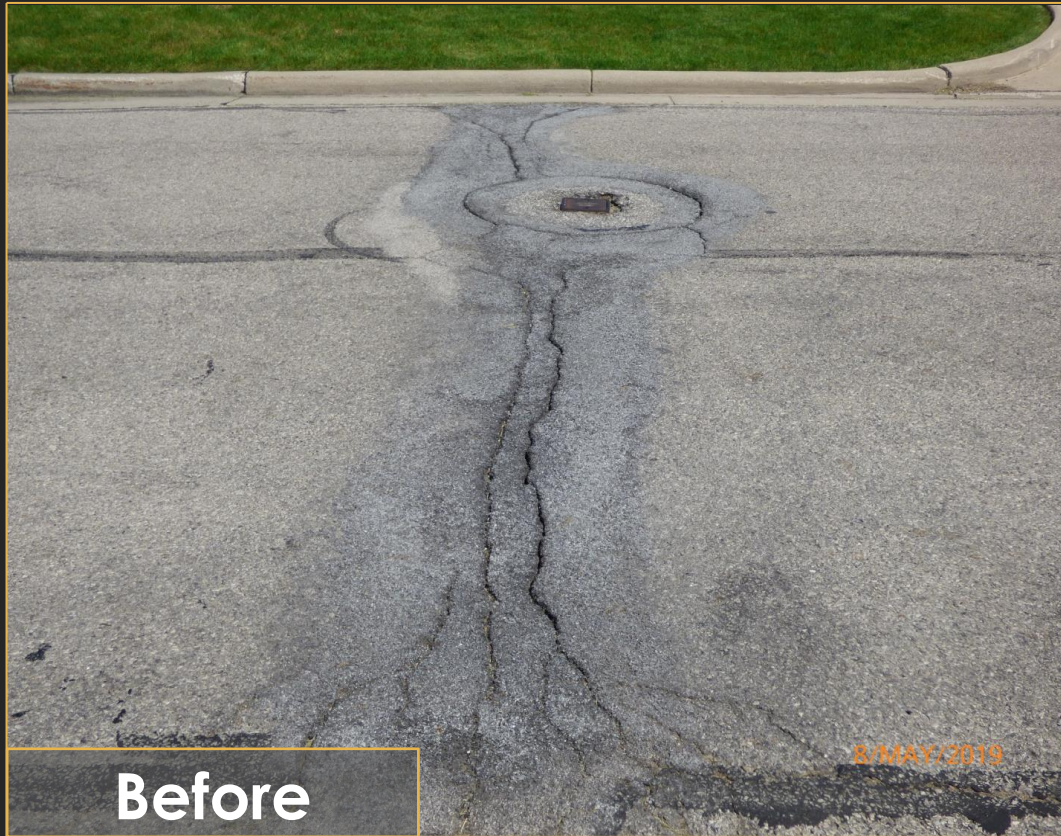
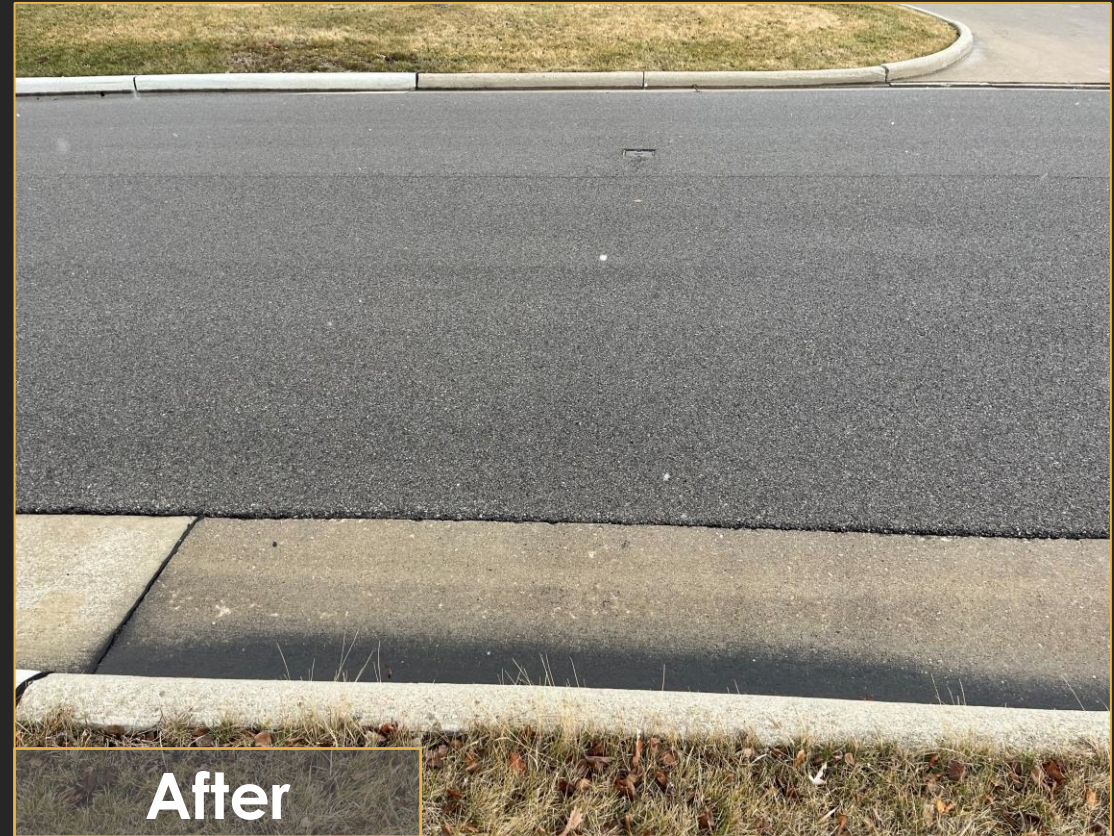
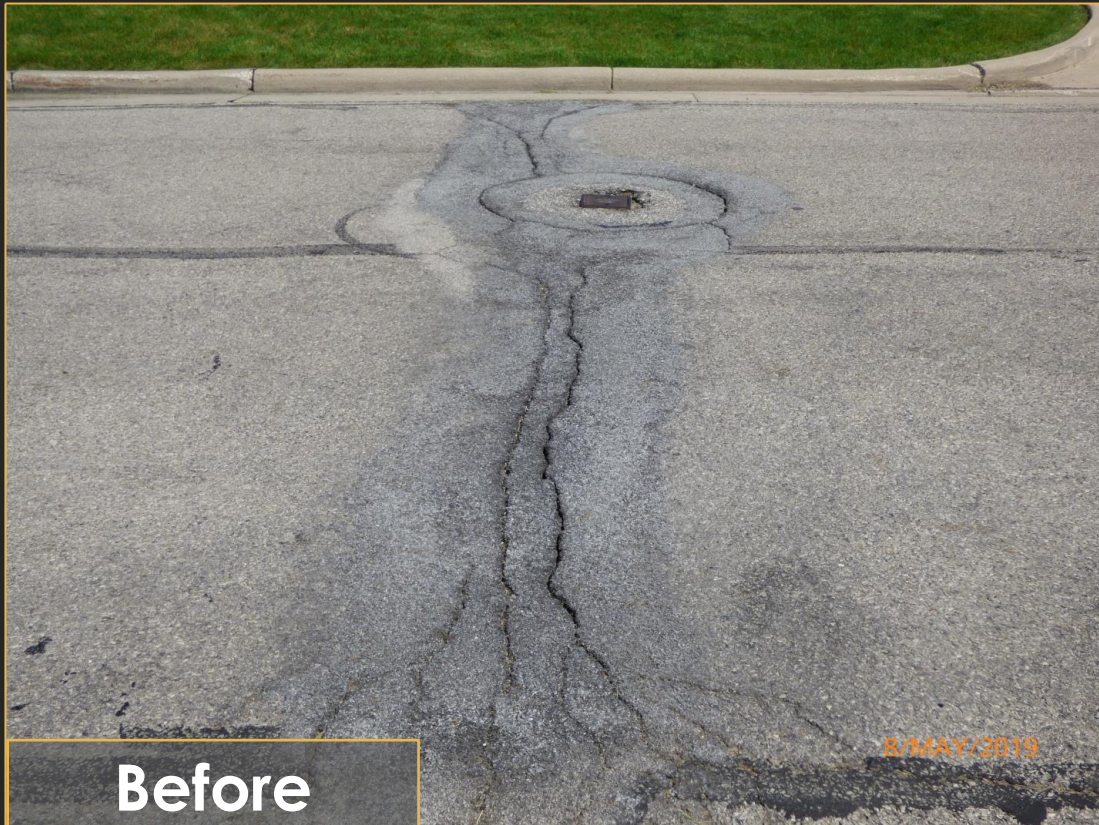
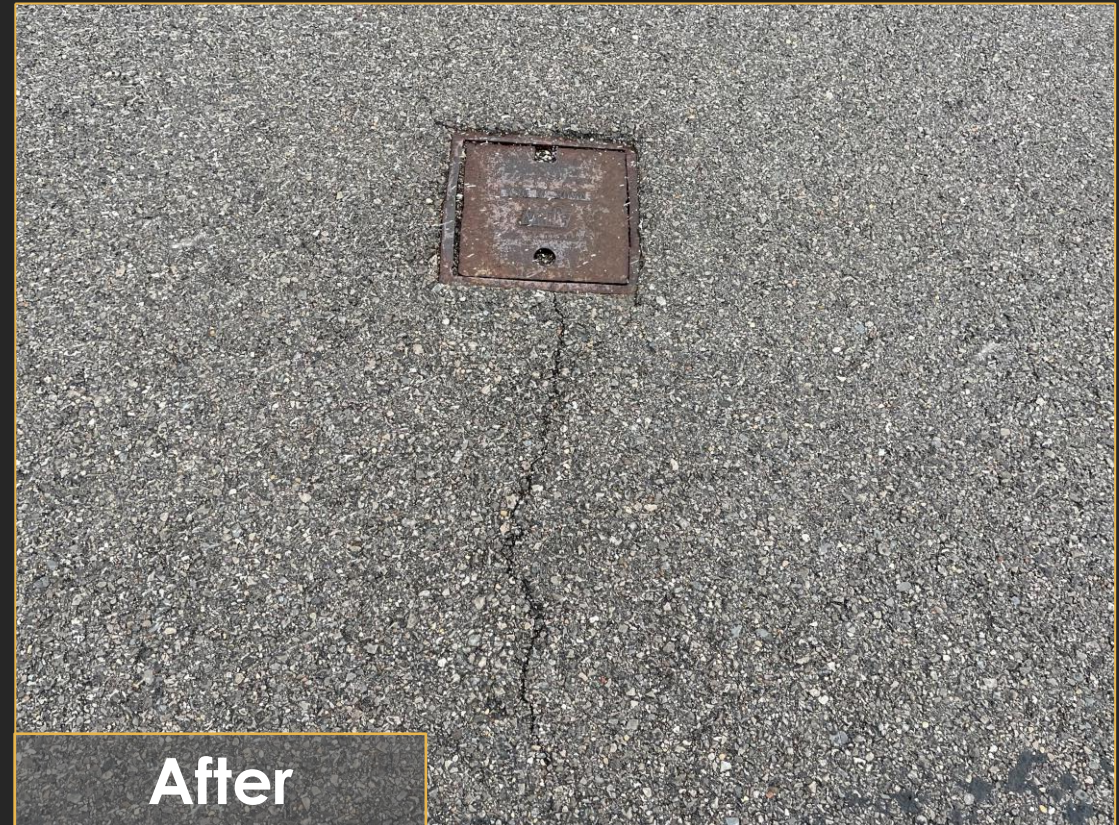
- 4 Winters Later

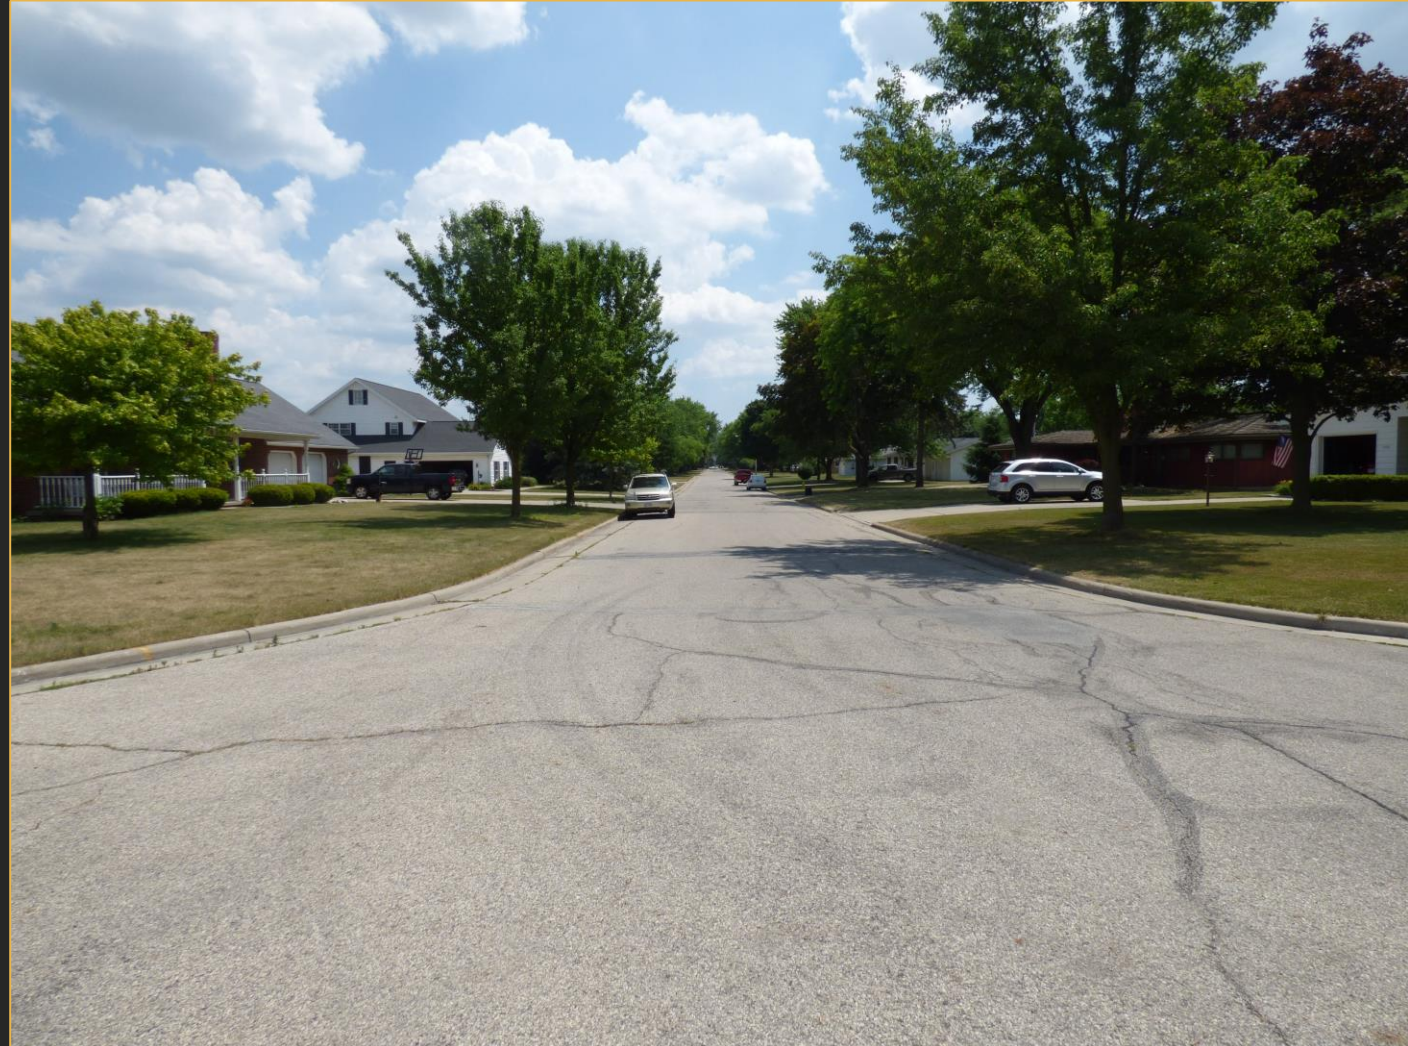
THERMAL & REFLECTIVE CRACKING

Buckeye Street – Built 1988

- 3300 LF, 24' wide, C/G
- 2-1/2" on 6"" on Dirt
- Local Street
- Residential Area
