Knightsbridge Arms Condominium Assoc *Nashua, NH*

Report #: 46958-0
Beginning: January 1, 2024
Expires: December 31, 2024

RESERVE STUDY

"Full"

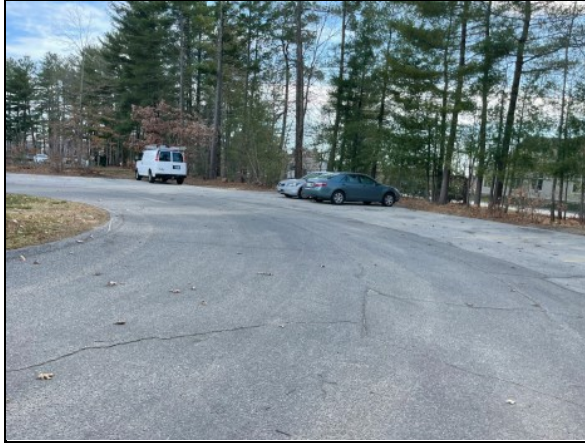
Useful Life:
28 years

Remaining Life:
1 years

Best Case: \$ 710,000

Worst Case: \$ 1,216,000

#	Component	Quantity	Useful Life	Rem. Useful Life	Current Cost Estimate	
					Best Case	Worst Case
Asphalt						
2220	Asphalt - Resurface	~202,733 SQFT	28	1	\$710,000	\$1,216,000
2230	Asphalt - Repair/Seal	~202,733 SQFT	4	0	\$30,400	\$50,700
Roof & Exterior						
2125	Tuck Pointing - Repair	~42,645 SQFT	10	9	\$213,000	\$325,000
2410	Building Mansard Roof -Rpr/Replace	36,384 SQFT	30	12	\$291,072	\$364,000
2410	Garage Mansard Roof - Rpr/Replace	12,930 SQFT	30	12	\$105,000	\$129,000
2420	Building Rubber Roof - Replace	93,648 SQFT	20	7	\$850,000	\$1,030,000
2425	Garage Rubber Roof - Replace	~67,424 SQFT	20	10	\$607,000	\$742,000
2450	Office Shingle Roof - Replace	~1,642 SQFT	25	17	\$11,500	\$13,000
2490	Chimney Caps - Replace	96 each	25	5	\$48,000	\$96,000
2525	Wood Siding - Repair	~14,072 SQFT	5	2	\$112,576	\$183,000
2530	Vinyl Siding A - Replace	18,596 SQFT	30	15	\$168,000	\$205,000
2530	Vinyl Siding B - Replace	18,596 SQFT	30	16	\$168,000	\$205,000

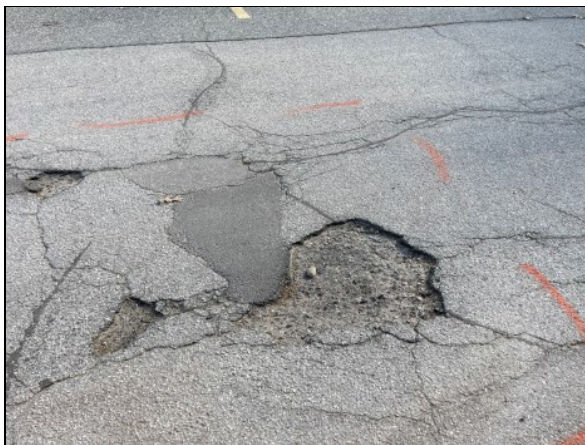
Useful Life:
4 years

Remaining Life:
0 years

Best Case: \$ 30,400

Worst Case: \$ 50,700

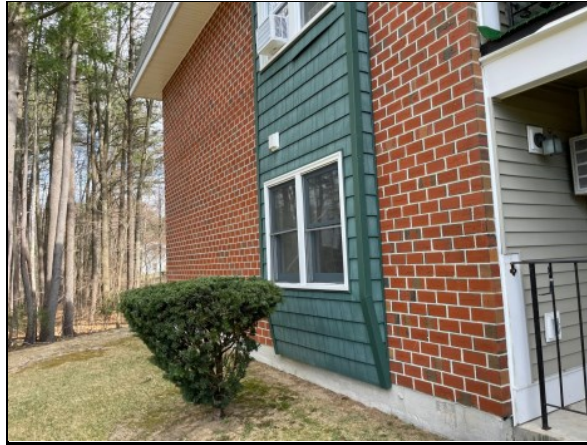
Useful Life:
30 years

Remaining Life:
15 years

Best Case: \$ 168,000

Worst Case: \$ 205,000

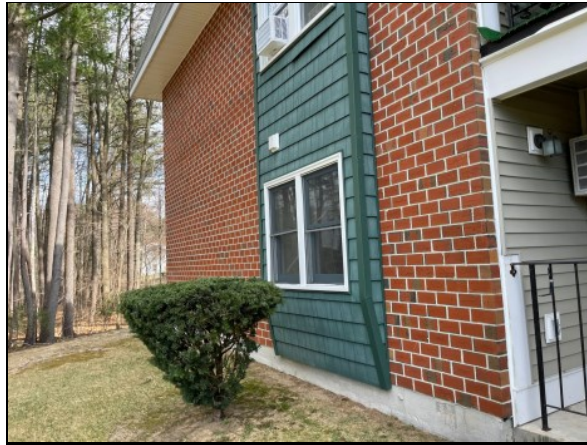
Useful Life:
30 years

Remaining Life:
16 years

Best Case: \$ 168,000

Worst Case: \$ 205,000

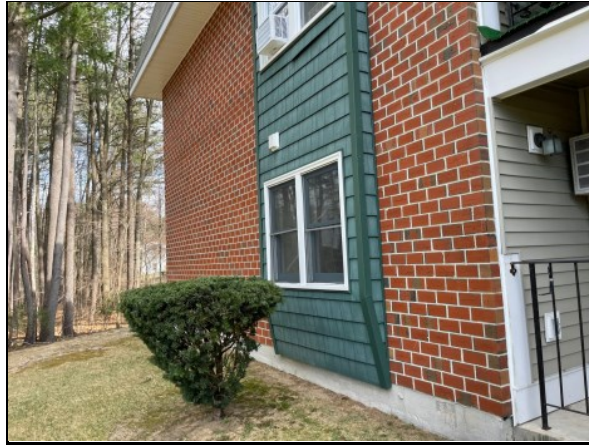
Useful Life:
30 years

Remaining Life:
17 years

Best Case: \$ 168,000

Worst Case: \$ 205,000

2530	Vinyl Siding C - Replace	18,596 SQFT	30	17	\$168,000	\$205,000
Fence & Railings						
2570	Railing Exterior - Replace	1,728 LNFT	30	14	\$69,100	\$105,000
2570	Railing Interior - Replace	1,416 LNFT	30	20	\$53,800	\$77,900
5552	Split Rail Fencing - Replace	~1,004 LNFT	15	1	\$3,300	\$8,000
5570	Basketball Court Fence - Replace	~372 LNFT	30	1	\$1,900	\$5,600
5570	Chain Link Fence - Replace	~1,098 LNFT	30	1	\$10,500	\$16,500
5570	Playground Fence - Replace	~147 LNFT	30	3	\$2,000	\$2,200
5570	Pool Fence - Replace	~287 LNFT	30	9	\$8,000	\$10,000
5570	Tennis Court Fence - Replace	~366 LNFT	30	1	\$10,000	\$12,000
Pool & Equipment						
3050	Main Pool Vinyl Liners - Replace	1 Each	7	0	\$4,000	\$4,800
3050	Wading Pool Vinyl Liners - Replace		7	0	\$4,000	\$4,800
5812	Pool Filter - Replace	2 each	10	5	\$2,400	\$2,400
5817	Pool Pump - Replace	2 each	10	1	\$1,500	\$2,500
5850	Salt Water Generator	2 each	10	1	\$2,700	\$3,800

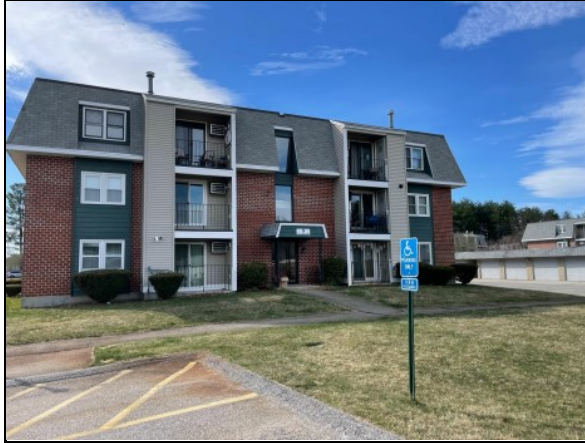
Useful Life:
30 years

Remaining Life:
14 years

Best Case: \$ 69,100

Worst Case: \$ 105,000

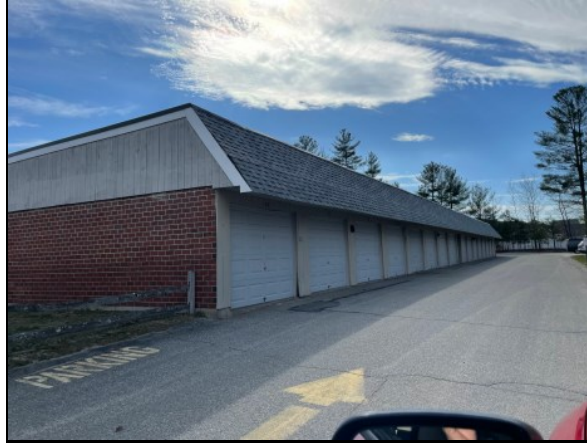
Useful Life:
25 years

Remaining Life:
14 years

Best Case: \$ 145,000

Worst Case: \$ 200,000

5930	Main Pool Cover - Replace		10	1	\$3,000	\$5,000
5930	Wading Pool Cover - Replace		10	1	\$3,000	\$5,000
Doors & Windows						
2317	Garage Doors - Repaint	290 each	25	14	\$145,000	\$200,000
2600	Laundry Doors - Replace	36 each	25	17	\$8,100	\$12,000
2600	Side Doors - Replace	12 each	25	8	\$12,000	\$17,400
2600	Water Heater Doors - Replace	288 each	25	10	\$14,000	\$17,300
2605	Entry Doors - Replace	24 each	25	11	\$30,000	\$34,800
2740	Windows - Repair/Replace	24 Each	35	4	\$25,000	\$30,000
2740	Windows - Repair/Replace	24 each	35	34	\$25,000	\$30,000
3125	Fire Doors - Replace	108 each	30	10	\$75,000	\$125,000
Lighting Fixtures						
5015	Lamp Posts - Replace	23 each	20	5	\$46,000	\$69,000
5032	Entry Light Sconces - Replace	60 each	20	17	\$9,000	\$13,500

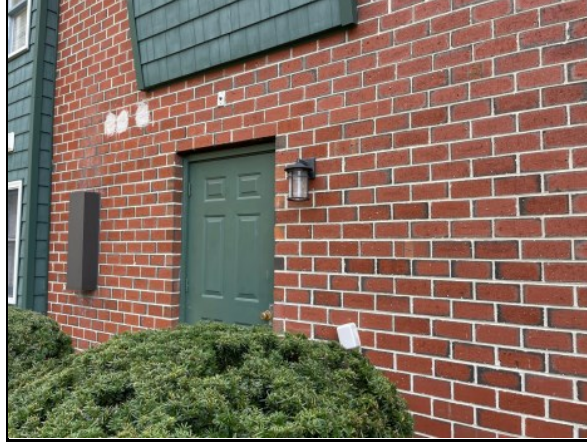
Comp #: 2600 Side Doors - Replace

Comments: There is no expectation to replace all of the doors at one time. This is an allowance to replace the individual doors when necessary to properly maintain appearance and functionality. Routine maintenance of closures, hinges, latches and hardware and other minor repairs should be handled using Operating funds. Keep all surfaces (other than glass) well painted and protected from moisture causing premature deterioration. As the history for replacement becomes evident, this should be adjusted to accurately meet the needs of the client.

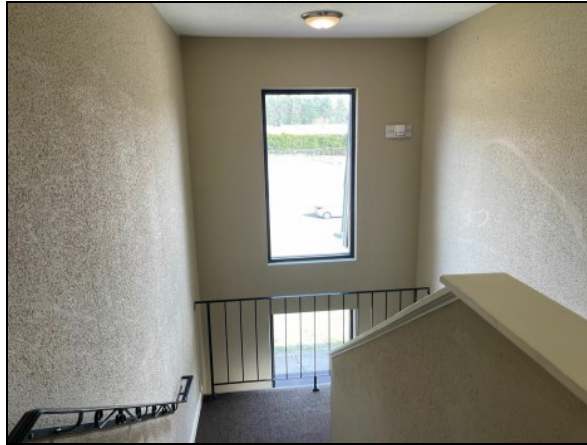
Comp #: 2740 Windows - Repair/Replace

History: About 50% have been replaced

Comments: These are typically long life components with no anticipation of total replacement. Due to aging and shifting of buildings the windows should be checked for proper seal and any remedial repairs should be addressed immediately. This funding is established by the association should major window repair or replacement be required.

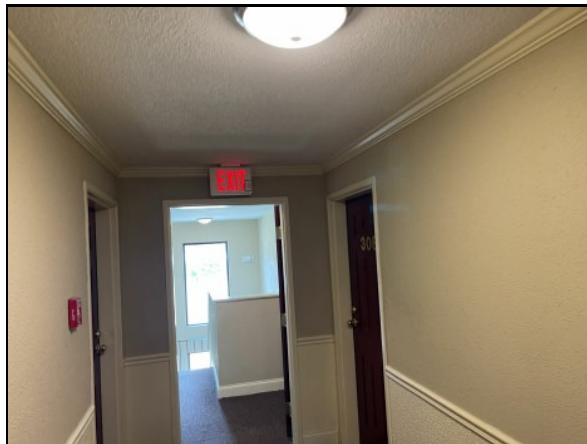
Comp #: 3125 Fire Doors - Replace

Comments: These should be routinely inspected by a qualified service provider. Follow the recommendations for maintenance or replacement.

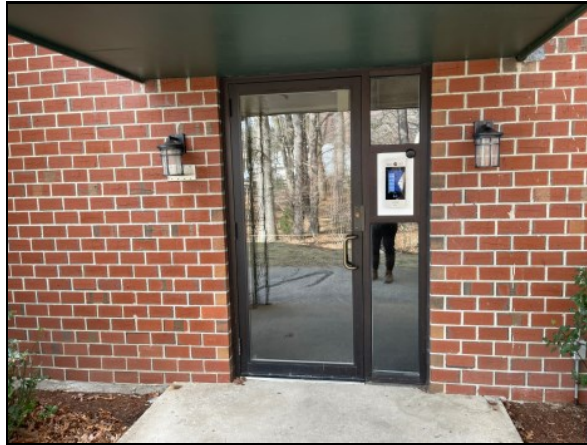
Comp #: 5032 Entry Light Sconces - Replace

Comments: Observed during daylight hours but assumed to be in functional, operating condition. As routine maintenance, clean by wiping down with an appropriate cleaner, change bulbs and repair as needed. Individual replacements should be considered an Operating expense. If available, an extra supply of replacement fixtures should be kept on-site to allow for prompt individual replacements. Best practice is to plan for total replacement to periodically restore an attractive aesthetic standard within the property's common areas. Based on evident conditions and repair/replacement history provided by the Client during this engagement, we recommend financially preparing for comprehensive replacement at the approximate time frame below. Unless otherwise noted, costs shown here are based on replacement with comparable quantity and style of lights as existing and installed by a qualified professional electrician. We recommend consideration of LED fixtures or other energy-saving options whenever possible.

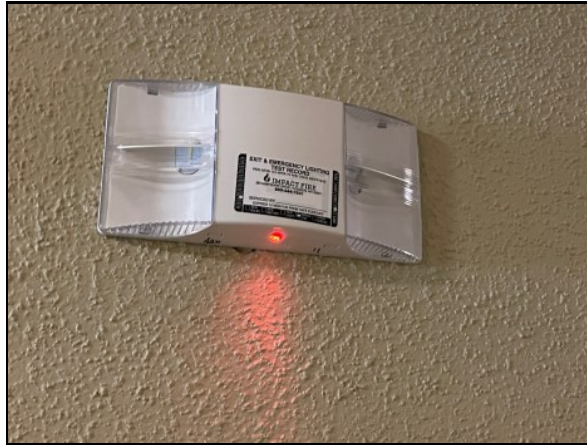
Comp #: 5040 Wall Pack Lights - Replace

Comments: These lights have a lower aesthetic priority but is important for safety. Should be inspected regularly to ensure that all areas are adequately lit. Fixtures are typically high-output and sometimes have shorter life expectancies due to constant usage. Individual replacements should be considered an Operating expense. If available, an extra supply of replacement fixtures should be kept on-site to allow for prompt individual replacements. Based on evident conditions and/or past repair/replacement history provided during this engagement, we recommend that the Client plan for comprehensive replacement at the approximate interval shown below. Replacement should be coordinated with exterior painting projects whenever possible. We recommend consideration of LED fixtures or other energy-saving options whenever possible.

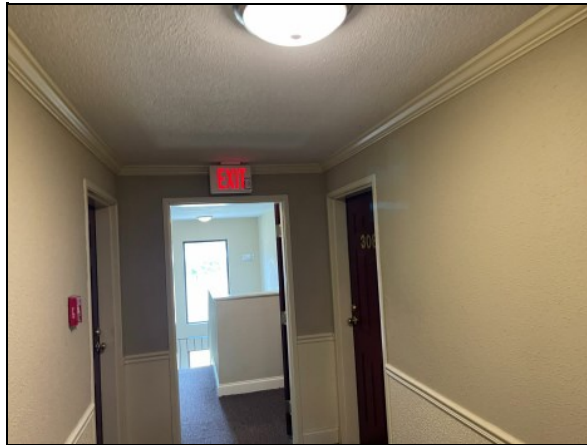
Comp #: 5050 Ceiling Lights - Replace

Comments: Not all lights were tested during inspection. It is assumed all to be in functional, operating condition. As routine maintenance, clean by wiping down with an appropriate cleaner, change bulbs and repair as needed. Individual replacements should be considered an Operating expense. If décor coordination is desired, an extra supply of replacement fixtures should be kept on-site to allow for prompt individual replacements. Unless otherwise noted, costs shown here are based on replacement with comparable quantity and style of lights as existing and installed by a qualified professional electrician. We recommend consideration of LED fixtures or other energy-saving options whenever possible. The lighting is aging normally.

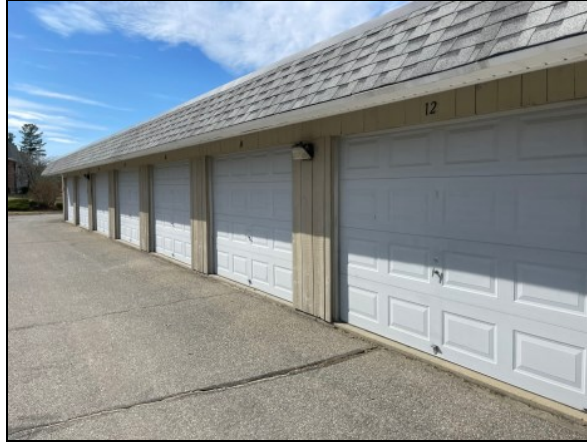
Comp #: 5050 Garage Lights - Replace

Comments: Not all lights were tested during inspection. It is assumed all to be in functional, operating condition. As routine maintenance, clean by wiping down with an appropriate cleaner, change bulbs and repair as needed. Individual replacements should be considered an Operating expense. If décor coordination is desired, an extra supply of replacement fixtures should be kept on-site to allow for prompt individual replacements. Unless otherwise noted, costs shown here are based on replacement with comparable quantity and style of lights as existing and installed by a qualified professional electrician. We recommend consideration of LED fixtures or other energy-saving options whenever possible. The lighting is aging normally.

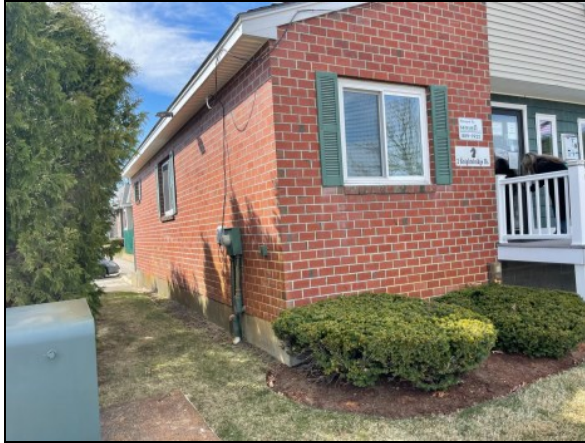
Comp #: 2740 Clubhouse Windows - Repair/Replace

Comments: These are typically long life components with no anticipation of total replacement. Due to aging and shifting of buildings the windows should be checked for proper seal and any remedial repairs should be addressed immediately. This funding is established by the association should major window repair or replacement be required.

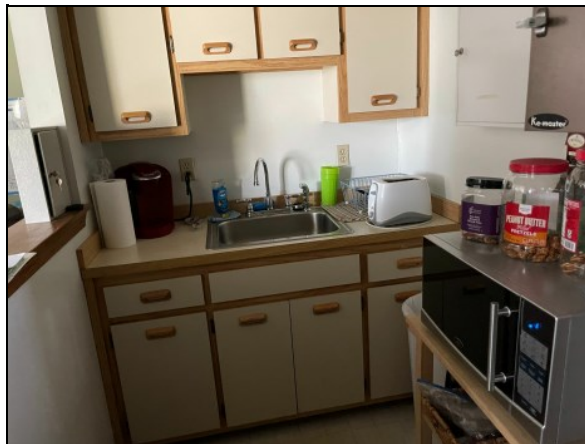
Comments: A typical remodel would include the replacement of cabinets, counters, lighting, appliances, and other dated or damaged elements of the facility. There is no expectation to replace all of the components with like for like, however, the funding needs to be established to replace with similar quantity and quality of the existing kitchen. The funding can be adjusted by the client when accurate plans for the remodel are established. Some of the components may remain based on conditions and overall project cost.

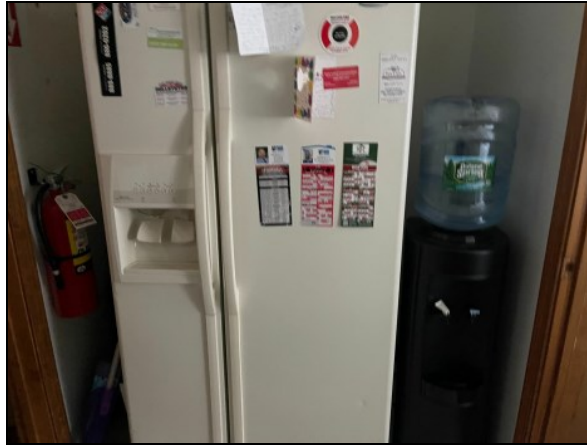
Comp #: 3325 Refrigerator/Freezer - Replace

Comments: The replacement cycle will depend greatly on use and abuse. Provide routine cleaning and maintenance to reach or extend average life. There is no expectation the appliances will be replaced with like-for-like units. This is an allowance to provide appliances that meet the needs of the community.

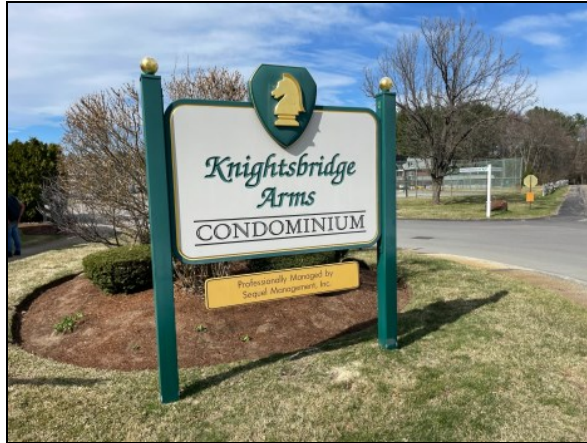
Comp #: 6805 Monument Sign - Replace/Refurbish

Useful Life:
20 years

Remaining Life:
16 years

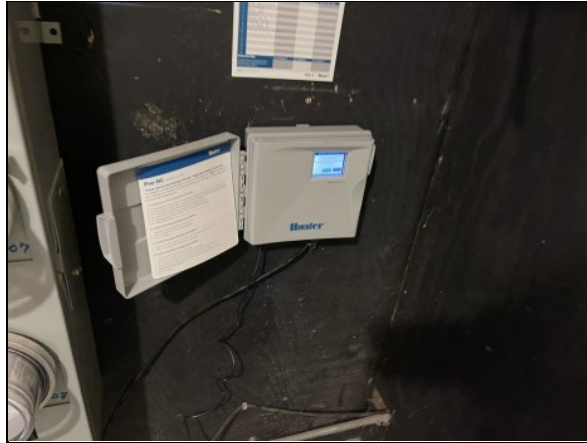
Comp #: 6900 Irrigation Controllers - Replace

Comments: Follow the recommendations of the contracted landscape maintenance vendor for repair or replacement needs.

Useful Life:
12 years

Remaining Life:
6 years
