Re: GTR-23015113-A0 and GTR-23015112-C0 (Peer review)
Project Name: Environmental Compliance Approval – Air Emissions (ECA/EASR – Air) Requirements for BESS Facility at 219 Peggs Mountain Rd., Armour, ON

Subject: Response to Peer Review Comments - Prepared by CAMBIUM – May 21, 2025

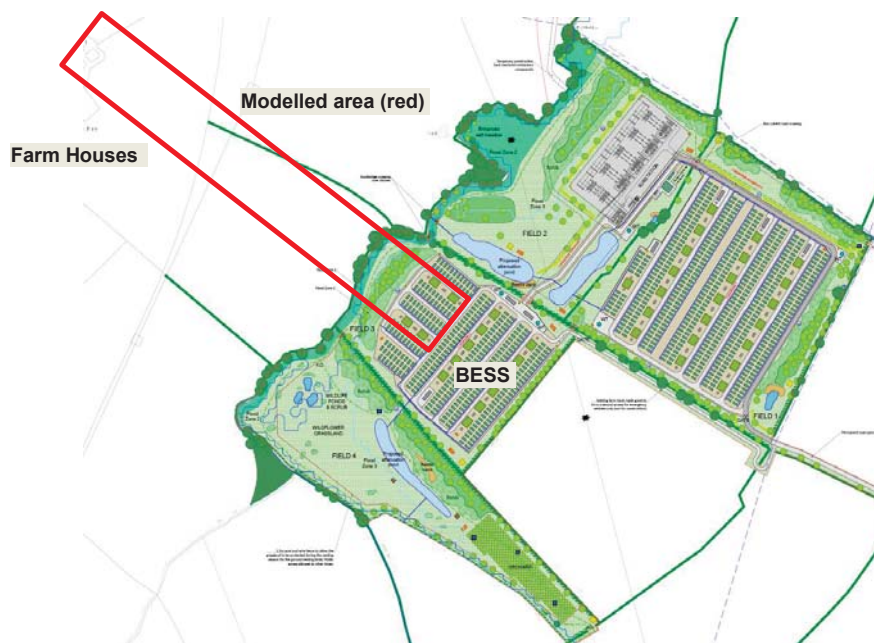
Figure 3-2: 3D model of East Claydon BESS Site

The 3D model was constructed from the BESS specification and site layout drawing (Ref. /2/, /3/). Figure 3-2 shows a plan view of the East Claydon BESS site and Figure 3-1 shows the 3D model and detailed view of the BESS container. Each BESS contains 10 racks which have 416 cells each. The BESS measure 6.1m x 2.1m x 2.6m in dimension and there are 480 total on the site. The 3D model considers a subsection of the site as marked in red in Figure 3-2. The presence of the rest of the site is not expected to have an effect on the results. The farm houses to the north west are also included in the model as these are the closest residential off-site buildings to the BESS site. The farm houses are approximately 470m from the nearest BESS.

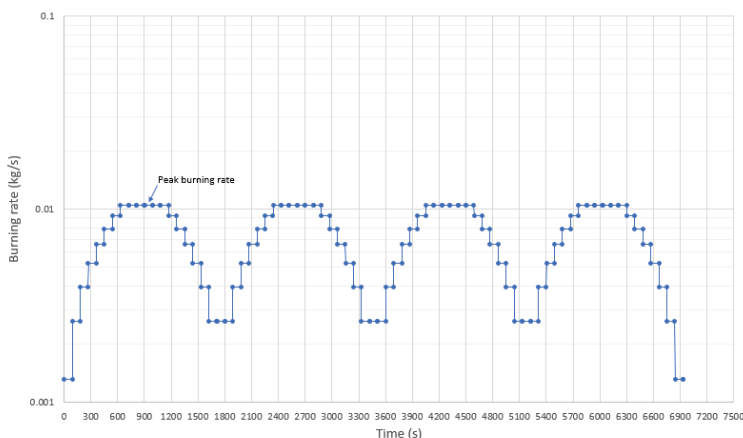
2x13 cell arrangement for first 4 modules

Figure 3-3: Example escalation in a rack and burning rate vs time plot

- If a single cell fails, the cell-to-cell propagation would spread outwards from the initiating cell to the neighbouring cells and so on until all cells are consumed. During the propagation, the number of cells engaged in thermal runaway would gradually increase at each escalation step and depending on the arrangement of the cells would reach a peak rate. An example of this is shown in Figure 3-3 where a peak number of cells that are in thermal runaway at the same time is approximately 2% of the entire rack as the failure propagates to each module, shown with the peaks and troughs. The racks have 416 cells which are assumed to be split into 16 levels/modules in a 2 x 13 arrangement. Cells are assumed to fail in a module and then propagate to the next module. This example conservatively assumes that escalation between cells takes 90s and that failure propagates to neighbouring cells. Cell to cell propagation has been observed to take up to 5mins.

- Assumptions:** Based on the assumptions and example escalation outlined above, a single cell has a peak release rate of 0.0013kg/s (1.3g/s). Conservatively assuming that 2% of the cells fail at the same time, there would be 8 cells in thermal runaway at the same time, we would have (8 x 0.0013kg/s =) 0.0104kg/s of offgas being burned at the peak of the fire per rack. It is therefore assumed that per rack the peak burning rate is ~0.0104kg/s. Assuming this failure profile, the rack fire would last approximately 2 hours which is of a similar magnitude to what has been observed historically (Ref. /9/, /10/).
