# SUBSURFACE SOIL INVESTIGATION

# Promontory Imagine School Third Filing Phase 1 Greeley, Colorado

**JOB NO. 184203**

**September 20, 2021**

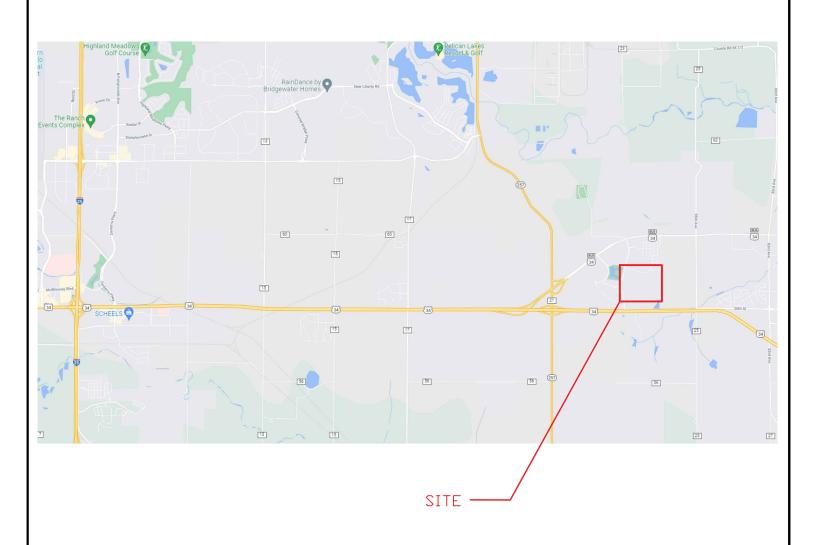
# VICINITY MAP

PROMONTORY SUBDIVISION
THIRD FILING

The project site lies in part of the east half of Section 11 and west half of Section 12, Township 5 North, Range 67 West of the 6<sup>th</sup> P.M., City of Greeley, Colorado. The project site is generally located to the west of the City of Greeley, Colorado. The site is located east of Promontory Parkway and in between Highway 34 Bypass and 16<sup>th</sup> Street. The approximate location of the proposed subdivision is shown in the Site Vicinity Map on Figure 1.

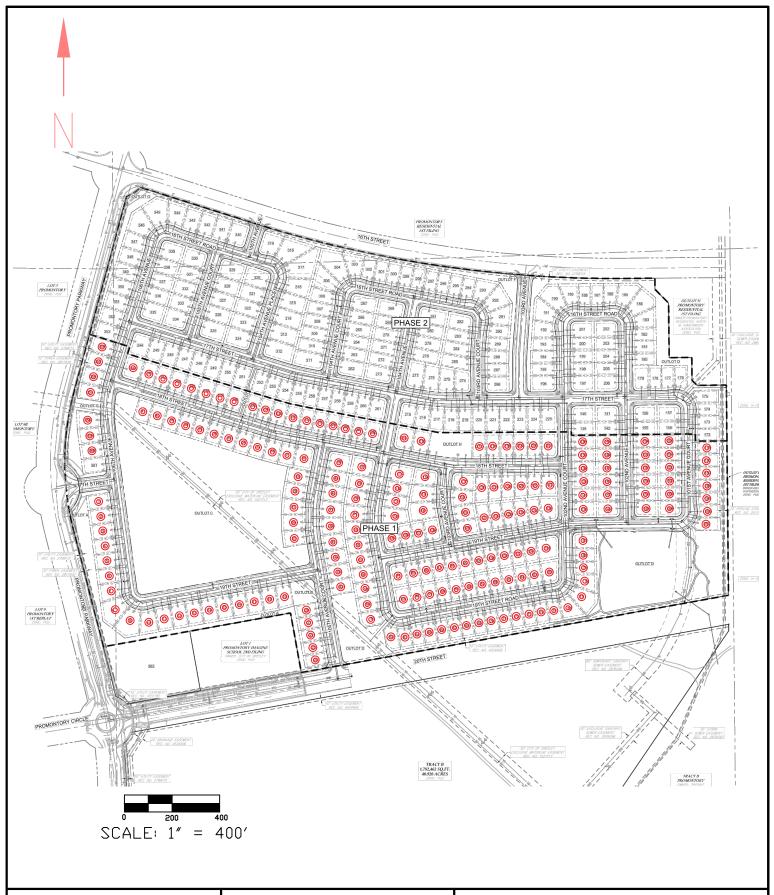
BORE LOCATION PLAN
PROMONTORY SUBDIVISION
THIRD FILING

GREELEY, COLORADO

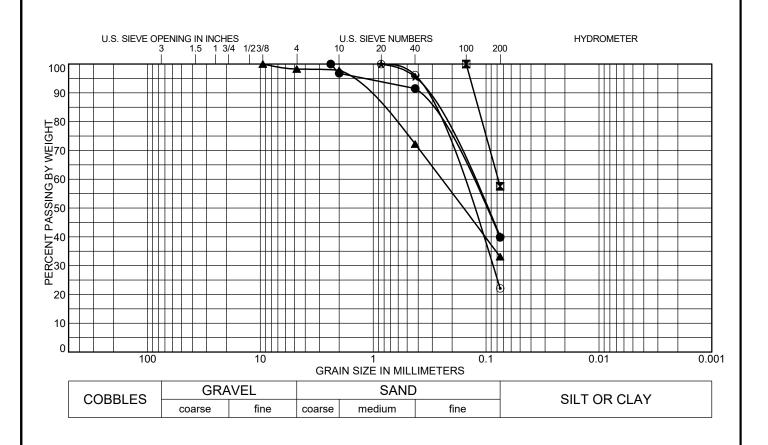
FIGURE No. 103

٦	Γest Boring	Depth (ft)		Classification							
•	Lot 003	9.0		SILTY SAND(SM)							
×	Lot 009	9.0		SANDY SILT(ML)							
▲	Lot 015	4.0			SILTY SAI	ND(SM)		20	20	NP	
*	Lot 019	9.0			CLAYEY SA	AND(SC)		43	17	26	
•	Lot 023	4.0				NP	NP	NP			
-	Test Boring	Depth (ft)	%Gravel								
				1

est Boring	Deptn (π)	%Gravei	%Sand	%SIIT	%Clay
•	Lot 003	9.0	0.0	60.2	39	).8
	Lot 009	9.0	0.0	42.4	57	<b>'.6</b>
lack	Lot 015	4.0	1.7	65.2	33	B.1
*	Lot 019	9.0	0.0	59.8	40	).2
•	Lot 023	4.0	0.0	77.9	22	2.1

The moisture content for the recovered samples was obtained in the laboratory. Grain-size analysis, Atterberg Limits and swell/consolidation tests were performed on selected samples for purposes of classification and to develop pertinent engineering properties. A Summary of Laboratory Test Results is presented in Figure 102. Soil Classification Data and Atterberg Limits are presented in Figures 103 through 111. Swell/Consolidation Test Results are presented in Figures 112 through 133.

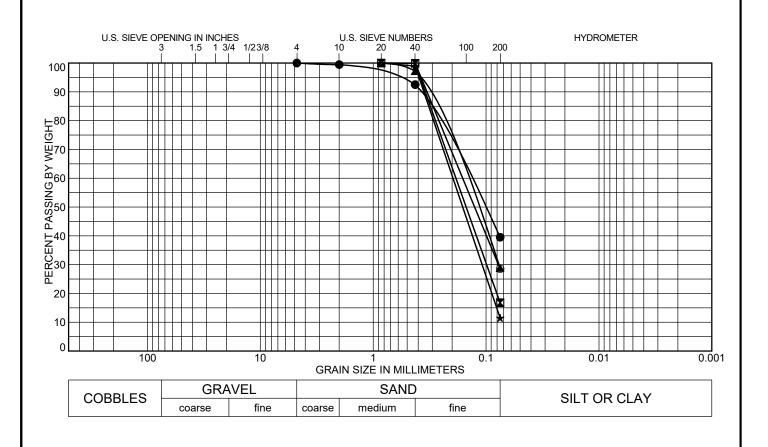
FIGURE No. 104

-	Test Boring	Depth (ft)			Classific	ation		LL	PL	PI
•	Lot 025	4.0		SILTY SAND(SM)					26	8
×	Lot 031	9.0		SILTY SAND(SM)					NP	NP
▲	Lot 035	4.0		SILTY SAND(SM)					18	2
*	Lot 041	9.0		POORLY GE	RADED SAN	ID with SILT	(SP-SM)	NP	NP	NP
•	Lot 042	9.0			SILTY SAM	ND(SM)		30	23	7
-	Test Boring	%Gravel	%Sand	%Silt	%Clay		•			
	Lot 025	4.0	0.0 60.5 39.5

rest borning	Deptii (it)	70 Glavei	/oSariu	70011	70 <b>O</b> lay
•	Lot 025	4.0	0.0	60.5	39	).5
	Lot 031	9.0	0.0	83.2	16	5.8
▲	Lot 035	4.0	0.0	71.2	28	3.8
*	Lot 041	9.0	0.0	88.5	11	.5
•	Lot 042	9.0	0.0	71.4	28	3.6
	LOI 042	9.0	0.0	71.4	20	0.0

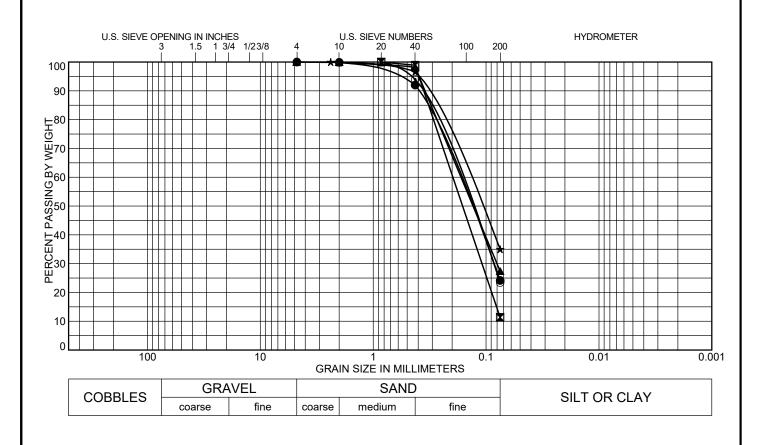
FIGURE No. 105

-	Test Boring	Depth (ft)		Classification						PI
•	Lot 044	4.0		SILTY SAND(SM)						NP
X	Lot 049	9.0		POORLY GRADED SAND with SILT(SP-SM)						5
<b>A</b>	Lot 055	4.0		SILTY, CLAYEY SAND(SC-SM)						5
*	Lot 062	4.0		SILTY	, CLAYEY	SAND(SC-SM)		21	15	6
•	Lot 069	4.0			SILTY SAI	ND(SM)		19	17	2
	Test Boring	Depth (ft)	%Gravel	%Gravel %Sand %Silt %Clay						
•	Lot 044	4.0	0.0	0.0 75.8 24.2						
	L of 049	9.0	0.0

ı	lest boring	Depth (It)	%Glavei	%Sand	70 <b>0</b> 111	%Clay
•	Lot 044	4.0	0.0	75.8	24	.2
X	Lot 049	9.0	0.0	88.7	11	.3
<b>A</b>	Lot 055	4.0	0.0	72.6	27	<b>.</b> .4
*	Lot 062	4.0	0.0	65.0	35	5.0
•	Lot 069	4.0	0.0	76.6	23	3.4

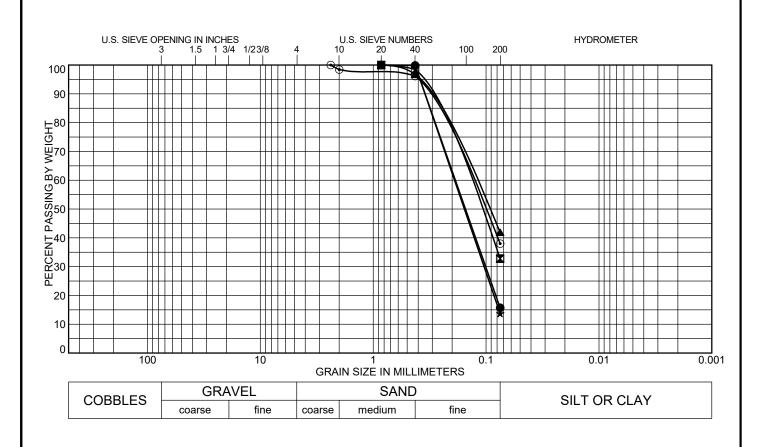
FIGURE No. 106

T	est Boring	Depth (ft)			Classification	n		LL	PL	ΡI
	Lot 080	9.0		SILTY SAND(SM)					NP	NP
	Lot 082	4.0		SILTY SAND(SM)					NP	NP
	Lot 085	9.0		SILTY, CLAYEY SAND(SC-SM)				23	17	6
*	Lot 090	9.0			SILTY SAND(S	SM)		NP	NP	NP
•	Lot 093	9.0			SILTY SAND(S	SM)		NP	NP	NP
Т	est Boring	Depth (ft)	%Gravel	Gravel %Sand %Silt %Clay						
•	Lot 080	9.0	იი 84.3 15.7

est Boring	Deptn (π)	%Gravei	%Sand	%5III	%Clay
•	Lot 080	9.0	0.0	84.3	15	5.7
X	Lot 082	4.0	0.0	67.2	32	2.8
<b>A</b>	Lot 085	9.0	0.0	58.1	41	.9
*	Lot 090	9.0	0.0	86.3	13	3.7
•	Lot 093	9.0	0.0	62.0	38	3.0

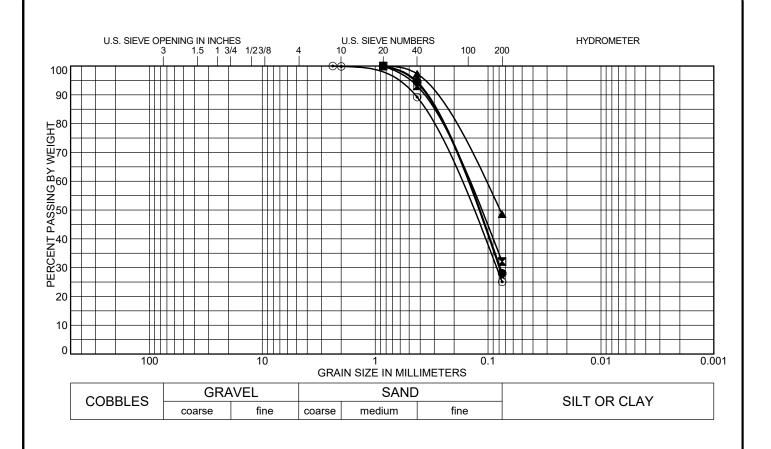
FIGURE No. 107

Test Boring	Depth (ft)		Classification			LL	PL	PI	
•	Lot 099	4.0		SILTY SAND(SM)				20	18	2
X	Lot 102	9.0		SILTY SAND(SM)				21	18	3
<b>A</b>	Lot 108	9.0		SILTY, CLAYEY SAND(SC-SM)				25	20	5
*	Lot 110	9.0			SILTY SAN	ID(SM)		NP	NP	NP
•	Lot 112	4.0		SILTY SAND(SM)				NP	NP	NP
	Test Boring Depth (ft)		%Gravel	%Sand	%Silt	%Clay

est Boring	Deptn (π)	%Gravei	%Sand	%SIIT	%Clay
•	Lot 099	4.0	0.0	72.0	28	3.0
X	Lot 102	9.0	0.0	67.9	32	2.1
<b>A</b>	Lot 108	9.0	0.0	51.5	48	3.5
*	Lot 110	9.0	0.0	72.8	27	.2
•	Lot 112	4.0	0.0	74.9	25	5.1

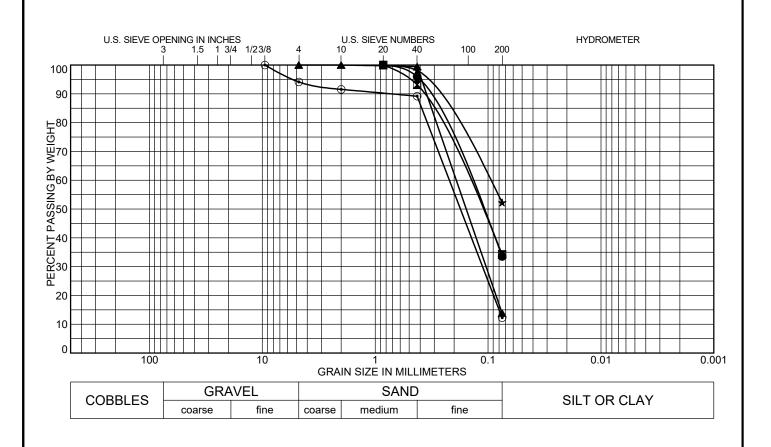
FIGURE No. 108

-	Test Boring	Depth (ft)		Classification					PL	PI
•	Lot 114	4.0		SILTY SAND(SM)				22	19	3
X	Lot 117	4.0		SILTY SAND(SM)					18	3
▲	Lot 121	9.0		SILTY SAND(SM)				NP	NP	NP
*	Lot 124	4.0		SAN	DY SILTY C	LAY(CL-ML)		23	19	4
•	Lot 127	9.0		SILTY, CLAYEY SAND(SC-SM)				27	21	6
-	Test Boring	Depth (ft)	%Gravel	%Gravel %Sand %Silt %Clay						
		_

l est Boring	Deptn (π)	%Gravei	%Sand	%SIIT	%Clay
•	Lot 114	4.0	0.0	66.5	33	.5
	Lot 117	4.0	0.0	65.8	34	.2
•	Lot 121	9.0	0.0	86.1	13	.9
*	Lot 124	4.0	0.0	47.7	52	3
•	Lot 127	9.0	5.9	81.9	12	3

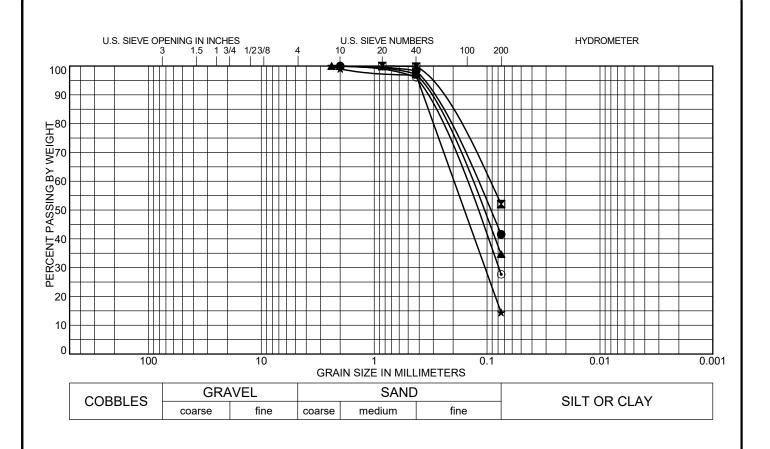
FIGURE No. 109

•	Lot 133	4.0	4.0 0 0 58.4 41.6							
•	Test Boring	Depth (ft)	%Gravel	Gravel %Sand %Silt %Clay						
•	Lot 149	4.0			SILTY SA	ND(SM)		NP	NP	NP
*	Lot 146	9.0			SILTY SA	ND(SM)		NP	NP	NP
▲	Lot 144	4.0		SILTY SAND(SM)				NP	NP	NP
X	Lot 138	9.0		SANDY SILTY CLAY(CL-ML)					20	4
•	Lot 133	4.0		SILTY SAND(SM)					17	3
-	Test Boring	Depth (ft)			Classific	cation		LL	PL	PI

ı	lest boring	Depth (It)	%Glavei	%Sand	70 <b>0</b> 111	%Clay
•	Lot 133	4.0	0.0	58.4	41.6	
X	Lot 138	9.0	0.0	48.0	52.0	
▲	Lot 144	4.0	0.0	65.3	34	.7
*	Lot 146	9.0	0.0	85.6	14.4	
•	Lot 149	4.0	0.0	72.3	27	7.7

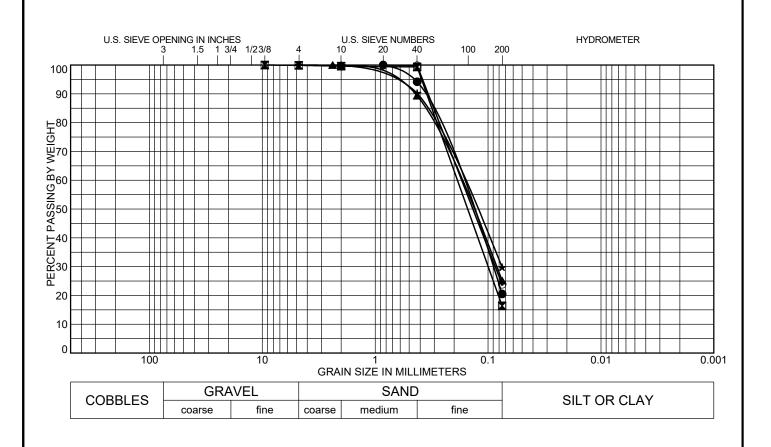
FIGURE No. 110

Test Boring Depth (ft)		Classification				LL	PL	PI		
•	Lot 160	4.0		SILTY SAND(SM)			NP	NP	NP	
×	Lot 163	9.0		SILTY SAND(SM)			NP	NP	NP	
<b>A</b>	Lot 168	4.0		SILTY SAND(SM)			20	21	NP	
*	Lot 171	4.0	SILTY SAND(SM)			18	16	2		
•	Lot 207	4.0	SILTY SAND(SM)			NP	NP	NP		
-	Test Boring Dep		%Gravel	%Sand	%Silt	%Clay				
						<del>'</del>	1

l est Boring	Deptn (π)	%Gravei	%Sand	%SIIT	%Clay
•	Lot 160	4.0	0.0	79.5	20.5	
	Lot 163	9.0	0.1	83.5	16.4	
<b>A</b>	Lot 168	4.0	0.0	74.8	25.2	
*	Lot 171	4.0	0.0	70.2	29	.8
•	Lot 207	4.0	0.0	76.1	23	.9

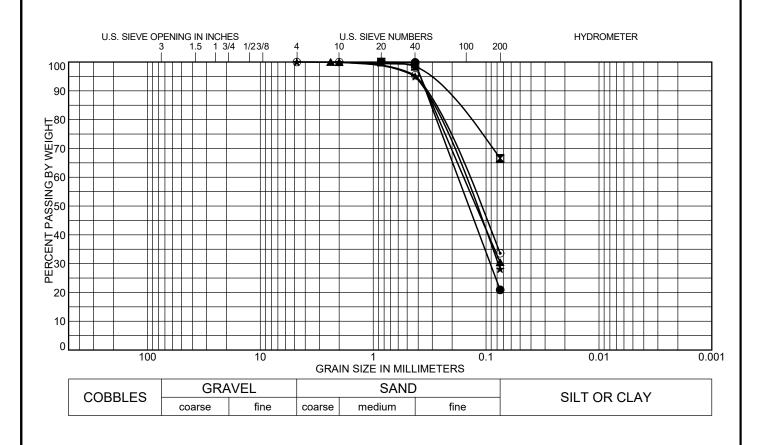
FIGURE No. 111

Test Boring Depth (ft)		Classification					LL	PL	PI		
•	Lot 212	9.0				NP	NP	NP			
	Lot 227	4.0		SA		27	19	8			
▲	Lot 233	9.0	SILTY SAND(SM)						NP	NP	
*	Lot 237	4.0				NP	NP	NP			
•	Lot 359	4.0			20	17	3				
٦	Гest Boring	Depth (ft)	%Gravel	%Sand	%Silt	%Clay					
•	Lot 212	9.0	0.0	79.1	20.9

rest boring	Depin (II)	%Graver	%Sand	700III	%Clay
•	Lot 212	9.0	0.0	79.1	20.9	
X	Lot 227	4.0	0.0	33.4	66	5.6
▲	Lot 233	9.0	0.0	69.5	30	.5
*	Lot 237	4.0	0.0	71.9	28	3.1
•	Lot 359	4.0	0.0	66.4	33	3.6

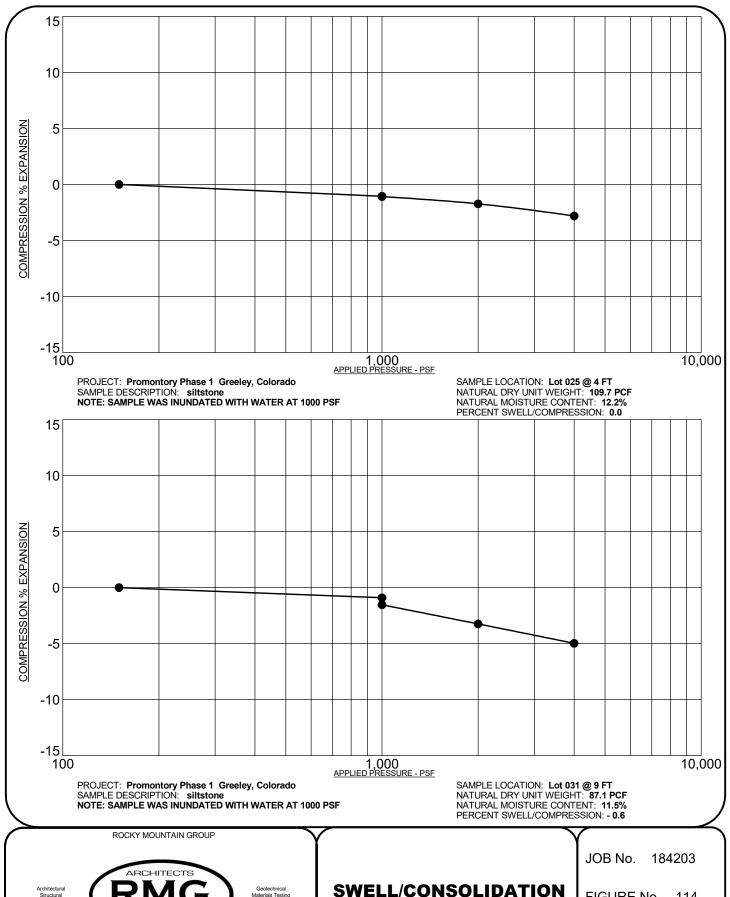
FIGURE No. 114

SWELL/CONSOLIDATION TEST RESULTS

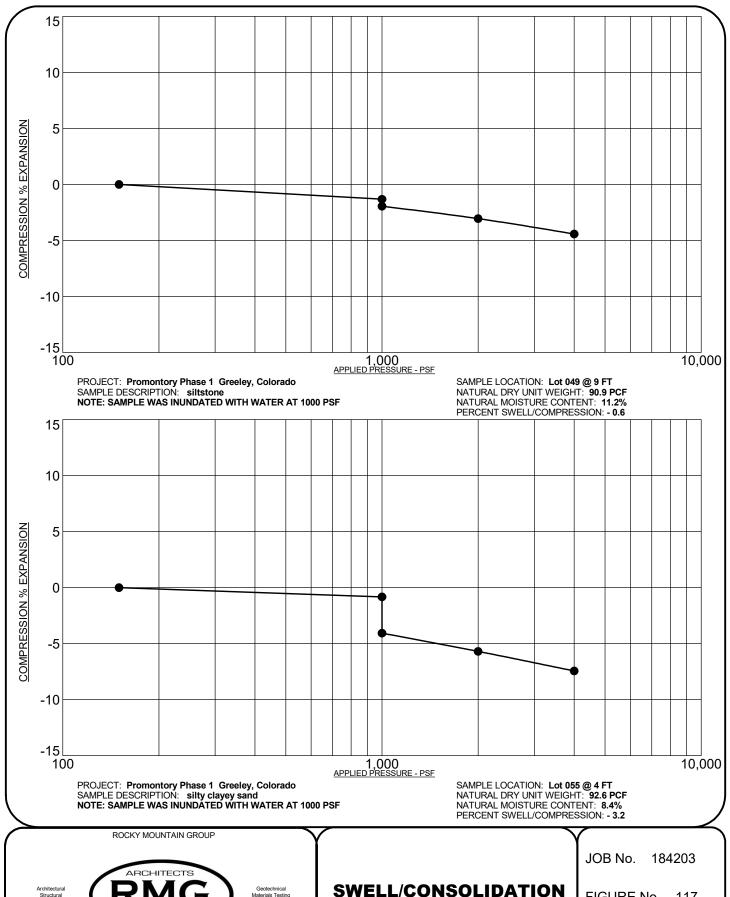
FIGURE No. 117

SWELL/CONSOLIDATION TEST RESULTS

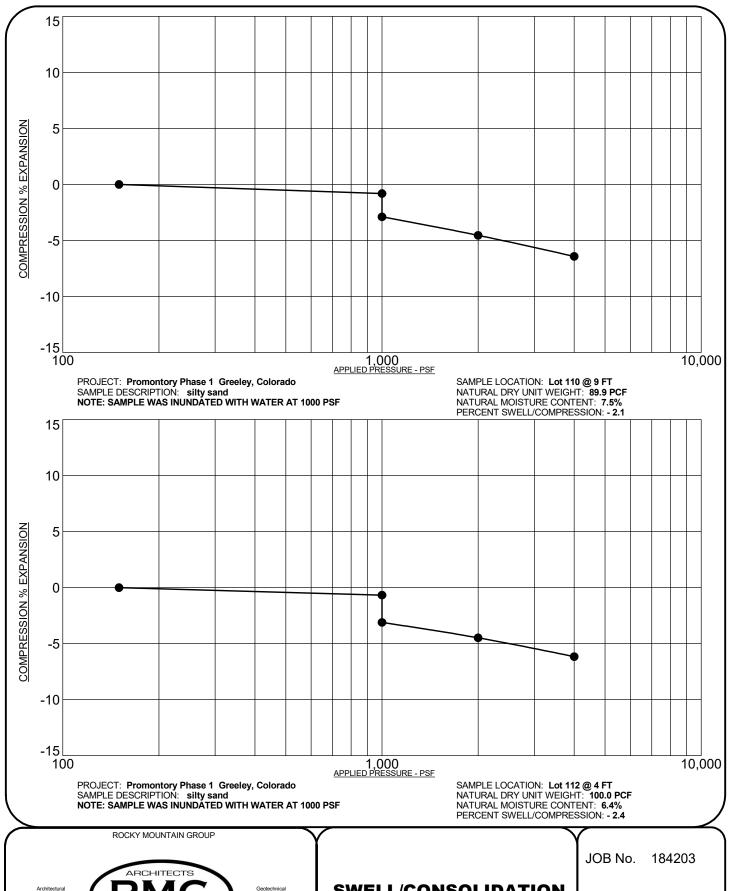
FIGURE No. 122

#### **TEST RESULTS**

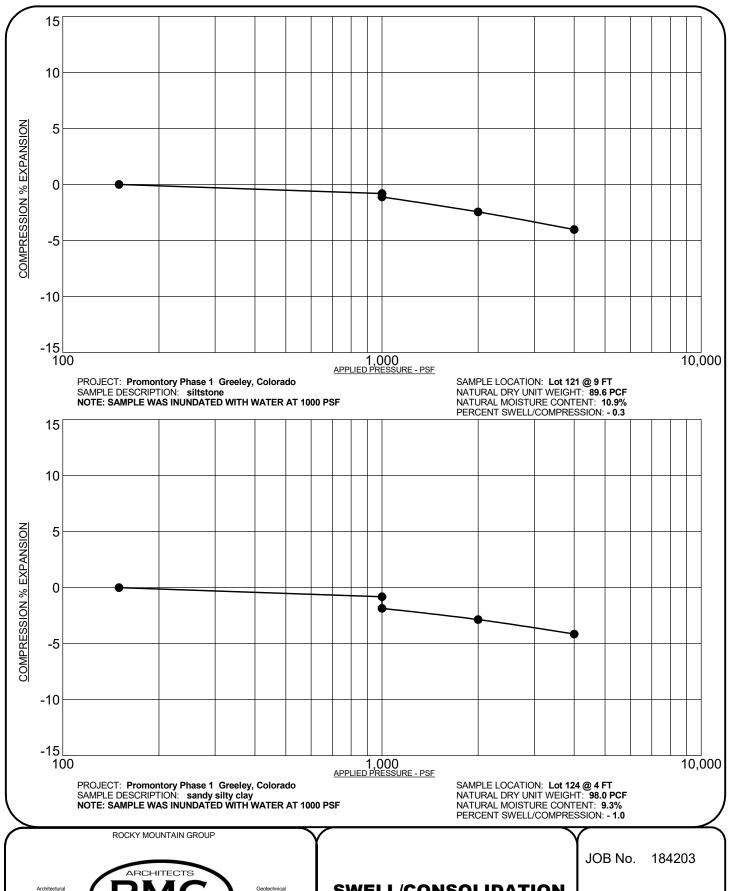
FIGURE No. 124

TEST RESULTS

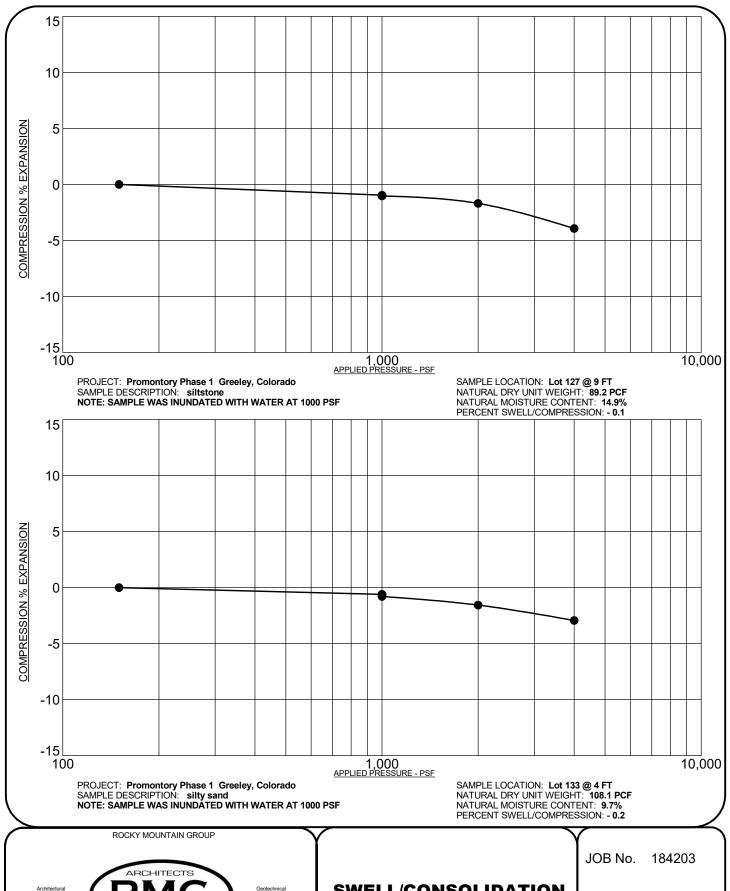
FIGURE No. 125

SWELL/CONSOLIDATION TEST RESULTS

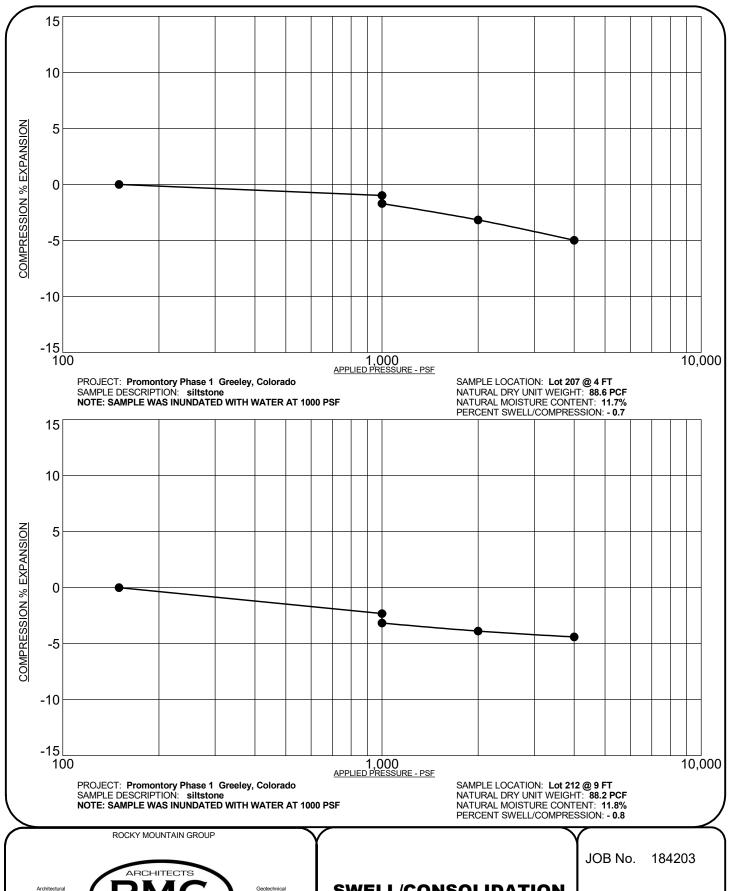
FIGURE No. 130

SWELL/CONSOLIDATION TEST RESULTS
