Home Report

49 Whitefauld Road
Dundee DD2 1RJ

Single Survey

Property Address	49 Whitefauld Road Dundee DD2 1RJ
Customer	Ian Cooper
Prepared by	Graham + Sibbald Property Consultants Limited
Date of Inspection	23/03/2026

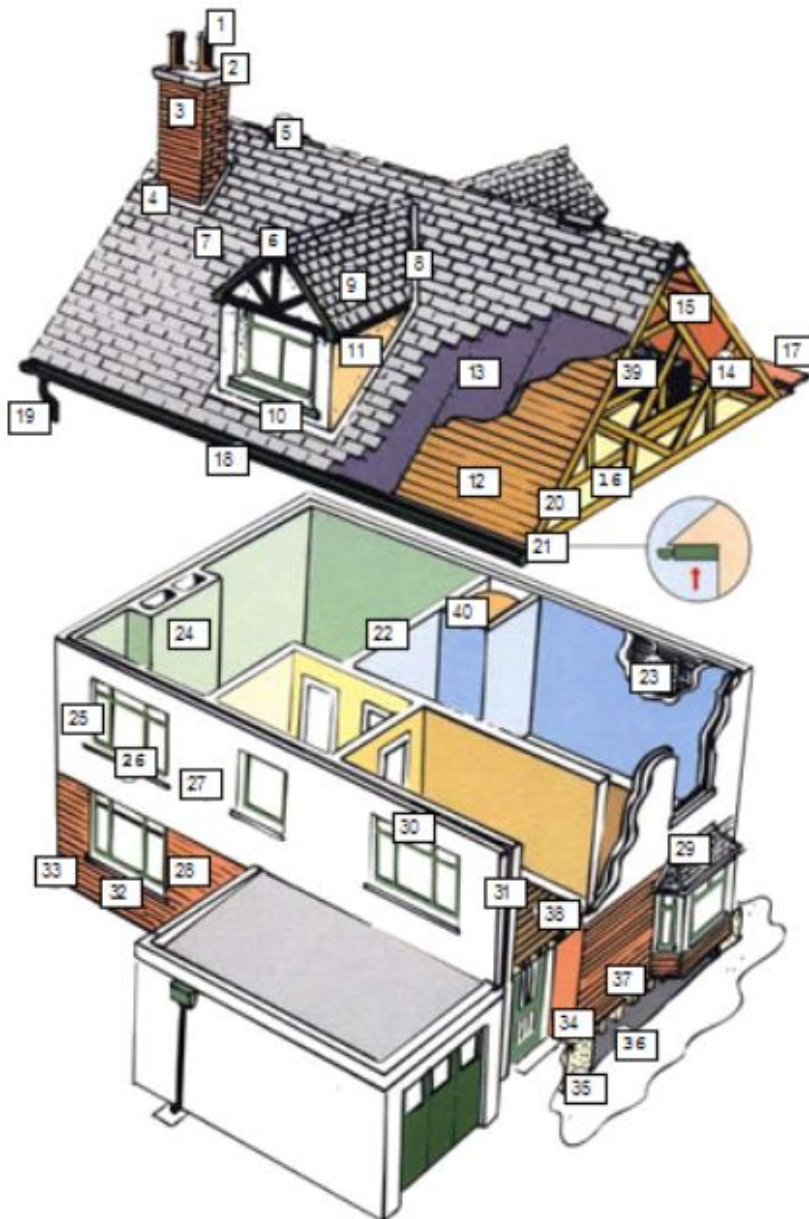
Sectional diagram showing elements of a typical house

1	Chimney pots
2	Coping stone
3	Chimney head
4	Flashing
5	Ridge ventilation
6	Ridge board
7	Slates / tiles
8	Valley guttering
9	Dormer projection
10	Dormer flashing
11	Dormer cheeks
12	Sarking
13	Roof felt
14	Trusses
15	Collar
16	Insulation
17	Parapet gutter
18	Eaves guttering
19	Rainwater downpipe
20	Verge boards / skewes
21	Soffit boards
22	Partition wall
23	Lath / plaster
24	Chimney breast
25	Window pointing
26	Window sills
27	Rendering
28	Brickwork / pointing
29	Bay window projection
30	Lintels
31	Cavity walls / wall ties
32	Subfloor ventilator
33	Damp proof course
34	Base course
35	Foundations
36	Solum
37	Floor joists
38	Floorboards
39	Water tank
40	Hot water tank

Reference may be made in this report to some or all of the above component parts of the property. This diagram may assist you in locating and understanding these items.

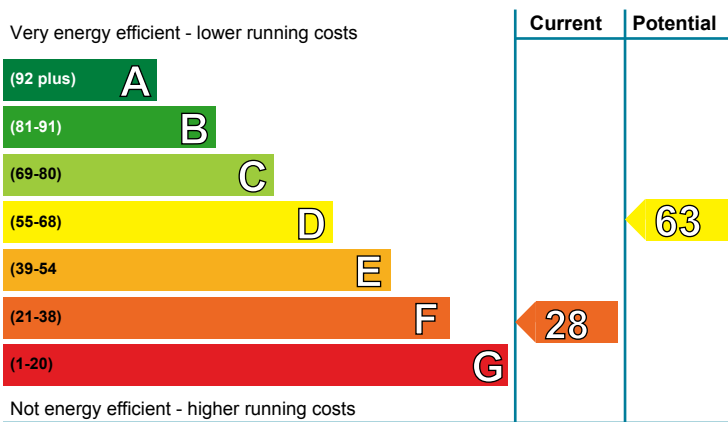
Energy Efficiency Rating

This graph shows the current efficiency of your home, taking into account both energy efficiency and fuel costs. The higher this rating, the lower your fuel bills are likely to be.

Your current rating is **band F (28)**. The average rating for EPCs in Scotland is **band D (61)**.

The potential rating shows the effect of undertaking all of the improvement measures listed within your recommendations report.
