RICS **HomeBuyer** Report...

1 The House
New Street Road
Anytown

02 February 2020

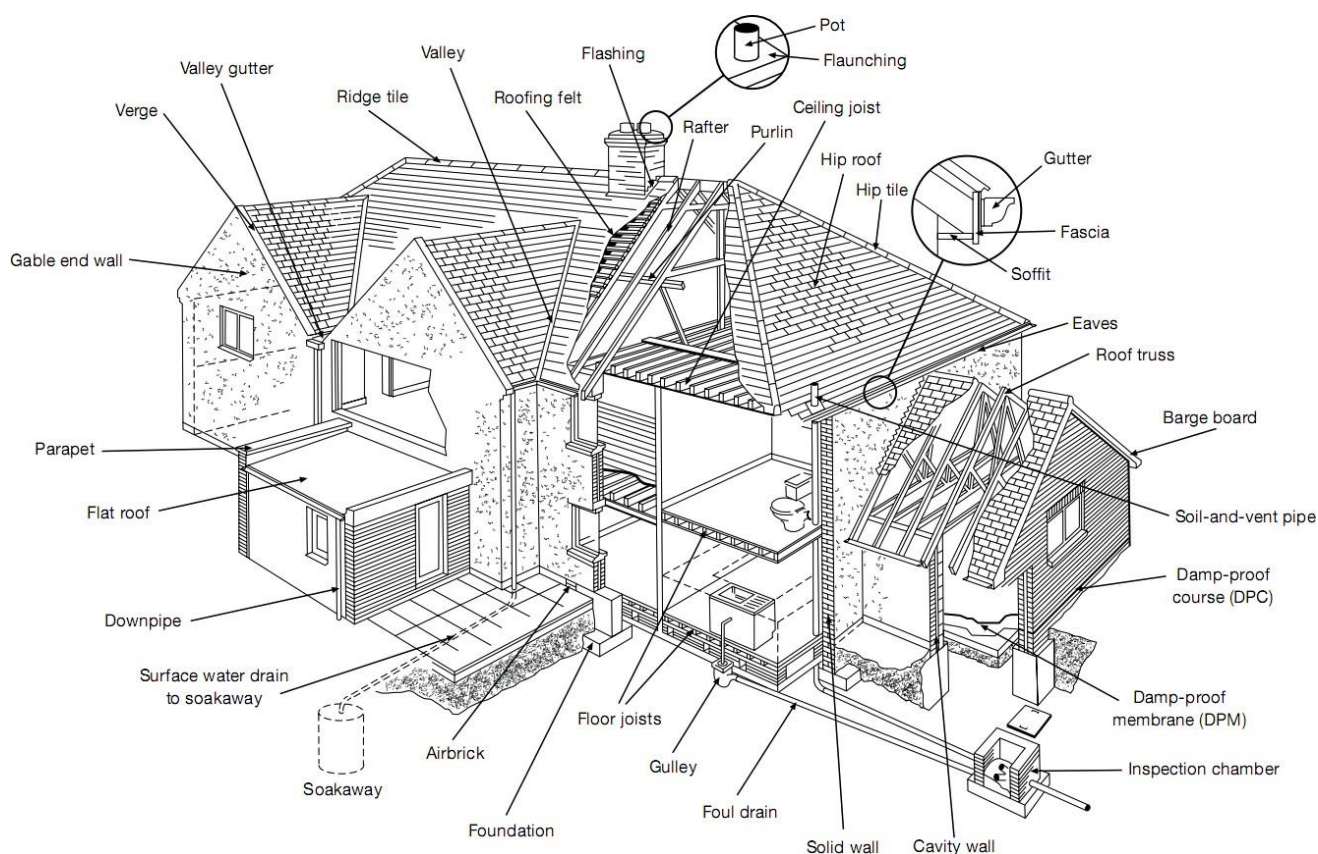
Typical house diagram

This diagram illustrates where you may find some of the building elements referred to in the report.
