Final Report

**Construction and Maintenance Assessment of Pervious Concrete Pavements**

Manoj Chopra  
Marty Wanielista  
Craig Ballock  
Josh Spence

January, 2007

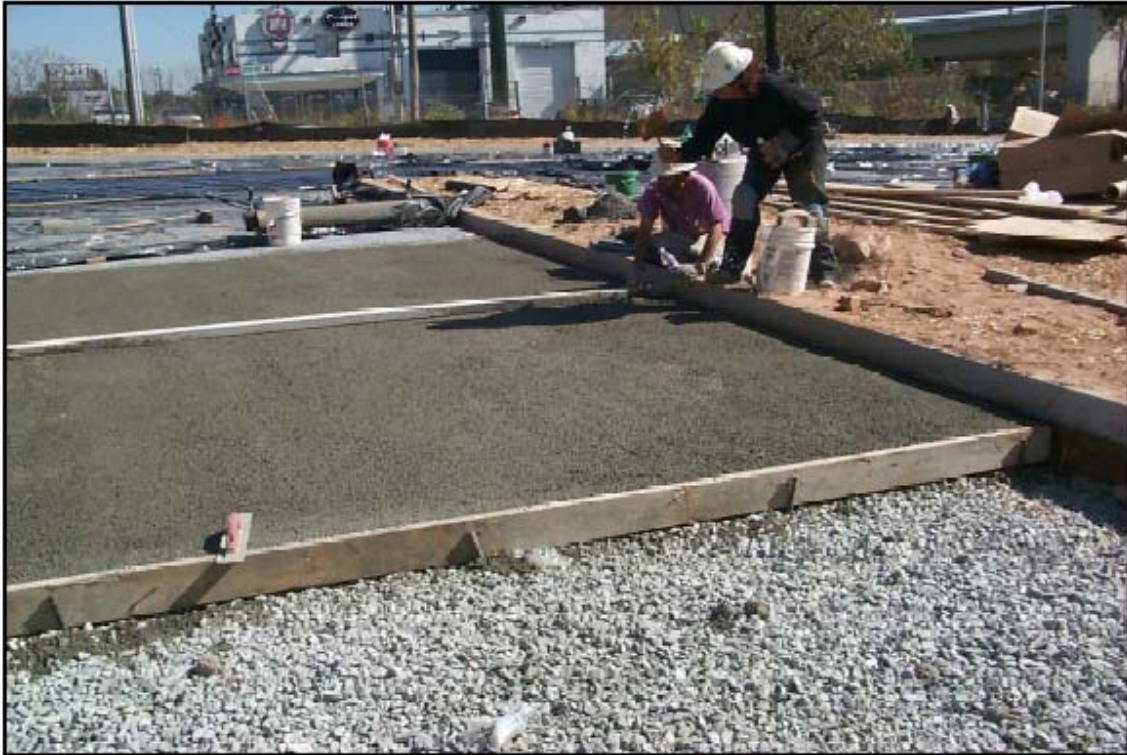
Porous concrete systems are typically used in low-traffic areas, such as, parking pads in parking lots, residential street parking lanes, recreational trails, golf cart and pedestrian paths and emergency vehicle and fire access lanes. Heavy vehicle traffic use must be limited to ensure raveling or structural failure does not occur in the porous pavement surface, which may fail under constant exposure to heavy vehicle traffic. The slopes of these installations should be flat or gentle to facilitate infiltration versus runoff and the EPA recommends a four-foot minimum clearance from the bottom of the system to the water table if infiltration is to be relied on to remove the stored water volume (EPA, 1999). Figure 2 shows a typical porous concrete installation.

Figure 2: Typical Porous Concrete Installation

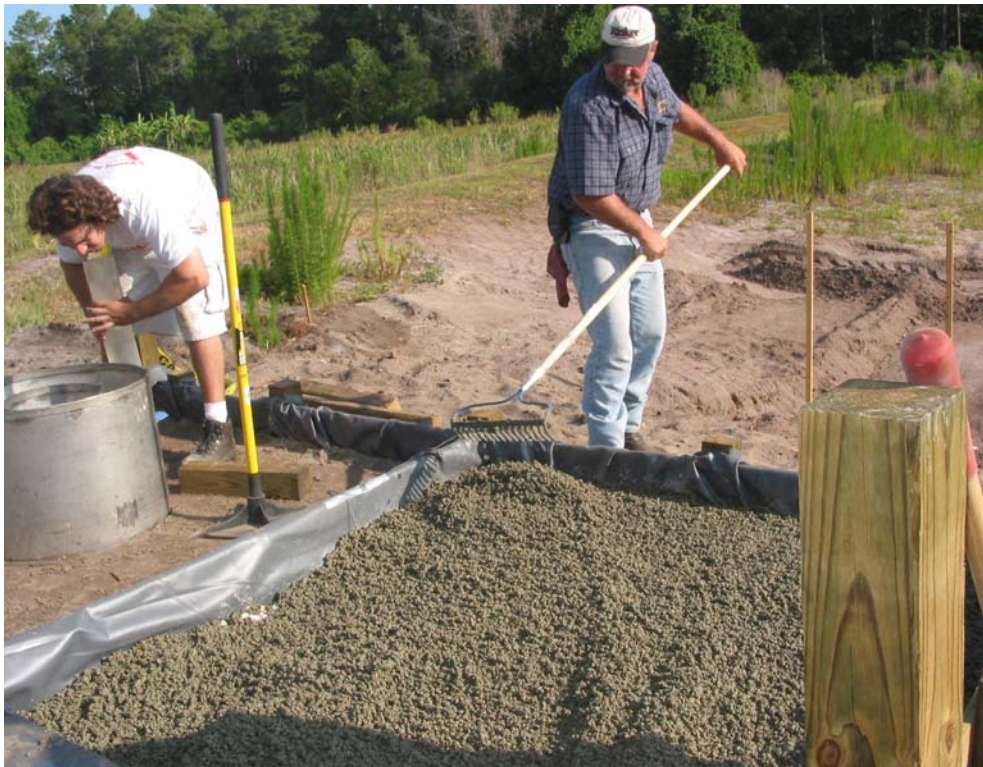
per hour as determined by application of a double-ring infiltrometers test (ASTM D 3385-94). One cell contains a five-inch deep reservoir of  $\frac{3}{8}$  to  $\frac{1}{2}$  inch coarse aggregate, and both cells have a five- inch thick pervious concrete slab. Depicted in Figure 3 is the installation of the pervious concrete in the test cells as well as a double-ring infiltrometer test being performed on the compacted subsoil.

Figure 3: Stormwater Academy Porous Concrete Test Cell Installation

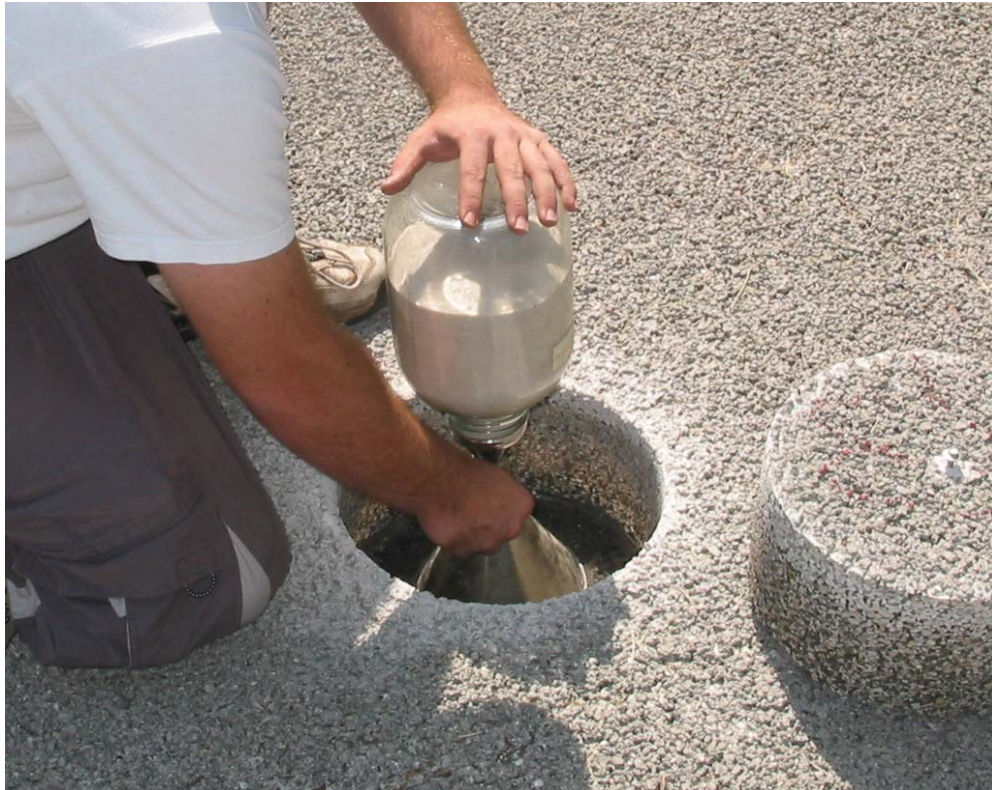
7. The field unit weight of the subsoil is then determined using the Sand Cone Method as outlined in ASTM D 1556 “Standard Test Method for Density and Unit Weight of Soil in Place by the Sand-Cone Method”. Figure 10 shows a sand cone test in progress.

Figure 10: Performing Sand Cone Test

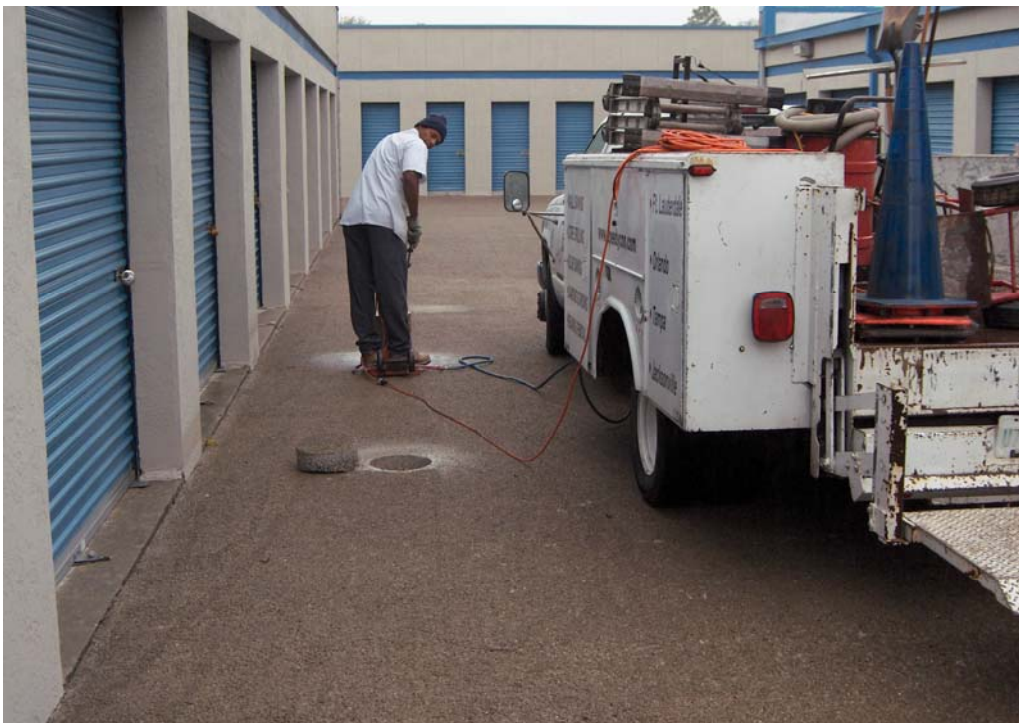
infiltration rates measured in the laboratory that ranged from a high of 627 to a low of 3 in/hr. Instances where the system infiltration rates are higher than the individual core infiltration rates measured in the lab is due to infiltration along the sidewall of the cores that occurred in the field but was restricted in the lab producing false high infiltration rates in the field. The cores performed in the area of cores 1, 2 and 3 exhibited higher infiltration rates than other areas. This result was anticipated as the pervious concrete surface in that area was after visual determination in better condition; this area is shown in Figure 16.

Figure 16: Sun Ray Store-Away Pervious Pavement at Core Locations 1, 2 & 3

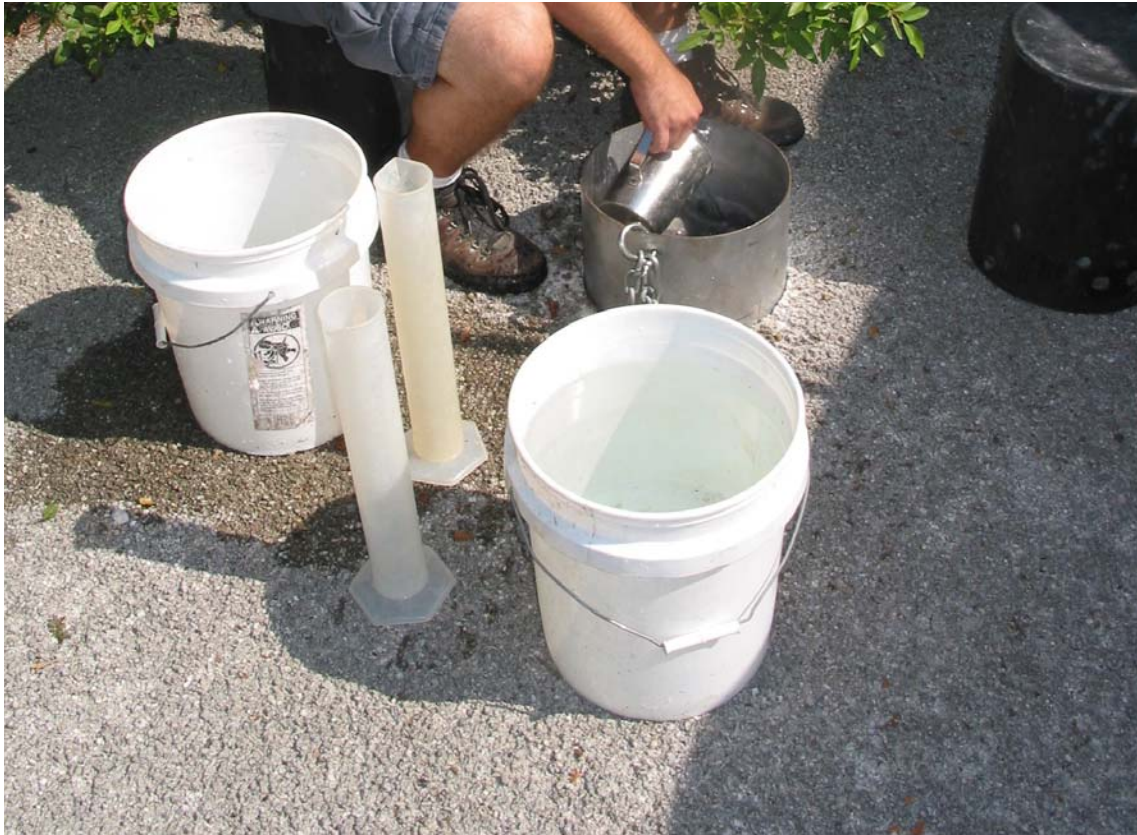
The subsoil characteristic to the pervious concrete parking lot at the Murphy Veterinarian Clinic exhibited infiltration rates typical of type A hydrologic soils. Infiltration rates of the subsoil ranged from 15.78 to 27.21 in/hr. in the field and 3.41 to 7.91 in/hr. in the laboratory permeability tests. The difference in infiltration rate is believed to be due to the higher level of compaction of the laboratory soil samples. Field system infiltration rates were not measured due to the lack of access to a power source at the field site, which limited the ability to grind the sides of the pervious concrete cores to allow the single-ring infiltrometer to fit around the core. Core infiltration rates exhibited infiltration rates measured in the laboratory that ranged from 2.3 to 24 in/hr. This result indicates that the pervious concrete surface is acting as the limiting factor at this pervious concrete installation. Figure 20 depicts a subsoil infiltration test being performed at the field site.

Figure 20: Murphy Veterinarian Clinic Core Test

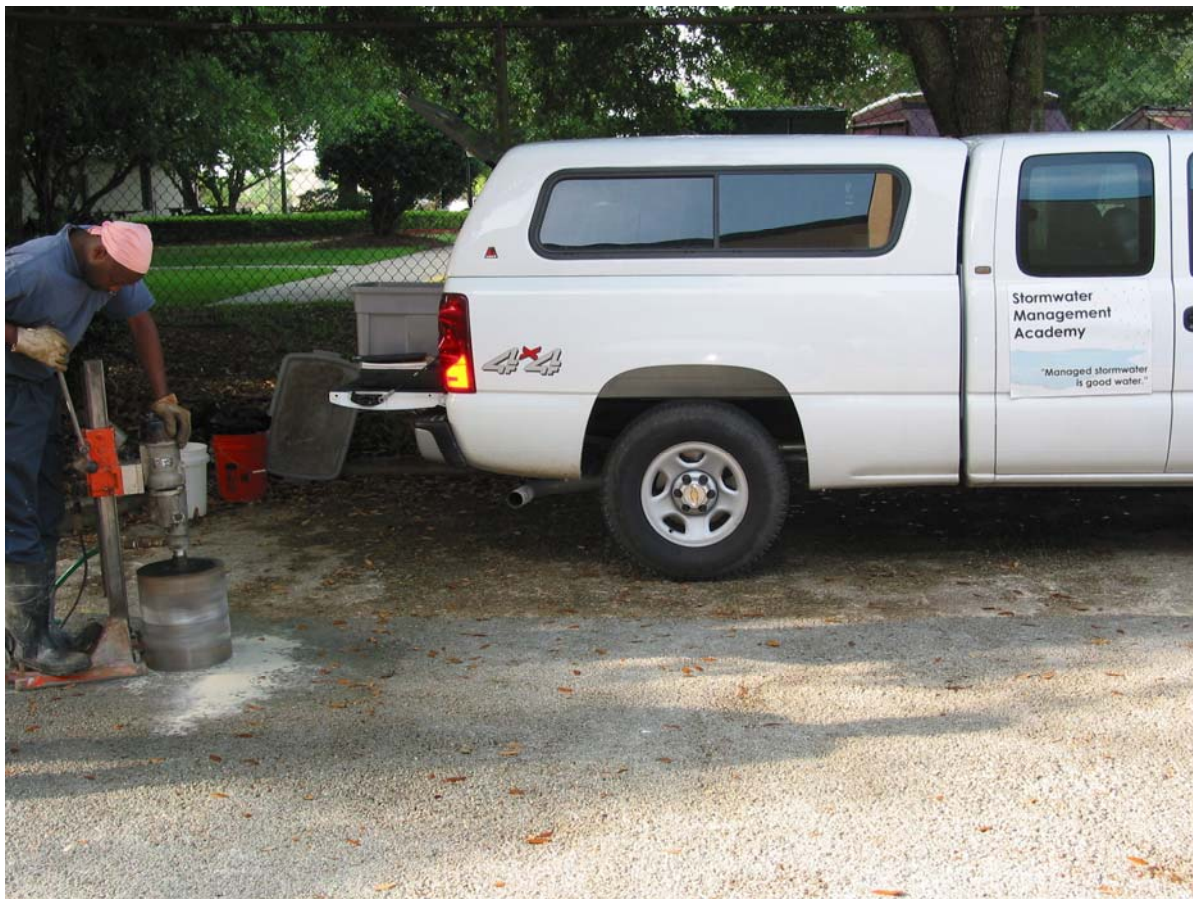
ranged from 0 to 5.2 in/hr. The cores performed in the area of cores 4, 5 and 6 exhibited higher infiltration rates than other areas. This result was anticipated as the condition of the pervious concrete surface in the other areas was compromised due to poor construction practices. Higher than typical unit weights are also indicative of poor construction practices. Low infiltration rates of the subsoil in the areas of Cores 4 through 6 was due to a layer of poorly draining, orange clay encountered directly beneath the pervious concrete. Figure 22 depicts the coring operation performed at this site.

Figure 22: FDEP Parking Lot Core Test

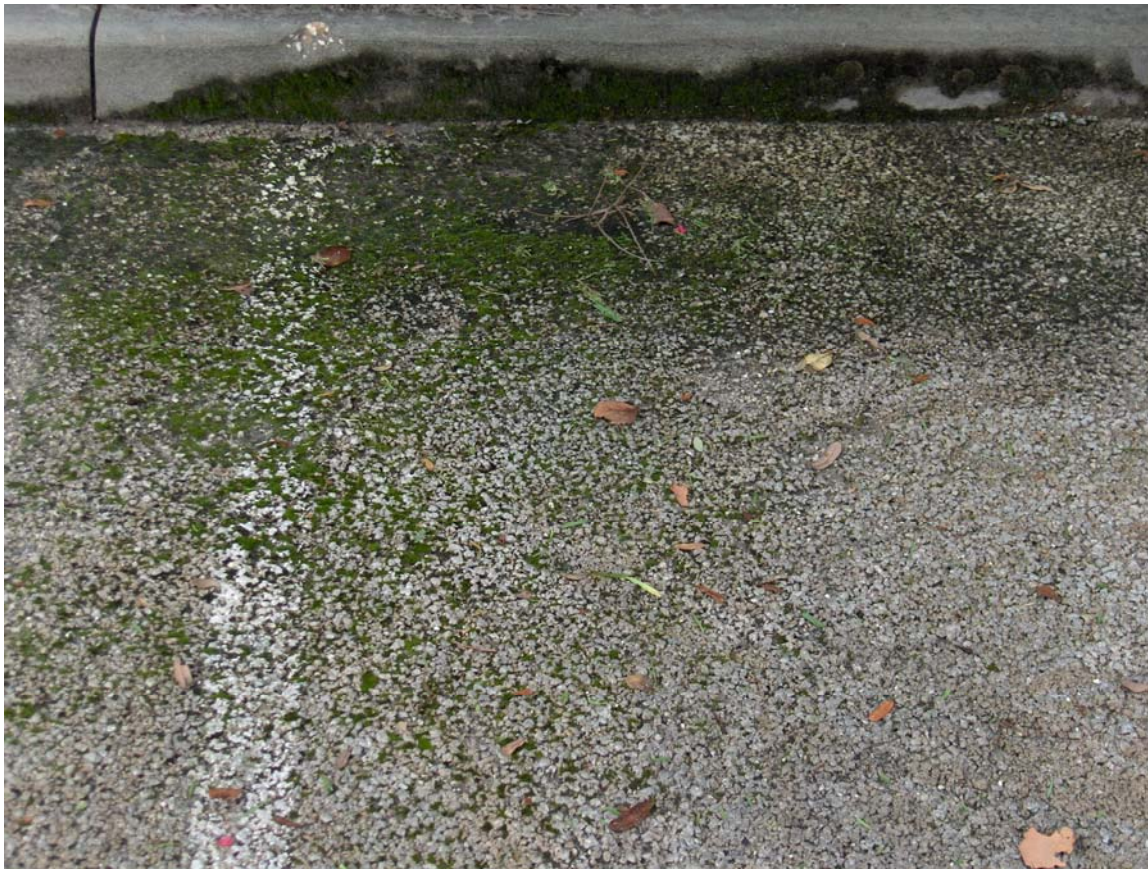
ranged from 8.54 to 9.07 in/hr. in the field and laboratory permeability tests confirmed these rates. Core infiltration rates measured in the laboratory ranged from 1.8 to 5.8 in/hr. Field system infiltration rates were not measured due to the lack of access to a power source on the site, which limited the ability to grind the sides of the pervious concrete cores to allow the single-ring infiltrometer to fit around the core. This result indicates that the pervious concrete surface is acting as the limiting factor at this pervious concrete installation. A photograph depicting the condition of the pervious concrete in this area is shown in Figure 24.

Figure 24: FCP&A Parking Lot

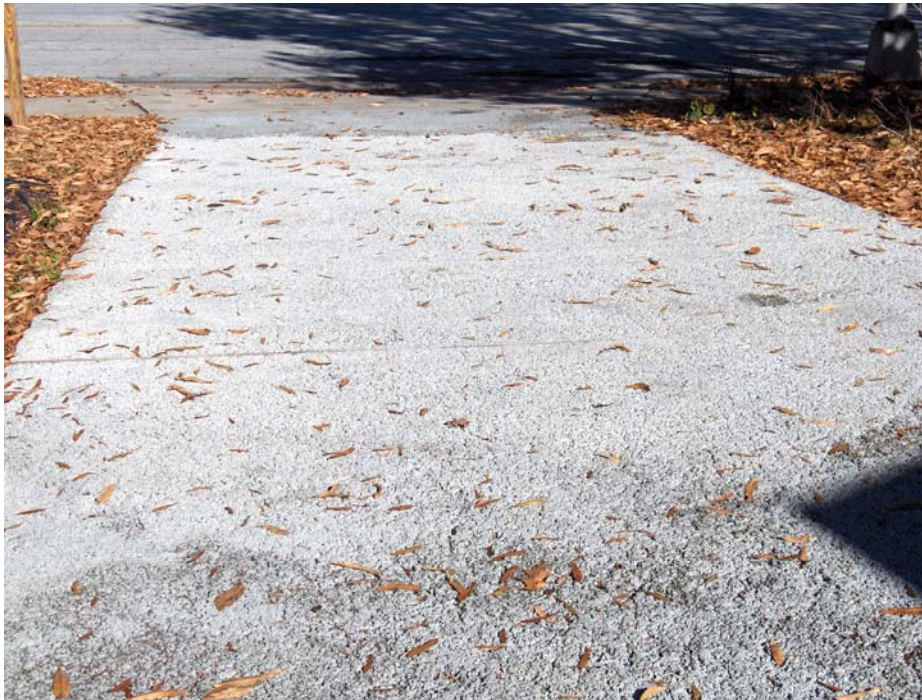
188 in/hr. This wide range of infiltration rates can be contributed to varying surficial pore sizes and unit weights in pervious concrete due to poor construction techniques. Field system infiltration rates were not measured due to the presence of a gravel reservoir, which the single-ring infiltrometer is unable to penetrate. These results indicate that the subsoil is acting as the limiting factor at this pervious concrete installation, however a gravel reservoir has added storage to the site to allow a longer recharge time. Laboratory tests indicate the gravel reservoir has a porosity of approximately 0.32 or a storage capacity of approximately 2 inches of water. Photographs depicting the condition of the pervious concrete in this area are shown in Figures 26, 27 and 28.

Figure 26: Southface Institute Parking Lot

Figure 27: Southface Institute Gravel Subbase

Figure 28: Southface Institute Parking Lot

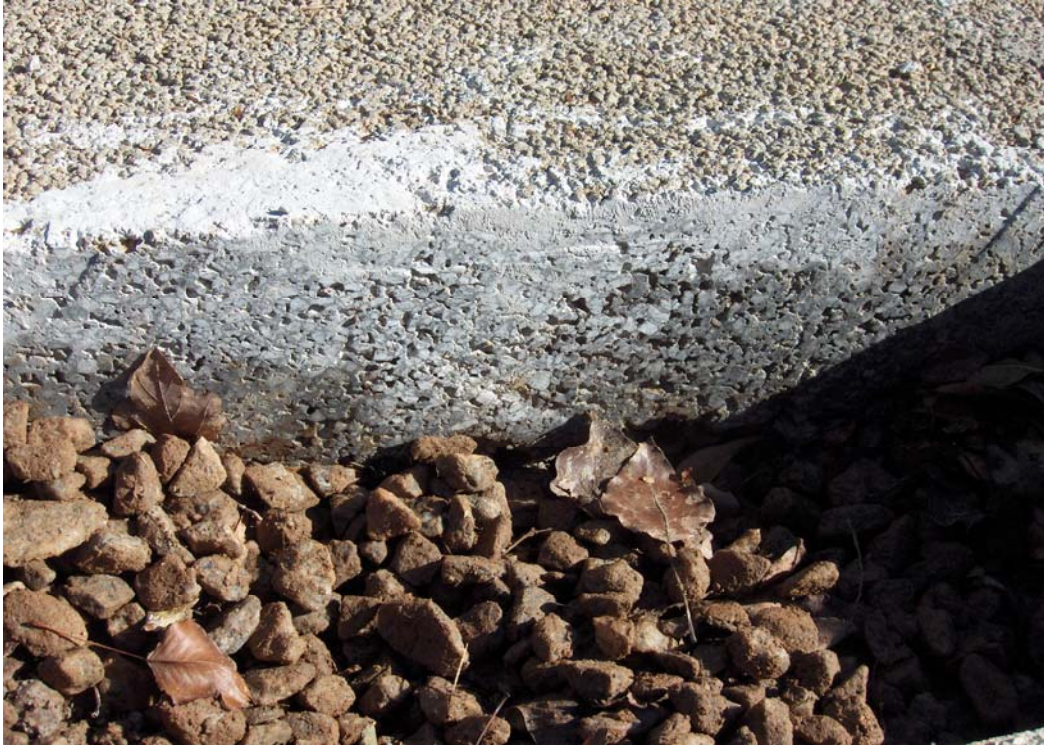
zero that was measured was due to a lack of voids present in the concrete due to poor construction techniques as verified by the comparatively high unit weight of the core. Field system infiltration rates were not measured due to the presence of a gravel reservoir, which the single-ring infiltrometer is unable to penetrate. These results indicate that the subsoil is acting as the limiting factor at this pervious concrete installation, however, a gravel reservoir has added storage to the site to allow a longer recharge time. Laboratory tests indicate the gravel reservoir has a porosity of approximately 0.32 or a storage capacity of approximately 2 inches of water. Photographs depicting the condition of the pervious concrete in this area are shown in Figures 30, 31 and 32.

Figure 30: Cleveland Park Parking Lot

Figure 31: Cleveland Park Parking Lot Pavement

Figure 32: Cleveland Park Parking Lot Reservoir

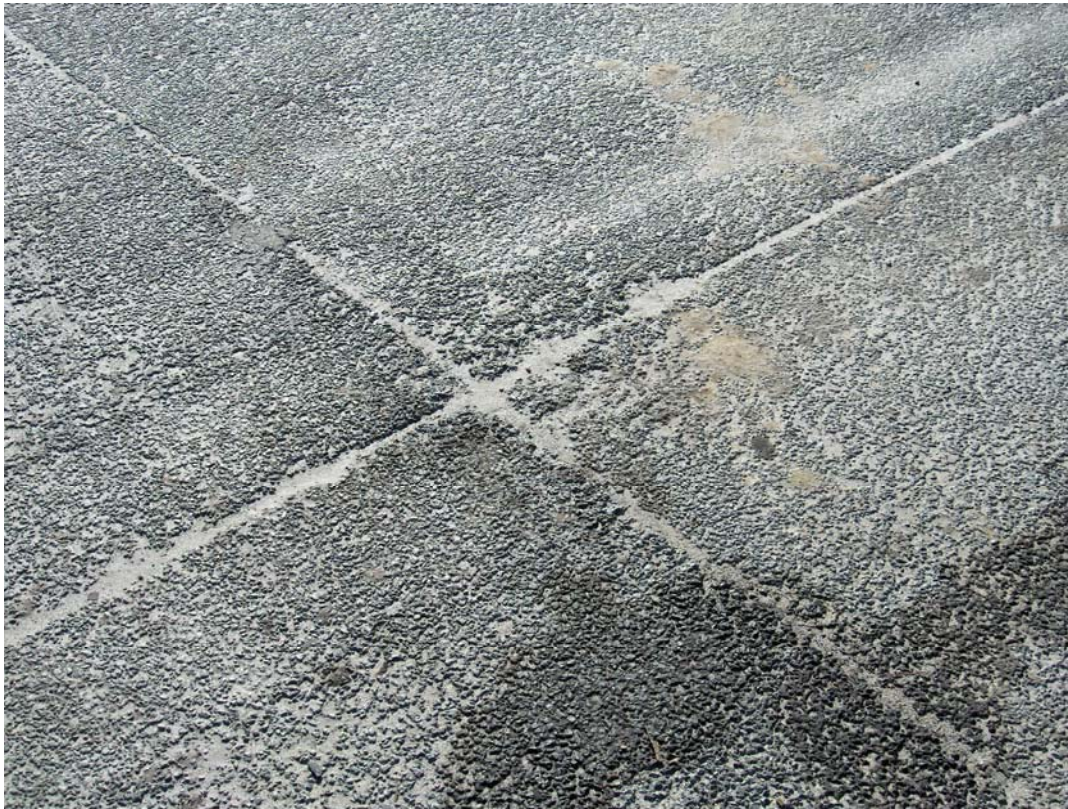
be attributed to varying surficial pore sizes in the pervious concrete due to poor construction techniques. Field system infiltration rates were not measured due to the presence of a gravel reservoir, which the single-ring infiltrometer is unable to penetrate. These results indicate that the subsoil is acting as the limiting factor at this pervious concrete installation, however, a gravel reservoir has added storage to the site to allow a longer recharge time. Laboratory tests indicate the gravel reservoir has a porosity of approximately 0.32 or a storage capacity of approximately 2 inches of water. Photographs depicting the condition of the pervious concrete in this area are shown in Figures 34, 35 and 36.

Figure 34: Effingham County Landfill

Figure 35: Effingham County Landfill Pervious Pavement

Figure 36: Effingham County Landfill Reservoir
