St. Davids-Queenston United Church
St. Davids, Ontario

Green Audit Report

Written By – David Patterson
Reviewed By – Stephen Collette BBEC, LEED AP, BSSO
Audit Date – May 18, 2012
Report Date – May 24, 2012

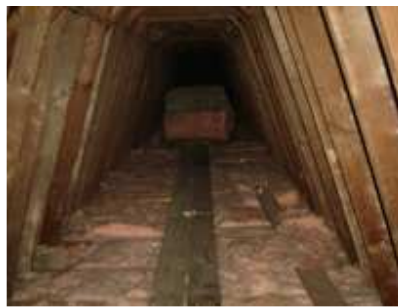
Insulation throughout the building is minimal. With the exception of the Sanctuary attic, which has 4-8 inches (R-12.5 to R-25) of fiberglass batts, we expect that there is little to no insulation throughout the rest of the space. In the long term, look at solutions for adding insulation to the walls throughout, and consider bumping up the level of insulation in the Sanctuary to achieve a minimum of R-30 – 40. This is by no means a small job and may not be achieved without major structural changes. It is recommended that each area be looked at and tackled as a part of planned upgrades or renovations. It is important to consult an architect prior to making any major structural changes who will be able determine the best way to add insulation to each space and to create an overall plan for the building.

- Considering adding insulation to the Sanctuary to achieve R-values into the 30's or 40's.
- When major interior renovations are undertaken, look at options to add insulation to the walls throughout the building.

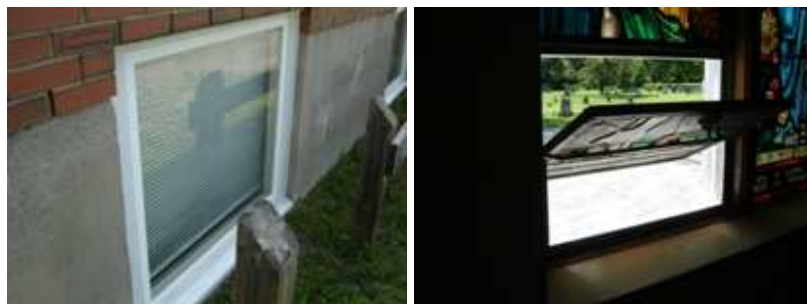
All windows in the Sanctuary are original to the building while the vast majority of the remaining windows have already been replaced or will be replaced in the near future with double paned models. Proceed with the planned replacement of these windows and add weather-stripping and continue to use storms on the exterior of the Sanctuary windows.

- Continue with the plan of replacing the remaining older model windows.
- Check weather-stripping every year and replace it as needed. After replacing the weather-stripping, check the door seal again. If the door still does not seal tightly to all sides of the jamb you either installed the weather-stripping badly or the door is bent and in need of replacement.

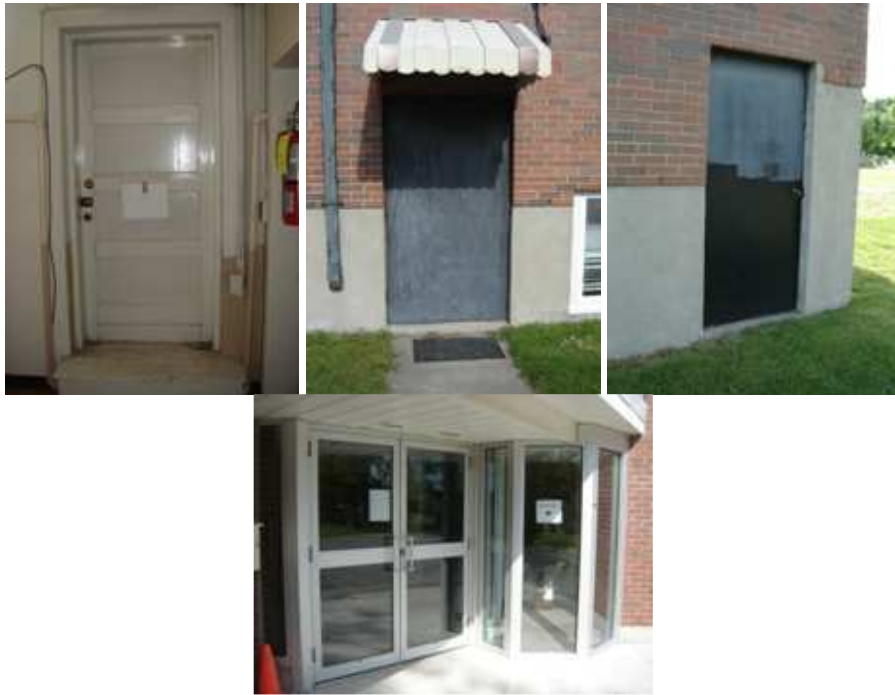
None of the exterior doors are recent models with the exception of the glass vestibule entrance which was completely redone in 1994. All remaining doors appear to be original to the building and should be repaired and/or replaced in the short term as air leakage around the edges and through the doors themselves were noted to be a major issue. New glass-less doors can come with insulation and can have R-values of up to 15, whereas older model doors will have R-values

less than 5. In the long term, consider replacing all exterior doors however weather stripping should be added or replaced on all of them in the short term.

- Check all windows and doors to ensure they close properly. Fix those that do not. In the short term, replace weather stripping around all exterior doors.

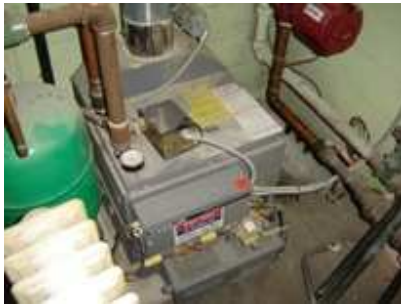
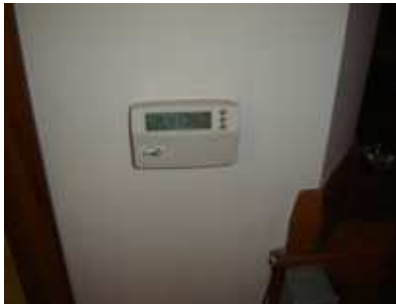
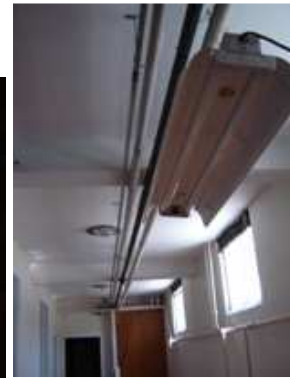
Heating of the Church is performed by a combination of electric baseboards and forced air entrance way heaters, a natural gas hot water boiler and a natural gas forced air system. Finally, a large gas radiant ceiling unit is occasionally used in the CE hall. The electric baseboards are responsible for heating the washrooms and Narthex while the boiler heats the Sanctuary and basement. The forced air system and radiant gas system heat the CE hall.

The boiler was approx. 10 years old and its estimated efficiency is in the low 80's. It was controlled by a single programmable thermostat located in the Sanctuary and heats the Sanctuary and basement below it. The single thermostat poses a problem for the Church because the basement tends to be a few degrees colder than the Sanctuary as a result of the location of the thermostat and thus the basement can be extremely uncomfortable during the winter. It is recommended to discuss with your contractor whether or not a second heating zone can be created to resolve this issue. Finally, most of the hot water pipes running through the basement were not wrapped in pipe insulation. It is recommended to wrap all pipes so that the heat being delivered gets to its intended destination.

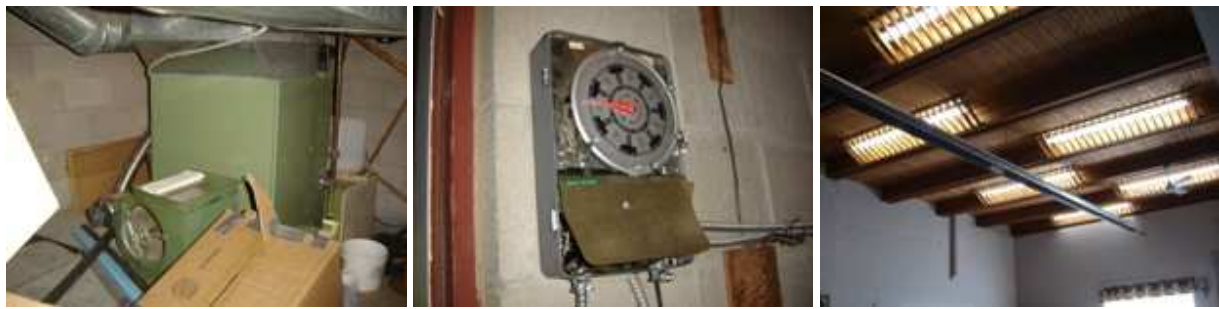
The forced air furnace in the CE hall is original to the addition (1964) and most likely very inefficient. Replacing this furnace as planned with a high efficiency furnace should save a huge amount of natural gas. This furnace is controlled by a dial type programmable thermostat. It has been set so that if it is ever turned up, it will automatically return to a pre-programmed set-back temperature and this feature appears to work well for the Church. As a result of the new furnace it is expected that the radiant heater will not be required, although it will not be removed. To this end, it may be beneficial to install a lock-box over the thermostat that controls the radiant heater to prevent users from turning it on.

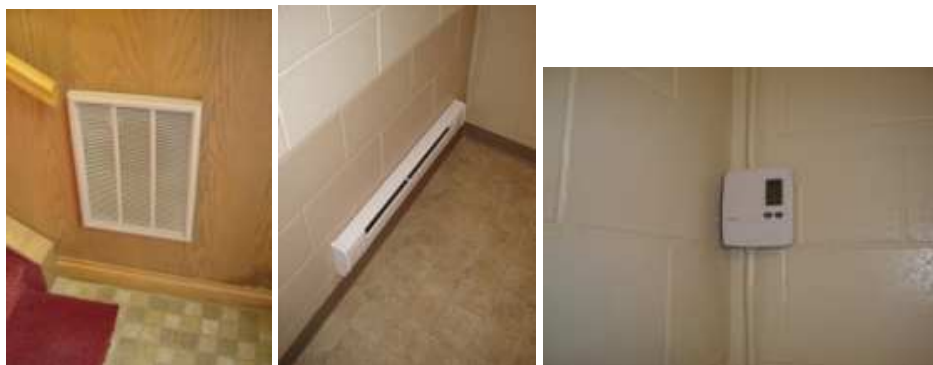
Finally, the washrooms and entry ways are heated by electric baseboards and entry way inserts. The inserts are controlled manually and used sparingly while the baseboards are controlled with a programmable thermostat.

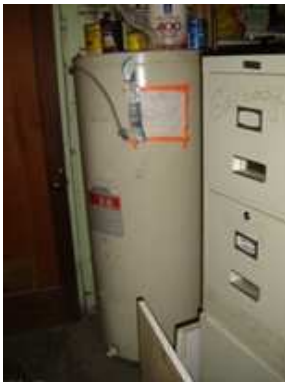
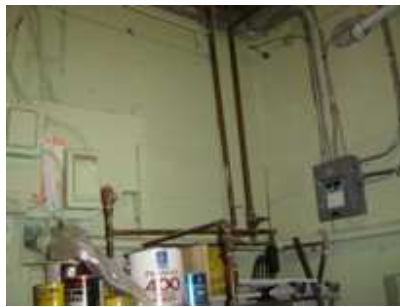
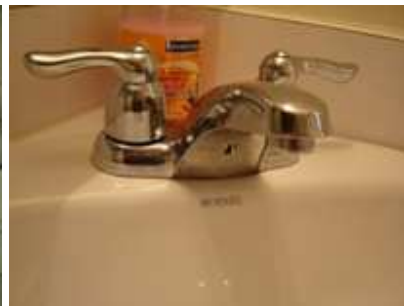
There was one large conventional electric hot water tank noted on the day of the audit. The tank services the whole church including the kitchen and washrooms. None of the visible pipes were wrapped in insulation and it is recommended that all accessible hot and cold water pipes are wrapped with pipe insulation throughout the building. All faucets had aerators of 1.5 GPM. Ultra low flow aerators are available in the range of 0.5-1.0 GPM and could help cut hot water usage even further.

The Church mentioned that they will be replacing their current electric hot water tank with a NG tank. An on demand hot water heater was considered however the contractor mentioned a potential issue with water quality as a result of minimal usage. It may be worth it to reconsider the on demand water heater as the pay off is quicker the less hot water is used. Because the Church gets such minimal use during the week this type of heater may suit them perfectly. We have not heard of water quality issues from on demand systems but a little bit of further research into this may be warranted.

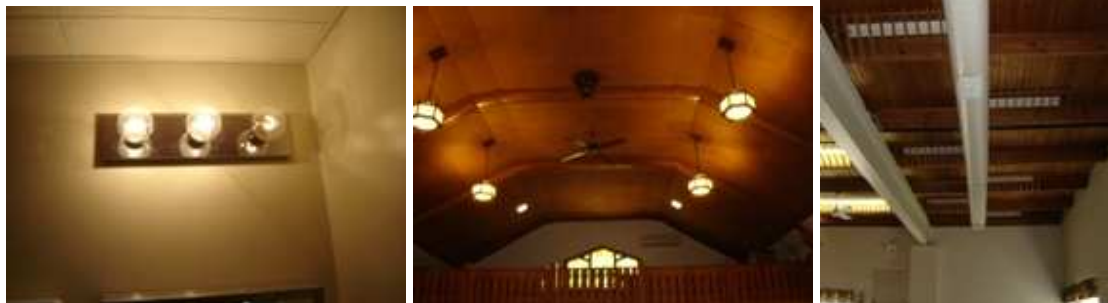
In the interior of the building, a mix of T8 and T12 fluorescent tubes, incandescent bulbs and halogen spot lights perform the lighting. The Church has already replaced a large portion of their lighting through the SaveOnEnergy program a few years ago and are about to retrofit the remainder of their lights, through the same program. Proceed as planned with the following recommendations.

1. Replace all remaining fluorescent T12 tubes with T8's.
2. Consider replacing the halogen pot lights in the vestibule with LED's.
3. Replace the incandescent bulbs in areas such as the washrooms with compact fluorescent lights.

- Replace all remaining fluorescent T12 tubes with T8's.
- Consider replacing the halogen spotlights in the vestibule with LED's.
- Replace incandescent bulbs in areas such as utility rooms, storage rooms, and boiler rooms with compact fluorescent lights.

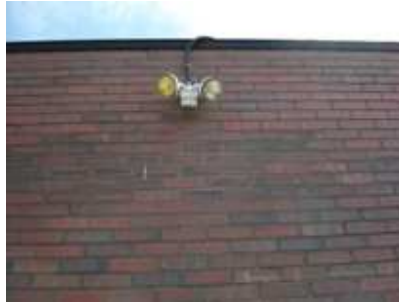
After replacing lighting, the next step will be to manage lighting usage in both the interior and exterior to ensure that lights are not left on unnecessarily. To this end, motion sensors can be installed in the washrooms and hallways. In areas that do not have motion sensors, signs can also be posted under light switches advising people to turn off the lights when they leave a space. Also, ensure that lights sensors or timers are installed on all exterior lights and that if light or motion sensors are installed, that they function properly.

Recommendations:

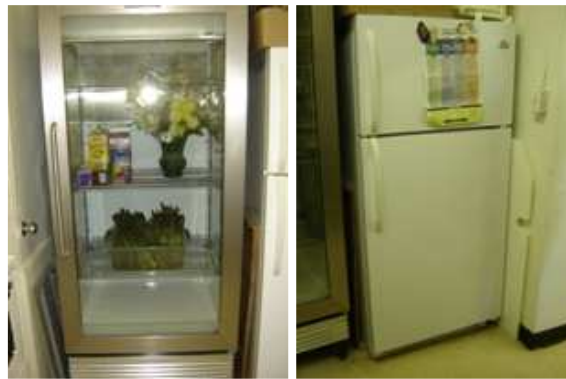
There are 2 refrigerators and a small chest freezer in use at the Church and all are relatively new. Typically, older refrigerators and freezers from the 1970's through the 90's can consume anywhere from 1000 to 2000 kWh per year while newer energy star models can consume as little as 350 kWh per year. It was discussed that the new, glass door refrigerator was purchased for use once a year. As the contents of both refrigerators could have fit in one of the units, the Church might consider turning one off when both are not required.

The fan for the forced air furnace was extremely old and when the Church replaces this furnace they should realize savings with the new fan in the high efficiency unit.

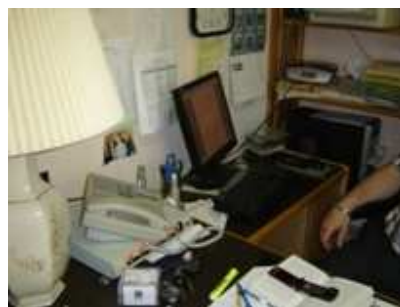
Desktop computers, printers, a photocopier and communication equipment were noted in the office area. It is recommended to set this computer up so that it goes into sleep mode after 15 minutes or so. Also, consider putting all electrical office equipment on easily accessible power bars. Many electronics continue to use electricity when they are plugged in, even when they are not in use or appear to be off. These are called 'Phantom loads'. Power bars with timers are also available.

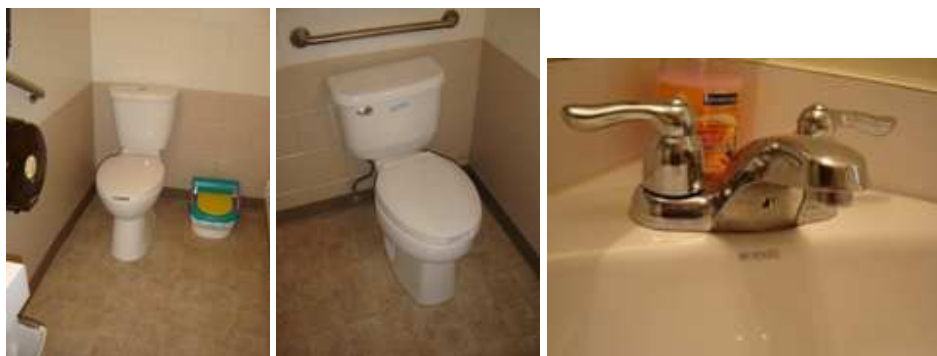
There are only two toilets in the building. Both toilets have been upgraded with one being a 6 litre low flush model while the other is a dual flush model, which was excellent to see. Furthermore, all faucets had aerators of 1.5 gallons per minute (GPM). In most buildings, 2.2 GPM is the norm so this was also great to see. Even lower flow aerators are available in the range of 0.5 – 1.0 GPM and the Church could investigate if lower flow aerators are feasible.

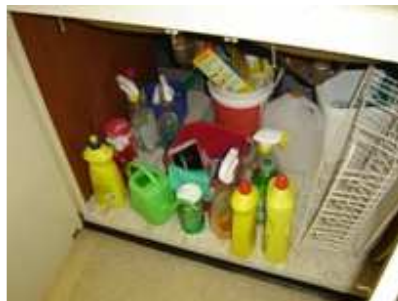
Chemical based cleaning products will kill the natural and required biological elements within a healthy wastewater system. The use of toxic cleaners is unnecessary and should be avoided.

Recommendations:

- The use of chemical cleaning products should be replaced with more natural based cleaners.

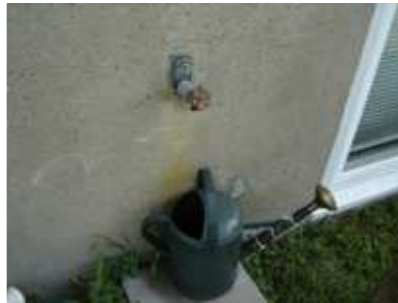
One dripping faucet was noted on the exterior of building. Running toilets and dripping faucets can add up to hundreds of litres of water wasted if left unchecked. Regular inspection of all plumbing lines should be carried out so as to ensure leaks are not occurring and this faucet should be repaired.

- Repair the dripping exterior faucet.
- Monthly inspections, or even more frequently, is a good idea to protect the building from water damage, and to catch and rectify leaks, so as to reduce the water consumption in the building from unnecessary issues. Having an inspection sheet identifying all areas to be inspected allows anyone within the congregation to carry out the inspection and reduces the responsibility from a few to many.

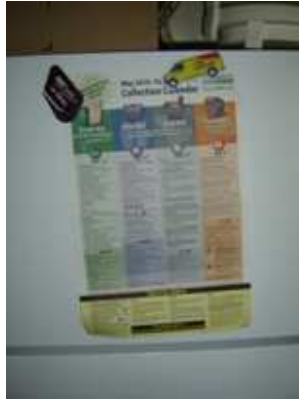
Recycling blue bins were not noted in many locations throughout the Church. The kitchen did have blue bins however there were no blue bins noted in any other locations. It is recommended that blue bins be put in all locations with the possibility of waste.

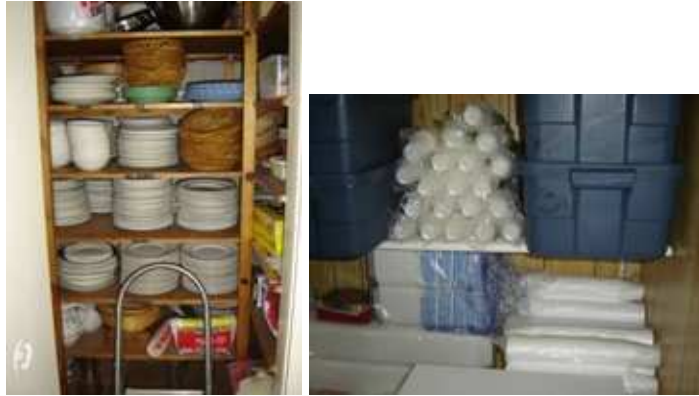
Disposable dishes and cutlery were not noted to be used excessively by the Church however we did note a large amount of Styrofoam product in the storage room off of the parlour. If disposable dishware must be used, a company called “Green Shift” offers biodegradable, disposable products and is a viable alternative to Styrofoam products.

Recommendations:

- Discontinue the use of single use dishware.
- Contact “Green Shift” for more information on biodegradable disposable products.

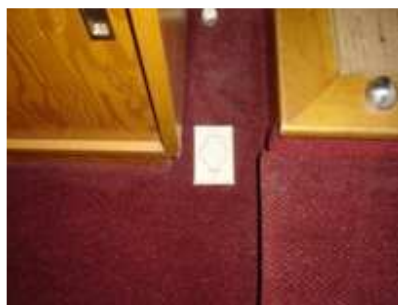
We normally recommend vacuuming with HEPA filter vacuums, however the only thing better than a HEPA filter vacuum, is a central vacuum system, which ensures that even the tiniest dust particles are captured and not spewed out of the vacuum exhaust in the interior of the building. A central vacuum system had been installed in Church.

Recommendations:

- Ensure that all vacuuming is carried out with the central vacuum system.

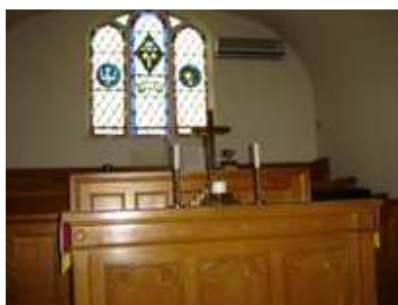
Candles were not noted to be a significant part of the Church's day to day operations however it is expected that a few are used on most Sunday's and on special occasions.

Recommendations:

- If and when candles are used, it is recommended to switch to more environmentally friendlier beeswax, palm oil or soy candles that are available in health food stores and co-ops. By removing the toxic candles and replacing them with earth friendly candles, it is a clear and

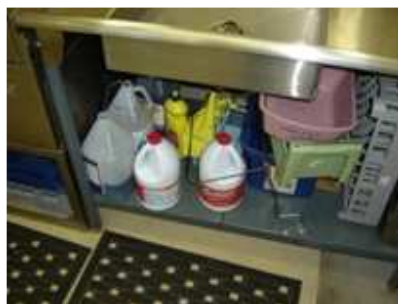
Chemical based cleaners were noted to be used throughout the building.

Recommendations:

- It is recommended that chemical based cleaning products be switched out for more natural based cleaning products. The chemical cleaners should be collected and taken to hazardous waste.
- If chemical based cleaners must be used, ensure that they are stored in a safe location away from the kitchen and air handler rooms.

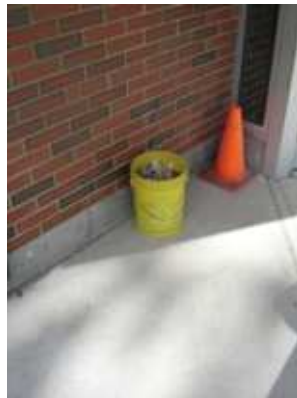
There is no smoking inside the Church, but it is expected that it is acceptable to smoke on the property.

Recommendations:

- It is recommended that the Church consider that there be no smoking on the property as a way of showing their concern for the congregation's health and well being, both those of the smokers, and those of the non smokers. It may be an opportunity as a community to help those who smoke to quit, and to ask them to consider not smoking in the clothes worn to the Church, so as to not impact other community member's health.

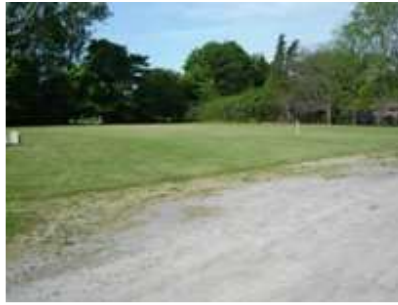
The Church property is primarily grass and gravel parking. It is not known whether or not pesticides or herbicides are in use but if so, it is recommended to discontinue their use.

Recommendations:

- If used, discontinue the use of pesticides and herbicides.

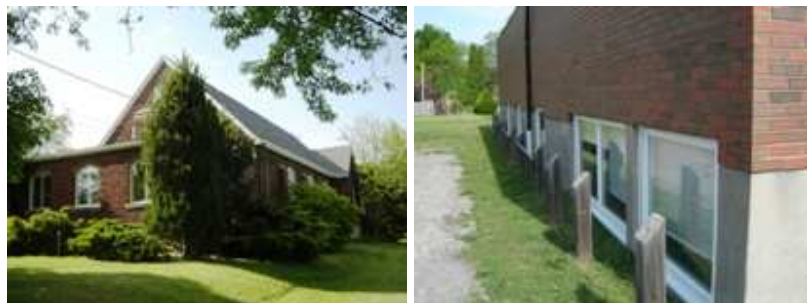
Grading is the slope of the land around the building so that the water will want to run away from the foundation and not towards it. This is called a positive slope or grade. A negative slope or grade is where the water runs towards the building. This can add undo hydrostatic pressure to the foundation walls with the excessive water and will lead to the ultimate failure of the wall system and allow water to enter the building walls. Grading does not have to be dramatic, but it must have a positive slope away from the building on all sides. In general, the grading of the land around the Church is flat to positive and could be improved in some areas.

- Understanding how water moves around the building is important to reduce the damage done by rainwater, and to utilize this free resource for other non explored uses such as watering the grounds.
- Rain barrels or large rain cisterns can be installed to capture rain for interior and exterior uses.

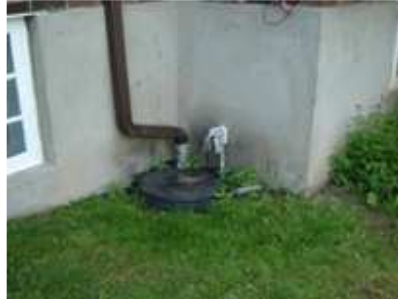
It is also important that rain water from the roof of the building be directed to as far away from the foundation as possible. Downspouts should extend a minimum of four feet away from the building.

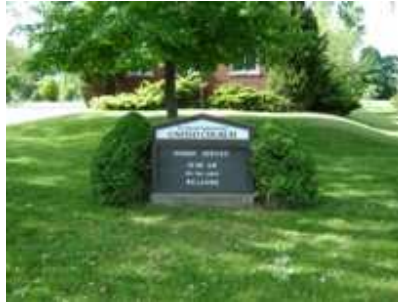
The Church has a fair amount of green space surrounding the building however much of it may be earmarked as cemetery space. There is room for a community garden and the Church should consider investigating the feasibility of one.

Recommendations:

- Investigate the possibility of a community garden. Many local environmental organizations may be able to assist in getting one off the ground.

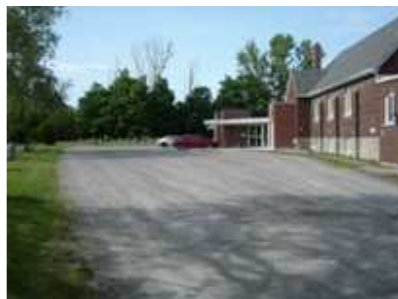
The Church has a large gravel parking lot, which they are looking at expanding and paving. Due to the high costs of asphalt and concrete, the Church is currently considering tar and chip.

If interested in a greener alternative to asphalt or concrete parking lots, there are new paving techniques, materials and designs on the market that are intended to minimize the impact that parking lots have on the environment. These include pervious paving materials, green parking lots and designs that are intended to reduce environmental impacts. Pervious concrete lets water infiltrate to maintain a natural water cycle, recharging groundwater and reducing storm water run-off.
