Restoring Nature in origin park

Brownfield Sites

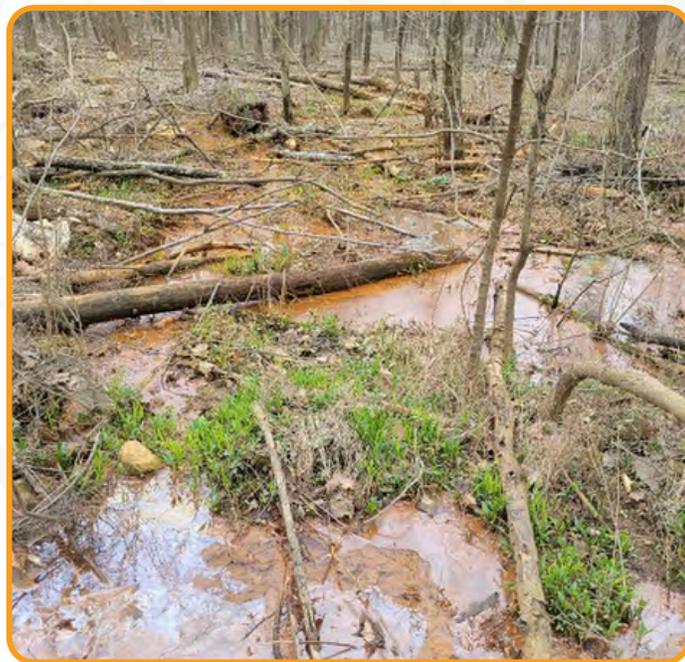
Image of leachate eruption on Western side

Because of this, environmental investigations associated with **illegal** open dumping and **landfilling operations**, including inspections and the collection of soil samples and drum contents, have been conducted periodically on the site since the 1980s. Evidence of operations as an unpermitted landfill and registered complaints in the 1980s resulted in the identification and subsequent removal of **15 buried drums** and In 2011, **65,000 cubic yards of contaminated soil** and **13,720 cubic yards of concrete** were removed from the site.

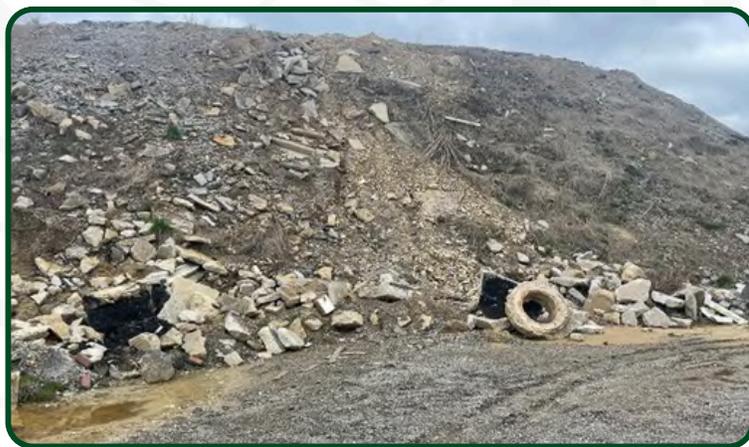
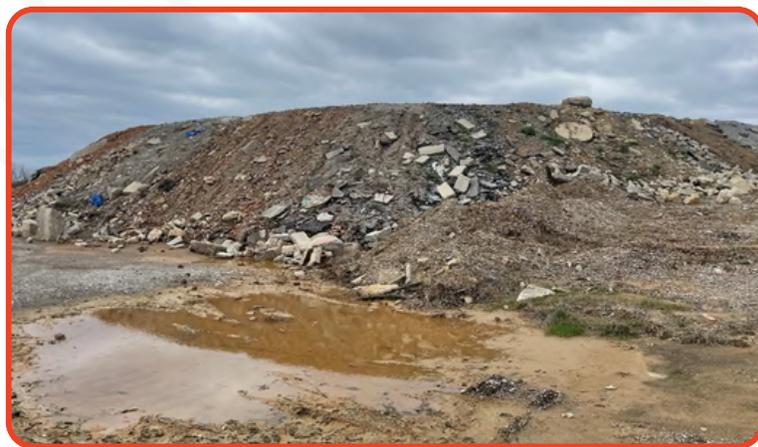
Images of stockpiled soil and debris

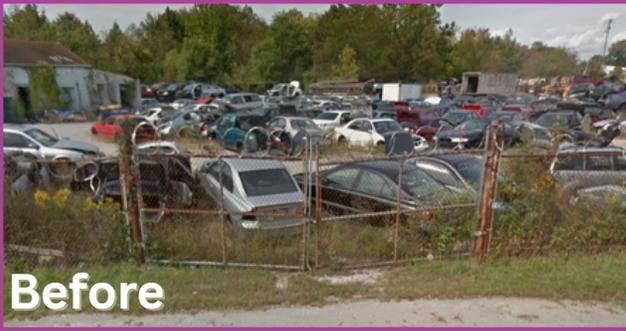
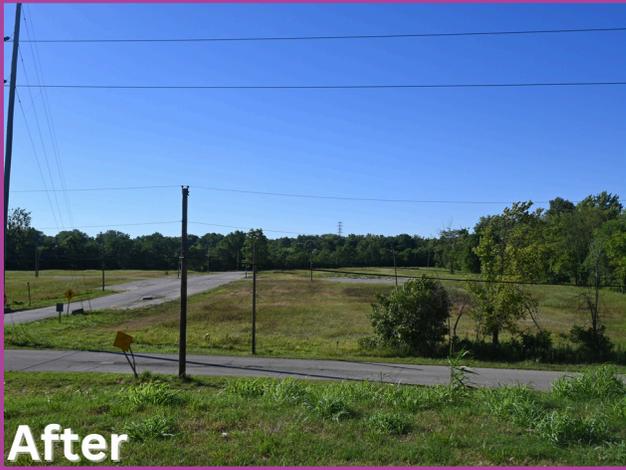
The images above capture the Marshall's Auto brownfield site's journey from its original state to a restored landscape.

Marshall's Auto was once an **auto salvage yard**. The **10.5 acre site** is located near **Silver Creek** and within a **half mile** of the **Ohio River**. It's also near **residential neighborhoods** and a **catholic high school**. The salvage yard had operated since the late 1960s and ceased operations in October 2022. Numerous **junk cars, piles of scrap metal, miscellaneous equipment, and containers of automotive fluids** have been stored throughout the site. **Aboveground storage tanks (ASTs)** were also used to store **gasoline, diesel and used oils**. The site had been issued numerous **violations** from the **Indiana Department of Environmental Management (IDEM)** for **water and solid waste and open dumping violations**; releases of **oil from car crushers**, absence of a **spill prevention plan**, and no **auto salvage yard license**.

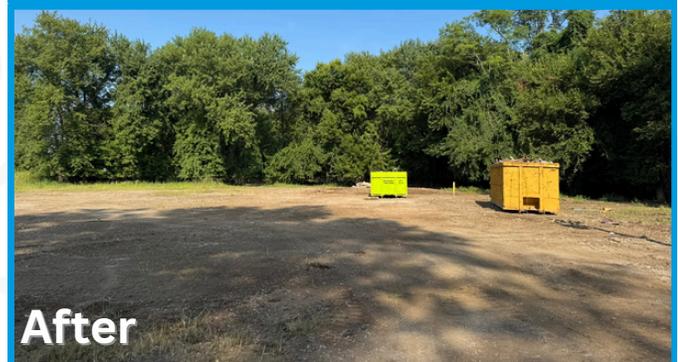
The images above depict the KWP brownfield site before cleanup and after completion, showcasing the park's dedication to environmental renewal.

Kentuckiana Wood Products (KWP) is a **1.7 acre site** located less than **400ft** from the **Ohio River** and immediately adjacent to the **103 acres** of **Buttonbush Woods**. Historically the site had been agricultural land, a pallet manufacturer, dumpster service, and most recently an **automotive repair shop** and **salvage yard**. The site possessed numerous **junk cars** and **heaps of scrap metal, car batteries, various containers of fluids, solvents, paints, urethane reducers, muriatic acid**, as well as a variety of **compressed gas cylinders**. ASTs were used to store **gasoline, diesel, and spent oils**. COCs are RCRA metals including **arsenic and lead** in the **groundwater** as well as **migrating contaminants** from the north western adjoining property of **CAB-X**.
