Our reference  
**V-USA-1-0-10**

## **Subject: VELUX® SKYLIGHT REPLACEMENT CLADDING PARTS**

## Skylight Deck Mount Models – Pictorial

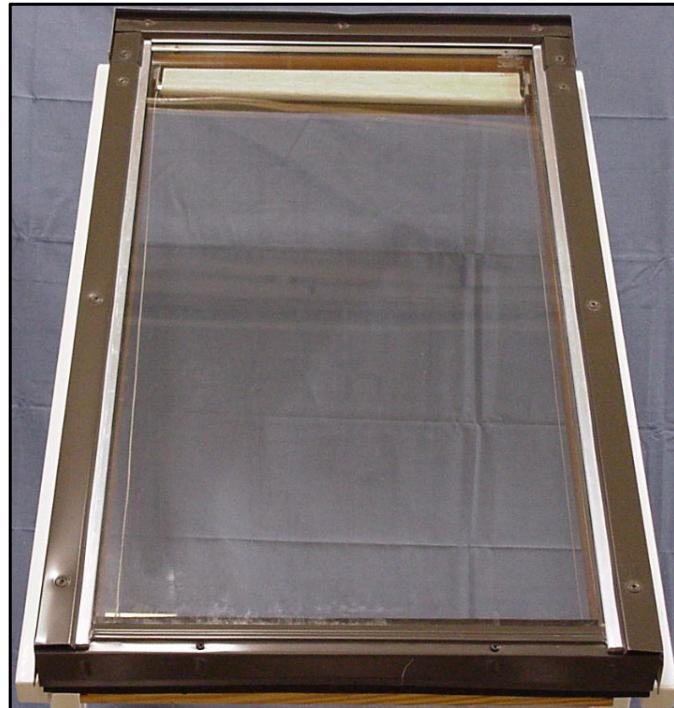
**FS M82 / FS M85 / FS M87****Mfg 12/1982 – 03/1995**

No replacement cladding parts.  
Skylight replacement only.  
Distinguished by exterior screws  
through the top of the cladding  
covers

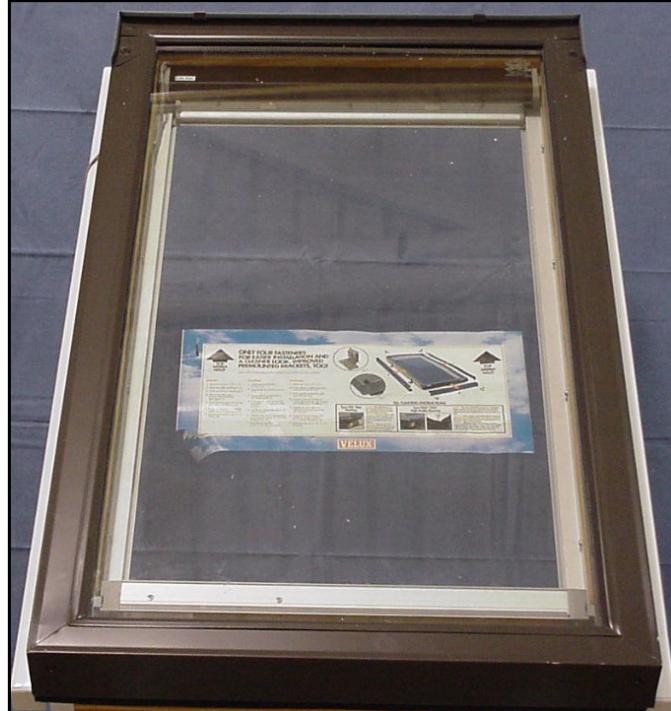
**FS M95****Mfg 04/1995 – 05/2004**

No replacement cladding parts.  
Skylight replacement only.

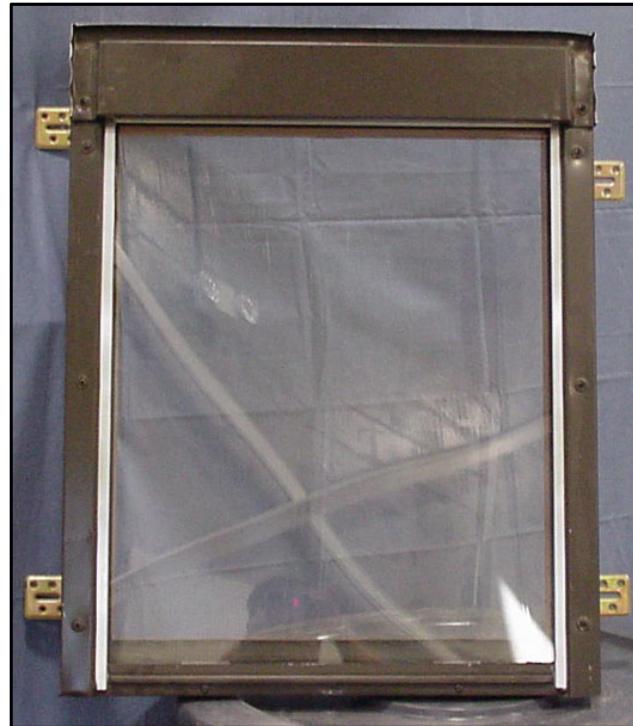
**FSF M87**

No replacement cladding parts.

Skylight replacement only with  
fixed or venting skylight.

Distinguished by exterior screws  
through the top of the cladding  
covers

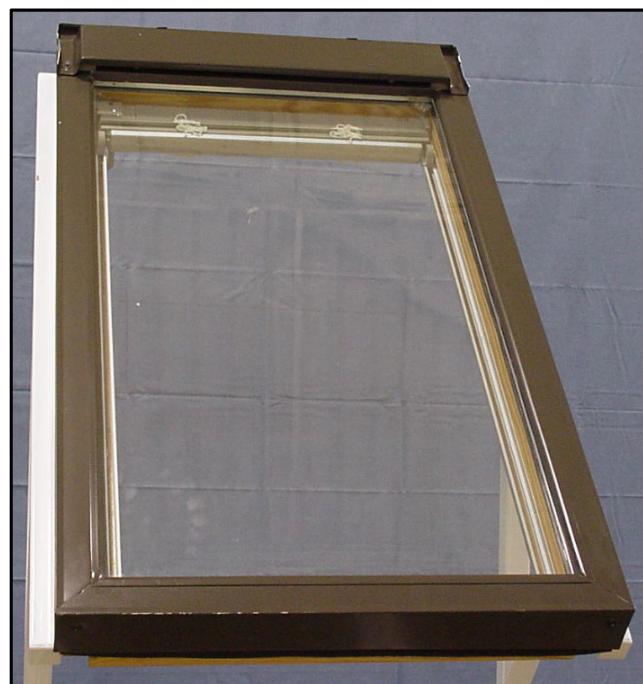
**FSF M95**

Replacement cladding parts  
available.

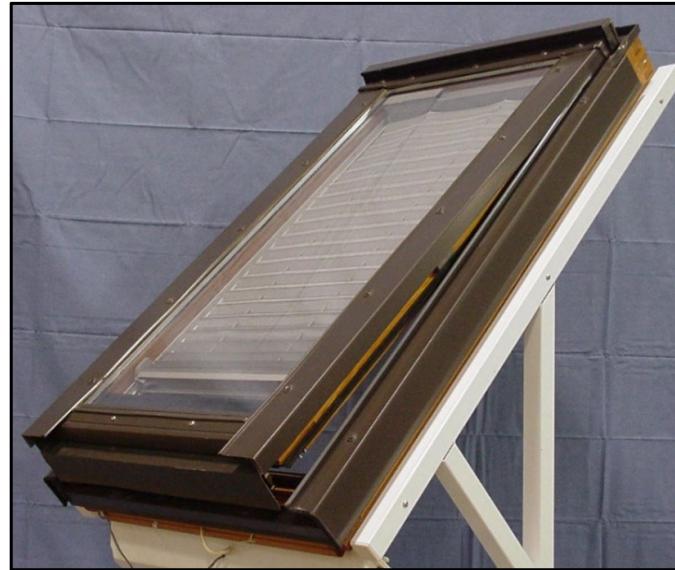
**VS M84 / VS M87 / VSC**

No replacement cladding parts.  
Skylight replacement only.  
Distinguished by exterior screws  
through the top of the cladding  
covers

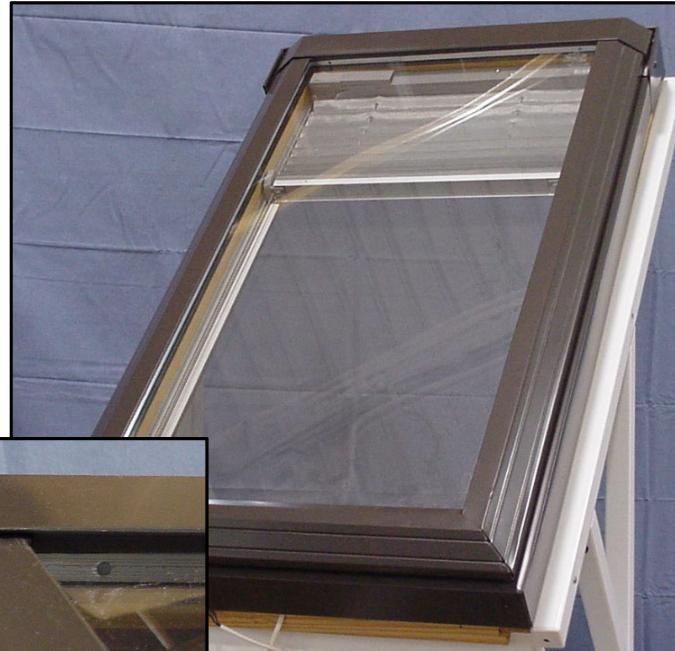
**VS M96 / VS M96B**

No replacement cladding parts.  
Skylight replacement only.  
Distinguished by no exterior  
screws in the side and bottom  
claddings and shape of top cladding  
cover.

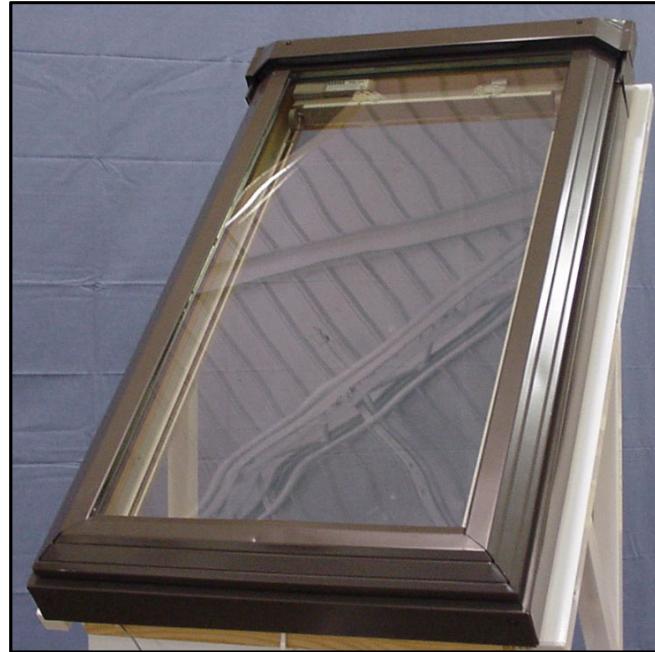
**VS M98 / VS M01 / VS M03**

No replacement cladding parts.  
Skylight replacement only.

Distinguished by shape of top  
cladding cover.

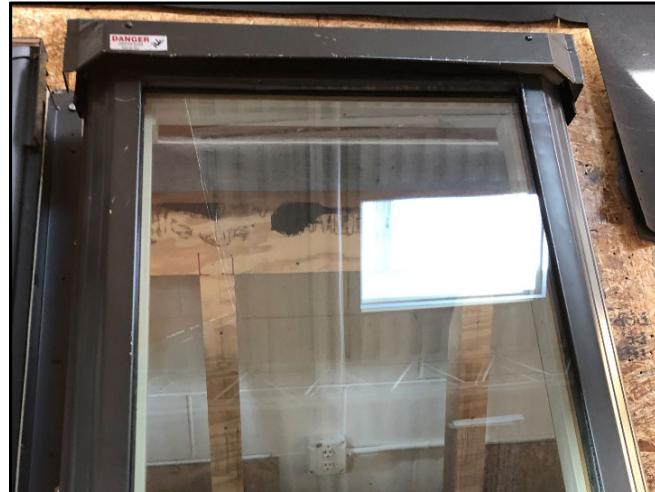
**VS / VSE H04****Mfg 05/2004 – 12/2009****VS / VSE / VSS A21****Mfg 01/2010 – Present**

Frame cladding parts available.  
Sash complete required if sash  
cladding damaged.

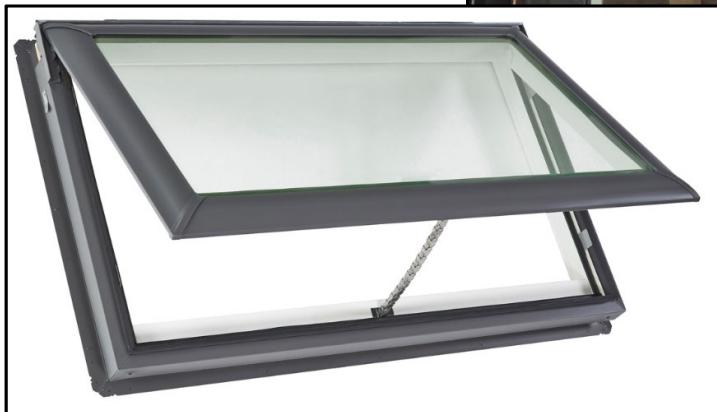
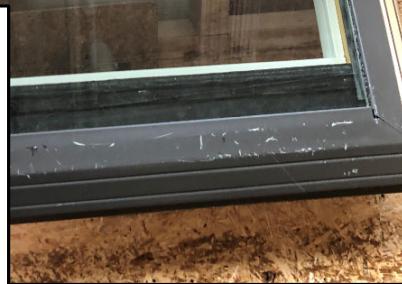
**A21 with rounded sash  
cladding and light grey color**
