## Event details

**Location of incident:** Grateley Station : BAE1 72m 55ch

**Discipline:** Works Delivery (Civils)

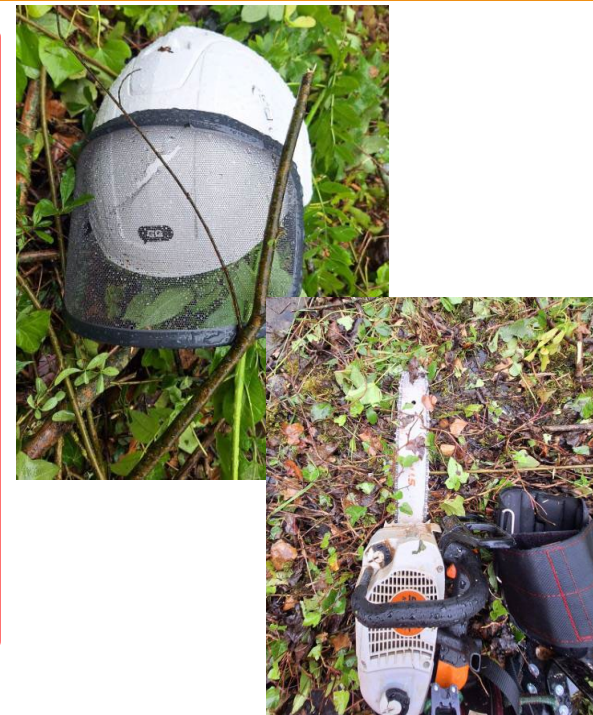
During the cutting operation, the chainsaw experienced a kickback event, causing the guide bar and chain to strike the operative's face after penetrating the visor of the safety helmet. Although the PPE absorbed a significant portion of the impact, the operative sustained a facial laceration and damage to the helmet and visor assembly.

Chainsaw kickback during cutting activity causing loss of control and contact with the operative's face.

- Reinforce chainsaw safety training, particularly: Awareness and avoidance of kickback zones. Correct cutting techniques and body positioning.
- Review task planning and dynamic risk assessments for vegetation work, especially in constrained environments.

- Incident reported and recorded in accordance with company procedures
- Post incident D&A undertaken on remaining team while IP and has attended A&E.
- Investigation initiated
- PC Management attended site to commence evidence gathering
- Initial statement taken from remaining team members
