2010 CICA Lift of the Year Awards

Category B (Cranes up to 130t capacity)

Applicant: Kelly's Crane Hire Pty Ltd

Job Location: Rex Range Road, Rex Highway

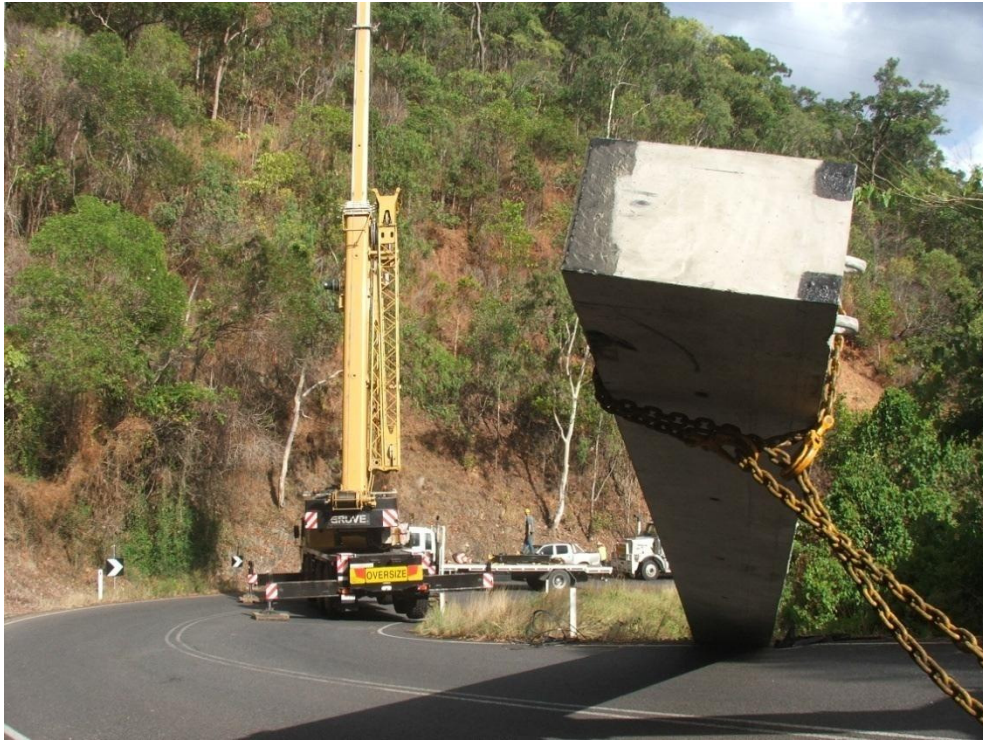
Our lift is the recovery of a 25T bridge girder and dolly which left the road along the Rex Highway approximately 1.5 hours north of Cairns. On 20 October 2009 a convoy of 4 trucks were transporting the first bridge girders from Cairns to Cooktown for the new Endeavour River Bridge. The first truck did not negotiate a sharp uphill bend wide enough and the wheels of the dolly ran over the kerb onto sloping ground. The weight of the 25T girder pulled the load clear of the truck, and the dolly, with the girder still attached, slid several metres into a gully.

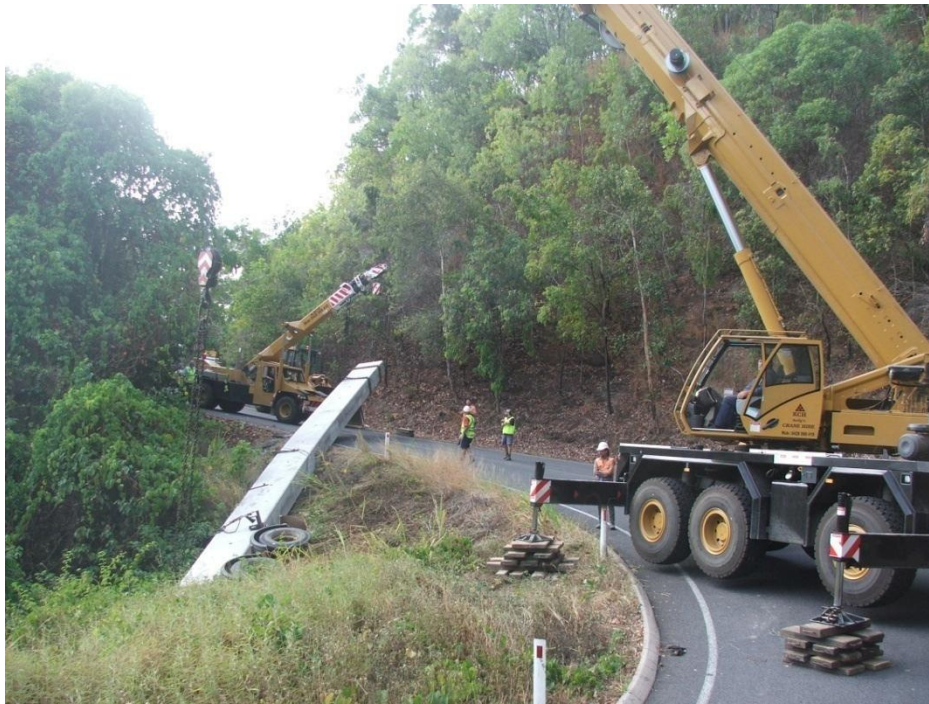
The job was planned to create a pivot point as close as possible to where the girder was in contact with the pavement. This was approximately half way along the girder and the weight of the top half of the girder would act as a counterweight. Two timber packers were used to create the pivot point. Timbers were also used at the top end of the girder for when the girder was righted so that it would not come in contact with the pavement and would act as a second pivot point for when the girder came into radius to lift one end.

One option to lighten the load was to disconnect the dolly from the girder but after consultation between the dogger, crane driver and client it was decided the risk was too high to send someone into the gully to disconnect the girder from the dolly.

Prior to the dogger walking down the girder it was attached at the top end to the 20T Franna with a 22T set of 2-legged chains and to the Case Loader with a 36T set of 2-legged chains to secure the load from sliding further into the gully. The chains on the loader and Franna were tensioned to take out any slack without adding any extra weight.

The Grove GMK3055 was set up with full counterweights with six drops of rope which gives 30.6T on the winch.

The dogger walked down the girder and attached a 22T set of 2-legged chains onto the lifting points on the concrete beam. The dogger inspected the chains attaching the bridge girder to the dolly and they appeared in good order.

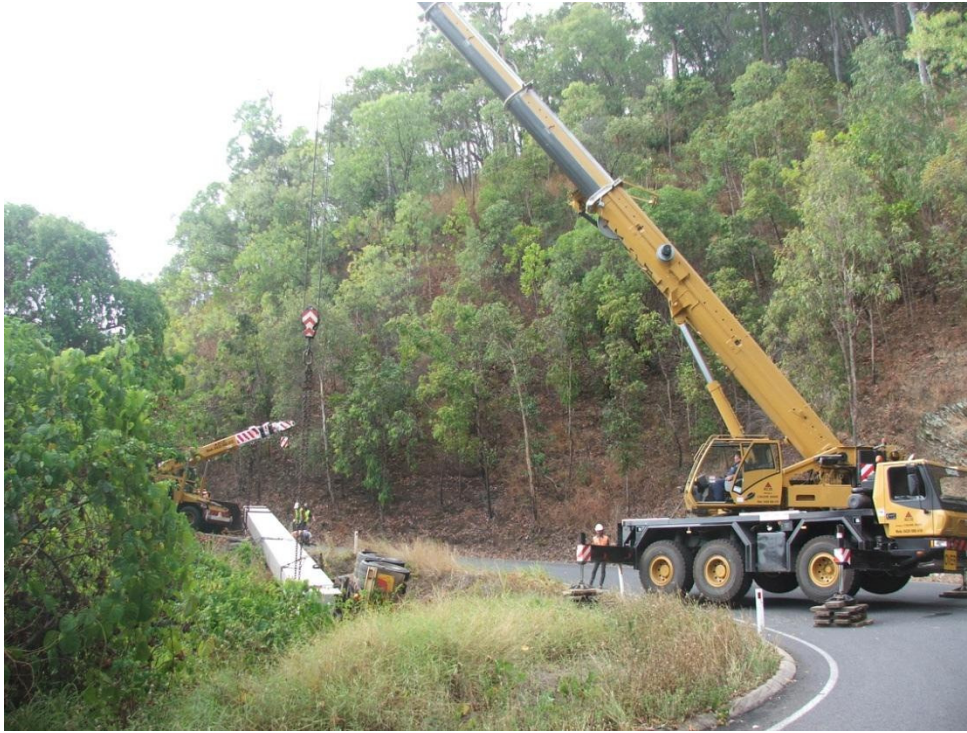
Prior to the lift commencing the Franna and loader drivers were instructed to follow the load rather than applying weight as this would overload the main crane. The Franna and loader were purely to secure the load and act as an anchorage point to prevent any sudden movement or slippage of the girder while the main crane brought the girder into a radius of 8m.

The estimated weight applied to lift the lower end of the girder and dolly by the Grove was 4.5-5T at a radius of 13m as the upper part of the girder was acting as a counter weight. The machine was good for 8.2T at this point.

The lift commenced and the dogger instructed the crane to follow the contour of the land to maximise safety until the load was within an 8m radius where the crane was good for 18.1T.

Once the load was within this radius the girder was rolled upright and lifted until it came in close contact to the pavement at the upper end. More packers were placed under the top end so that it had something to pivot on.

The 55T Grove took the full weight of its end of the girder and lifted it off the centre pivot point onto the opposite end pivot point. The weight on the 55T Grove was 14.5T at this time.

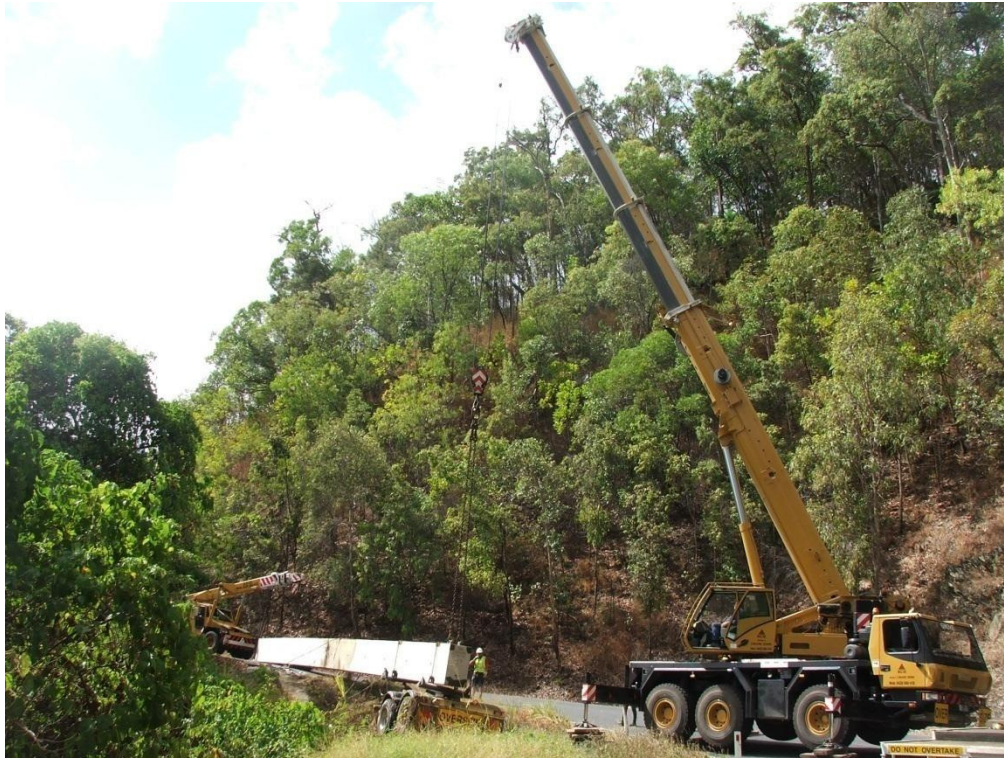
When the end of the girder made contact with the end pivot point the crane slewed until the wheels of the dolly could be placed onto the pavement. The wheels were chocked to stop any downhill movement before the full weight of the girder was released.

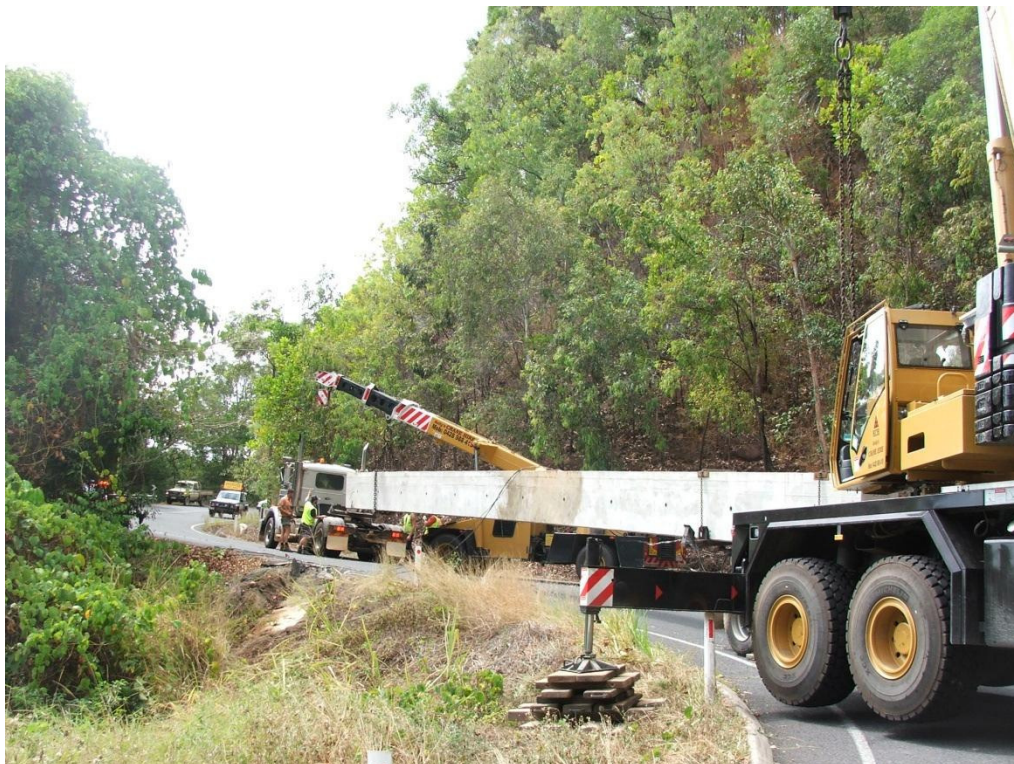
The Grove was no longer required and the 20T Franna was re-positioned to lift the front end of the bridge girder. It was attached to the 36T set of 2-legged chains with a 2.5m radius where the crane was good for 13.9T. The truck reversed under the girder and it was re-attached.
