ASTM G31 FIELD CORROSION EXPOSURE REPORT

CoilSafe® – 26,200 Hour Sea Water Submersion Exposure Test — Galveston Island, Texas

Product:	CoilSafe® Coating	Standard:	ASTM G31
Duration:	26,200 hrs.	Environment:	Sea Water Submersion
Location:	Galveston Island, TX	Coating:	8-micron covalent film

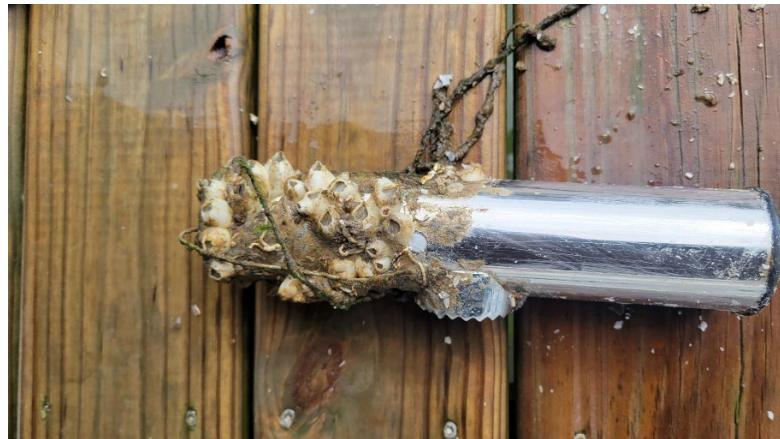
Stainless Steel

Uncoated

Coated

After 26,20000 hours of natural Sea Water submersion exposure, CoilSafe® exhibited complete corrosion resistance, while the uncoated sections of the samples showed extensive deterioration consistent with chloride-driven corrosion. Testing verified by CZI labs.
