# Oregon NW Home Inspections

## Property Inspection Report

1234 NE Anywhere, Anywhere, OR 97777

Date of Inspection: 8/10/2022 Time: 9:00 AM

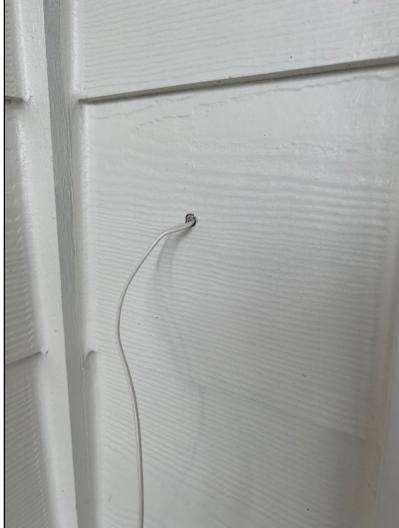
Doorbell has not yet been installed.
Page 19 Item: 4	Doors	<ul style="list-style-type: none"><li>• Missing weatherstripping noted at front door. Recommend installation.</li></ul>

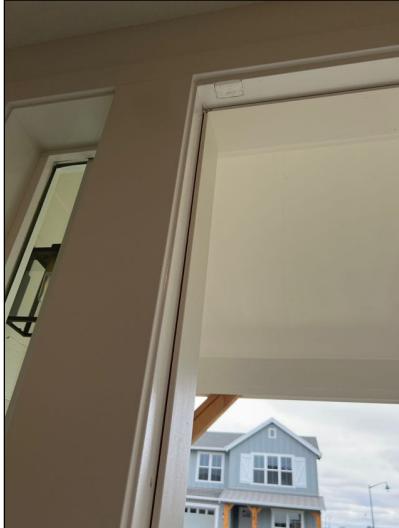
Missing weatherstripping noted at front door. Recommend installation.
Page 20 Item: 8	Patio Doors	<ul style="list-style-type: none"><li>• The patio door did not latch properly. Recommend repair.</li></ul>

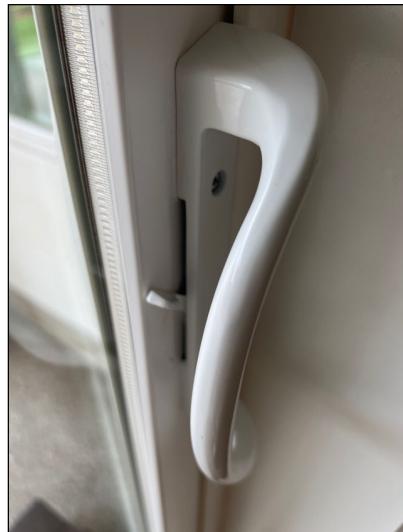
The patio door did not latch properly. Recommend repair.

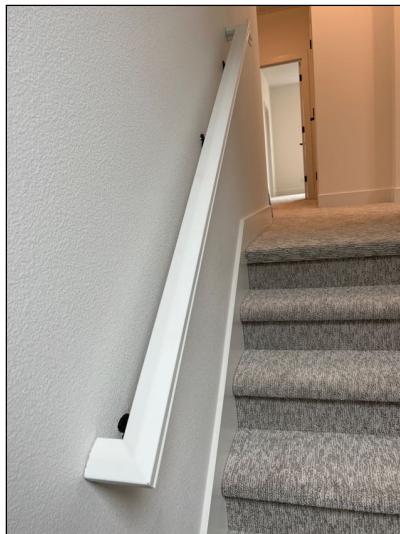
Upper hand rail is a little loose. Recommend tightening as needed.

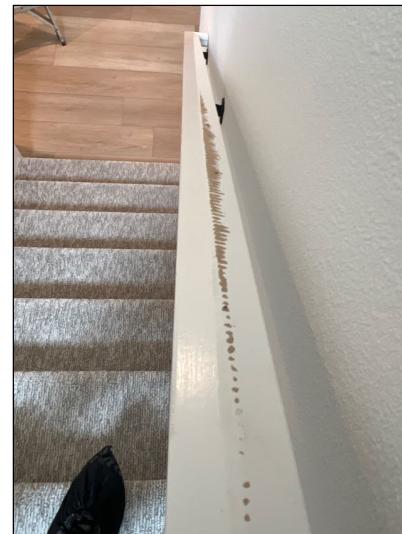
Cosmetic damage observed at lower handrail. Recommend repair.

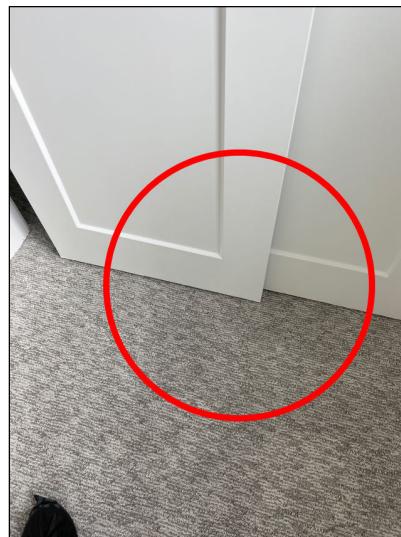
Closet door guides are missing. Recommend they are installed.

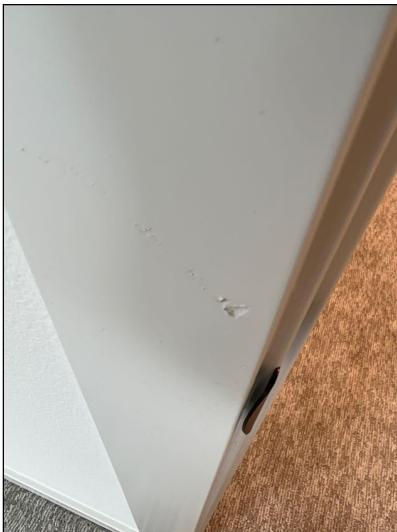
Some areas of minor cosmetic repairs are needed.

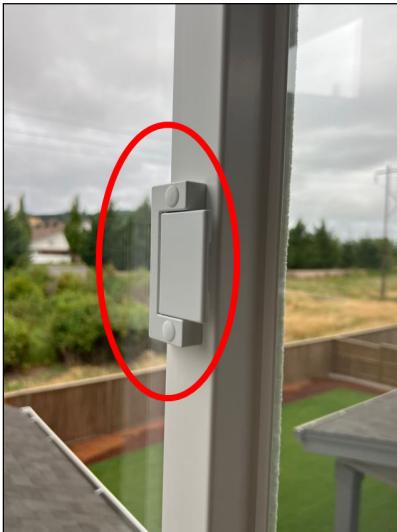
Right side master bedroom sliding window does not latch properly. Recommend adjustment/repair.

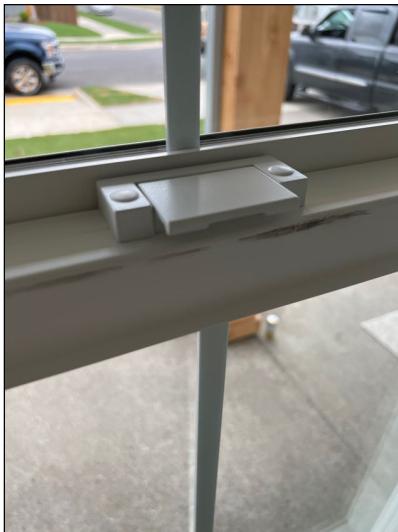
Right side single hung window at main floor right front bedroom does not latch properly.  
Recommend adjustment/repair.

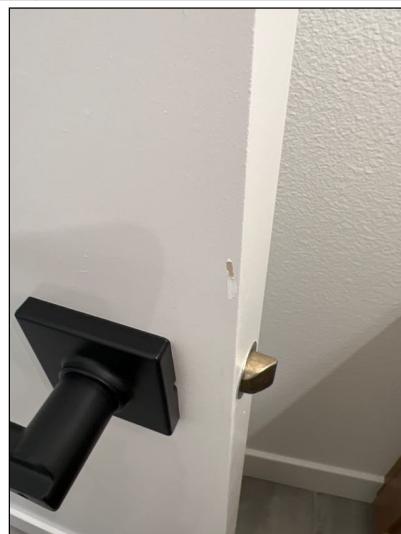
Minor cosmetic damage observed at upstairs hallway bathroom door. Touchup paint is needed.

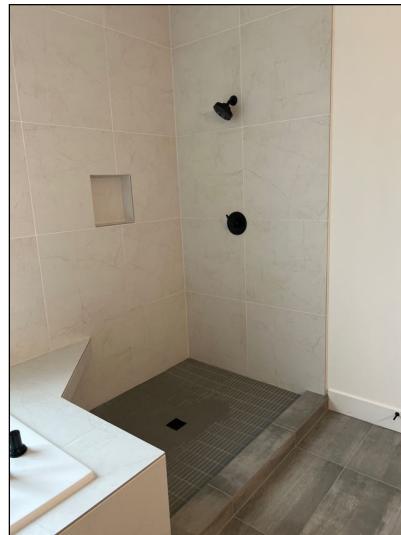
Enclosure not yet installed.

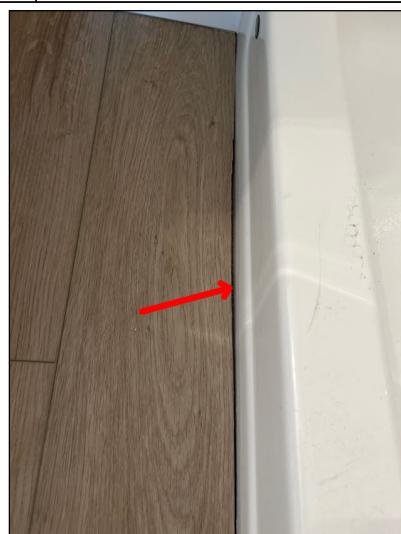
Recommend caulking where the tub or shower meets the floor.

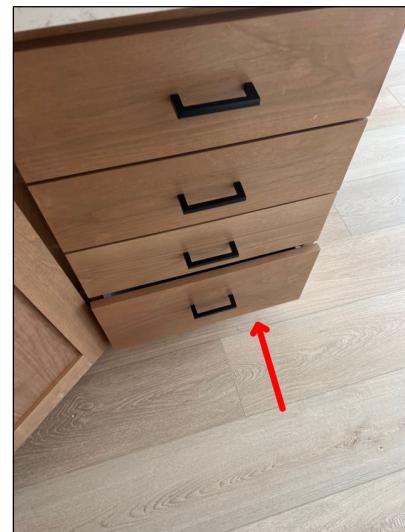
Cabinet drawers appear to be off track and need adjustment- left of cook top and bottom right of sink.

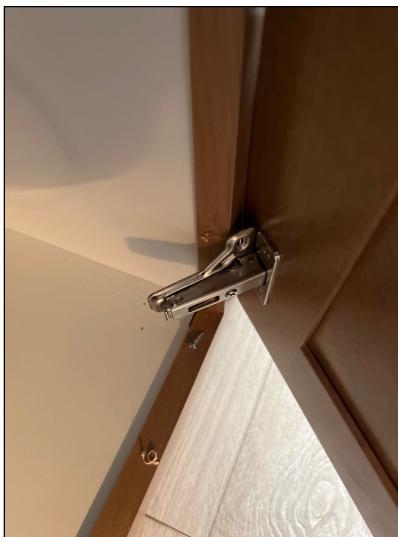
Tighten hinges under sink.

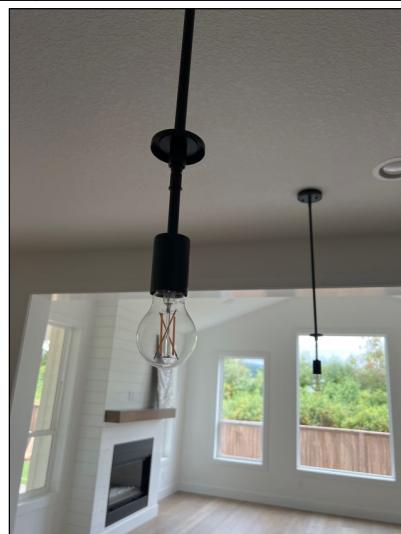
Kitchen island light fixture covers appear to be missing.

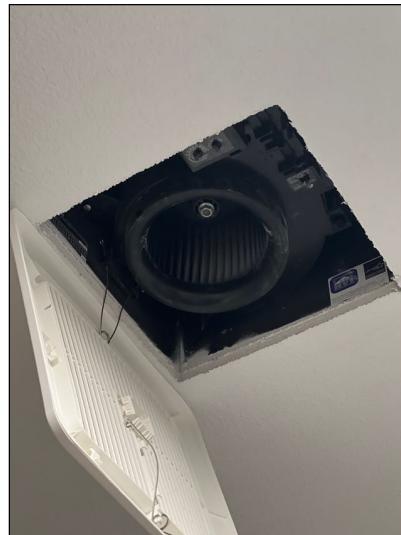
Exhaust fan is inoperable. Recommend repair.

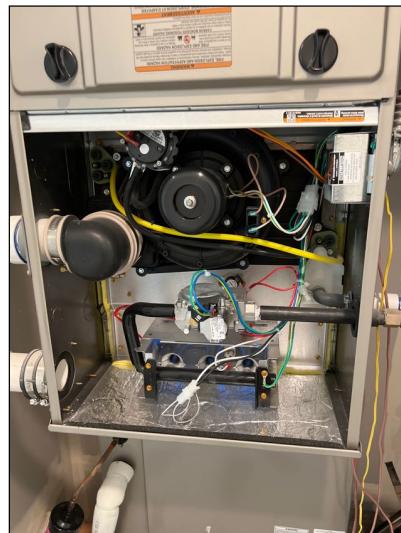
Construction dust buildup observed in service compartment and draft tubes. Recommend furnace is cleaned.

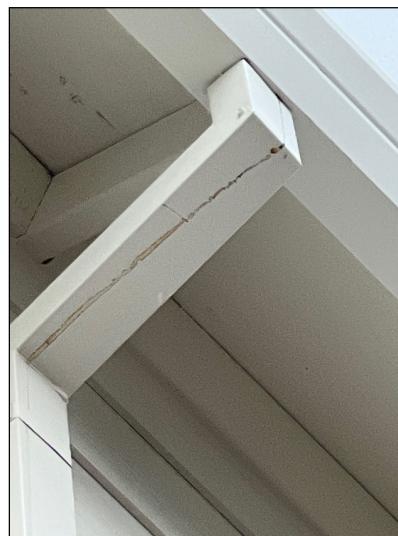
Signs of downspout leaking At right front of structure. Recommend review to ensure a watertight seal and proper drainage.

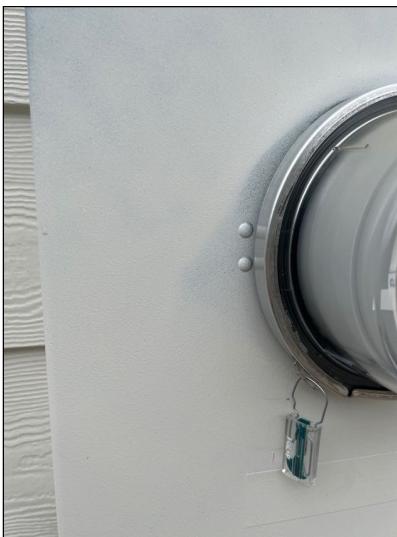
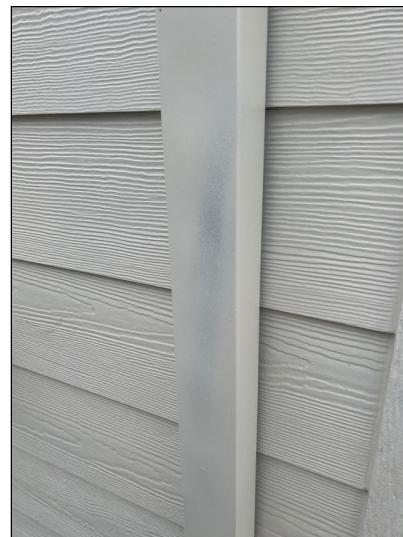
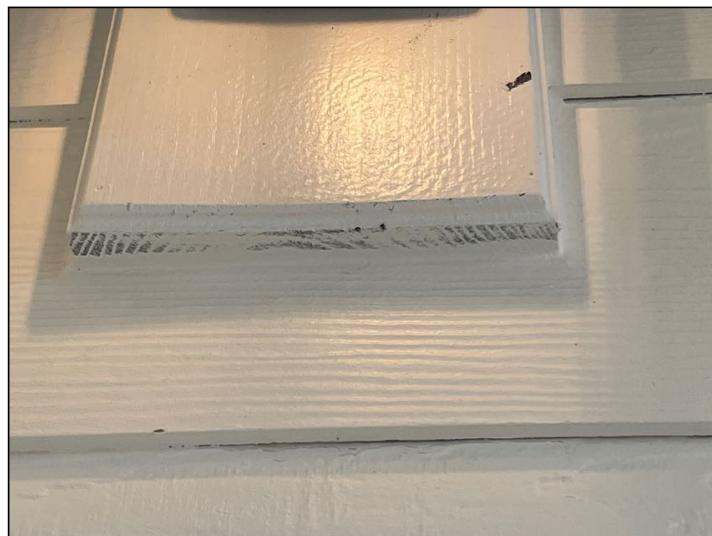
Touch up paint is needed in some areas.

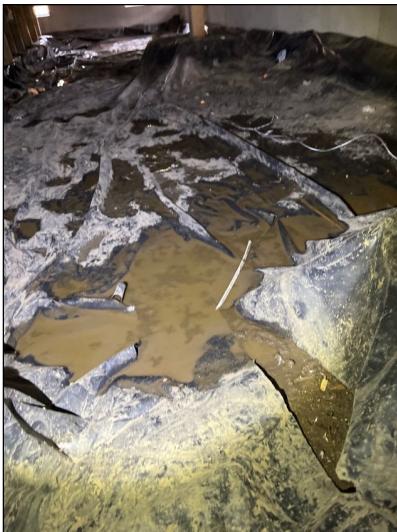
Standing water noted in crawlspace. May be residual from construction phase. This can lead to mold and other moisture issues within this home. Recommend review by licensed foundation drainage specialist to ensure sump pump is sufficient.

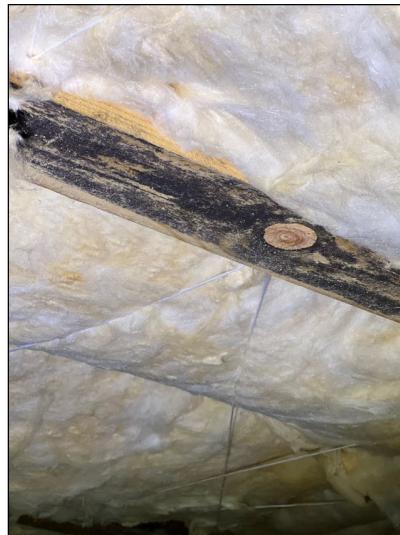
Biological organic growth observed at some framing members. Recommend affected areas are cleaned with an antimicrobial detergent and sealed with Kilz or something similar. Most likely from lumber being stored in wet conditions before/during construction.

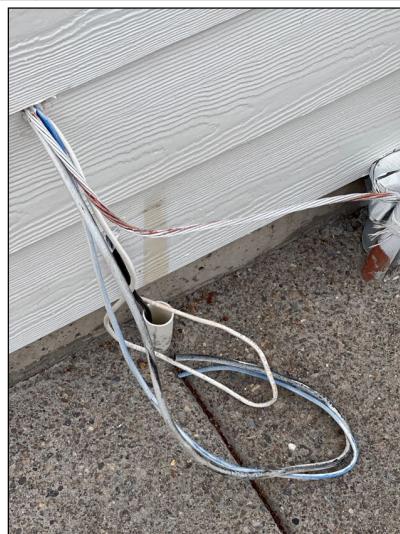
Low voltage electrical installation is incomplete and left front instruction.

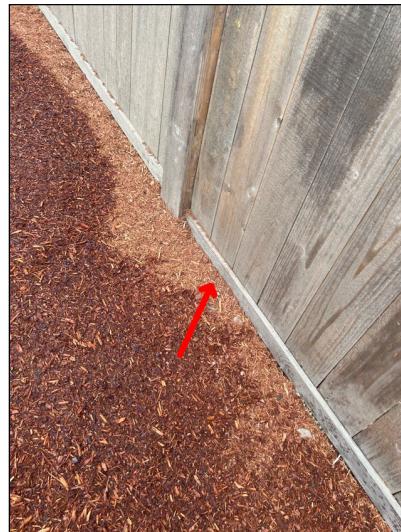
Recommend one inch between soil and fence to prevent decay.

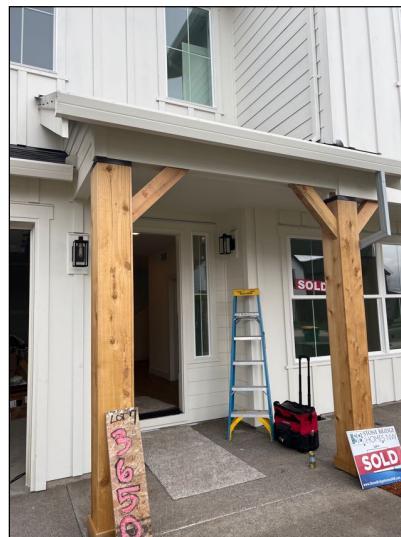
Paint posts as needed.

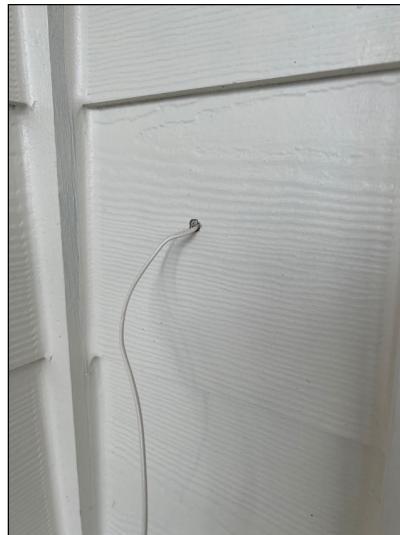
Doorbell has not yet been installed.

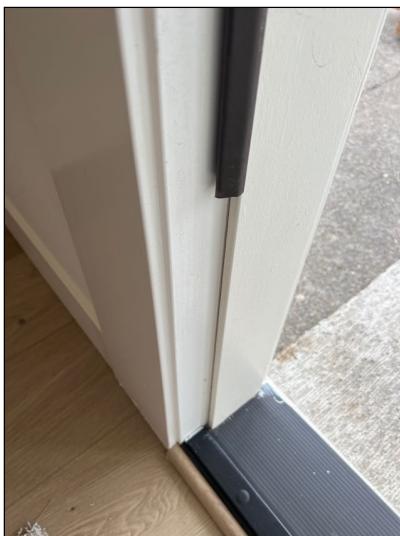
Missing weatherstripping noted at front door.  
Recommend installation.

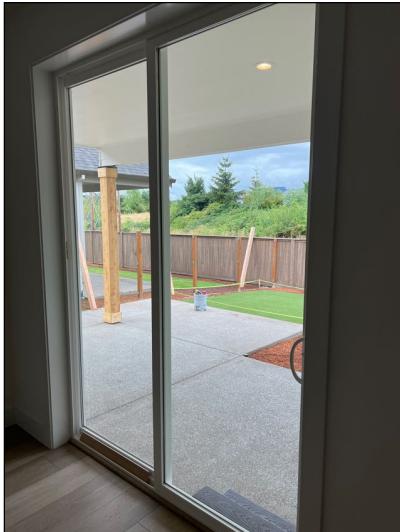
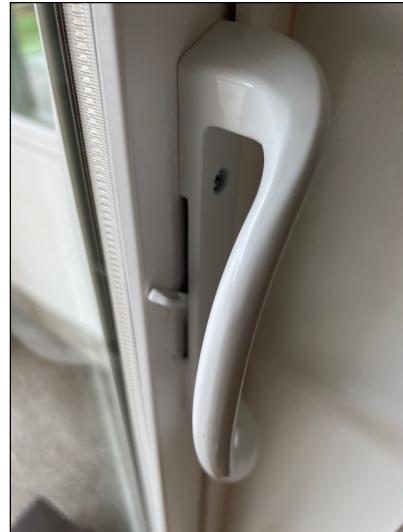
- The patio door did not latch properly. Recommend repair.

The patio door did not latch properly.  
Recommend repair.

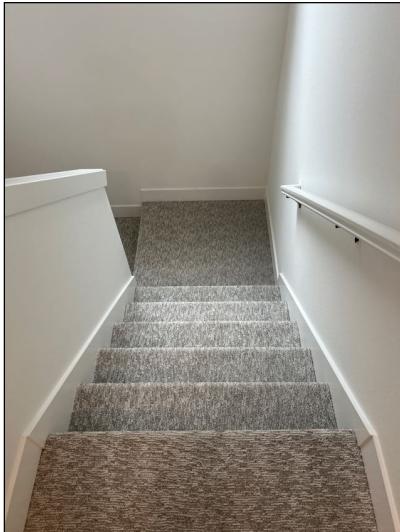
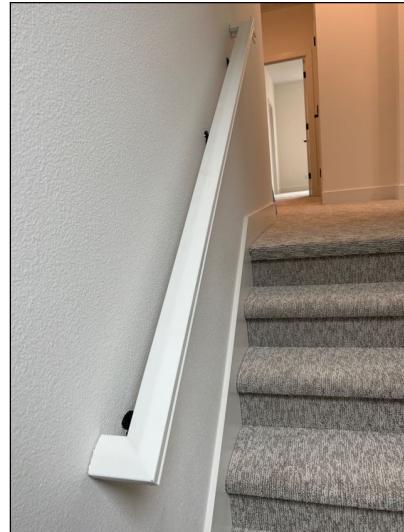
Upper hand rail is a little loose. Recommend tightening as needed.

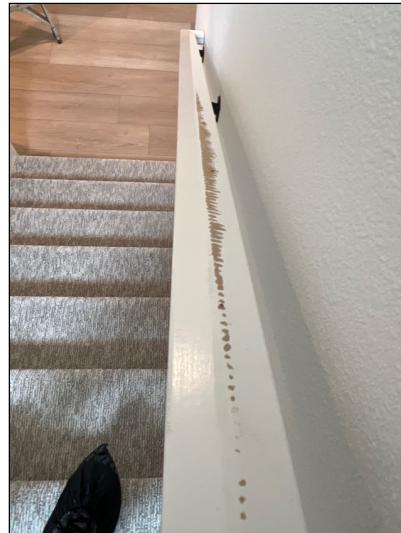
Cosmetic damage observed at lower handrail. Recommend repair.

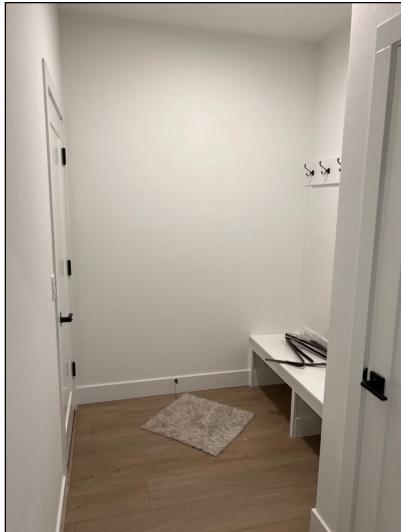
- Touch up paint needed in several areas.

Touch up paint needed in several areas.

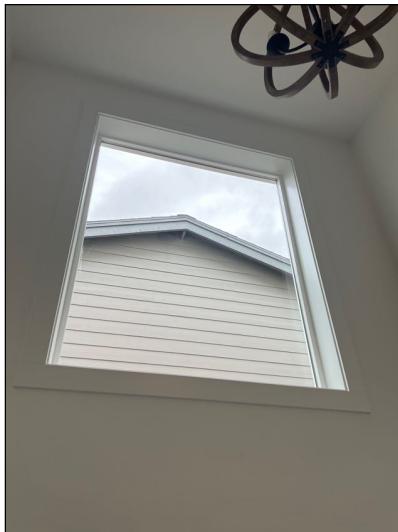
- Windows are checked for failed seals. There are times when seals have failed and it difficult to tell failure from a visual inspection.
- **Screens have not yet been installed throughout home.**

Screens have not yet been installed throughout home.

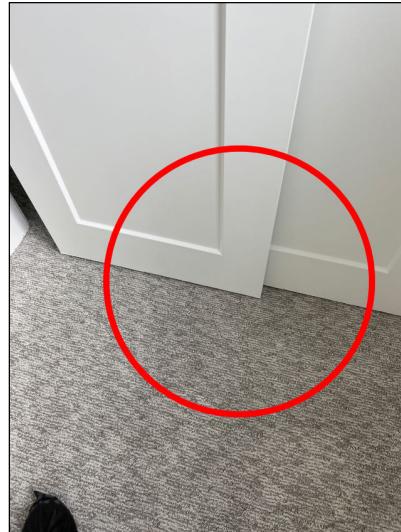
- The closets are in serviceable condition.
- **Closet door guides are missing. Recommend they are installed.**

Closet door guides are missing. Recommend they are installed.

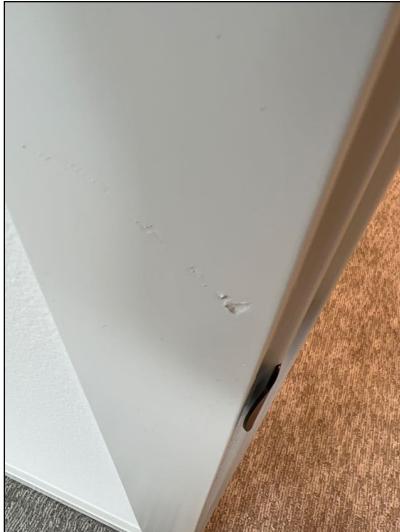
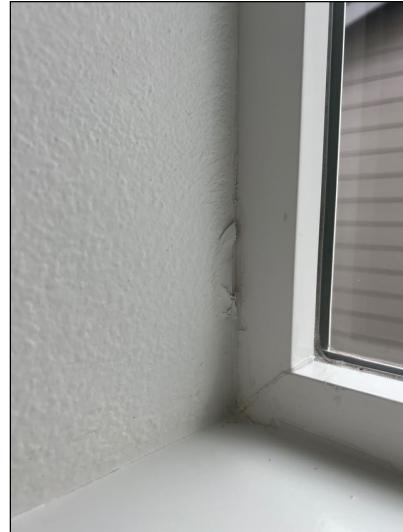
Some areas of minor cosmetic repairs are needed.

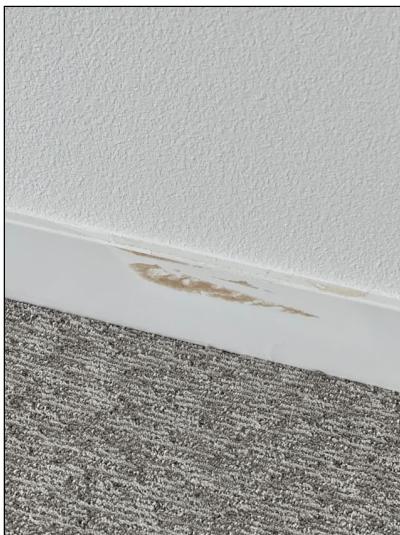
Some areas of minor cosmetic repairs are needed.

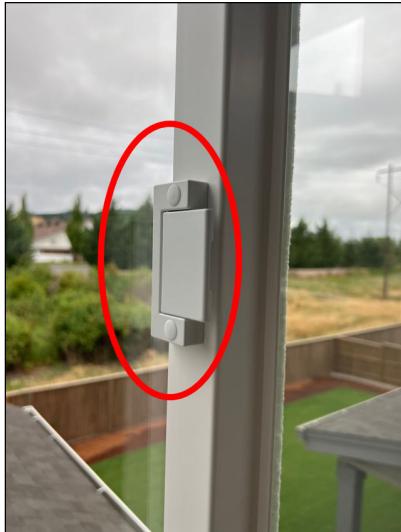
Right side master bedroom sliding window does not latch properly. Recommend adjustment/repair.

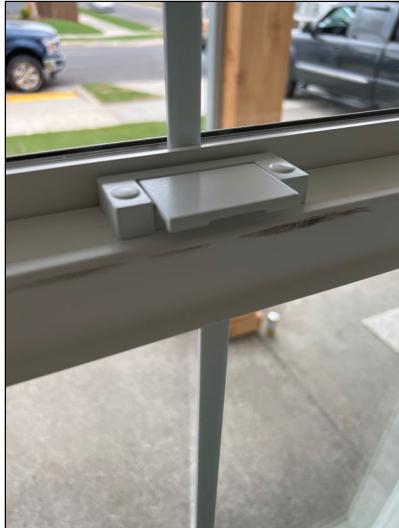
Right side single hung window at main floor right front bedroom does not latch properly. Recommend adjustment/repair.

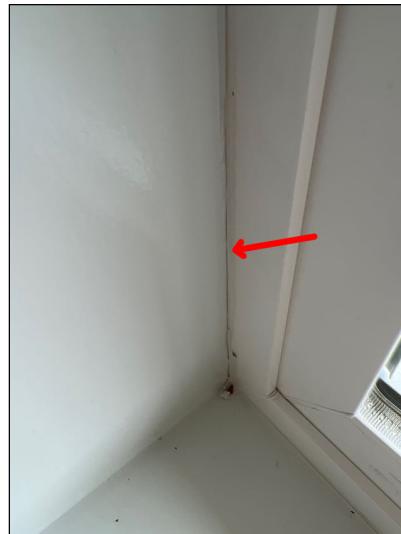
Re caulk at bedroom windows as needed.

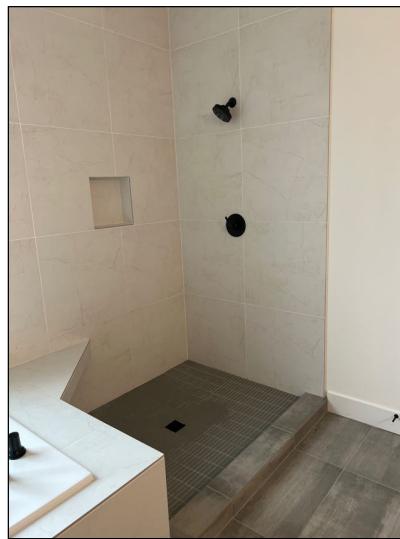
- Enclosure not yet installed.

Enclosure not yet installed.

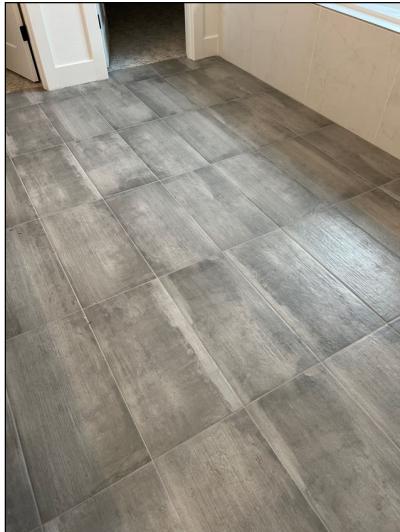
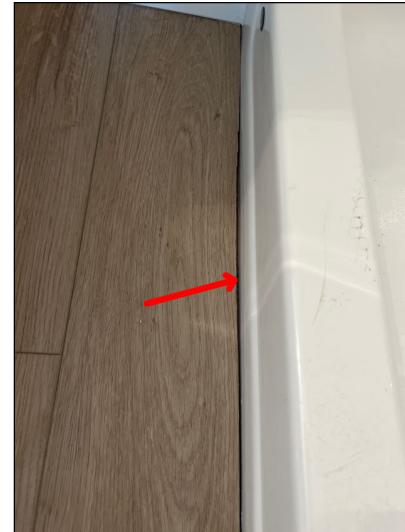
- Bathroom floors inspected with thermal imaging camera. Tested dry at time of inspection.
- Recommend caulking where the tub or shower meets the floor.

Recommend caulking where the tub or shower meets the floor.

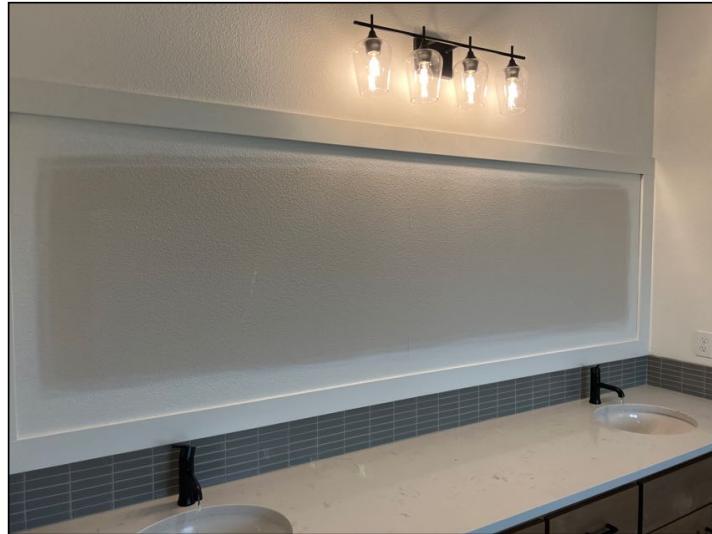
- Mirrors have not yet been installed.

Mirrors have not yet been installed.

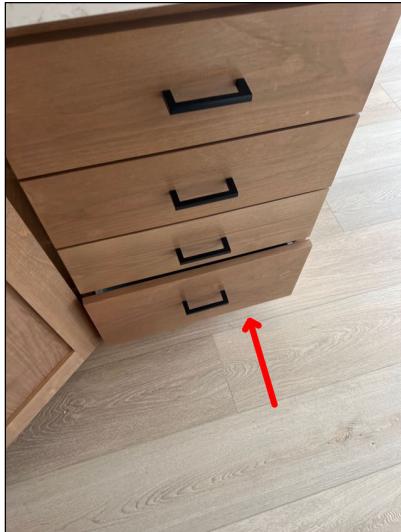
Cabinet drawers appear to be off track and need adjustment- left of cook top and bottom right of sink.

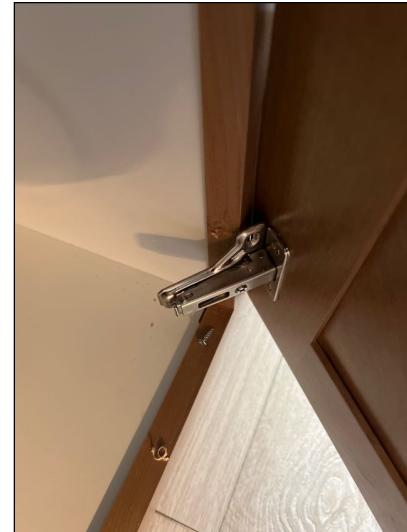
Tighten hinges under sink.

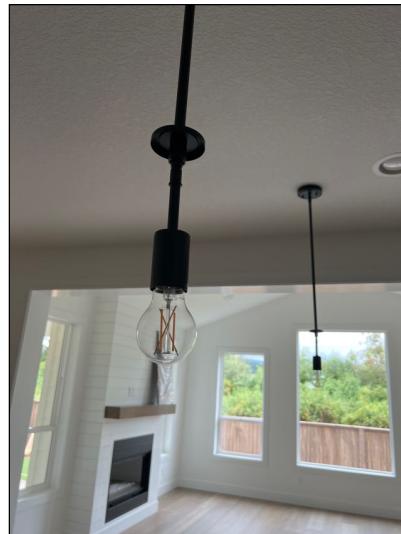
- No major system safety or function concerns noted at time of inspection.
- Kitchen island light fixture covers appear to be missing.

Kitchen island light fixture covers appear to be missing.

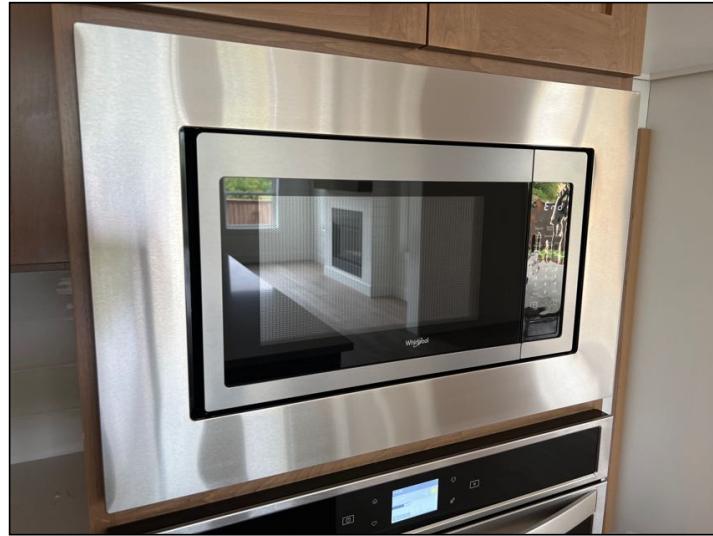
- Functional at the time of inspection.

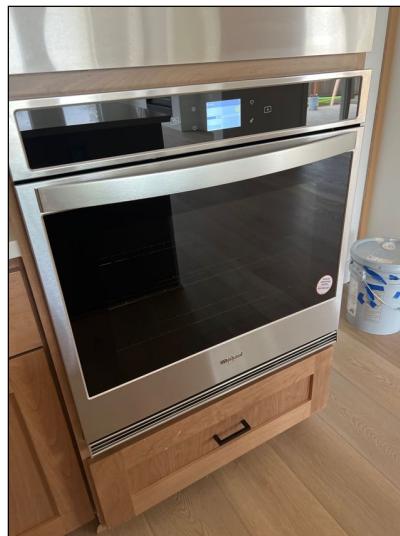
### 11. Oven & Range

- Oven(s) operated when tested.

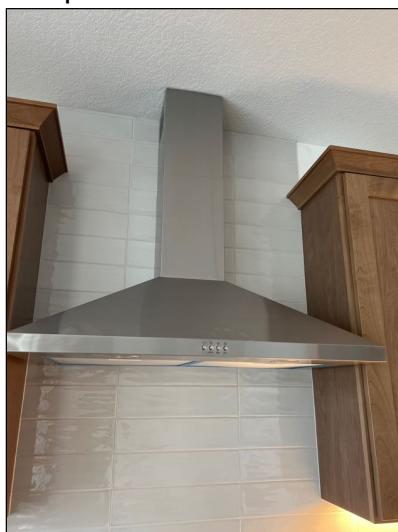
**16. Vent Condition**

- Exhaust fan is operational.

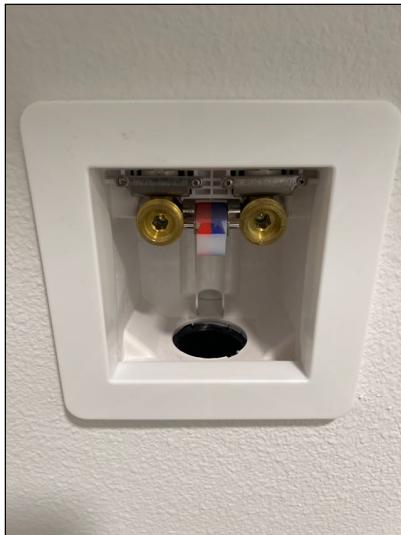
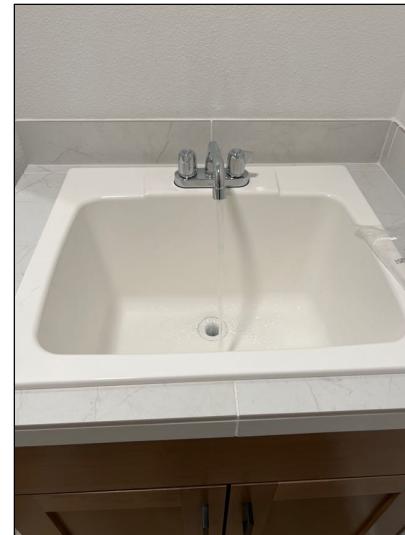
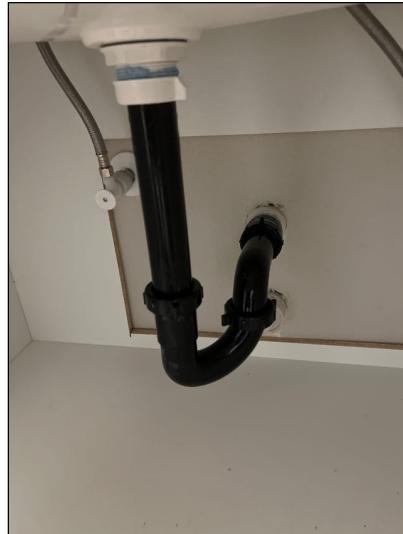
**8. Plumbing**

Observations:  
• Utility sink is functional.

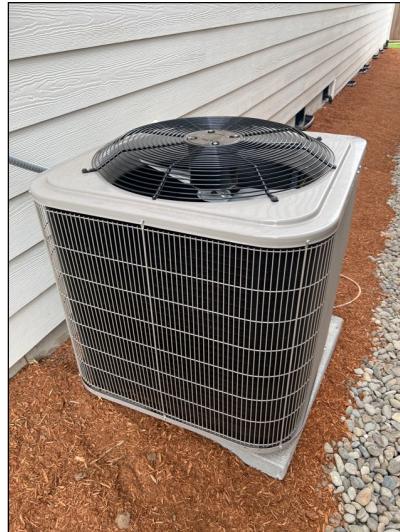
### 1. AC Compress Condition

- The AC unit was not ran due to the outside temperature.
- Maintenance Tip: Recommend that HVAC professional seasonally check the air conditioning unit, and ensure the unit is level. This can be accomplished at the same time as the annual furnace inspection.

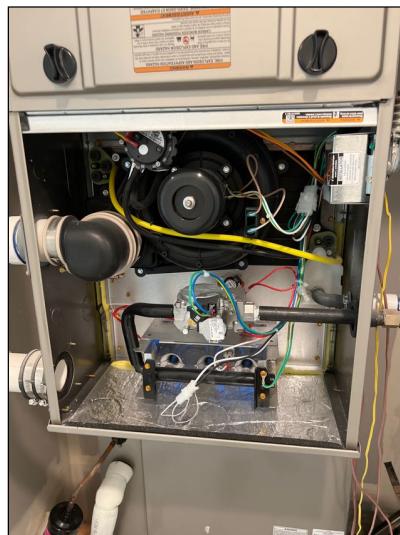
Construction dust buildup observed in service compartment and draft tubes. Recommend furnace is cleaned.

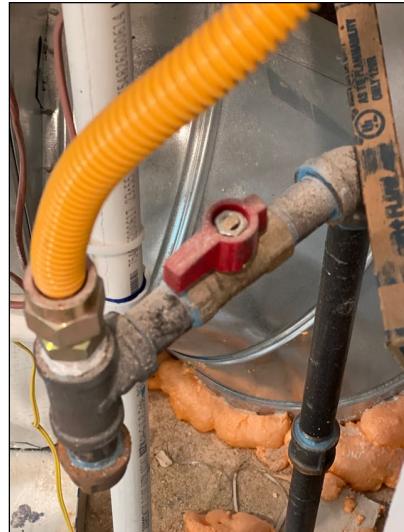
## 6. Gas Valves

- Gas shut off valves were present and appear functional.

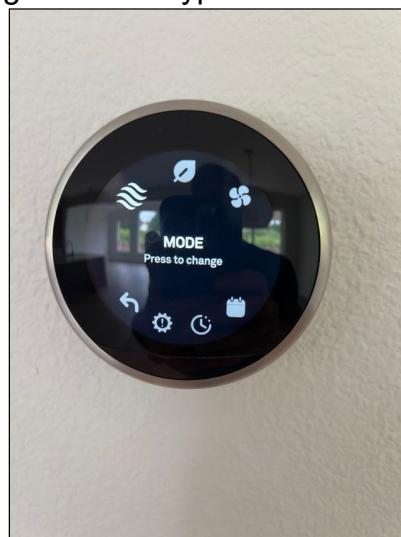
## 10. Thermostats

- Furnace responded well to thermostat.
- Digital - programmable type.

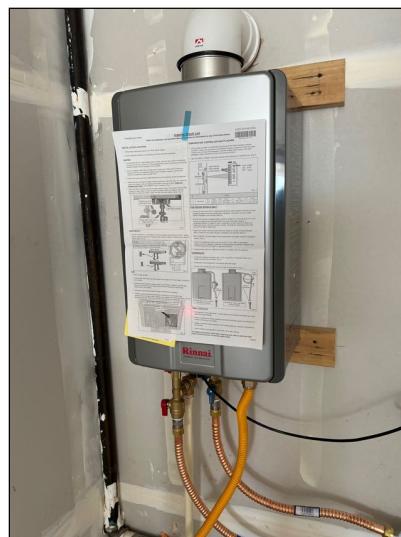
### 2. Water Heater Condition

- Water Source: Public
- On-demand water heater noted.

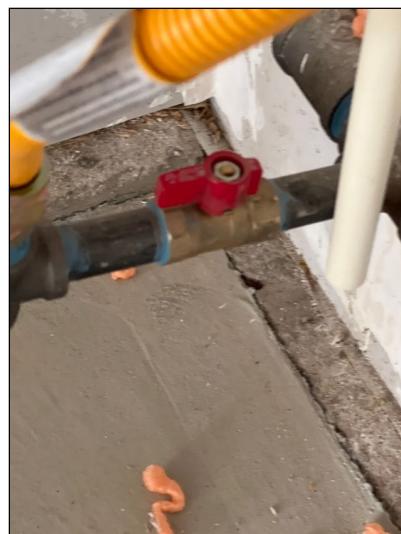
#### 4. Gas Valve

- Appears functional.

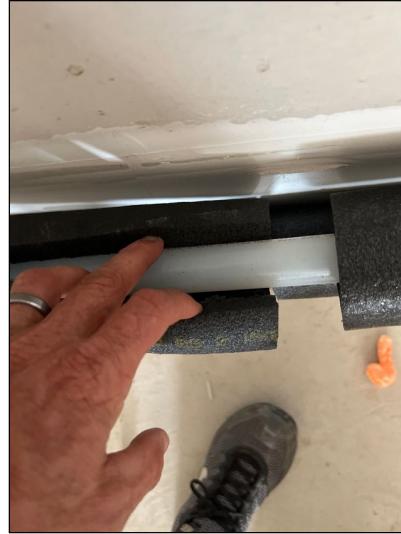
- Most of the piping is concealed.
- No deficiencies observed at the visible portions of the supply piping.

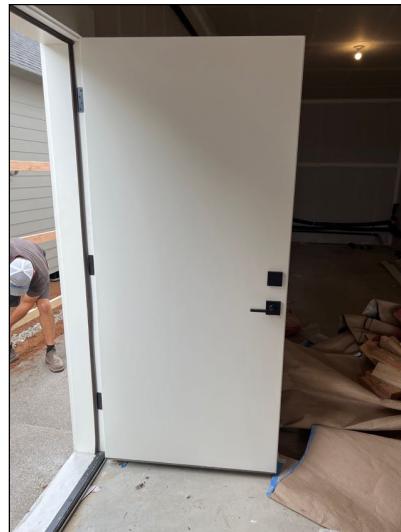
**Garage****1. Exterior Door**

- Appeared functional, at time of inspection.

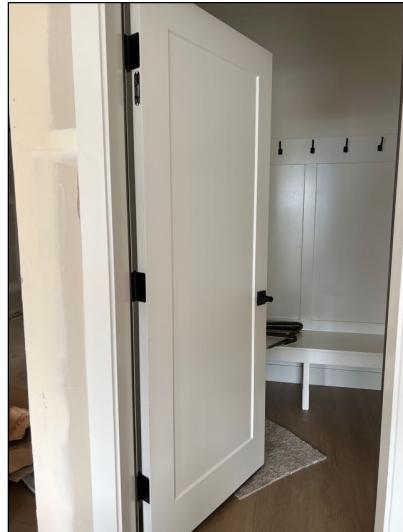
**2. Fire Door**

- Appeared satisfactory and functional, at time of inspection.

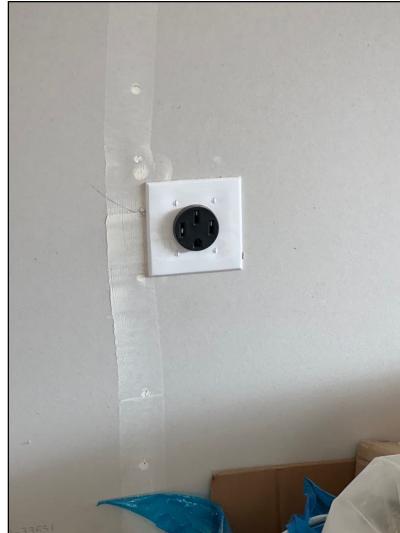
### 3. Electrical

- There is power to the 240 volt outlets.

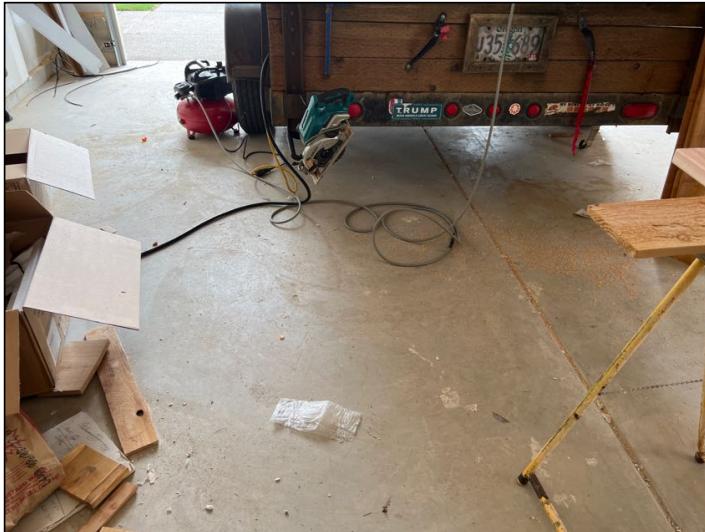
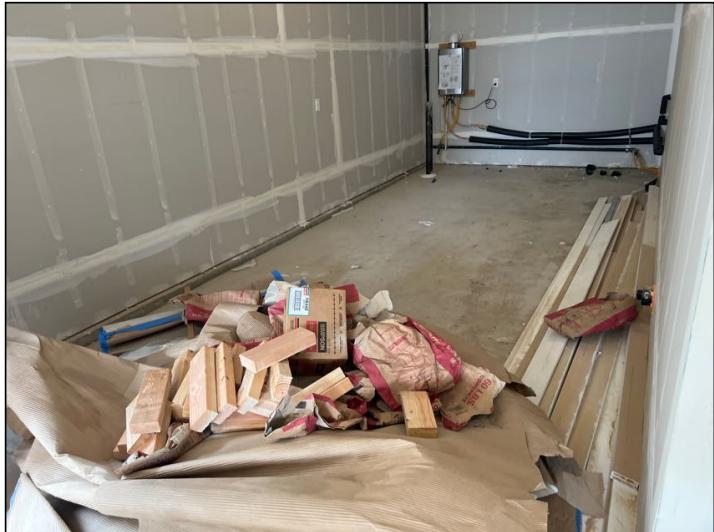
### 6. Floor Condition

- Appears functional.
- Common cement cracks noted.

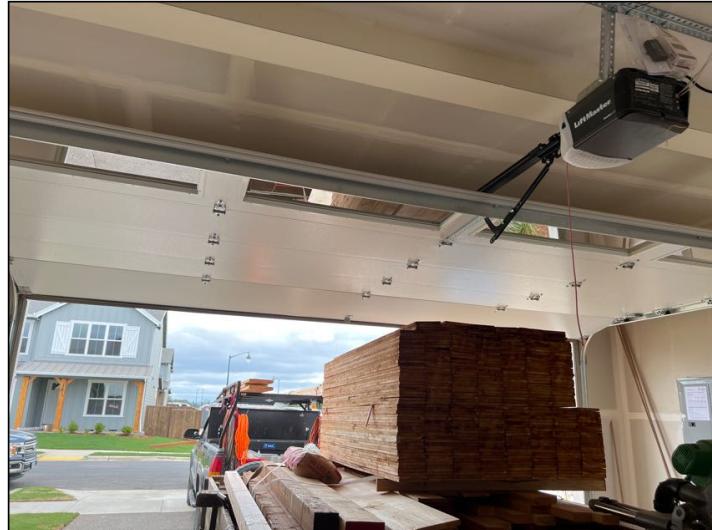
### 7. Garage Door Condition

- Appears operational- Visually inspected only. Garage door was not accessible for operation. How me

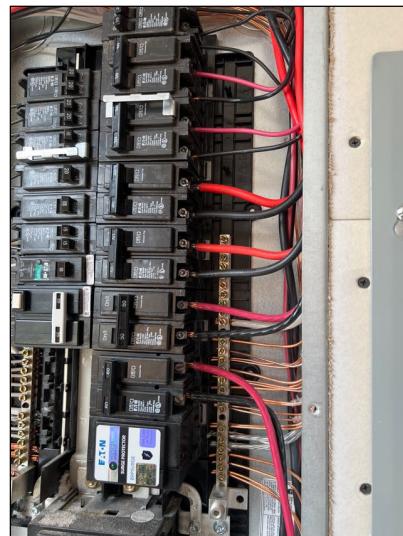
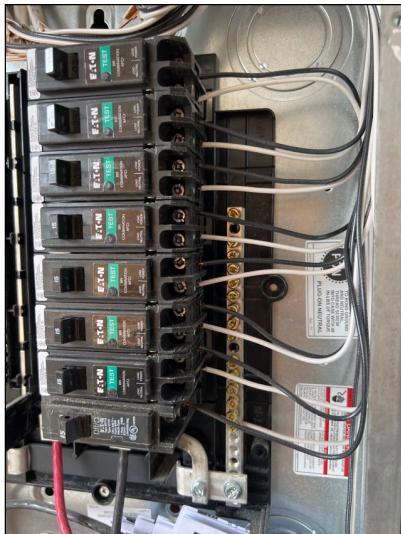
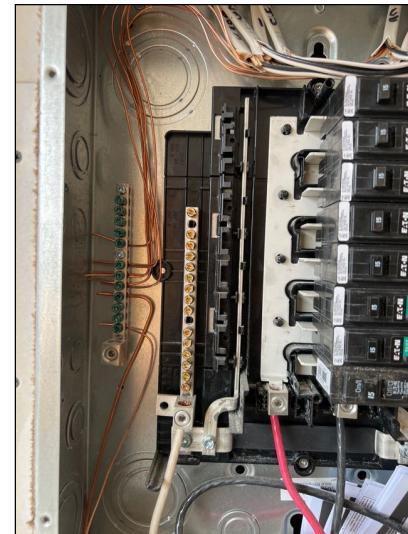
**2. Breakers**

- Circuit breakers appeared serviceable.

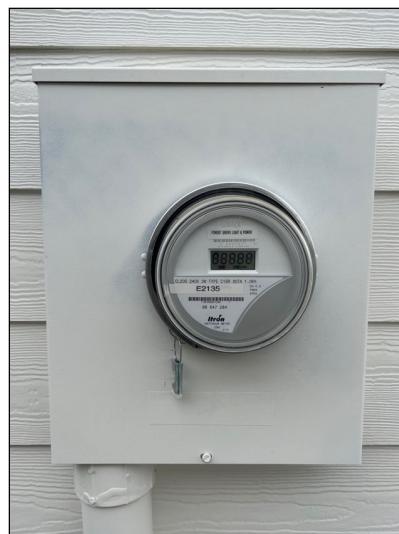
### 3. Cable Feeds

- There is an underground service lateral noted.

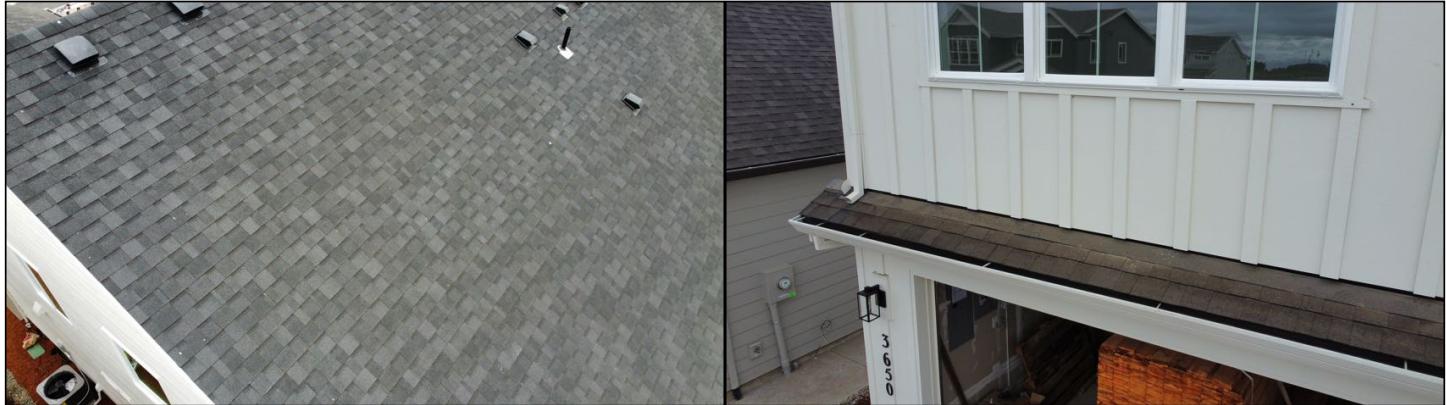
- Visible flashing appears functional.

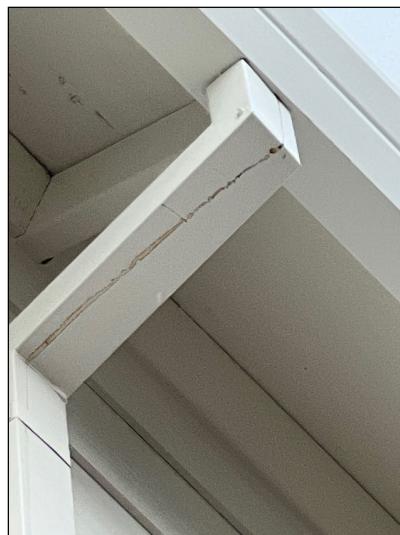
Signs of downspout leaking At right front of structure. Recommend review to ensure a watertight seal and proper drainage.

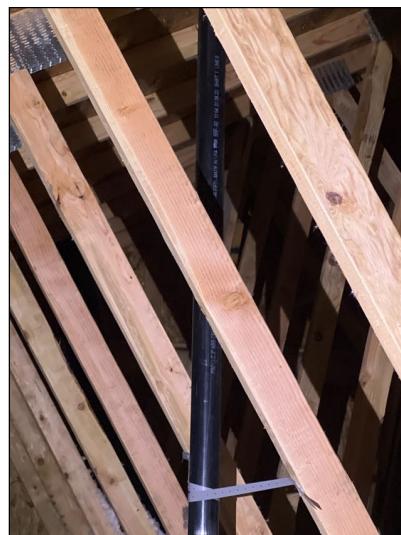
- ABS plumbing vents

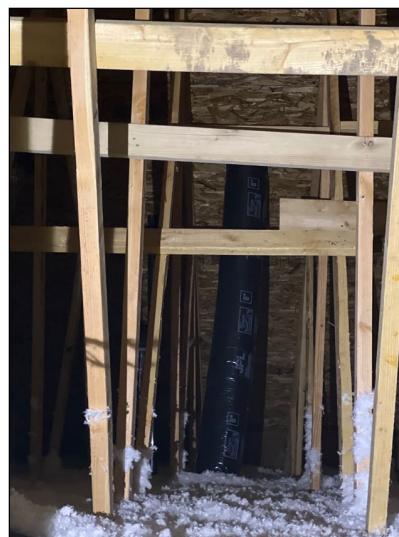
- Functional.
- Properly vented to exterior of structure.

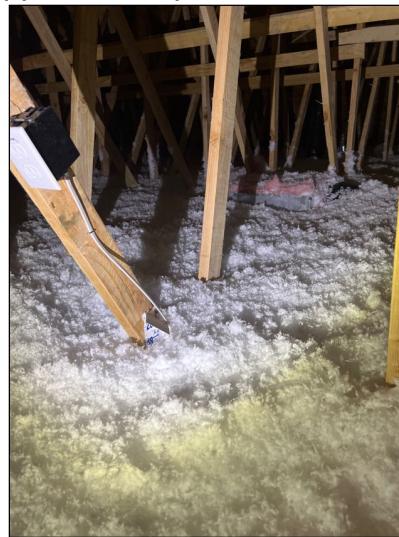
- Insulation appears adequate.

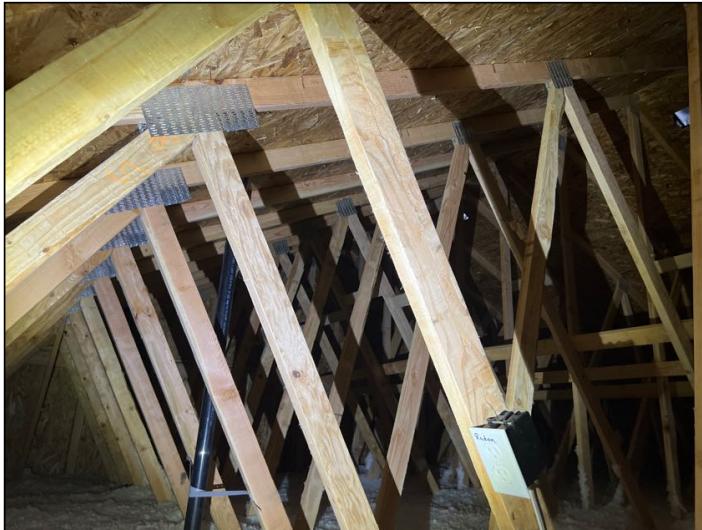
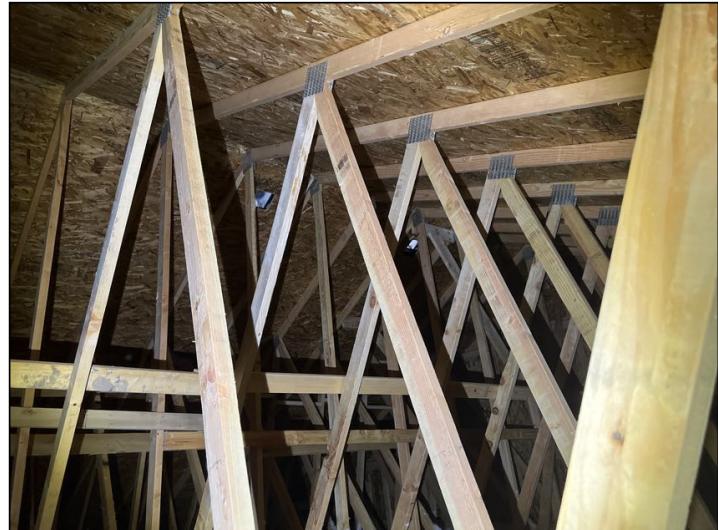
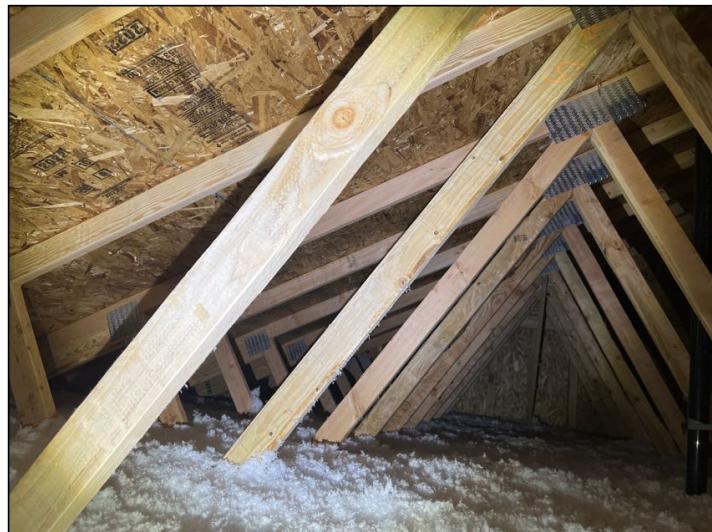
- Appears structurally sound.

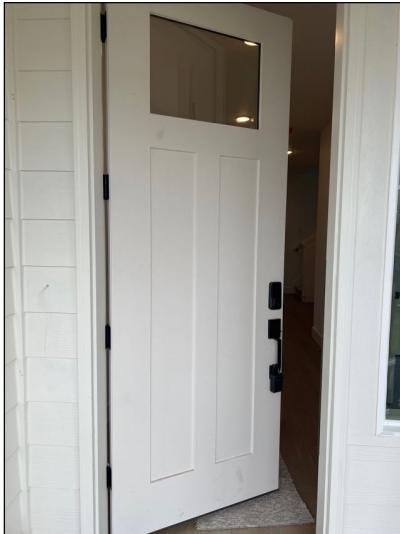
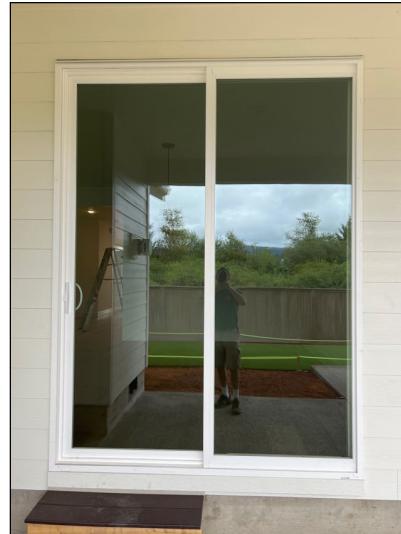
- Appeared in functional and in satisfactory condition, at time of inspection.

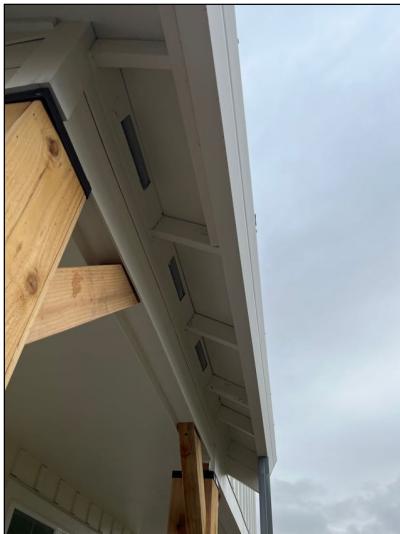
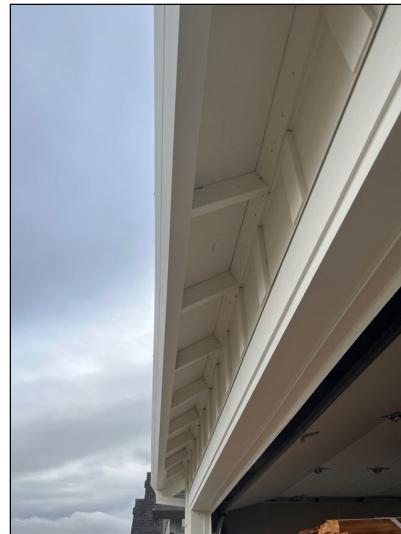
- Appears functional.

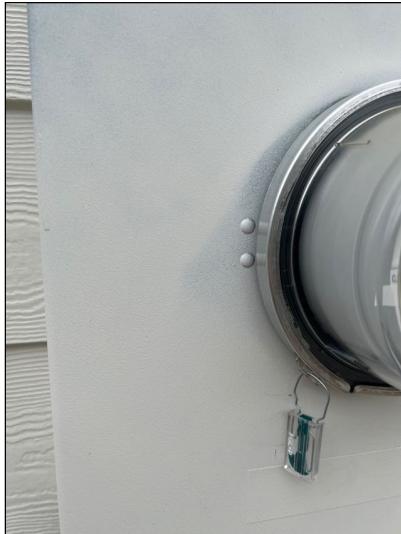
Touch up paint is needed in some areas.

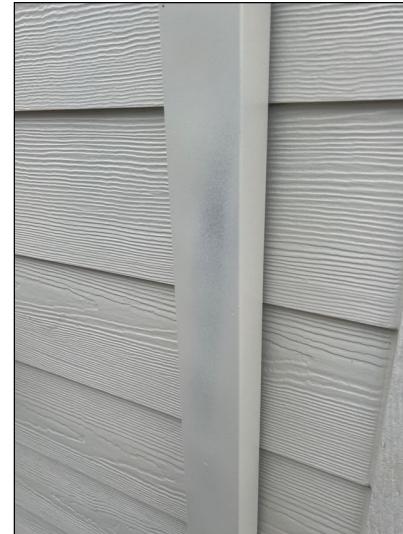
Touch up paint is needed in some areas.

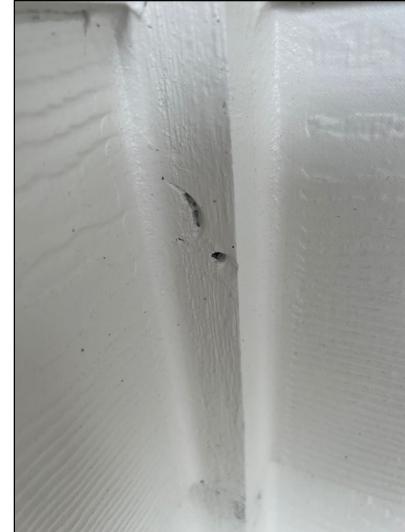
Natural wood trim has some knot holes. Consider caulking or, at the very least, monitoring for the presence of insects, bird damage, or other activity.

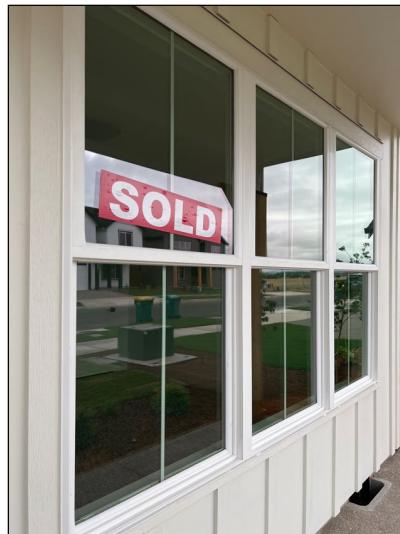
- Components appeared in satisfactory condition at time of inspection.

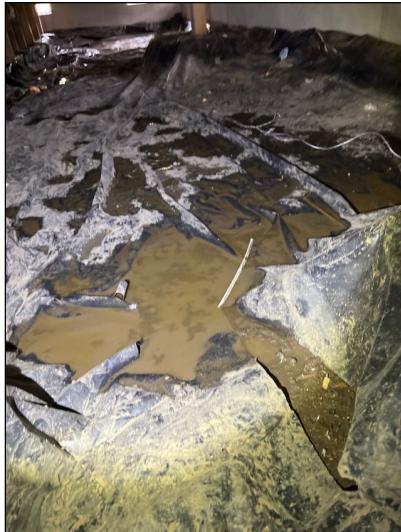
Standing water noted in crawlspace. May be residual from construction phase. This can lead to mold and other moisture issues within this home.

Recommend review by licensed foundation drainage specialist to ensure sump pump is sufficient.

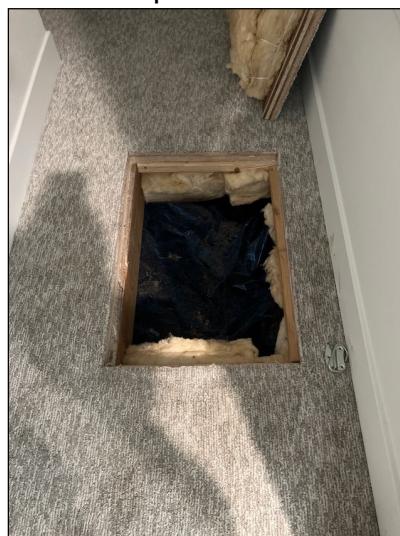
- Interior access panel installed and functional during the inspection.
- Some areas of Crawlspace not accessible due to standing water.
