# Oregon NW Home Inspections

## Property Inspection Report

1234 NE Anywhere, Anywhere, OR 97777

Date of Inspection: 8/10/2022 Time: 9:00 AM

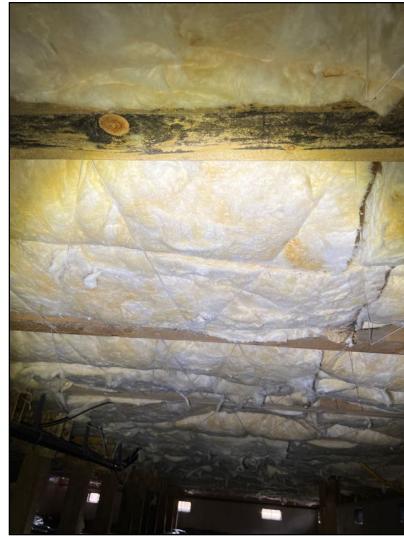
- Subfloor insulation noted. Appears functional. Limits view of subfloor.

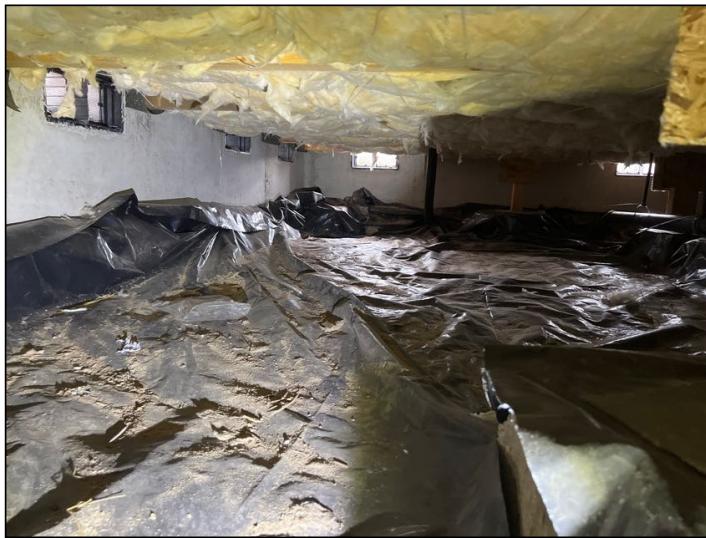
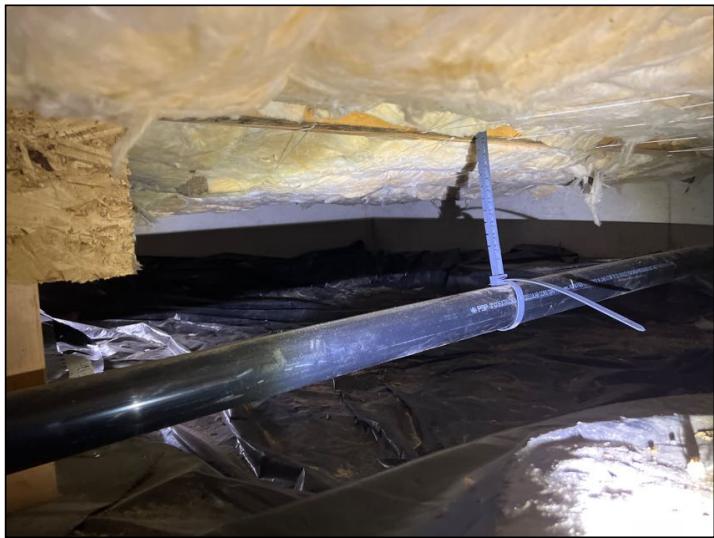
- In place and functional.

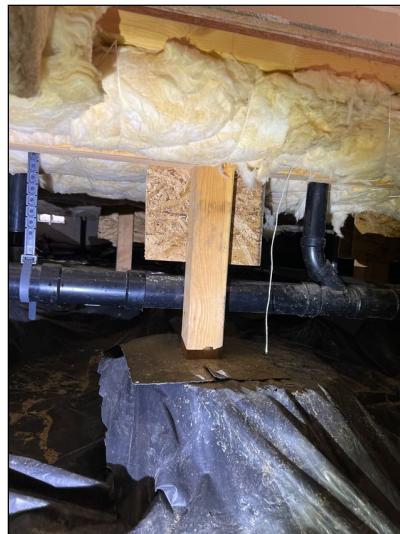
- Concrete piers/wood posts support floor above.

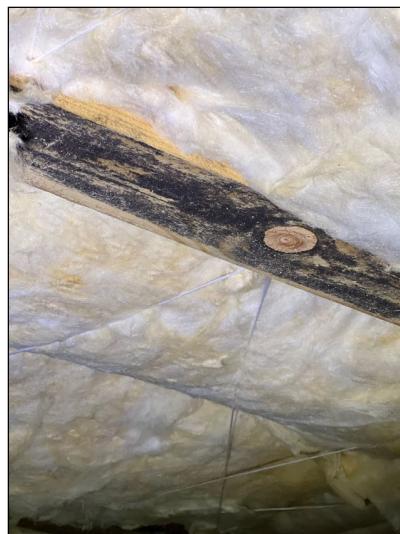
Biological organic growth observed at some framing members. Recommend affected areas are cleaned with an antimicrobial detergent and sealed with Kilz or something similar. Most likely from lumber being stored in wet conditions before/during construction.

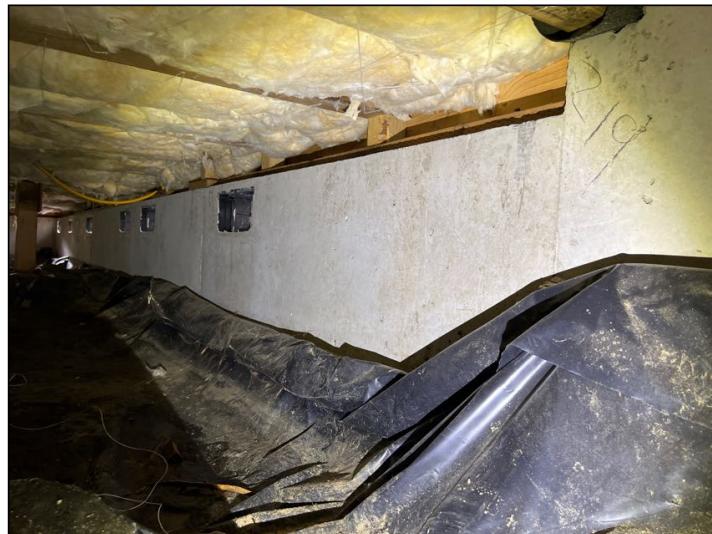
- Walls appear functional.

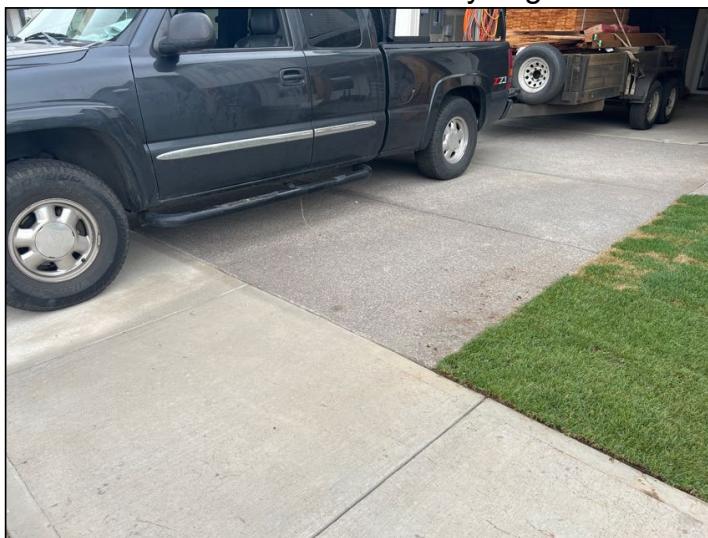
- Sidewalk is in good condition.
- Driveway in good condition.

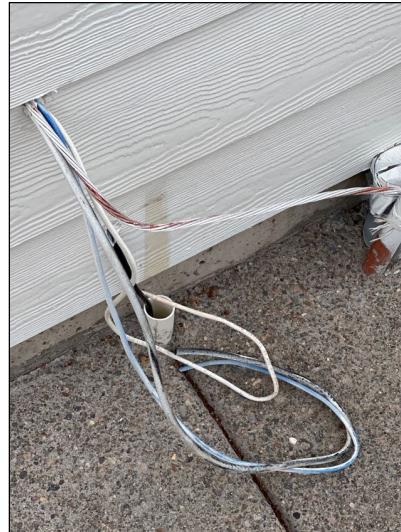
Low voltage electrical installation is incomplete and left front instruction.

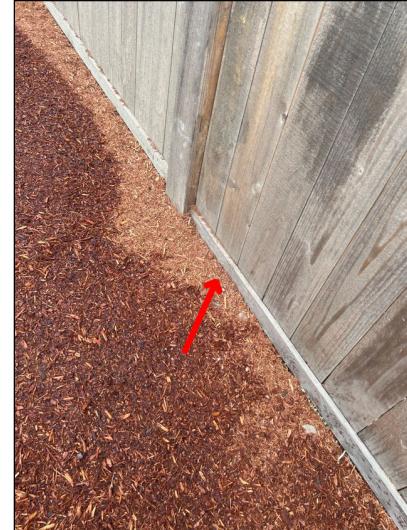
Fence installation is incomplete.

Recommend one inch between soil and fence to prevent decay.

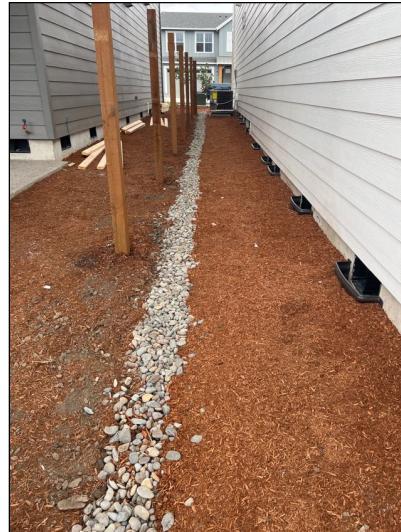
- Lot grading and drainage have a significant impact on the building because of the effect that moisture can have on the foundation. It is important that surface runoff water be adequately diverted away from the home. Ideally, lot grading should slope away and fall one inch every foot for a distance of five feet around the perimeter of the building.
- Drainage system appears to be in place.

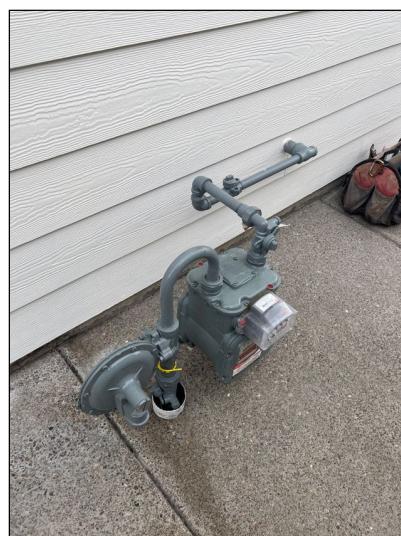
- Meter located at exterior.

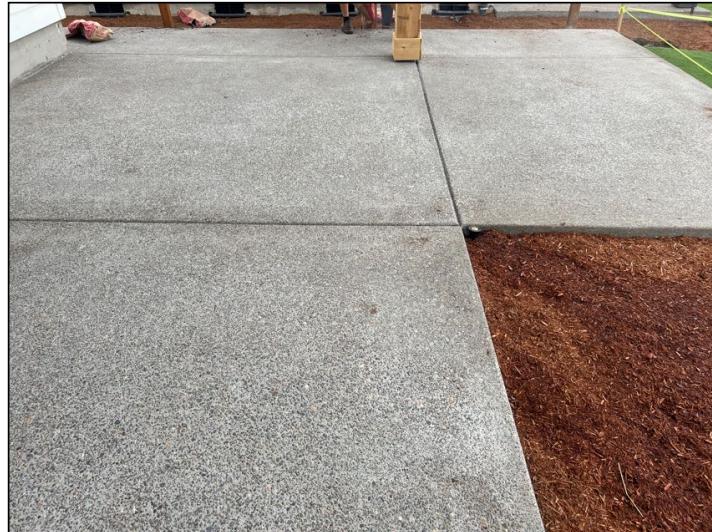
- Slab is in good condition.

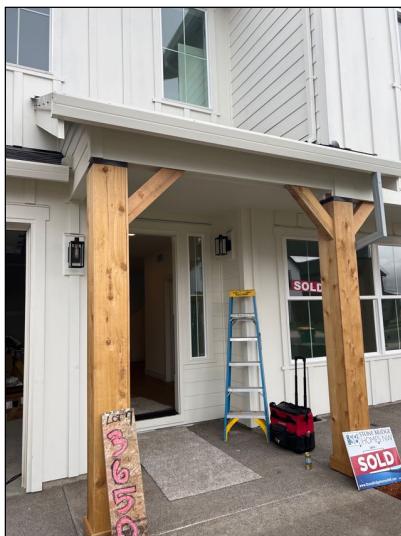
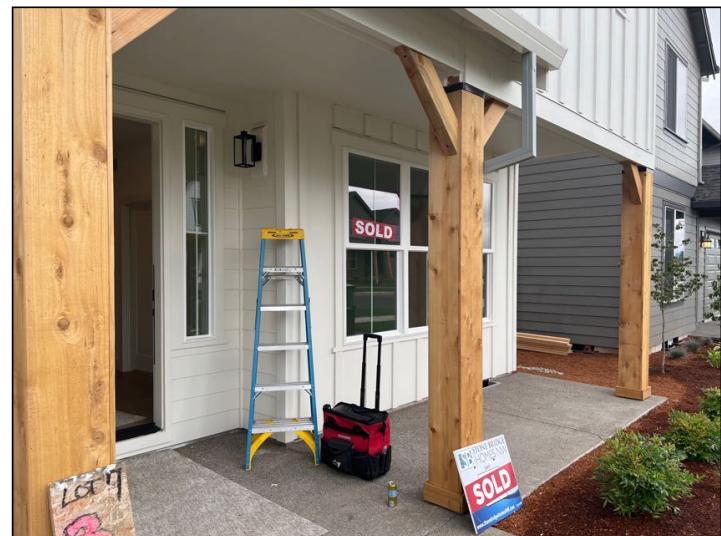
- Paint posts as needed.
