# Insight Home Inspections

## Home Inspection Report

**8195 North Park Dr**

Inspected on Wed, Oct 17 2018 at 2:14 PM

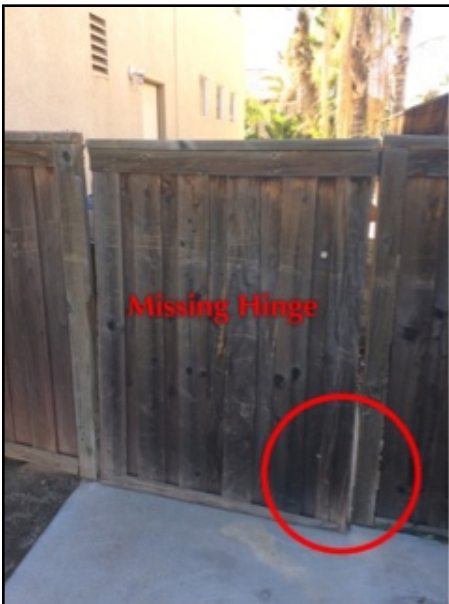
Figure 3-3

Comment 3:  
Both side gates are not functioning properly due to natural break down of material.  
Recommend repair.

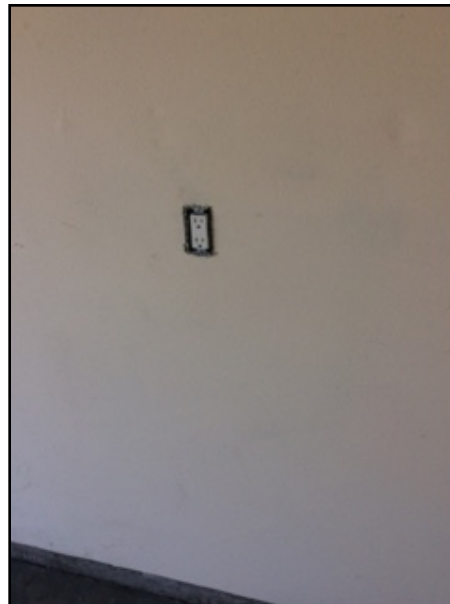
Figure 10-2

Comment 10:  
Multiple outlets are missing face plates. This exposes "hot" connections.  
Recommend repair.

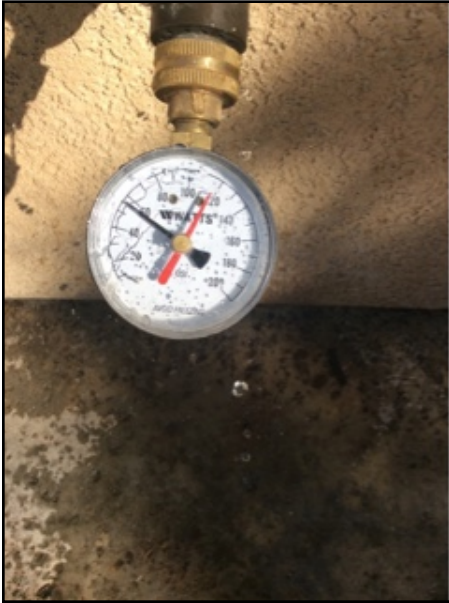
Figure 13-1

Comment 13:  
Water pressure is satisfactory at 55 psi.

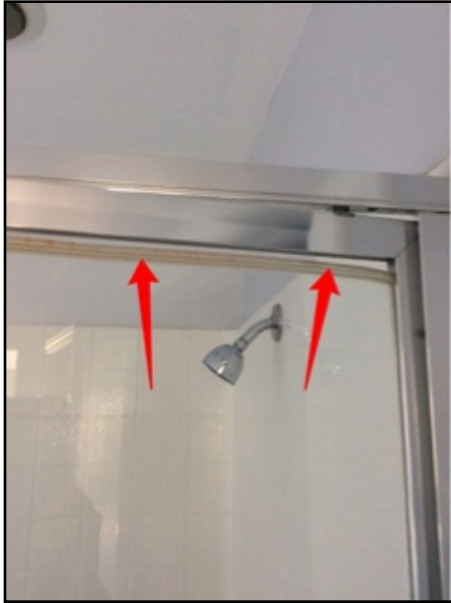
Figure 29-1

Appears glass is slipping away from top of frame.

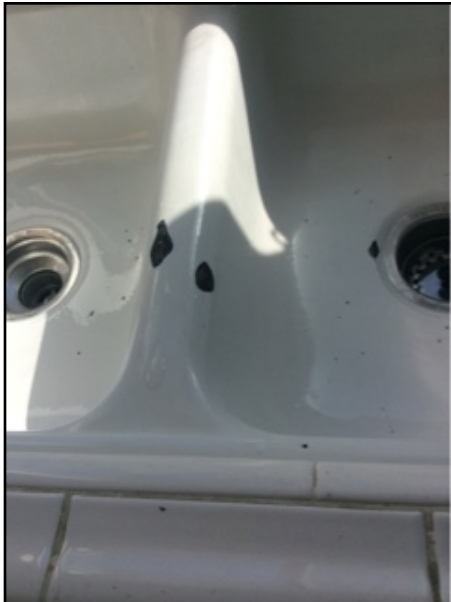
Figure 35-1

Comment 35:  
Chipped sink surface in multiple areas.

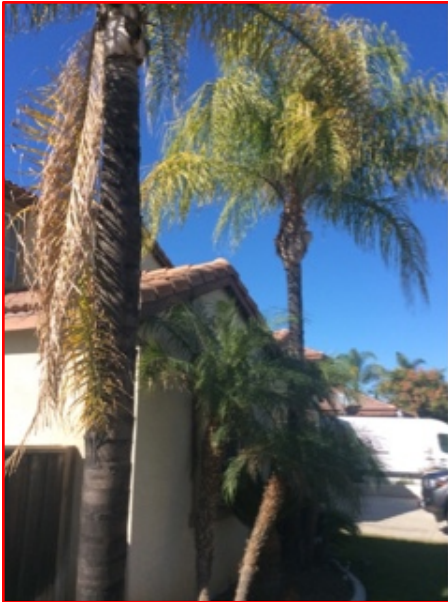
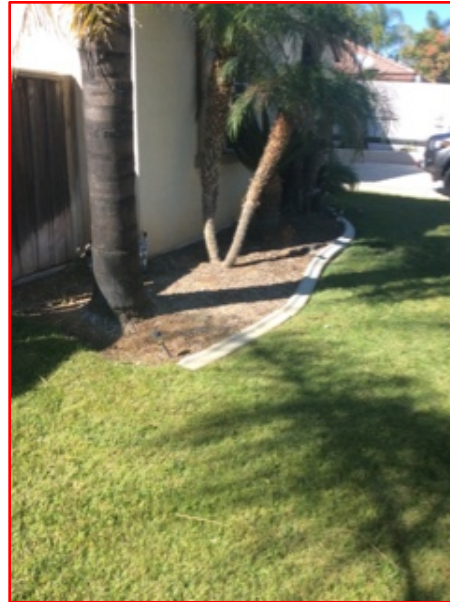
1) Palms in front of property are within 6 feet of structure and growing against structure. This may lead to structural damage. Recommend removing larger palms and trimming away from structure.

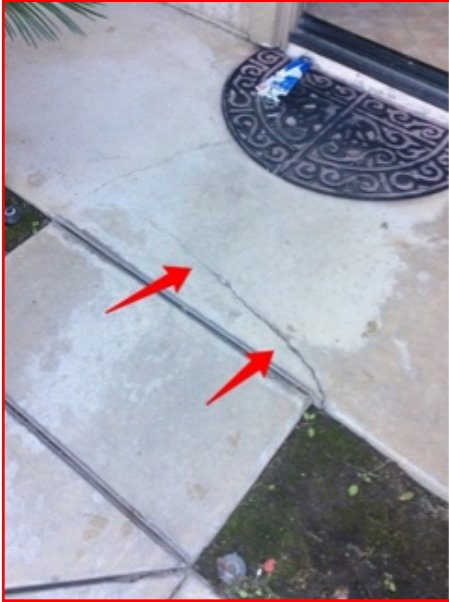
Figure 2-1

2) Slight crack in in entryway concrete. This may shift and become a trip hazard in future. Recommend repair.

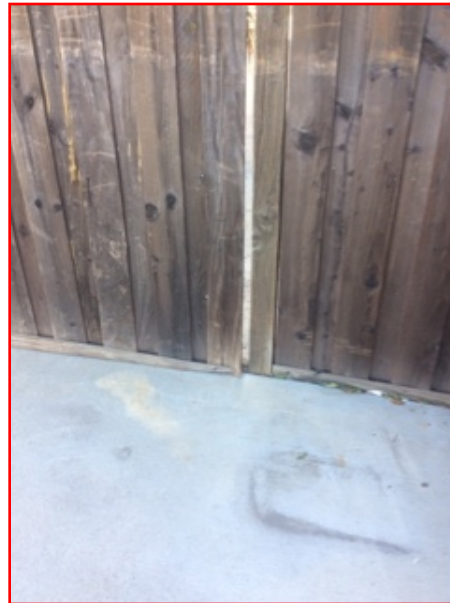
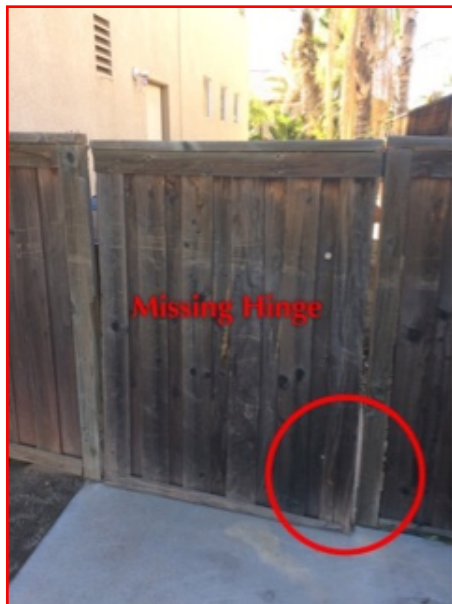
3) Both side gates are not functioning properly due to natural break down of material. Recommend repair.

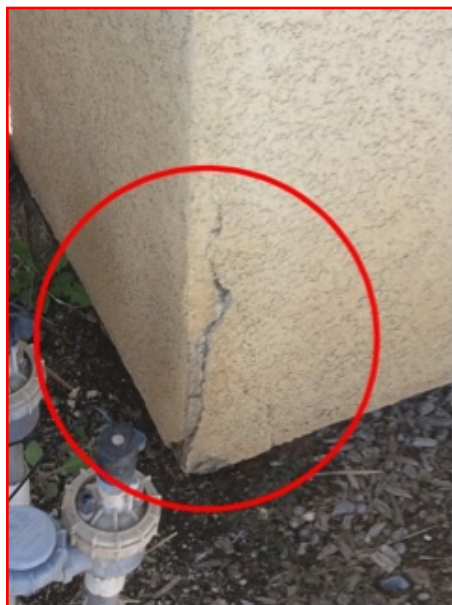
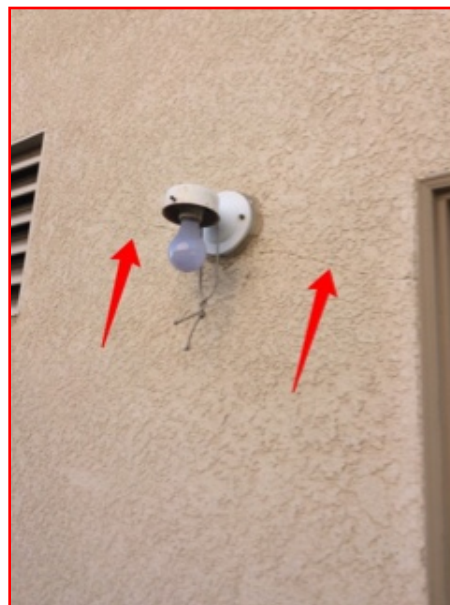
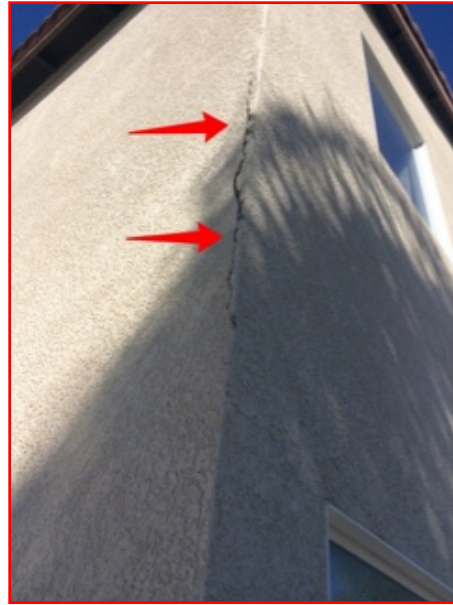
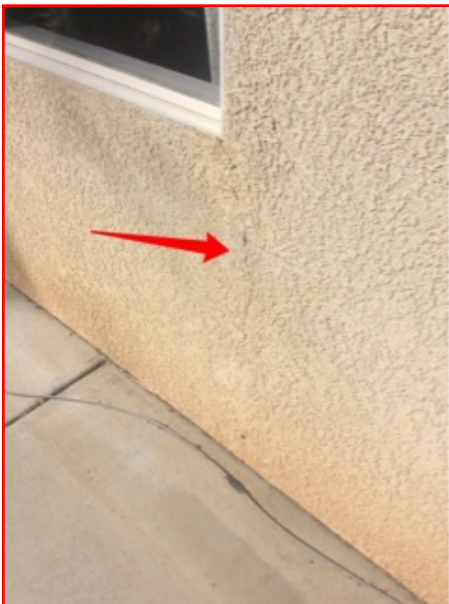
4) Multiple areas of cracked and failing stucco. Does not appear to be structural. Recommend repair to prevent water intrusion.

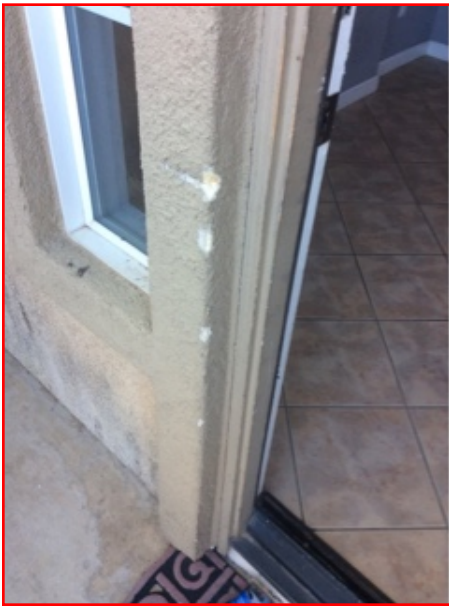
7) Exposed foam from failing stucco. Recommend repairing to prevent water intrusion.

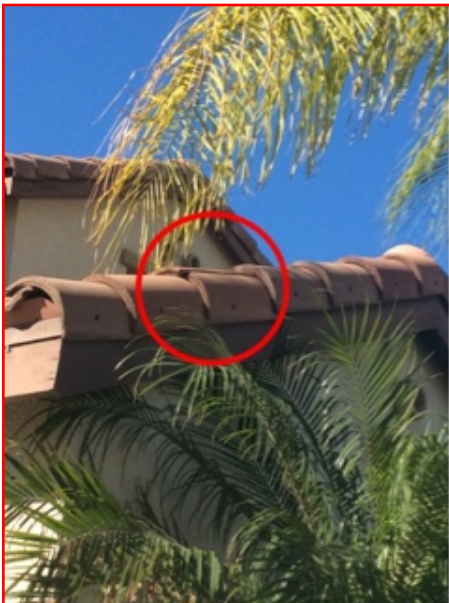
Figure 8-1

8) Improper end tile. Separation in tile will allow moisture to penetrate into wood fascia. Recommend replacement.

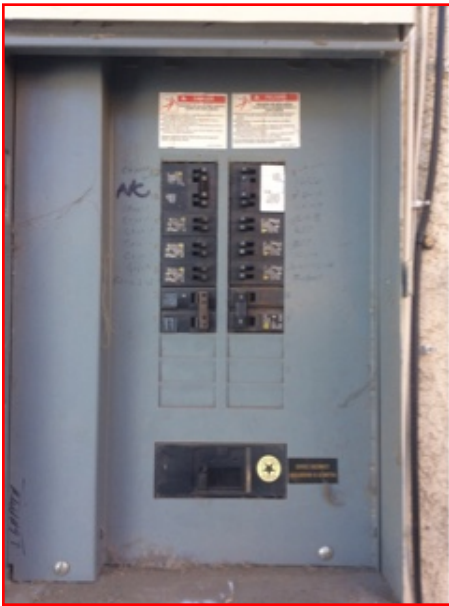
Figure 9-1

9) Labels are needed for all breakers.

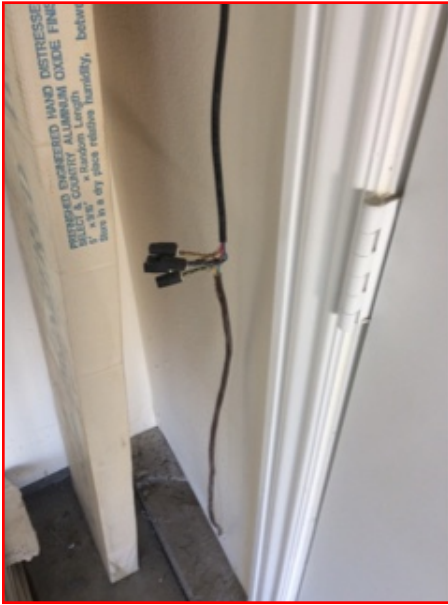
Figure 11-1

11) Recommend proper junction box for sprinkler wire. Wires need to be mounted properly.

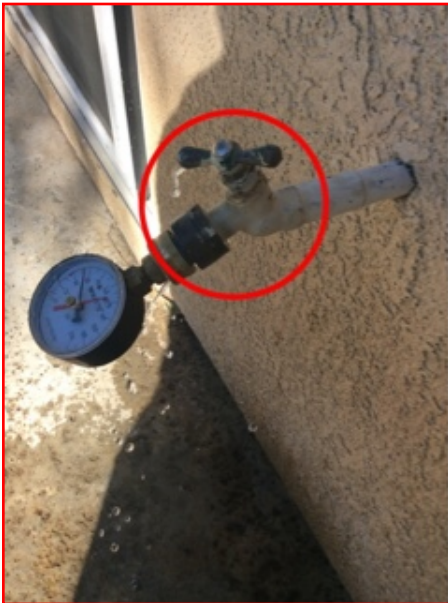
Figure 14-1

12) Hose bib valve is leaking when opened under pressure. Recommend replacing.

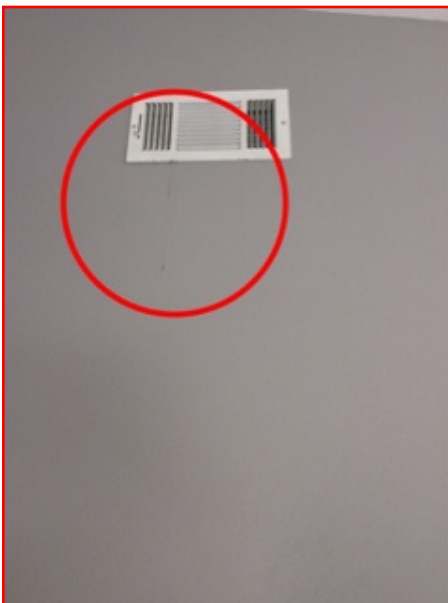
Figure 16-1

14) Yellow water drips from vents typically indicate condensation drainage stoppage or multiple issues caused by a clogged air filter. Recommend further evaluation and service by a HVAC technician.

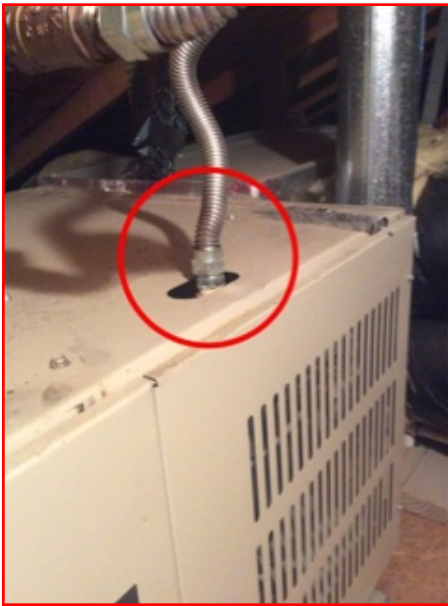
Figure 17-1

15) Possible slight gas leak at supply line. Recommend further evaluation.

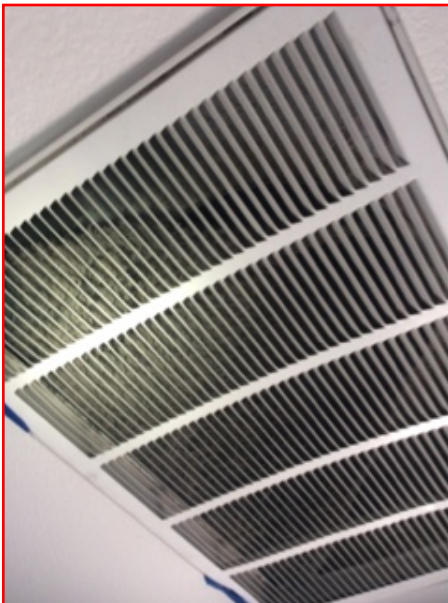
Figure 18-1

16) Air return filter is extremely dirty and needs to be replaced. Recommend replacing filter every 3-6 months.

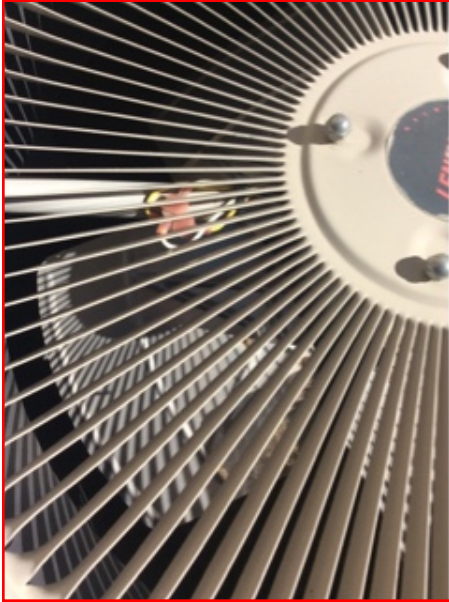
Figure 19-1

17) Wiring in condenser indicates motor has been replaced or a "quick start" may have been installed. Recommend further evaluation.

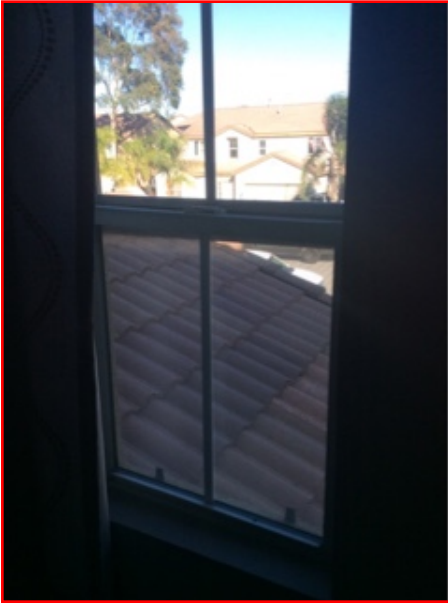
Figure 20-1

18) Single hung window in upstairs bedroom is not staying open. Recommend repair.

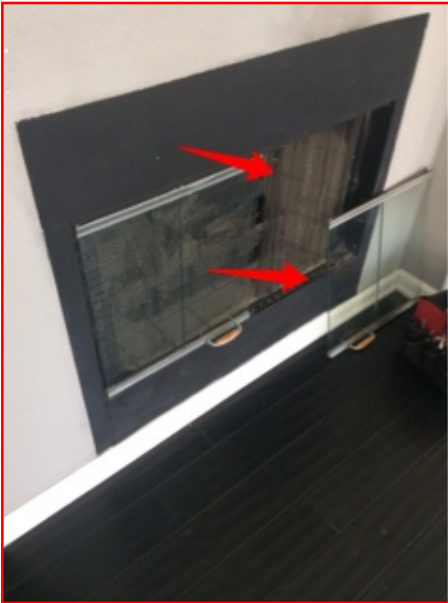
Figure 21-1

19) Fire place door is off hinge. Recommend repair.

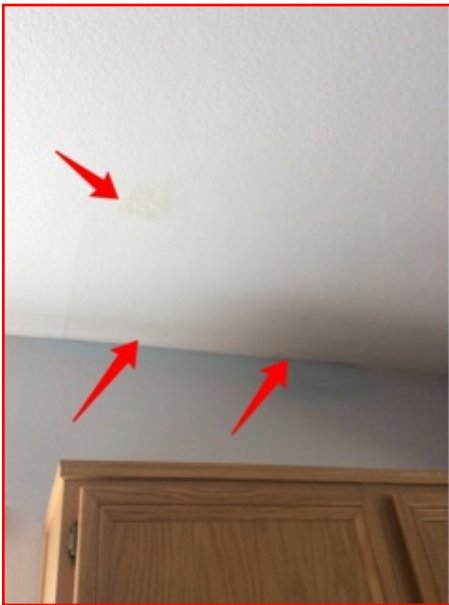
Figure 23-1

21) Ceiling patch in kitchen indicates previous leak from above shower. Moisture not present at time of inspection.

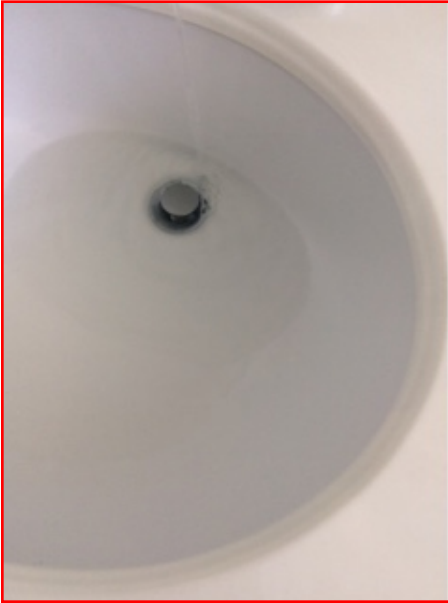
Figure 24-1

22) Sink is not draining at a satisfactory rate. Recommend repair.

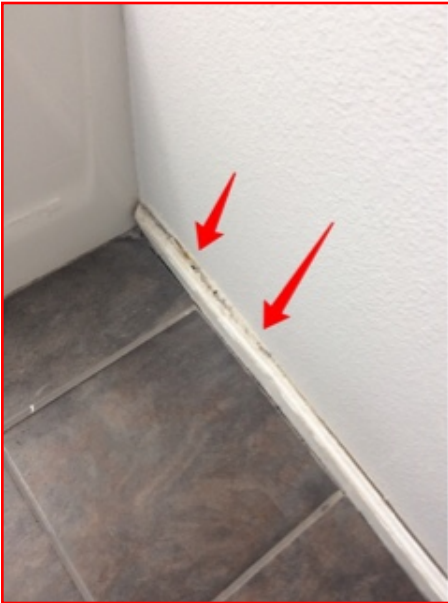
Figure 25-1

23) Baseboard is warped due to moisture exposure from the shower.

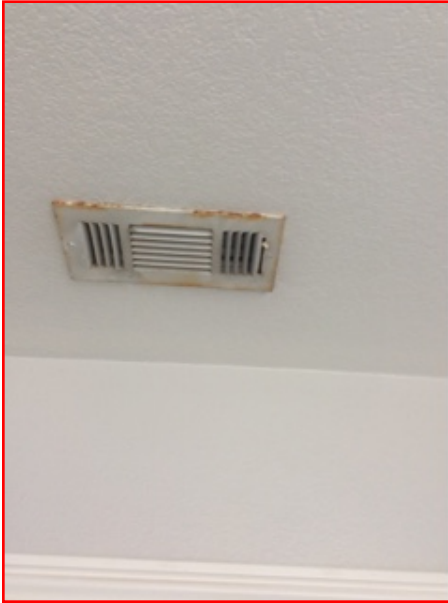
Figure 26-1

24) Rusted vents are indications of poor ventilation.

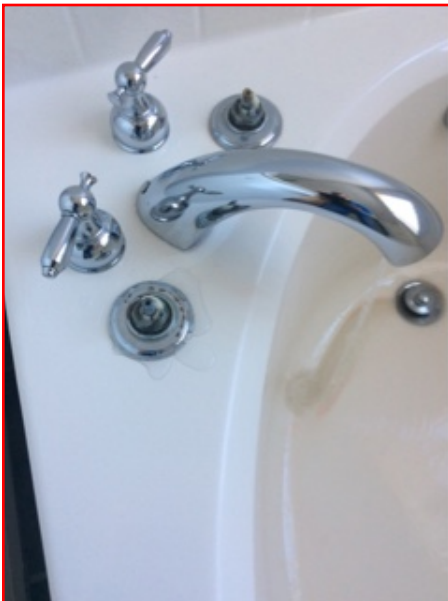
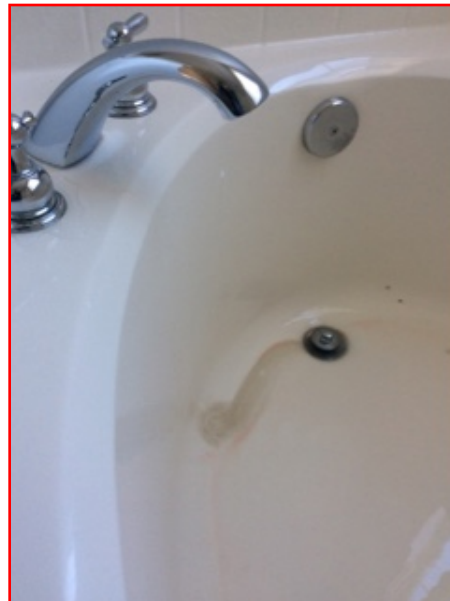
25) Tub fixture handles are not properly mounted and are leaking from valve and spout. Recommend repair.

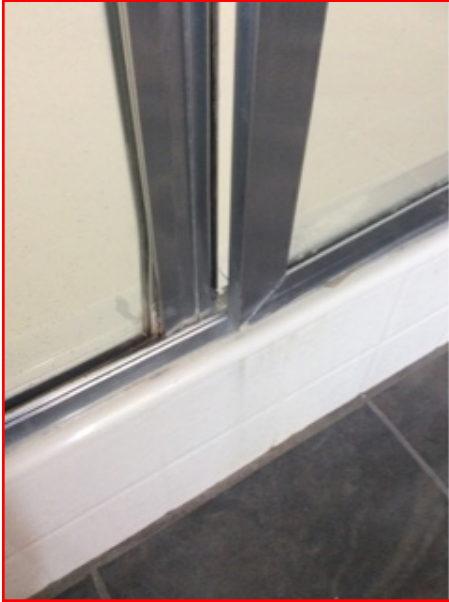
Figure 28-1

Shower door is not hanging even on hinge causing door to get stuck on frame. Recommend repair.

26) Shower door is not hanging even on hinge causing door to get stuck on frame. Recommend repair.

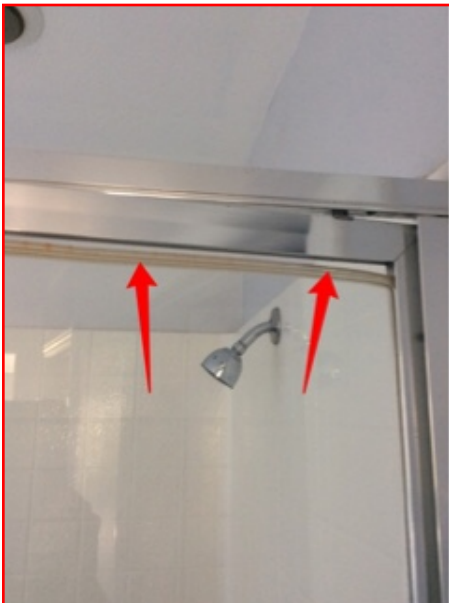
Figure 29-1

27) Appears glass is slipping away from top of frame.

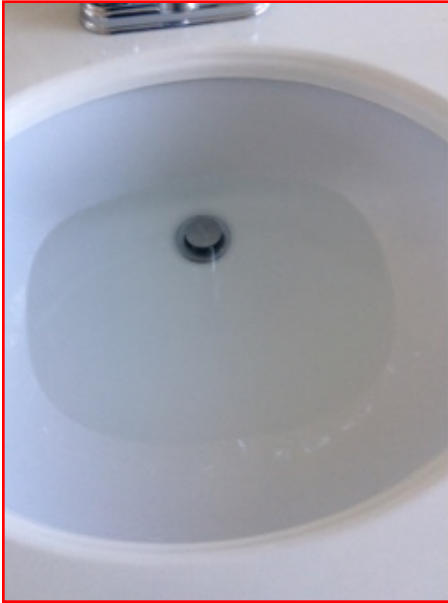
Figure 30-1

Double Vanity  
Condition: Marginal

Comment 30:  
Sink is not draining at a satisfactory rate. Recommend repair.

28) Sink is not draining at a satisfactory rate. Recommend repair.

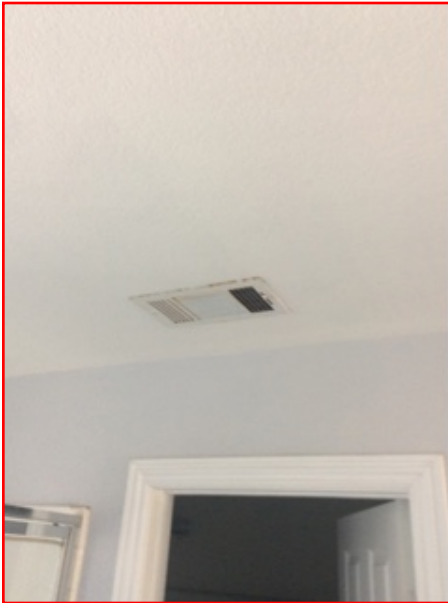
Figure 31-1

Comment 31:  
Rusted vent indicates poor ventilation.

29) Rusted vent indicates poor ventilation.

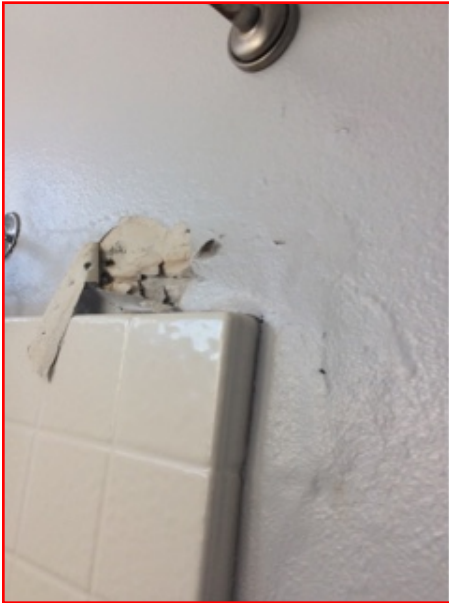
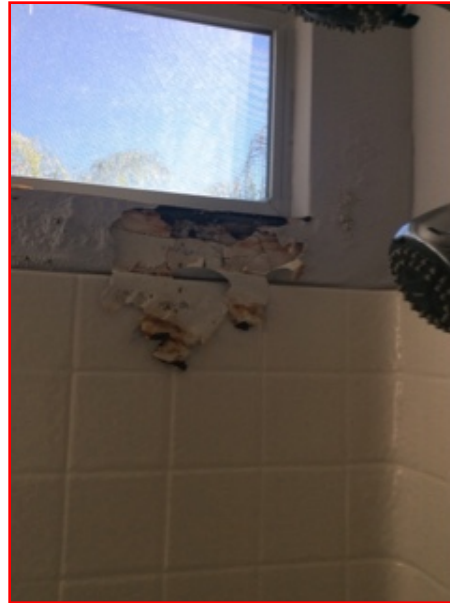
Water damage and possible fungal growth above shower walls. A direct sample of possible growth was taken and sent to Lab for analysis. Proper mold remediation will be needed if lab analysis come back as mold growth.

30) Water damage and possible fungal growth above shower walls. A direct sample of possible growth was taken and sent to Lab for analysis. Proper mold remediation will be needed if lab analysis come back as mold growth.

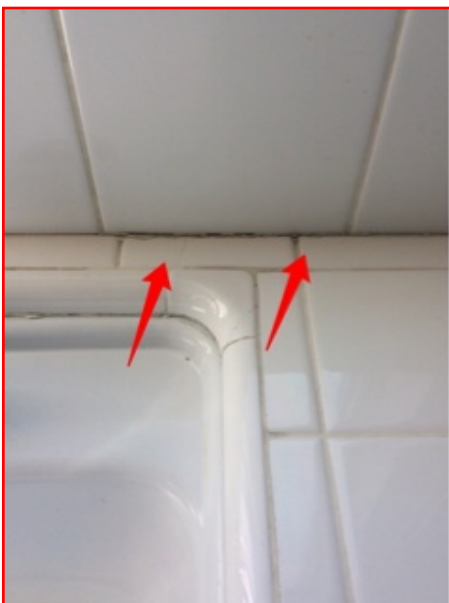
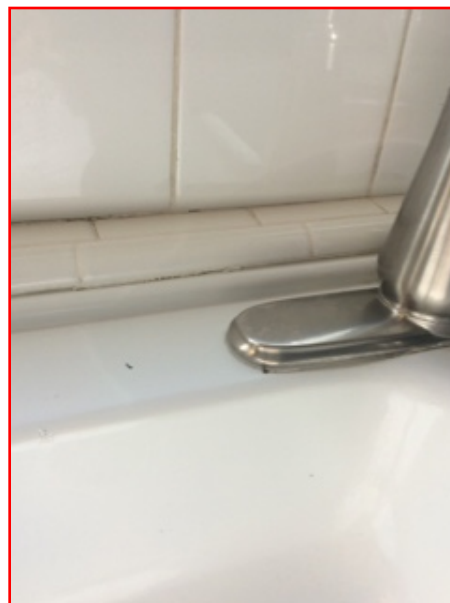
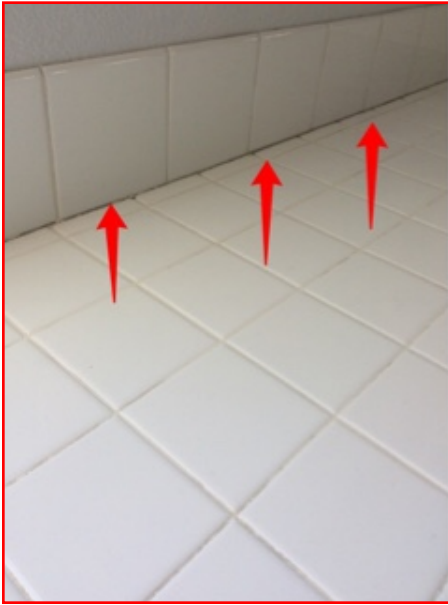
Failing grout along counter and backsplash. Recommend repair to prevent moisture intrusion.

31) Failing grout along counter and backsplash. Recommend repair to prevent moisture intrusion.

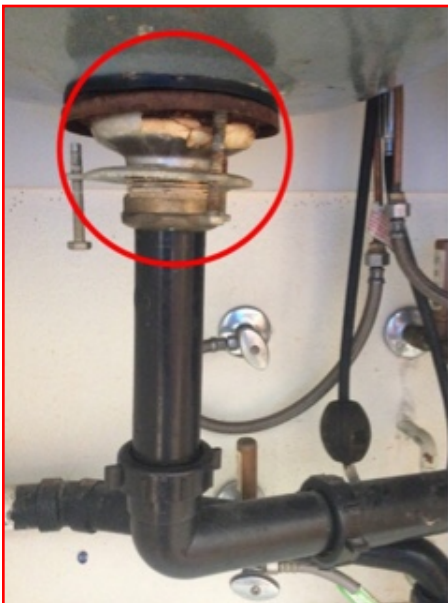
Figure 34-1

Comment 34:  
Strainer body, gasket and lock nut are all heavily corroded and rusted.  
Recommend repair p.

32) Strainer body, gasket and lock nut are all heavily corroded and rusted. Recommend repair p.

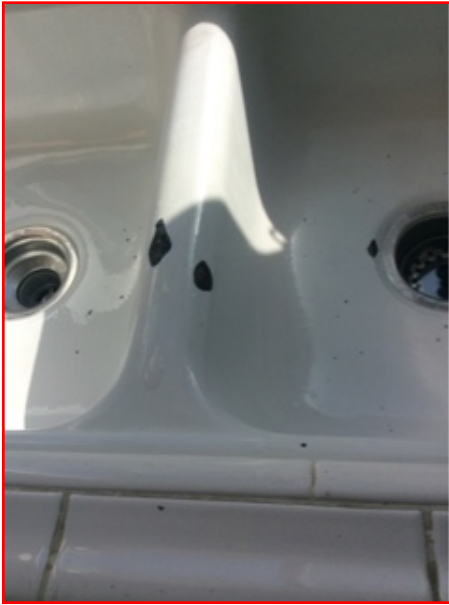
Figure 35-1

33) Chipped sink surface in multiple areas.

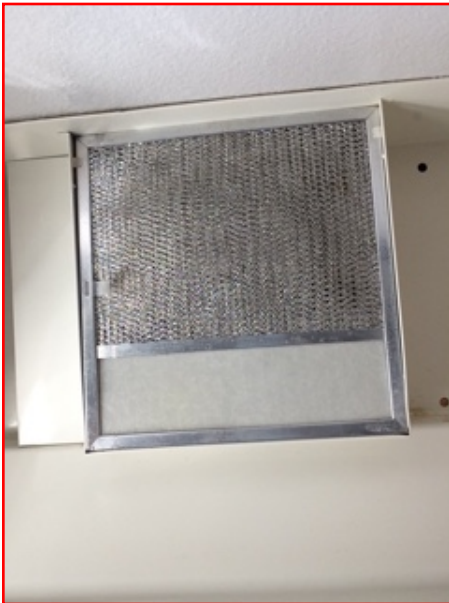
Figure 36-1

Comment 36:  
Hood light is not functioning. Recommend replacing light bulb.

34) Hood light is not functioning. Recommend replacing light bulb.
