Revised
FULL RESERVE STUDY
East Lake Woodlands
Community Association, Inc.

Oldsmar, Florida
Inspected - February 22, 2021
Revised - July 9, 2021

East Lake Woodlands Community Association, Inc.
Oldsmar, Florida

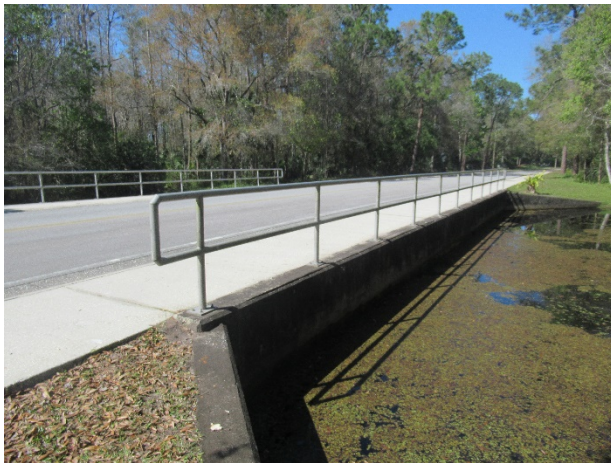
- Box Culverts (We consider the replacement of the railings as well as the asphalt pavement in the Reserve Study, but do not anticipate a predictable replacement date of the box culvert concrete structures)

Box culverts

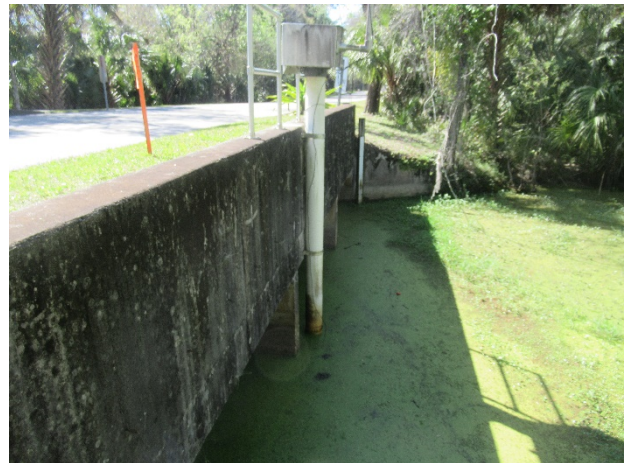
Box culverts

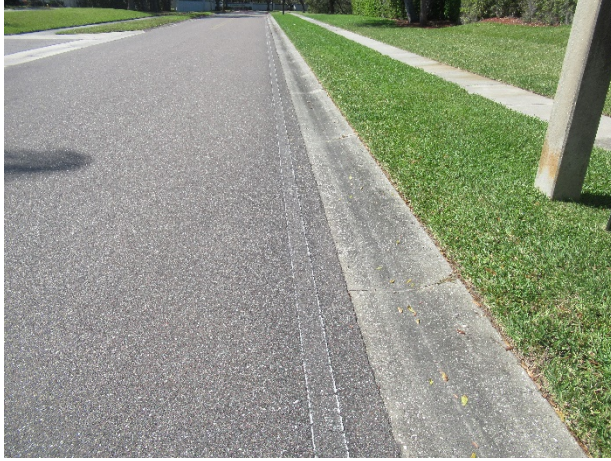
**Asphalt pavement – replaced in 2011 –
deterioration of the striping evident**

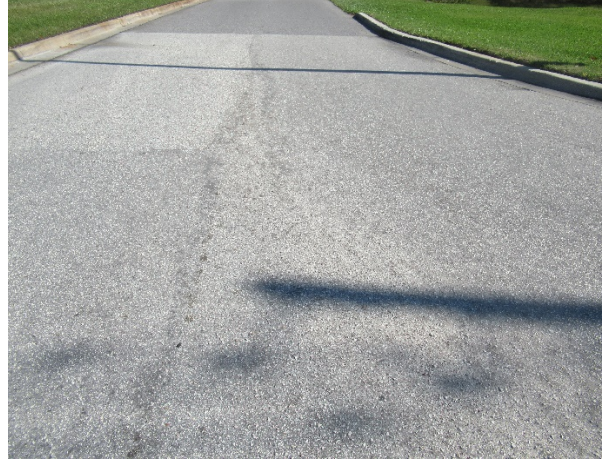
**Asphalt pavement – replaced in 2012 – south
gate entrance – raveling evident**

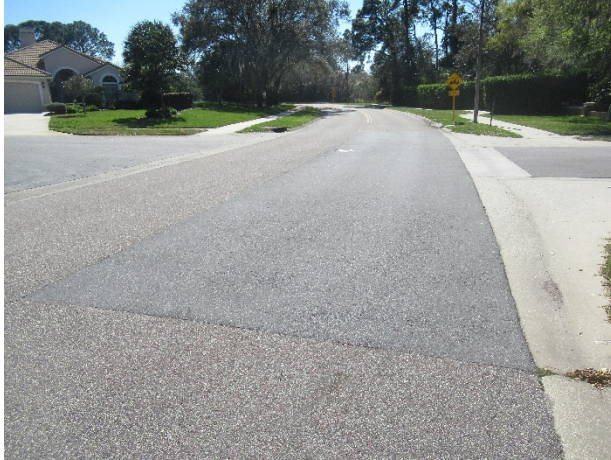
Asphalt pavement – replaced in 2013 – patch repairs evident

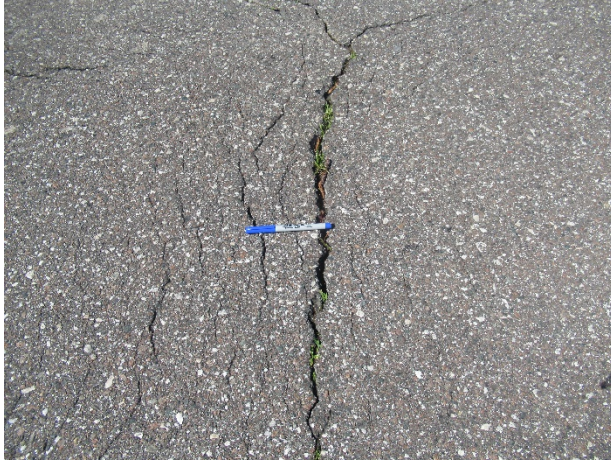
Asphalt pavement – Woodlands Drive – longitudinal cracks evident

Useful Life: 15- to 20-years with the benefit of timely patching with the exclusion of the roads at Woodlands Drive. At the request of the Board as well as due to the conditions noted during our inspection, we have reduced to useful life to repaving every 12 years for the Woodlands Drive section of asphalt pavement.

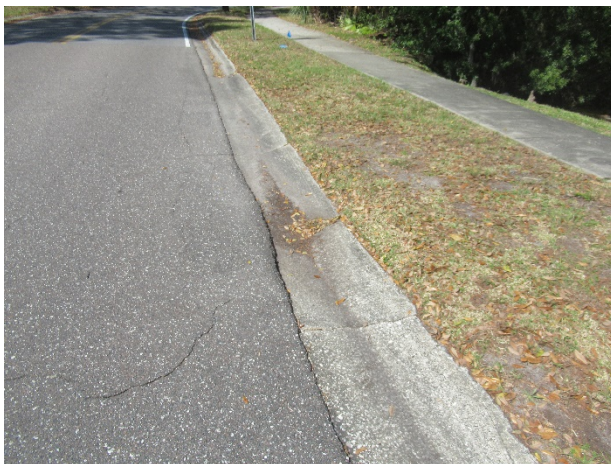
Concrete curbs and gutters – settlement evident

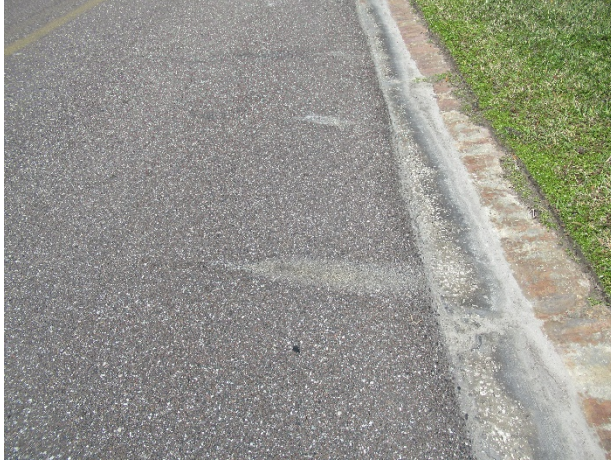
Concrete curbs and gutters – rust stains evident

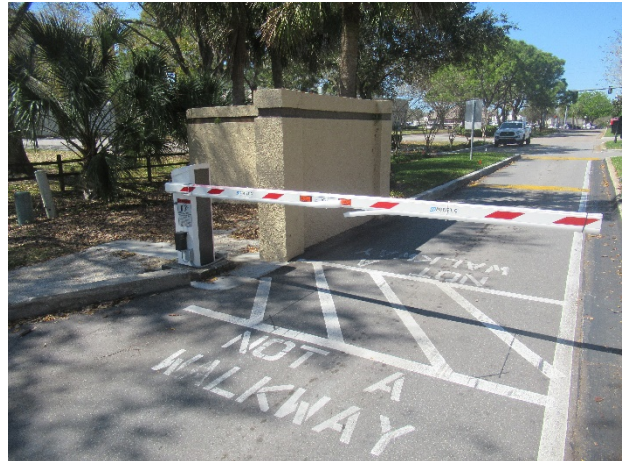
**Barrier arms and Operators – Woodlands
Parkway - overview**

Useful Life: Up to 10 years for the barrier arms and operators and up to 20 years for the sliding gates excluding the barrier arms and operators at the Woodlands Parkway entrance. Due to historical information provided by the Board, we have depicted the barrier arms and operators to be replaced every five years due to that entrance having a lower than expected useful life.

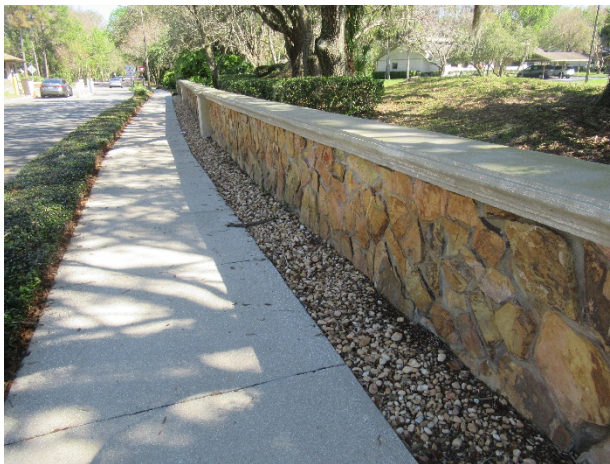
Condition: Good to fair overall with organic growth on the top cap

Knee walls - overview

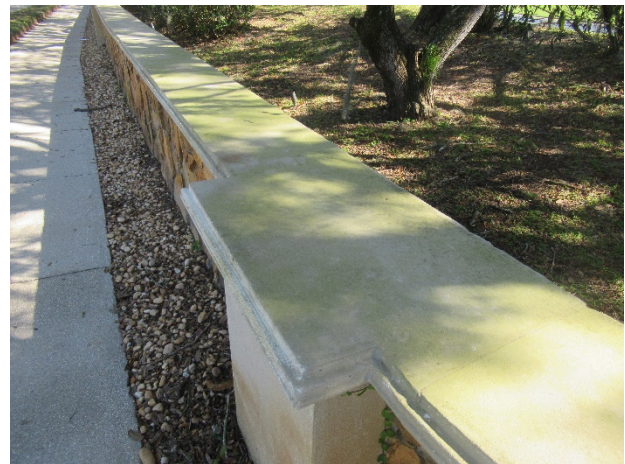
Knee walls – organic growth on the top cap

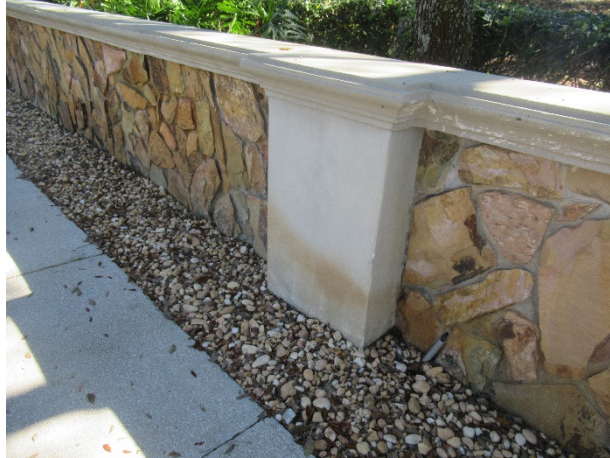
Knee walls – deterioration due to irrigation staining evident

Useful Life: We depict inspections and capital repairs every 10- to 15 -years

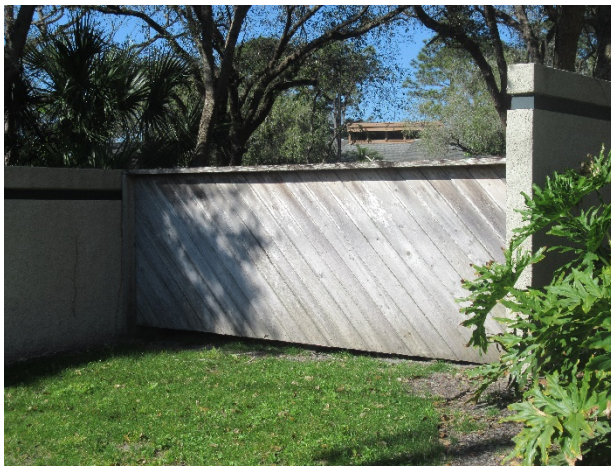
Perimeter walls – wood fence sections - Sunflower

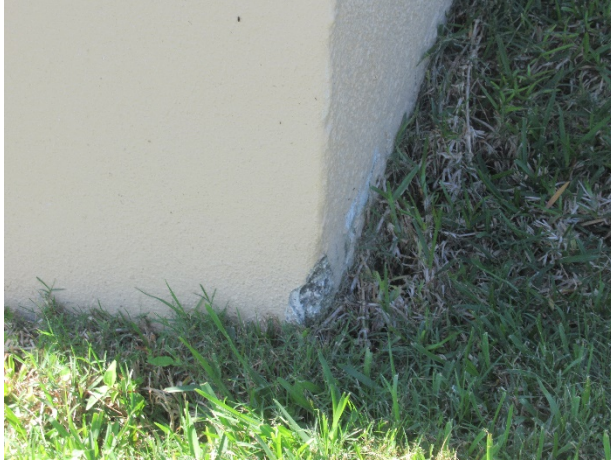
Condition: The walls are in fair condition overall with deterioration of the stucco coatings evident as well as deterioration of the wood fences at the perimeter wall on Sunflower

Perimeter walls – deterioration of the stucco coatings evident - South Entrance

Expenditure Detail Notes: Expenditure timing and costs are depicted in the **Reserve Expenditures** table in Section 3. Our estimate of cost anticipates repair or replacement of or up to one percent (1%), of the stucco in coordination with each paint finish application. Additionally, our estimate of cost for inspections and capital repairs of the perimeter walls at the Sunflower entrance include an allowance for replacement of up to fifty percent (50%) of the total quantity per event. The exact amount of area in need of repair will be discretionary based on the actual future conditions and the desired appearance. Each paint product has the limited ability to cover and seal cracks but we recommend repair of all cracks which exceed the ability of the paint product to bridge.

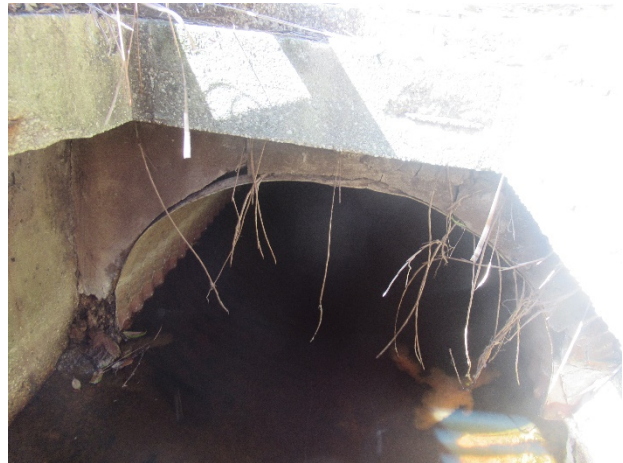
Condition: There have been a history of leaks as well as settlement at the pipes. We are informed that both of the sections of pipes will be televised in 2021 in order to determine if there are any obstructions.

Elkway – corrugated metal piping

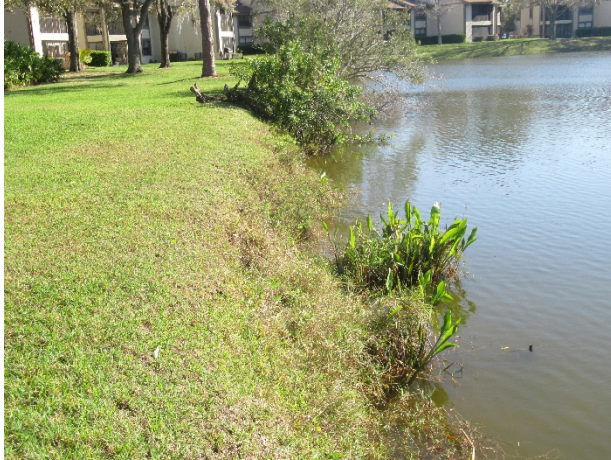
Condition: Good to fair overall with minor erosion evident

Pond shorelines – minor erosion evident

Expenditure Detail Notes: Expenditure timing and costs are depicted in the **Reserve Expenditures** table in Section 3. We recommend the Association plan to install a combination of plantings, shoreline stabilizations, and littoral shelf plantings around the pond along 735 linear feet, or approximately fifteen percent (15%), of the shoreline per event.

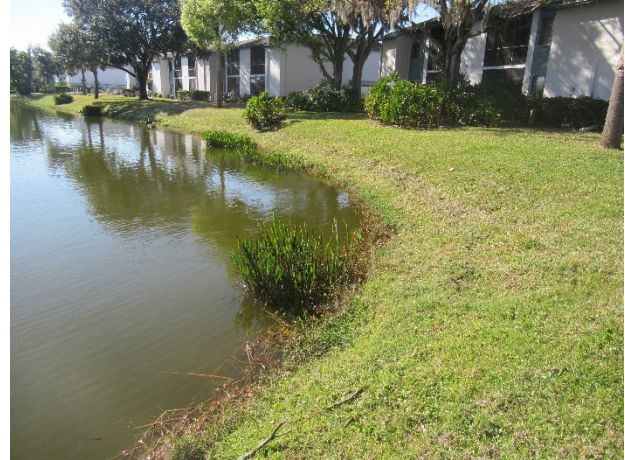
Pond shorelines – minor erosion evident

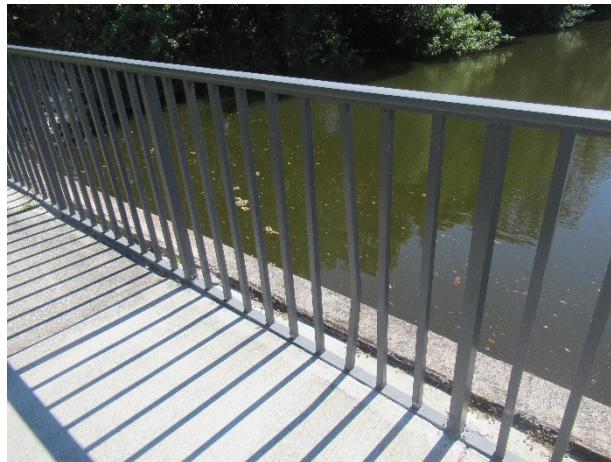
Condition: Good to fair overall with minor deterioration of the paint finishes evident

Metal railings – deterioration of the paint finishes evident

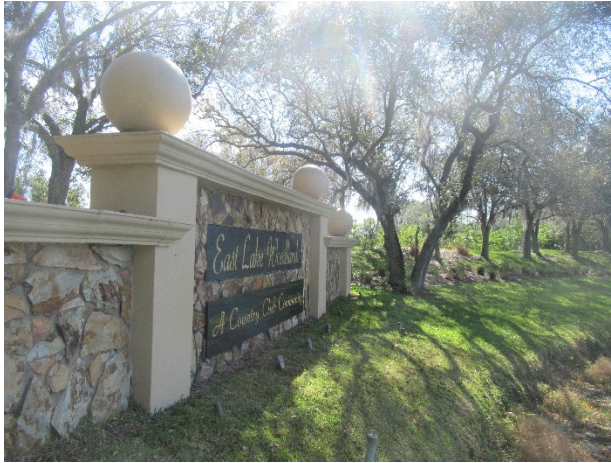
Entrance monument signage – south gate house

Condition: Fair overall with deterioration of the paint finishes evident.

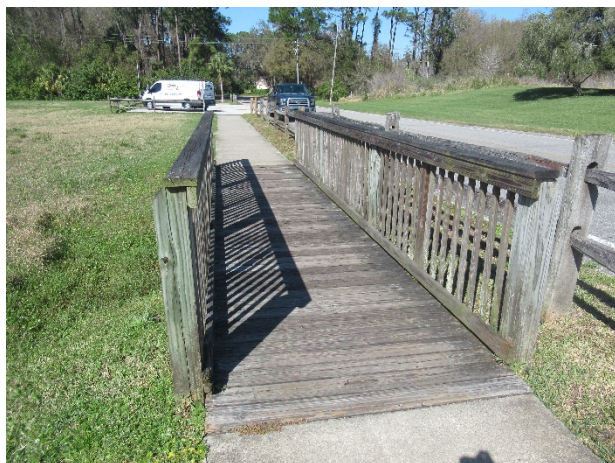
Wood walkways - overview

Condition: Good to fair overall with previous repairs evident
