PROPERTY INSPECTION REPORT

141 Greenville St. Newnan, GA. 30263

Dec 8, 2021

1599

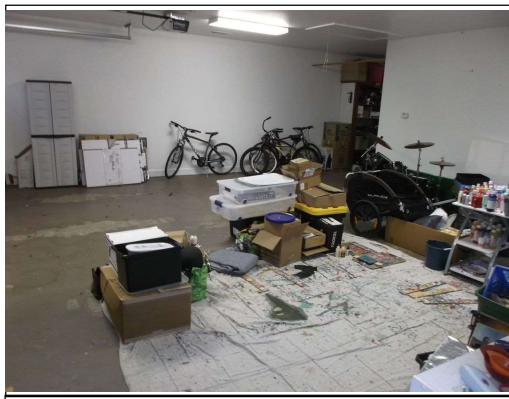
Belongings in garage

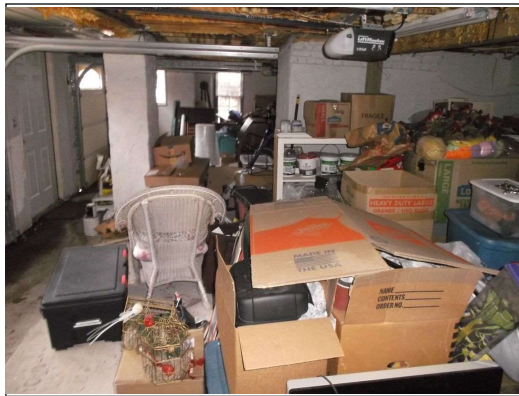
Belongings block view

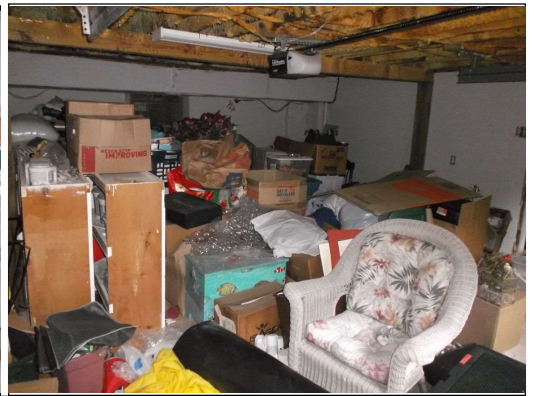
Belongings block view

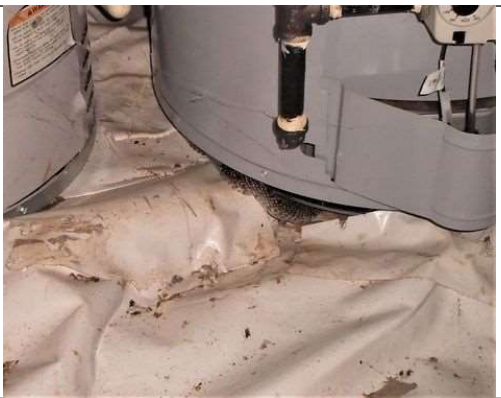
Snake or skin under water heater

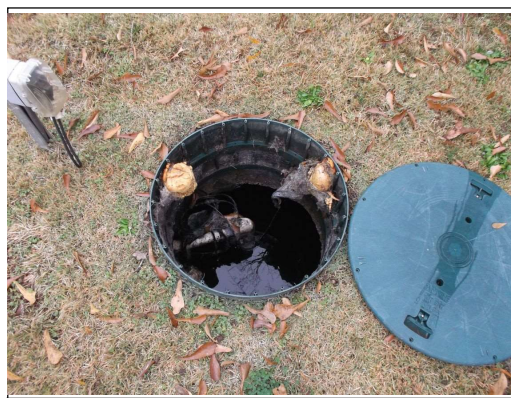
Could not see pump start up

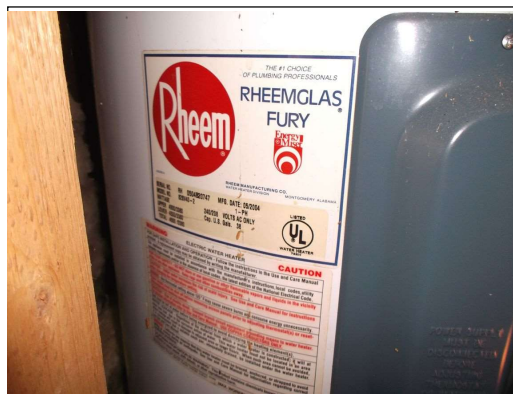
Water heater in the basement and in the pool house are near the end of use (water heaters have a good life of 11 years)(pool house water heater 2004..).

Label date 2004
