Paris Pressley REI

3196 Church St. East Point, GA.

Page 3 KEY TO THE INSPECTION REPORT

Report #: 54

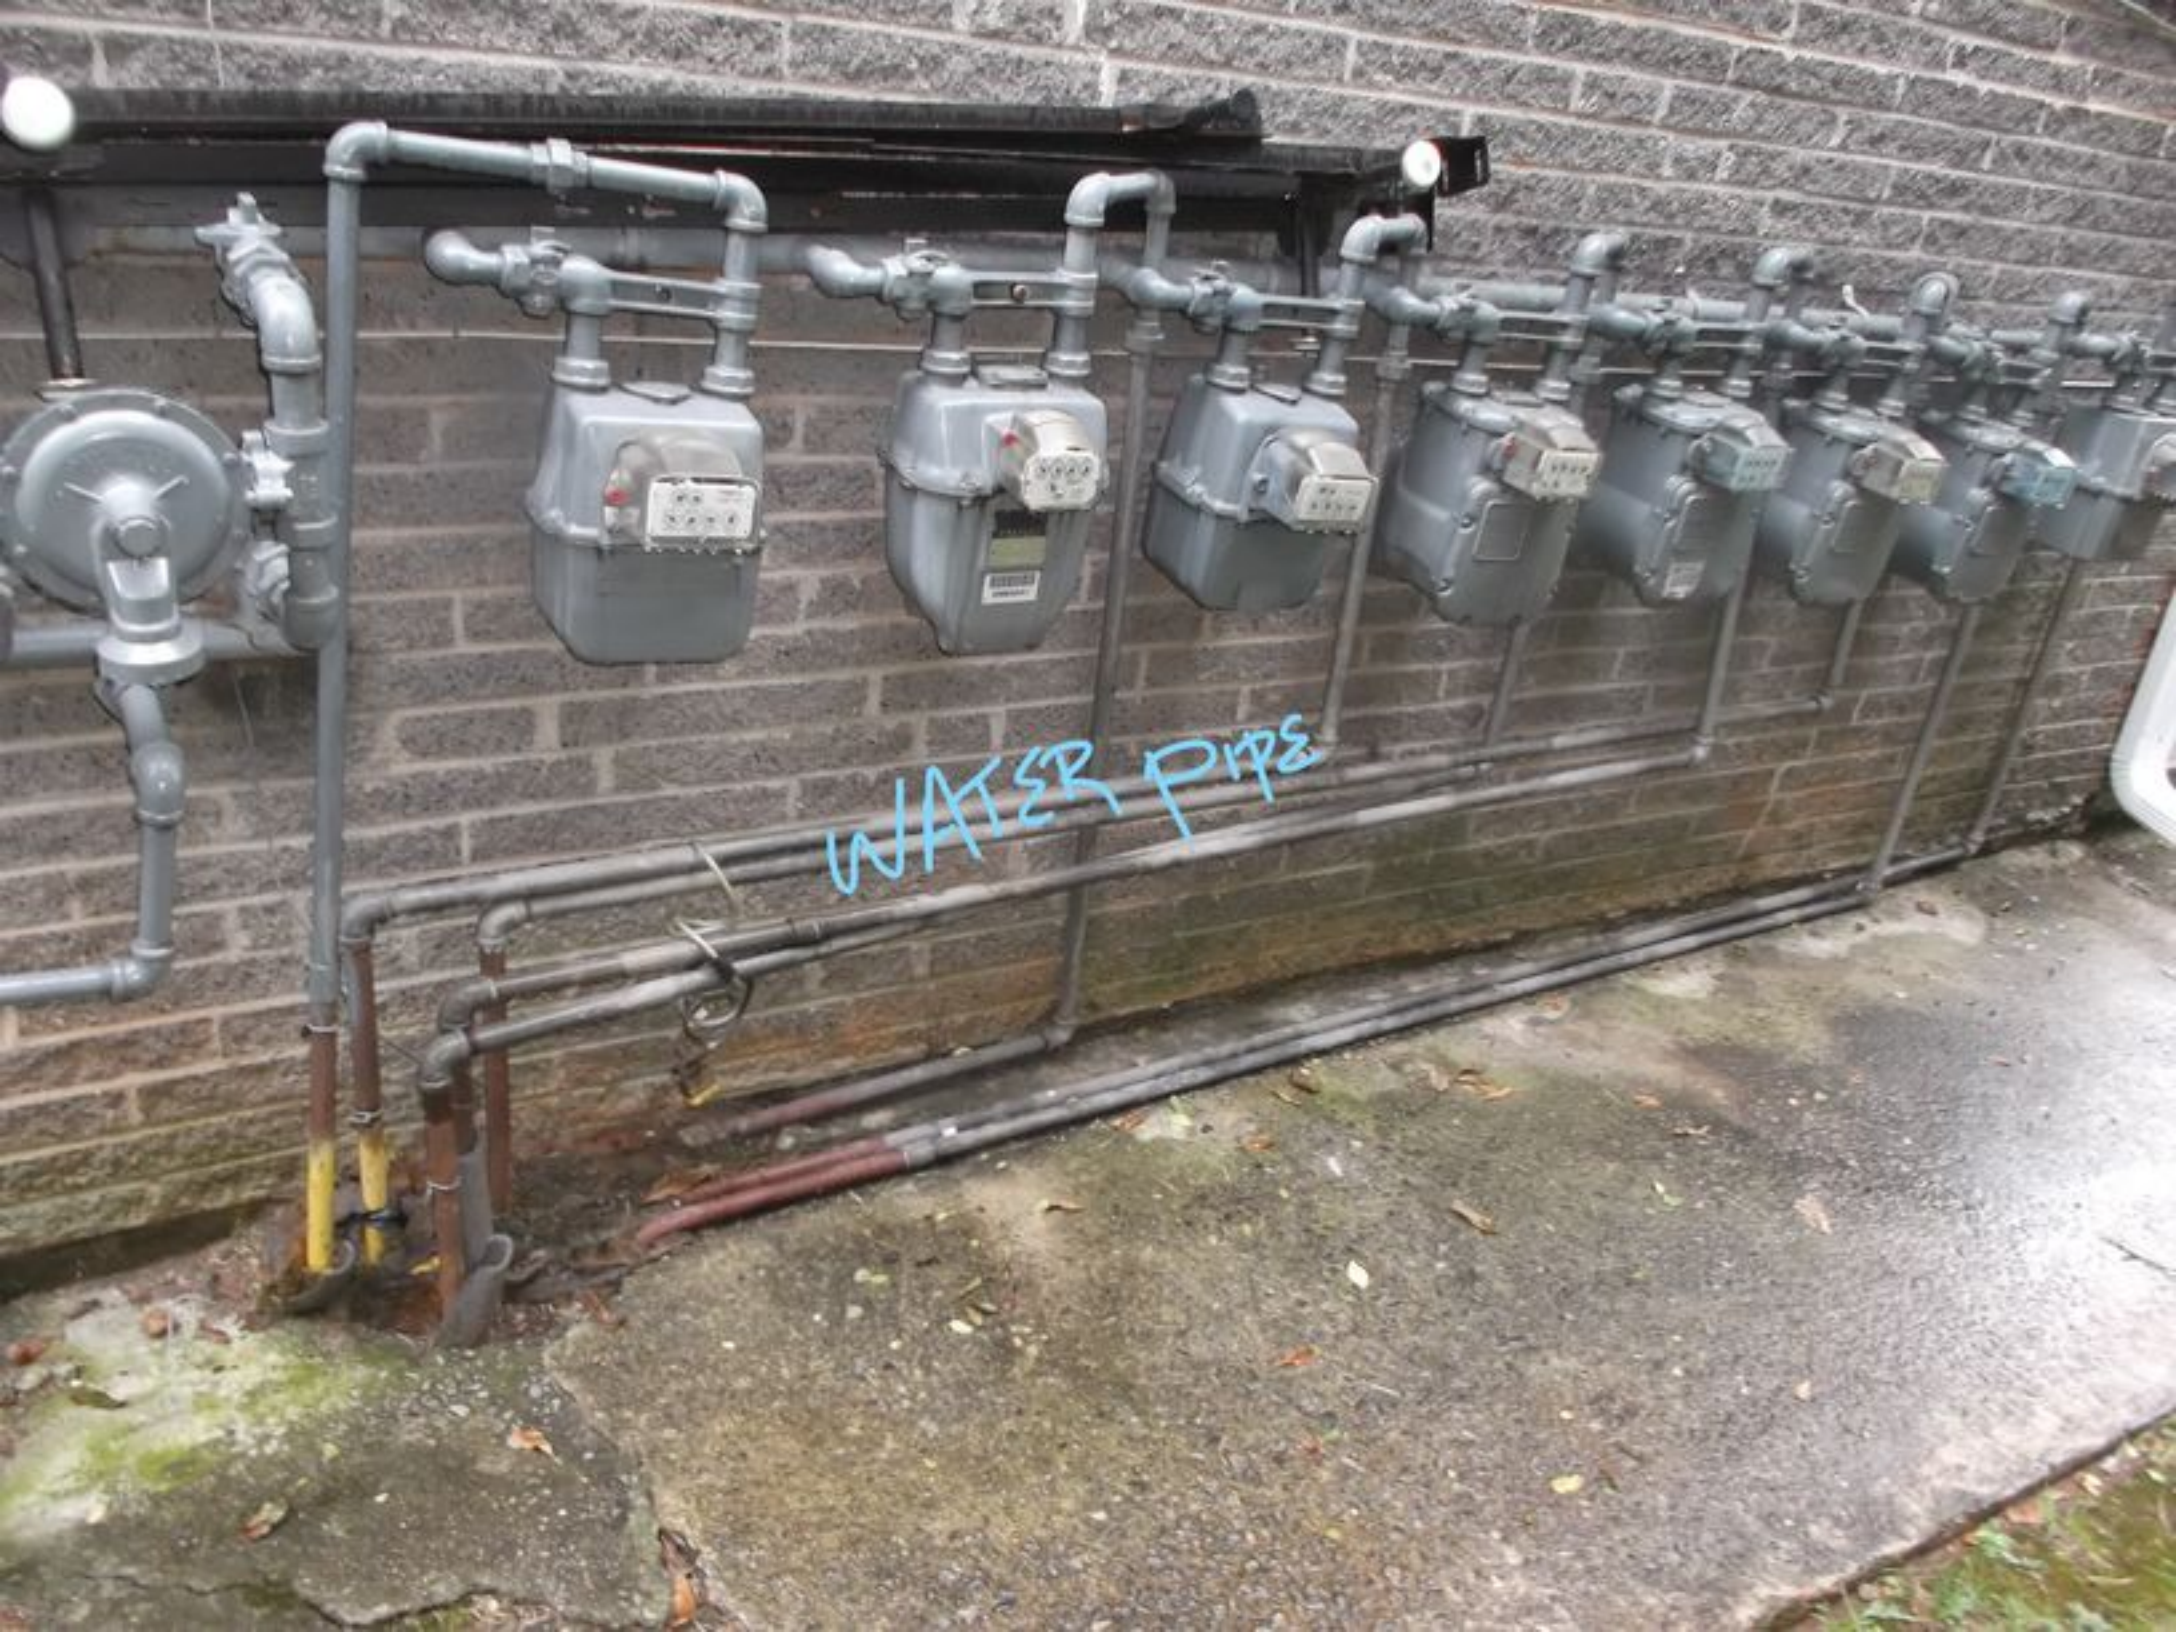
WATER PIPE

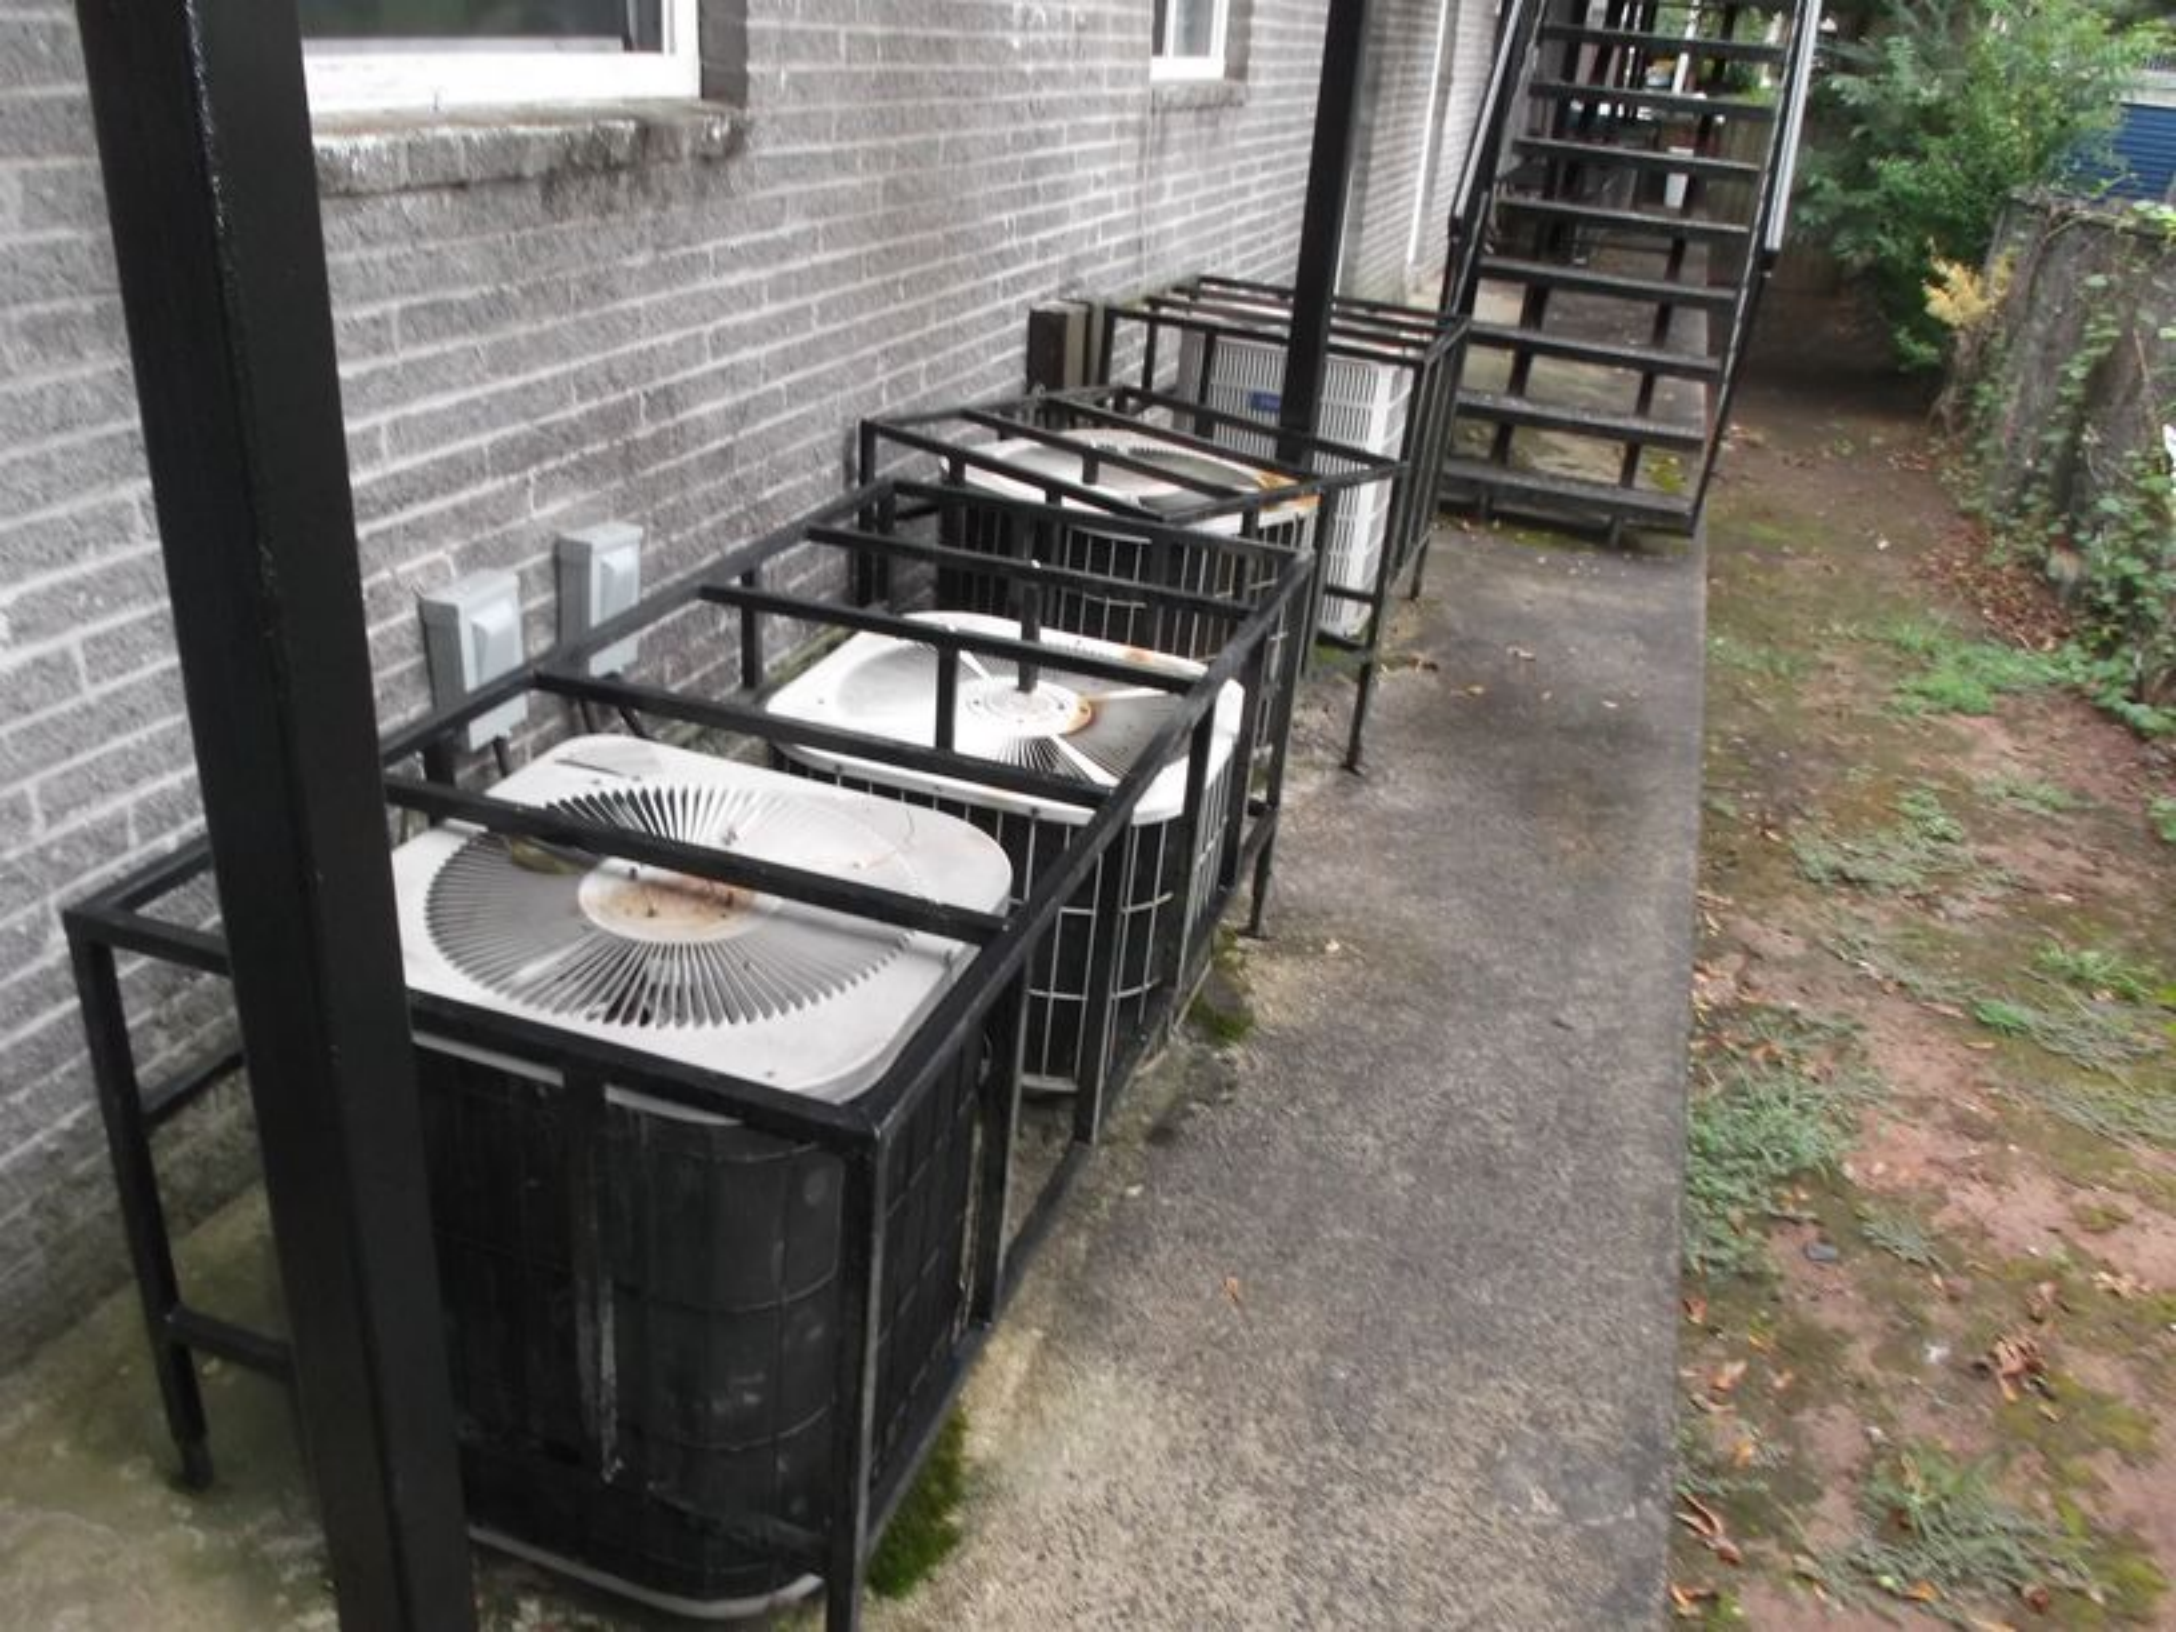
NO INSULATION

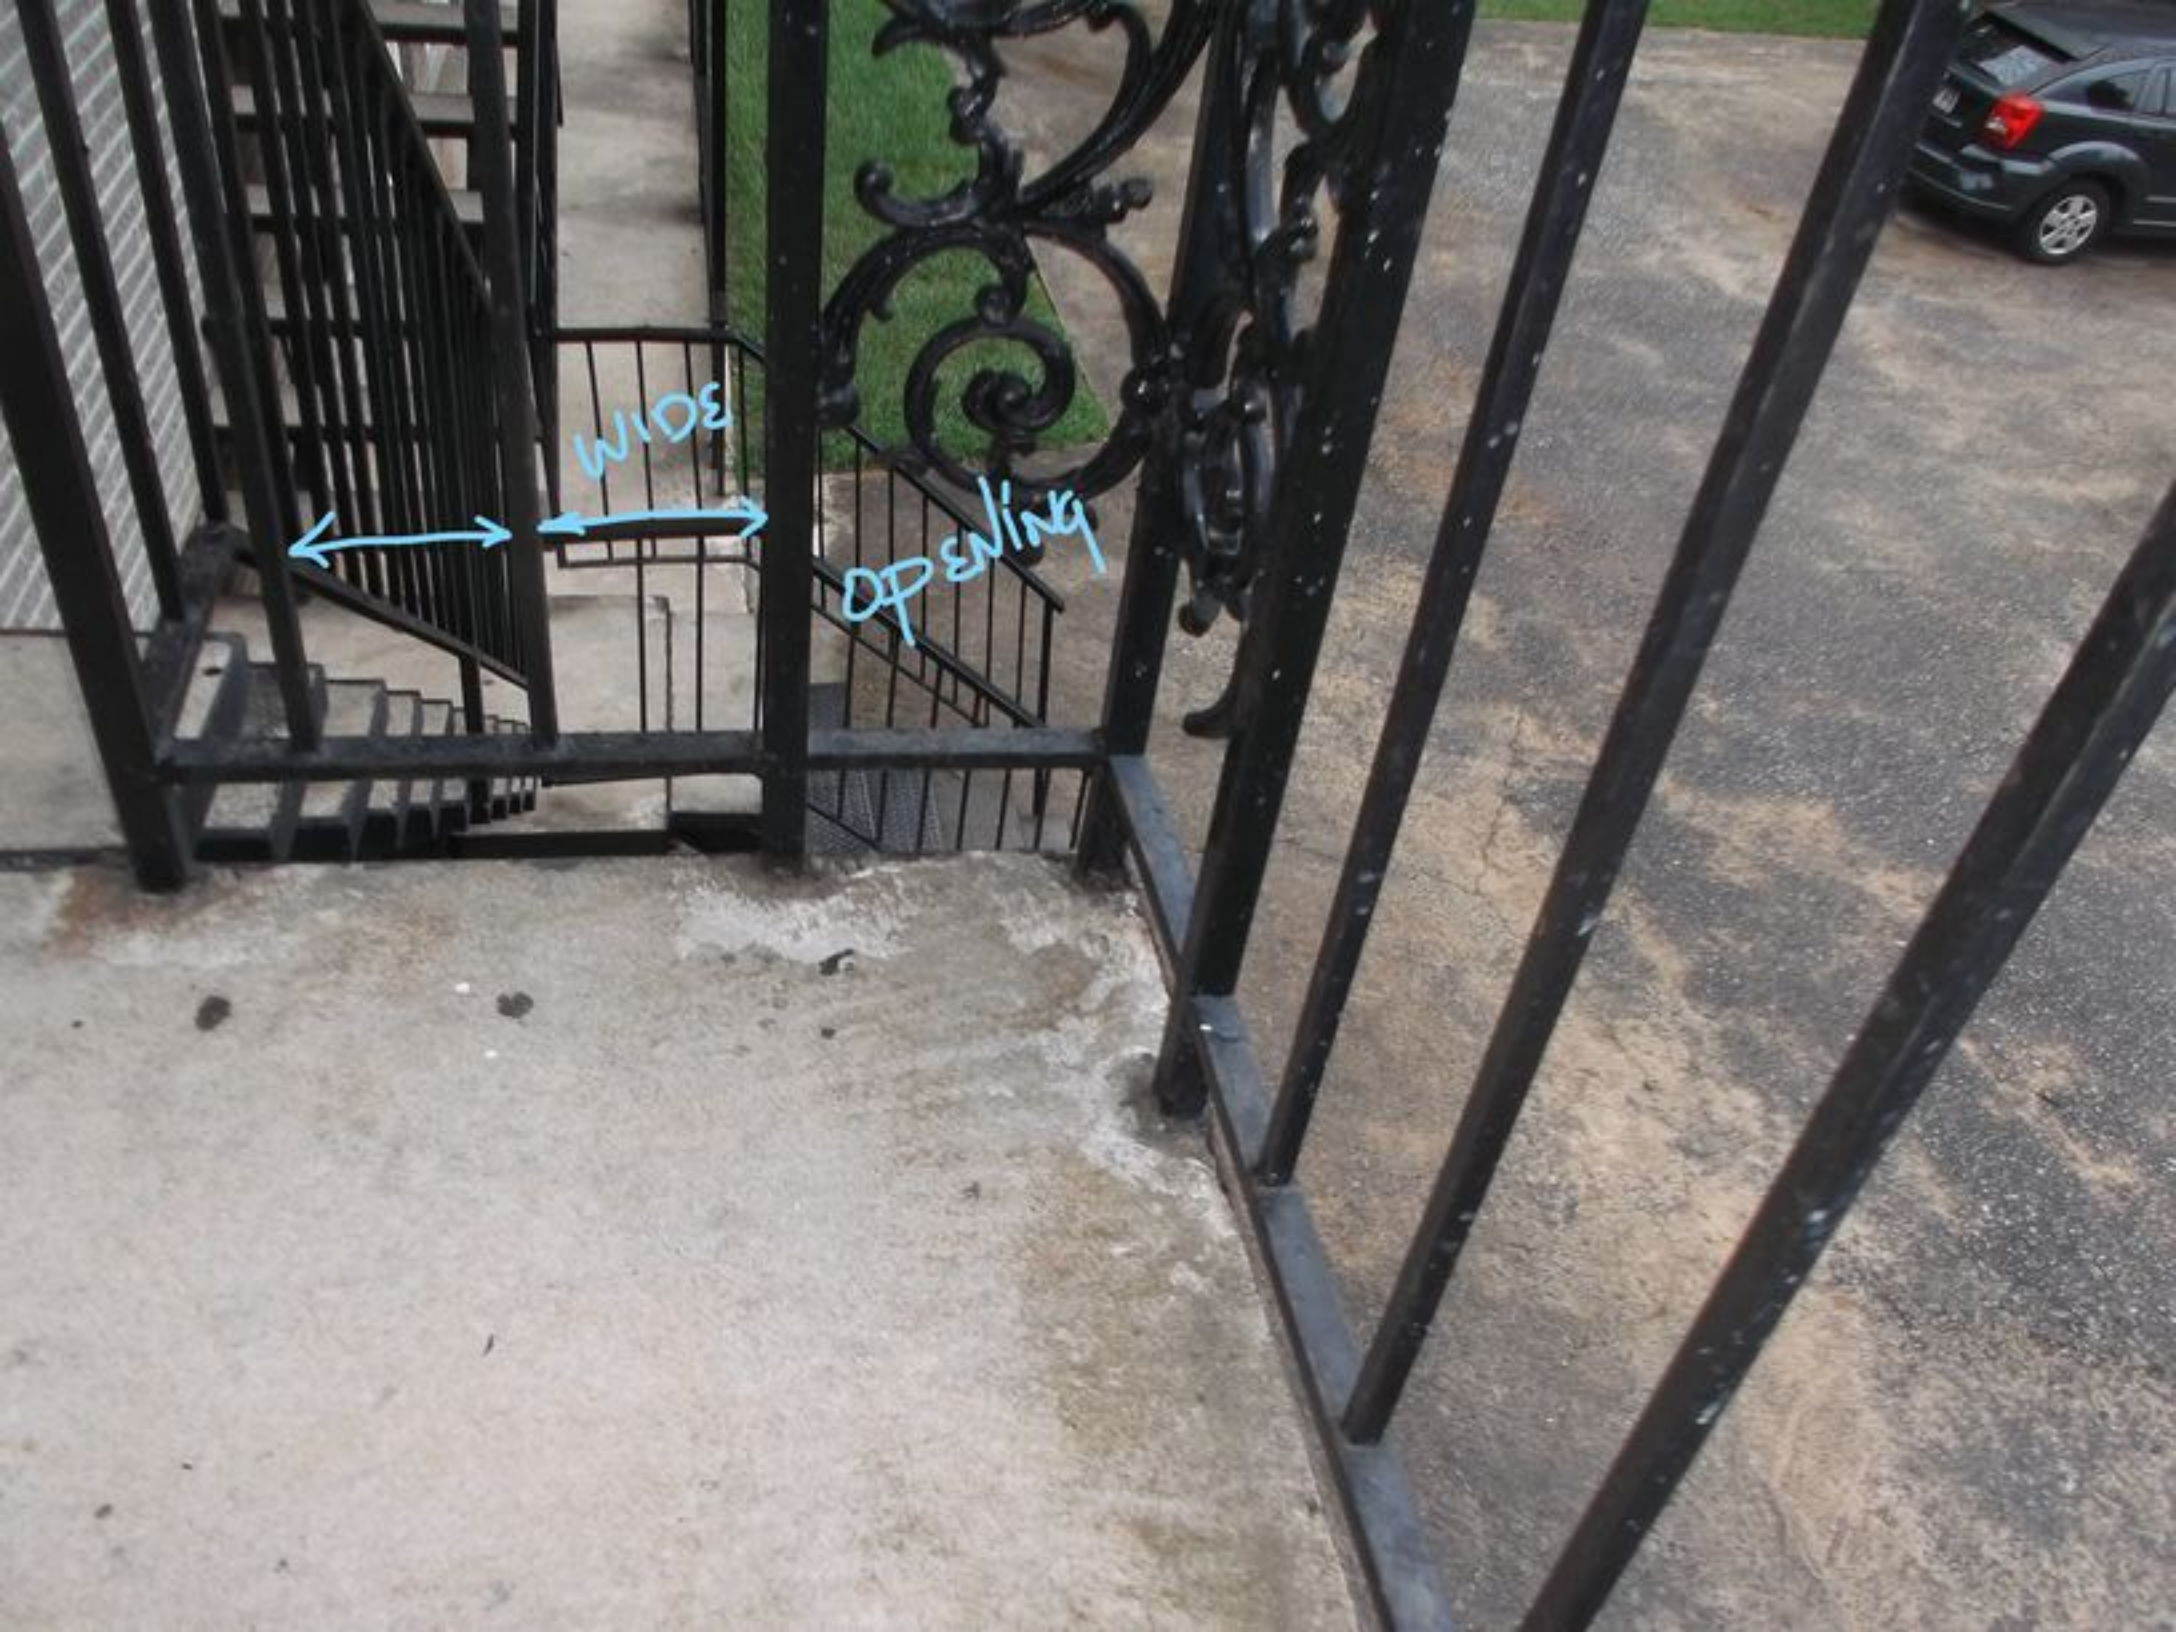
WIDE
OPENING

30 IN

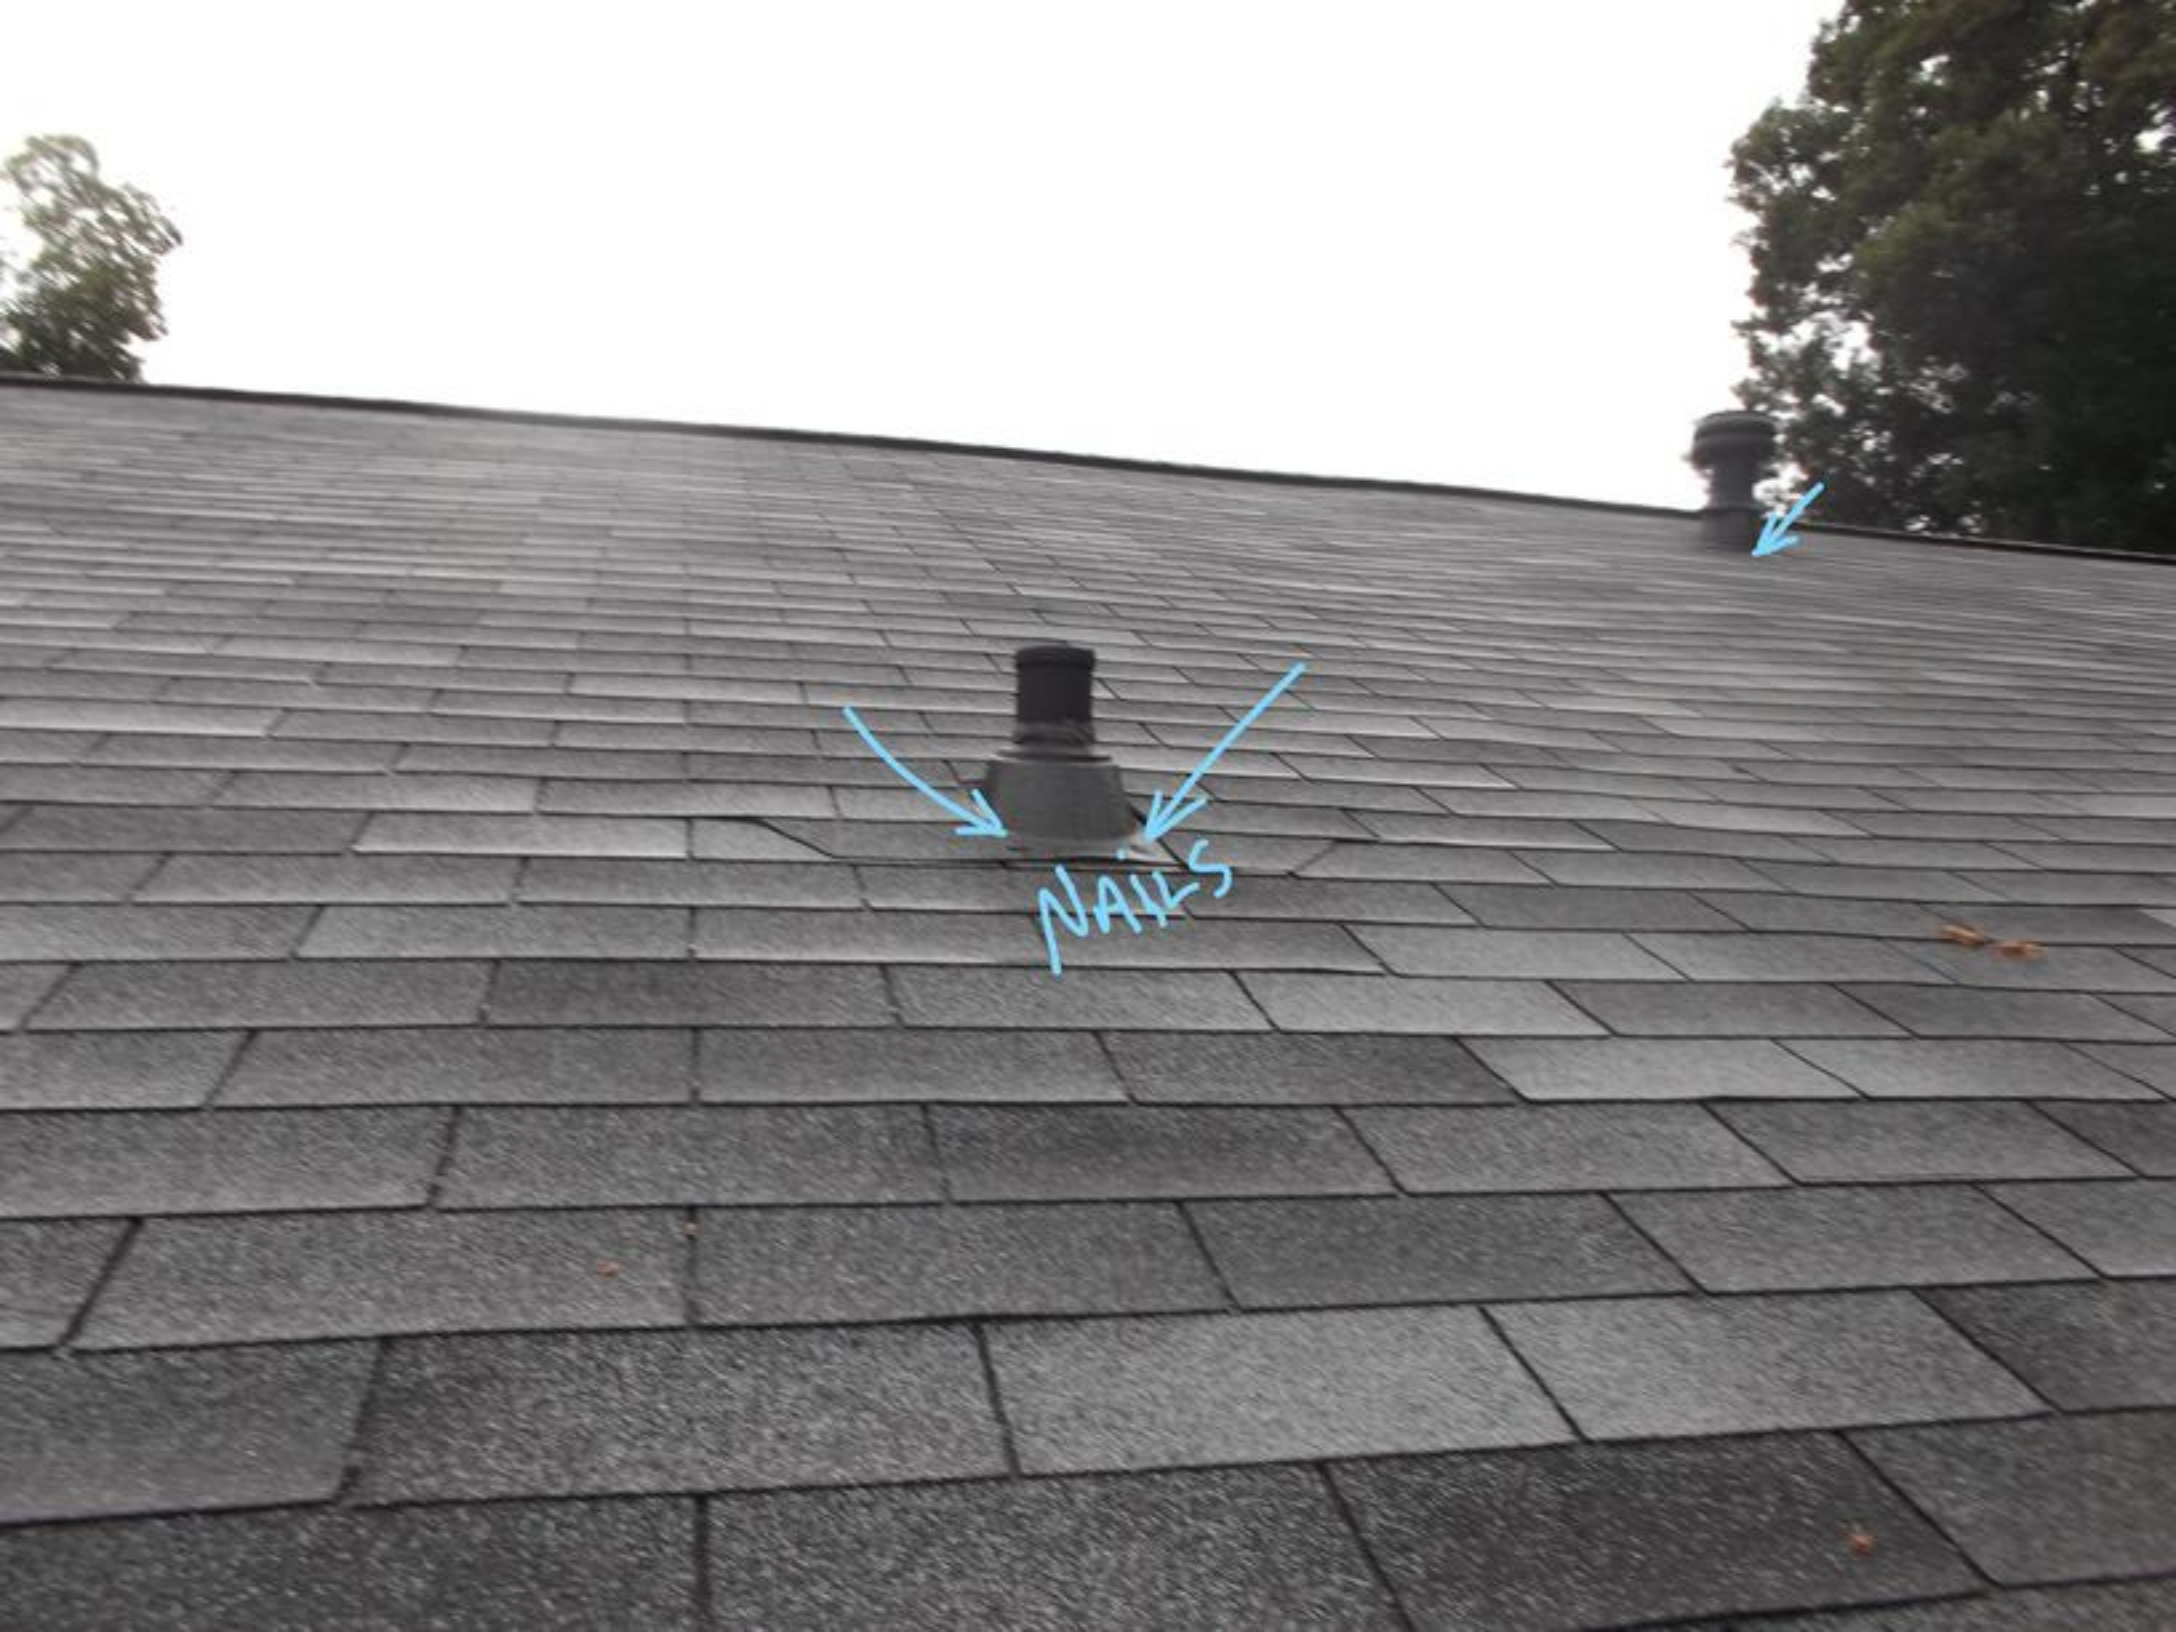
NAILS

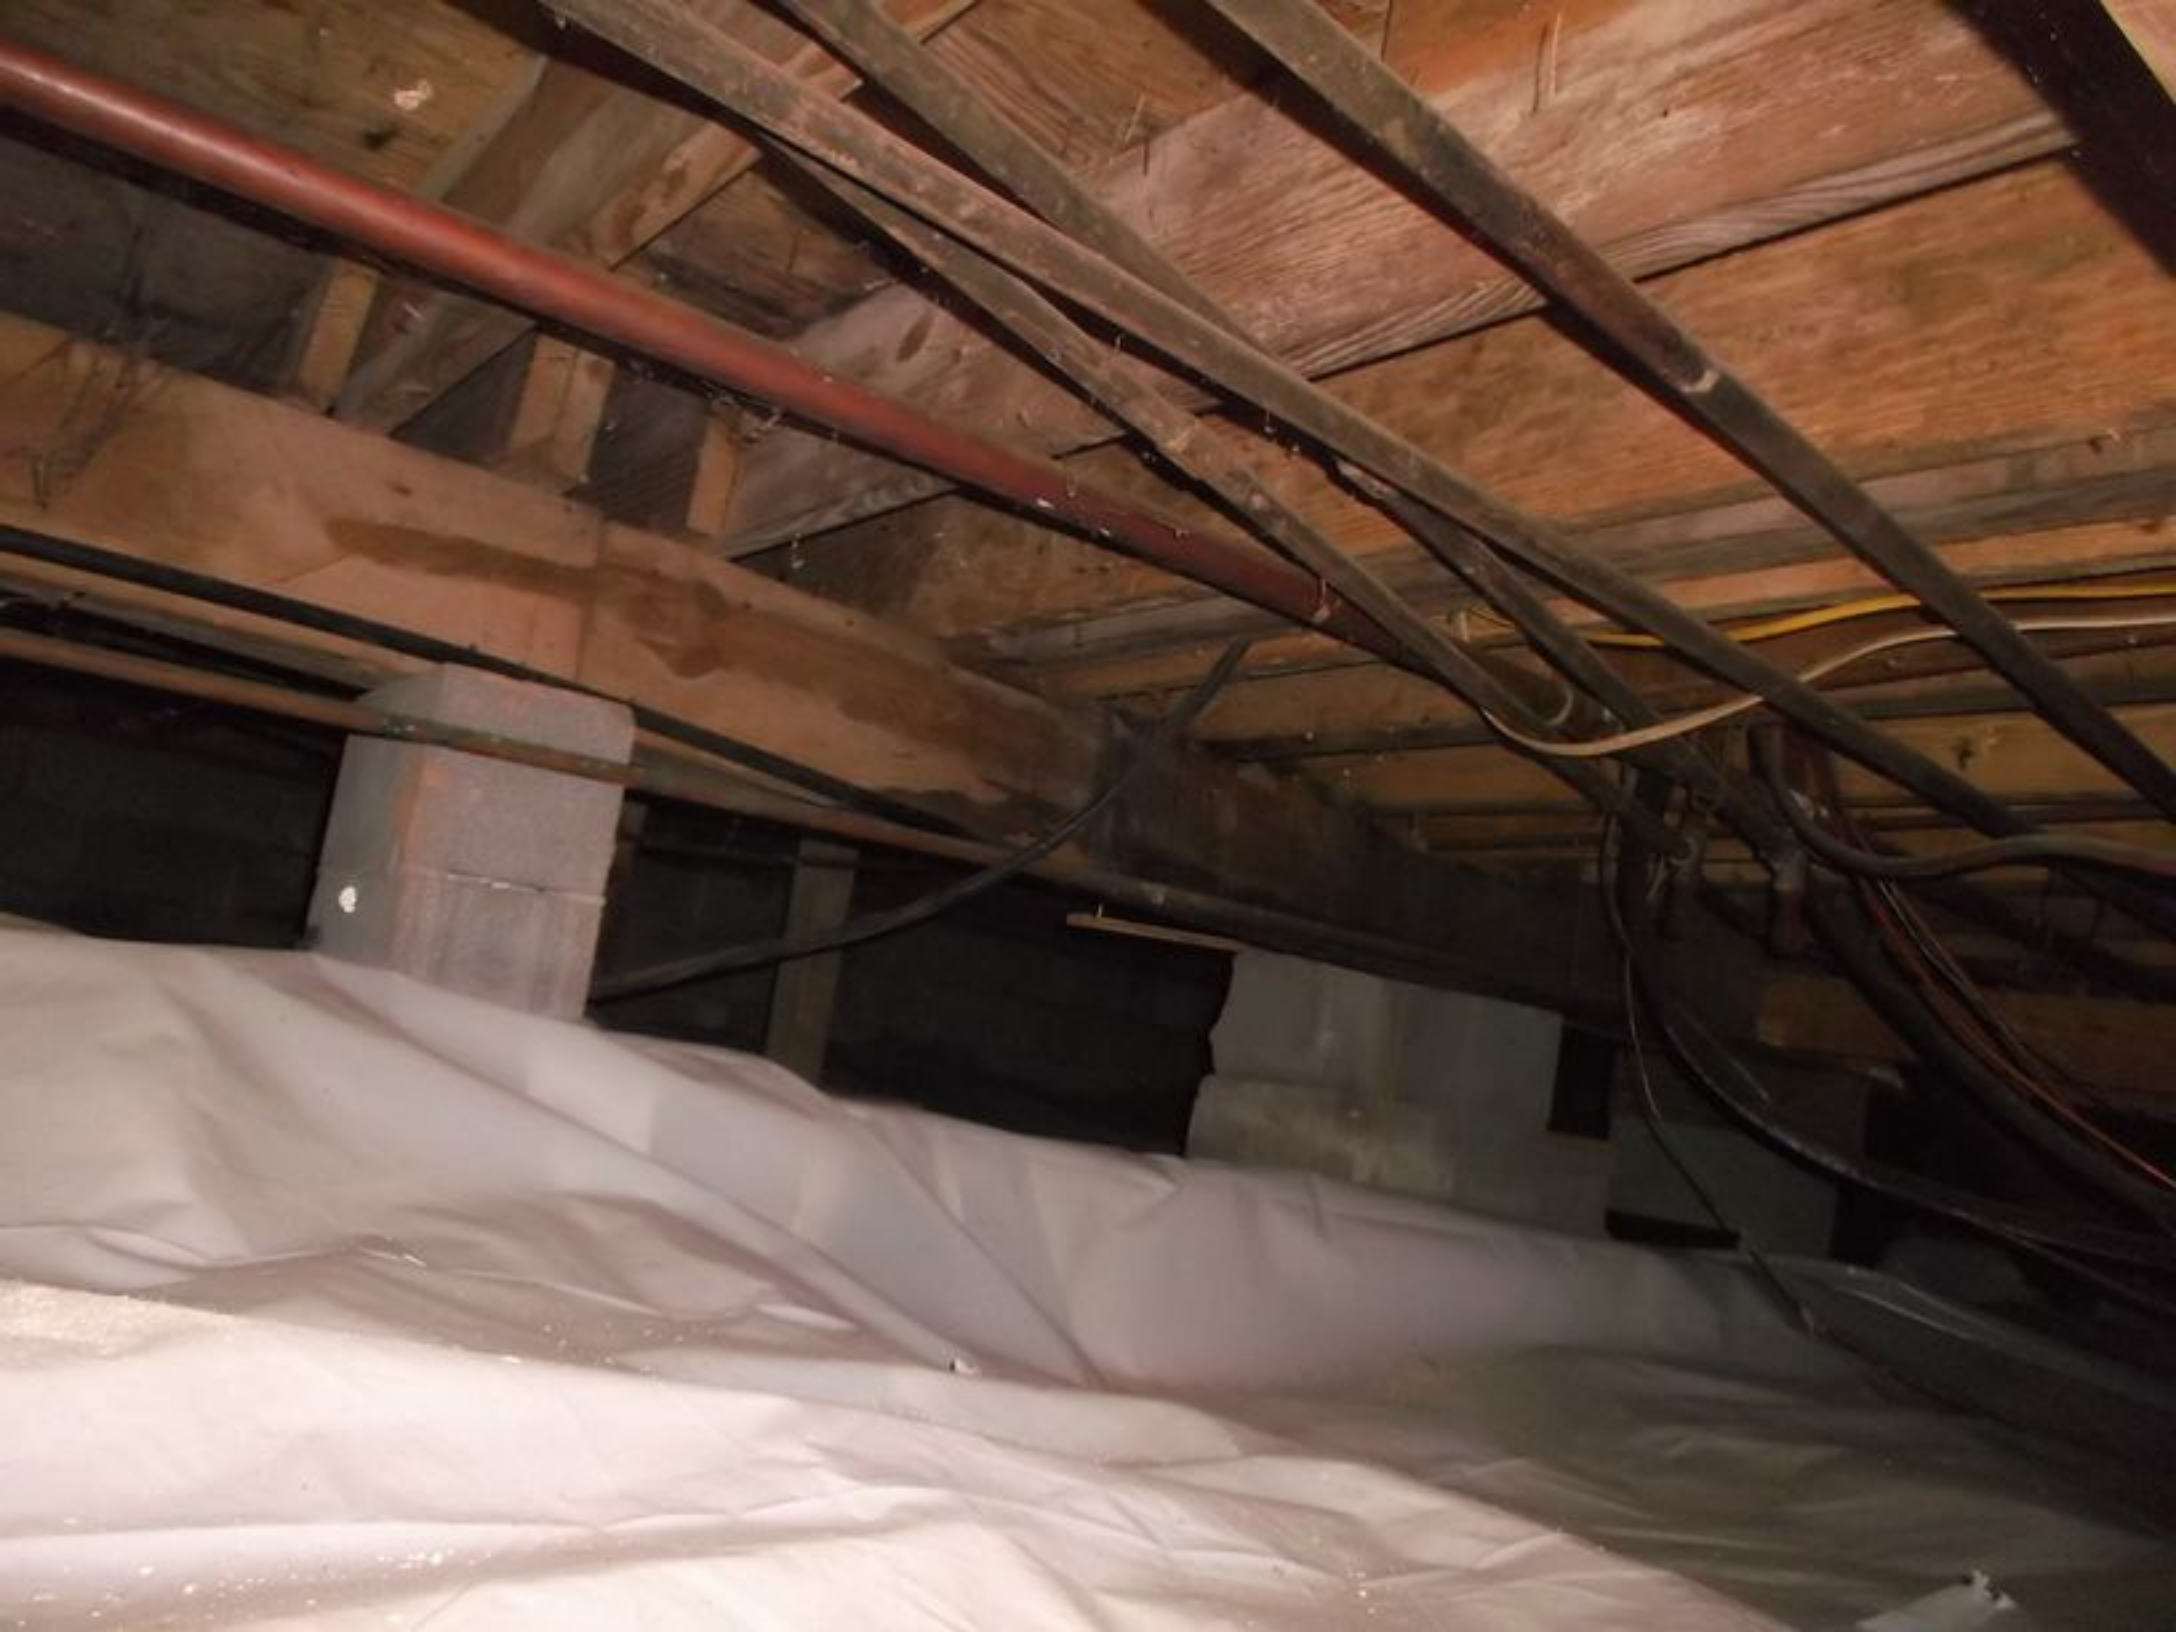
3-5
FUNGUS

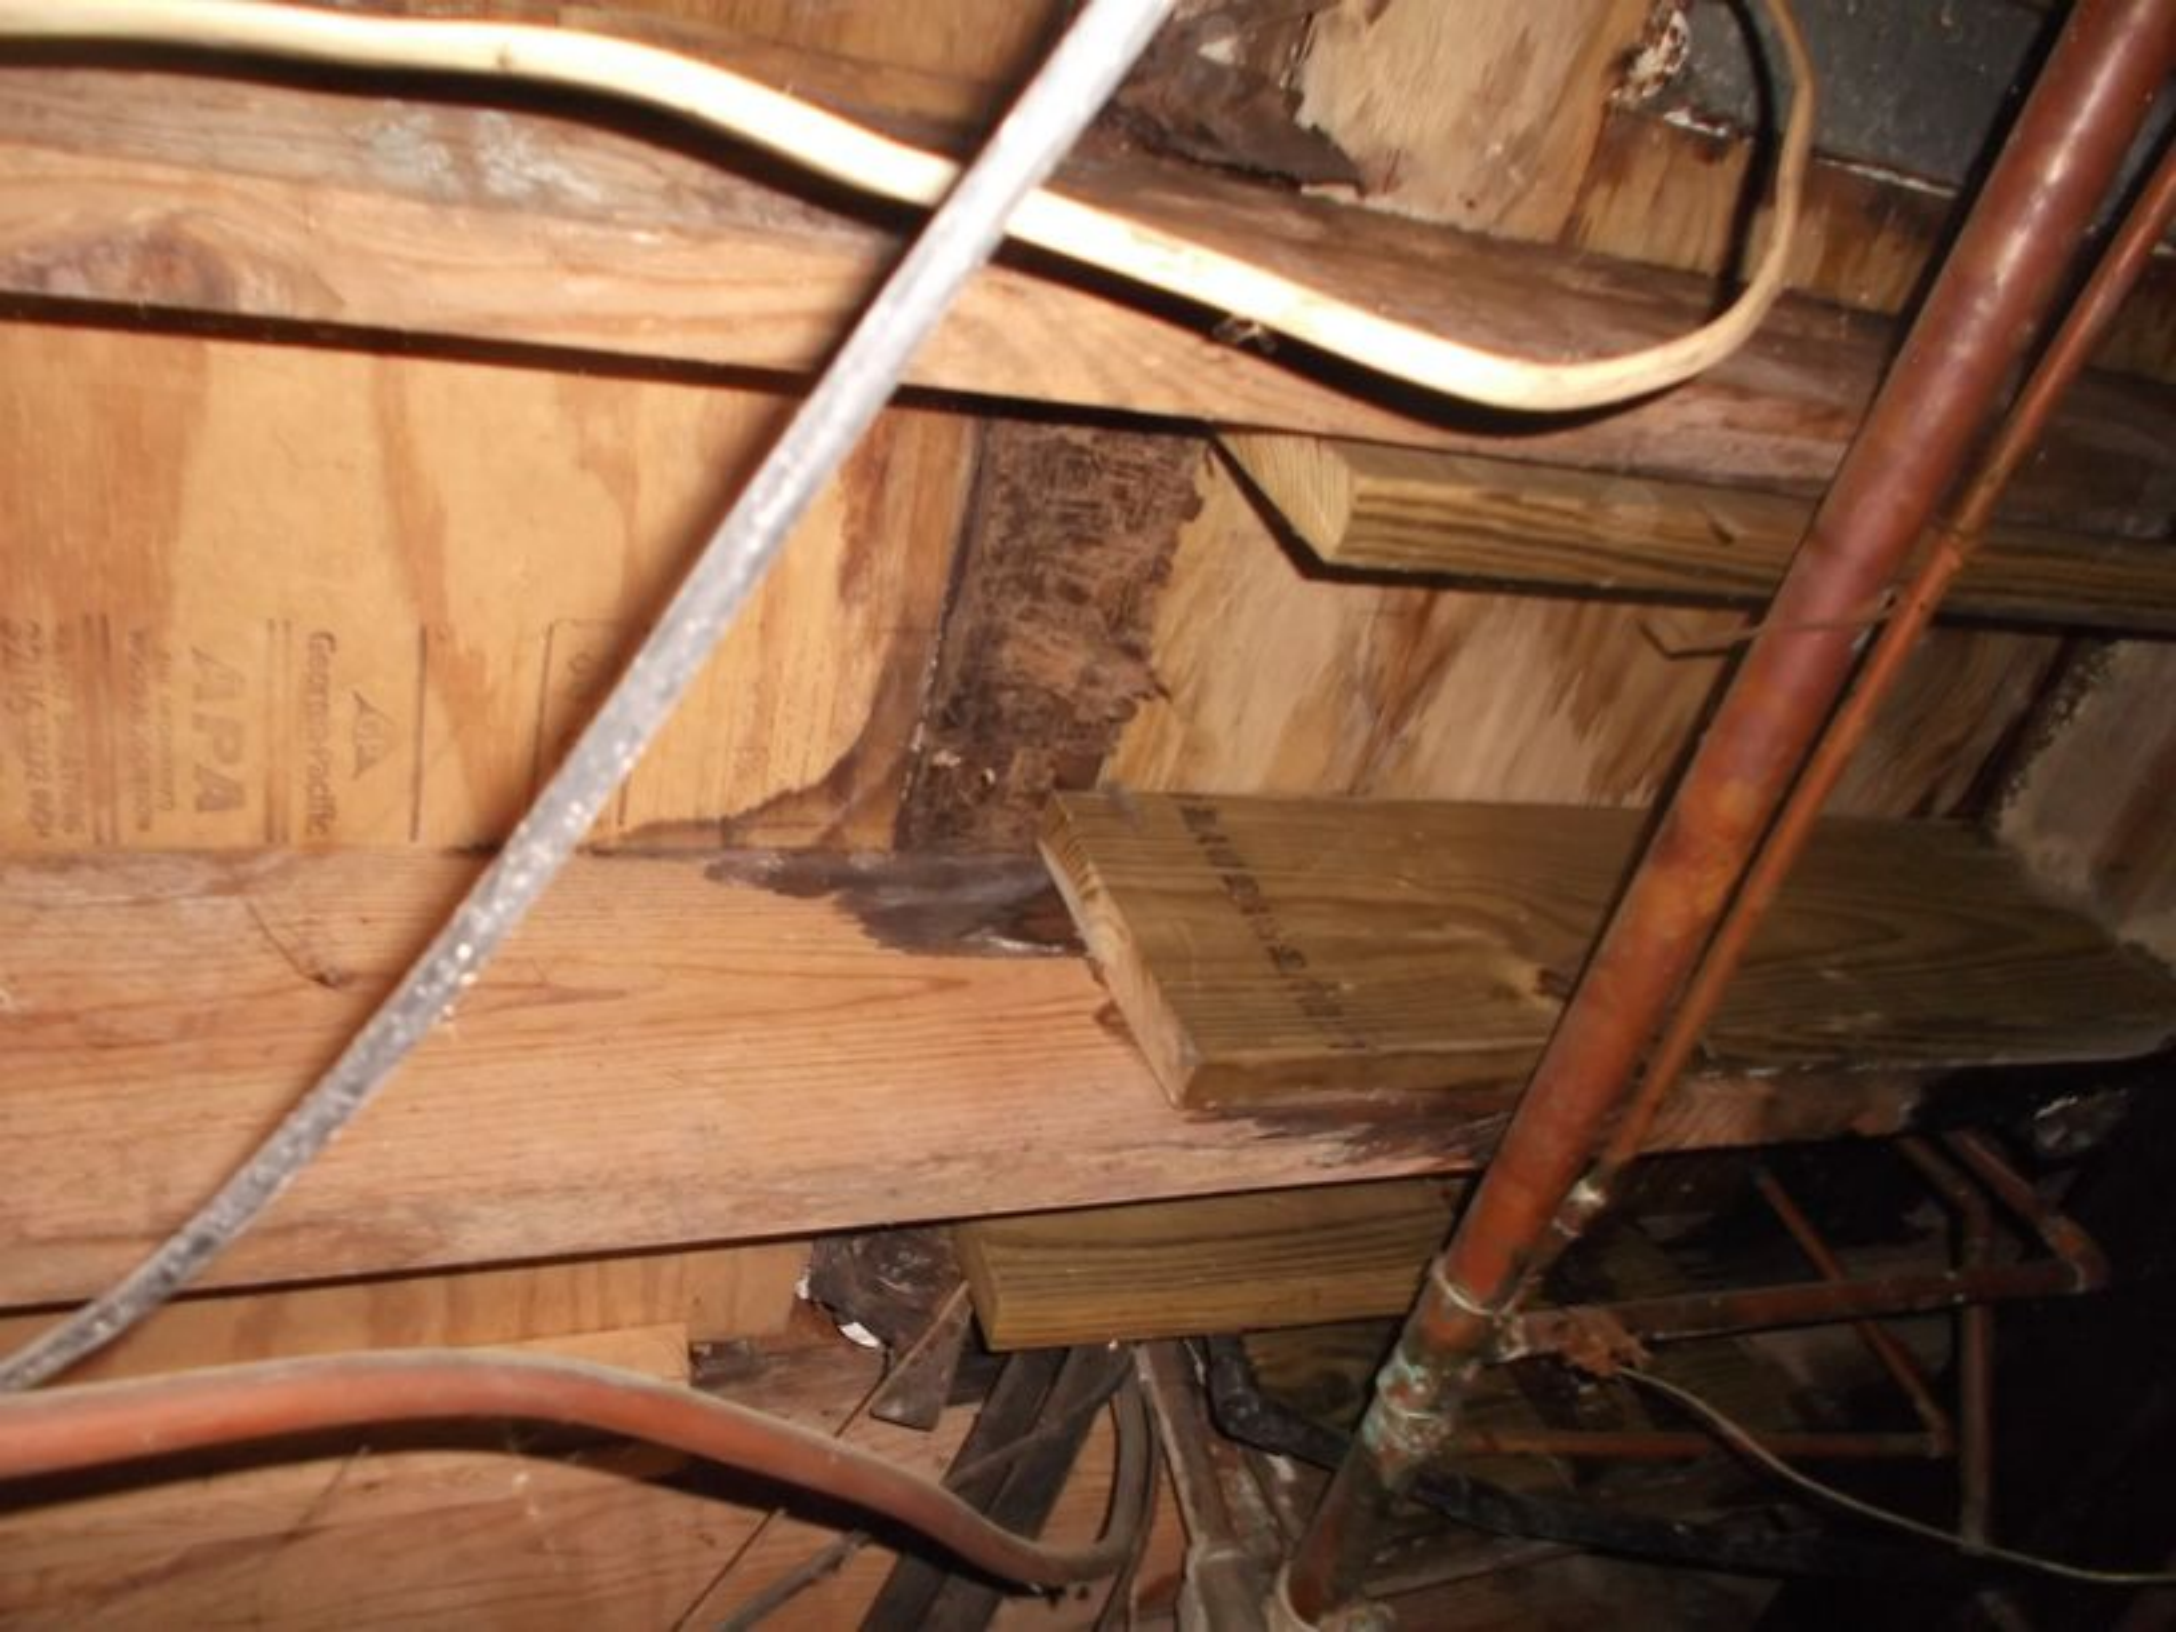
WATER
