Paris Pressley REI

3196 Church St. East Point, GA.

Page 3 KEY TO THE INSPECTION REPORT

Report #: 54

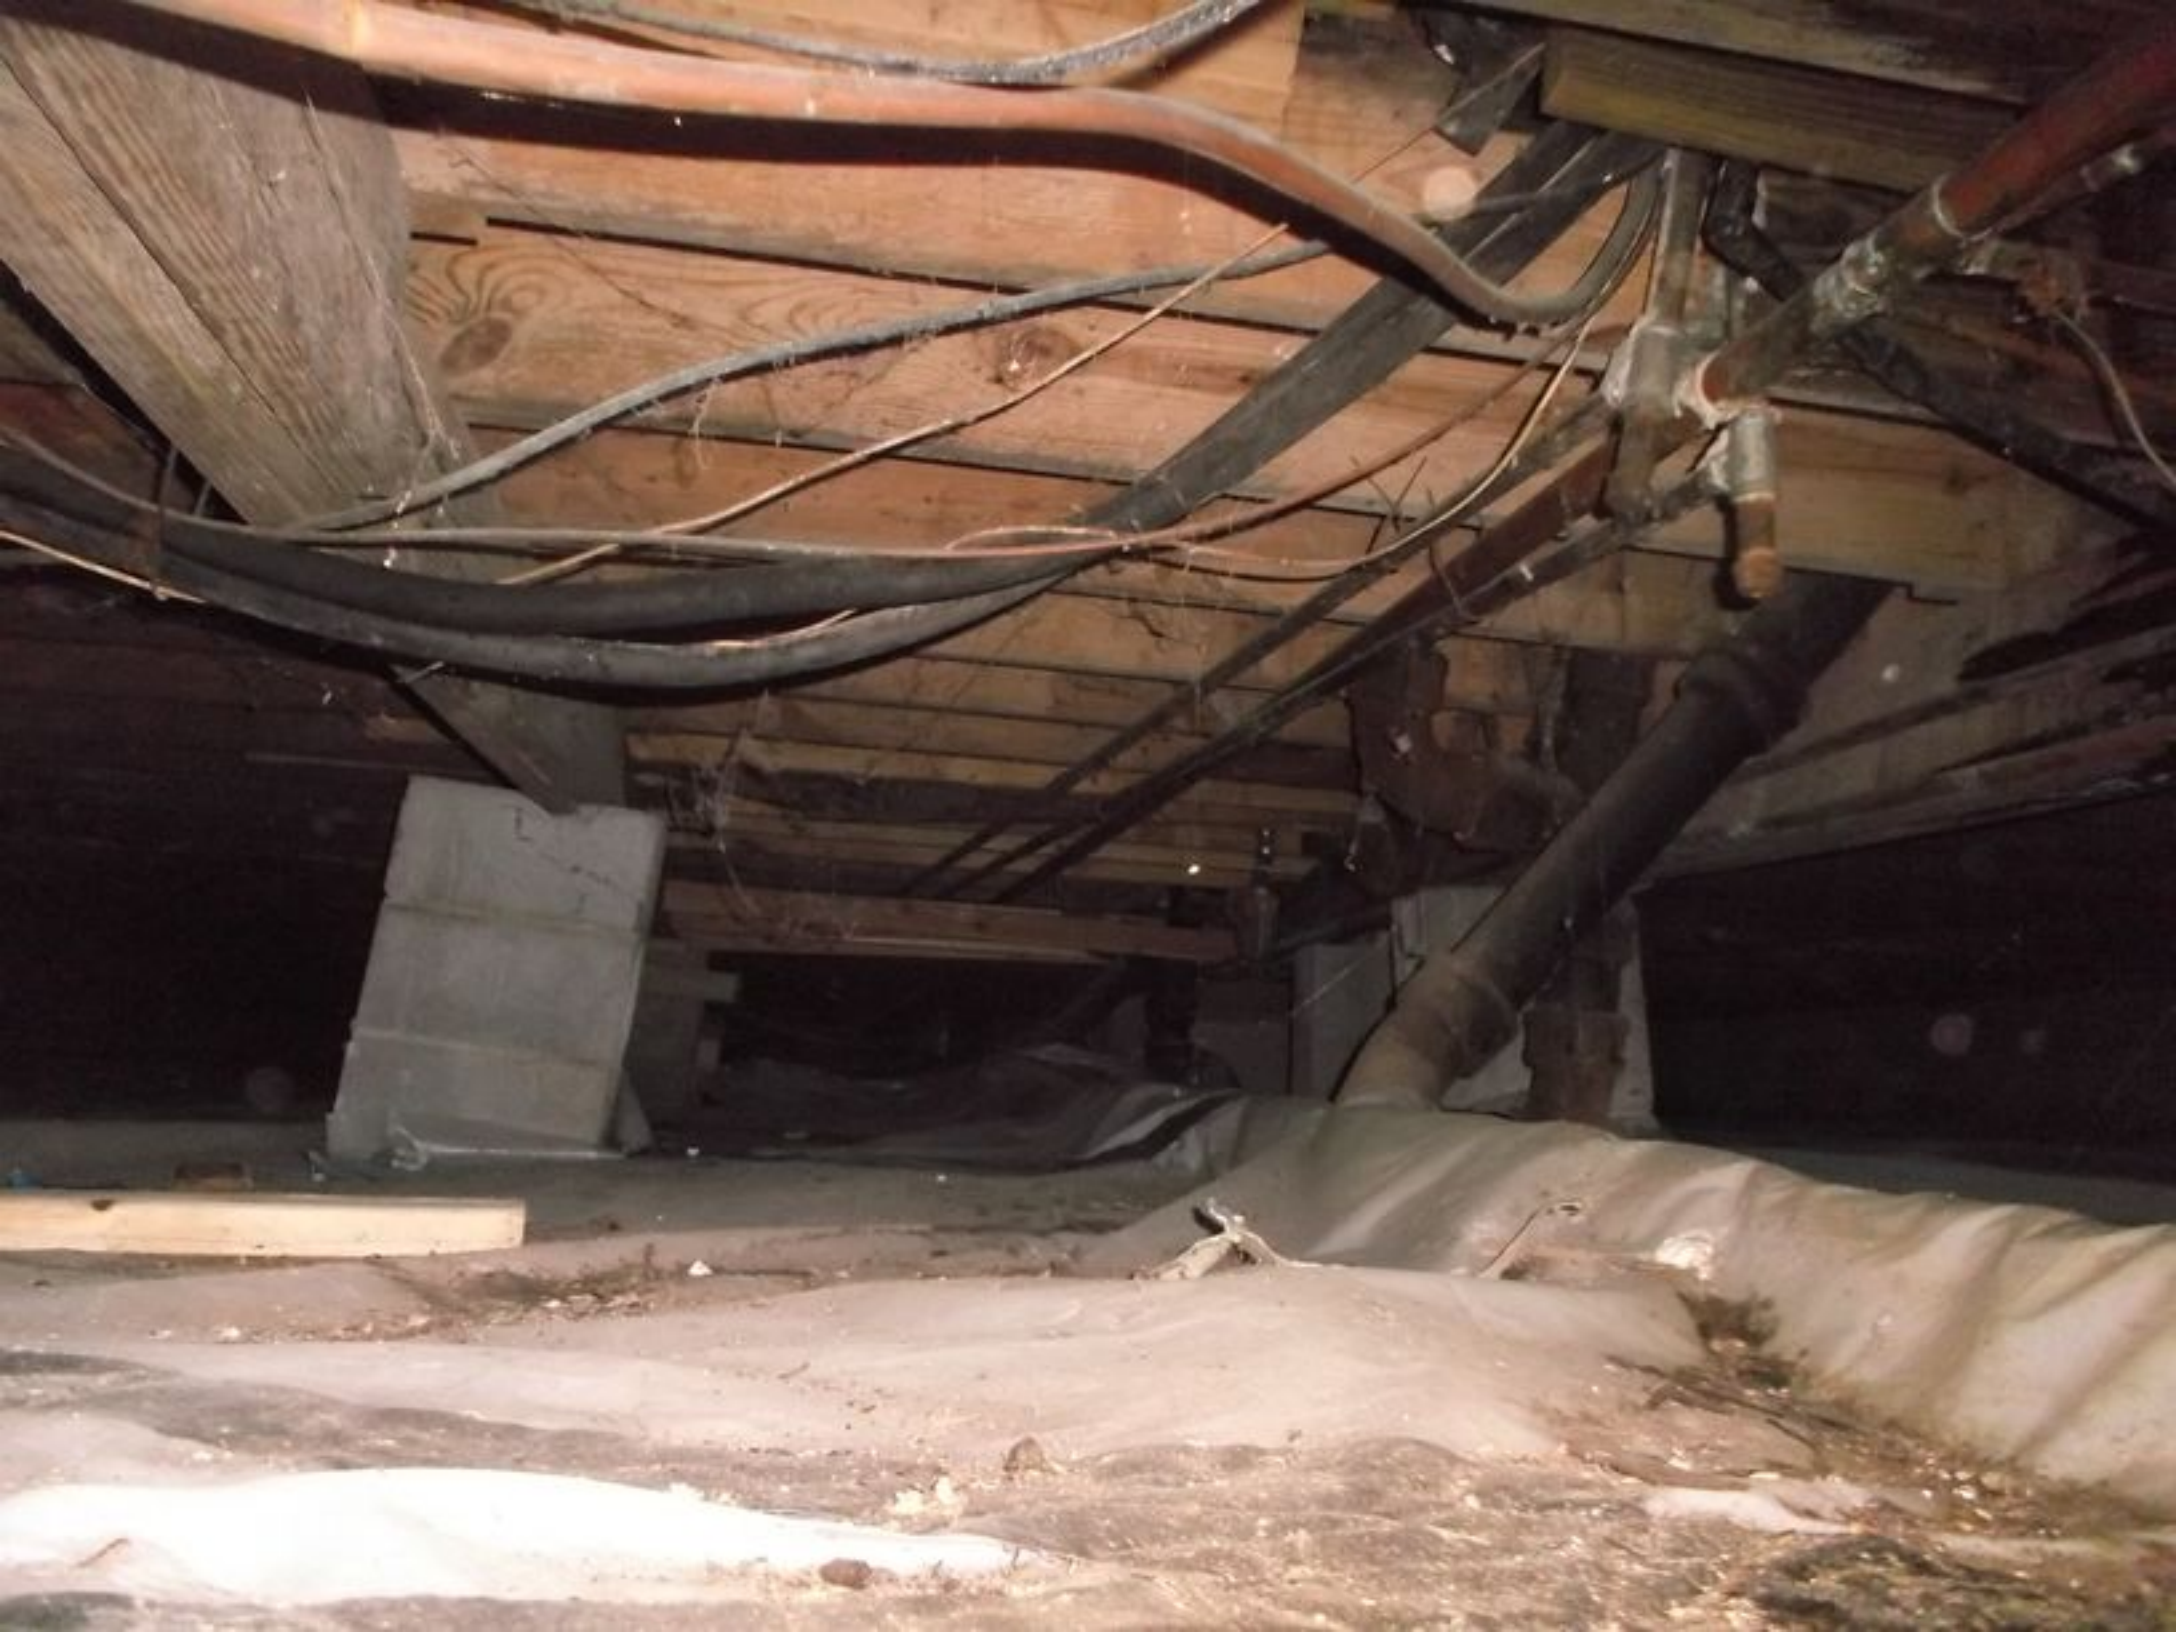
WATER

NO PRESSURE
VALVE

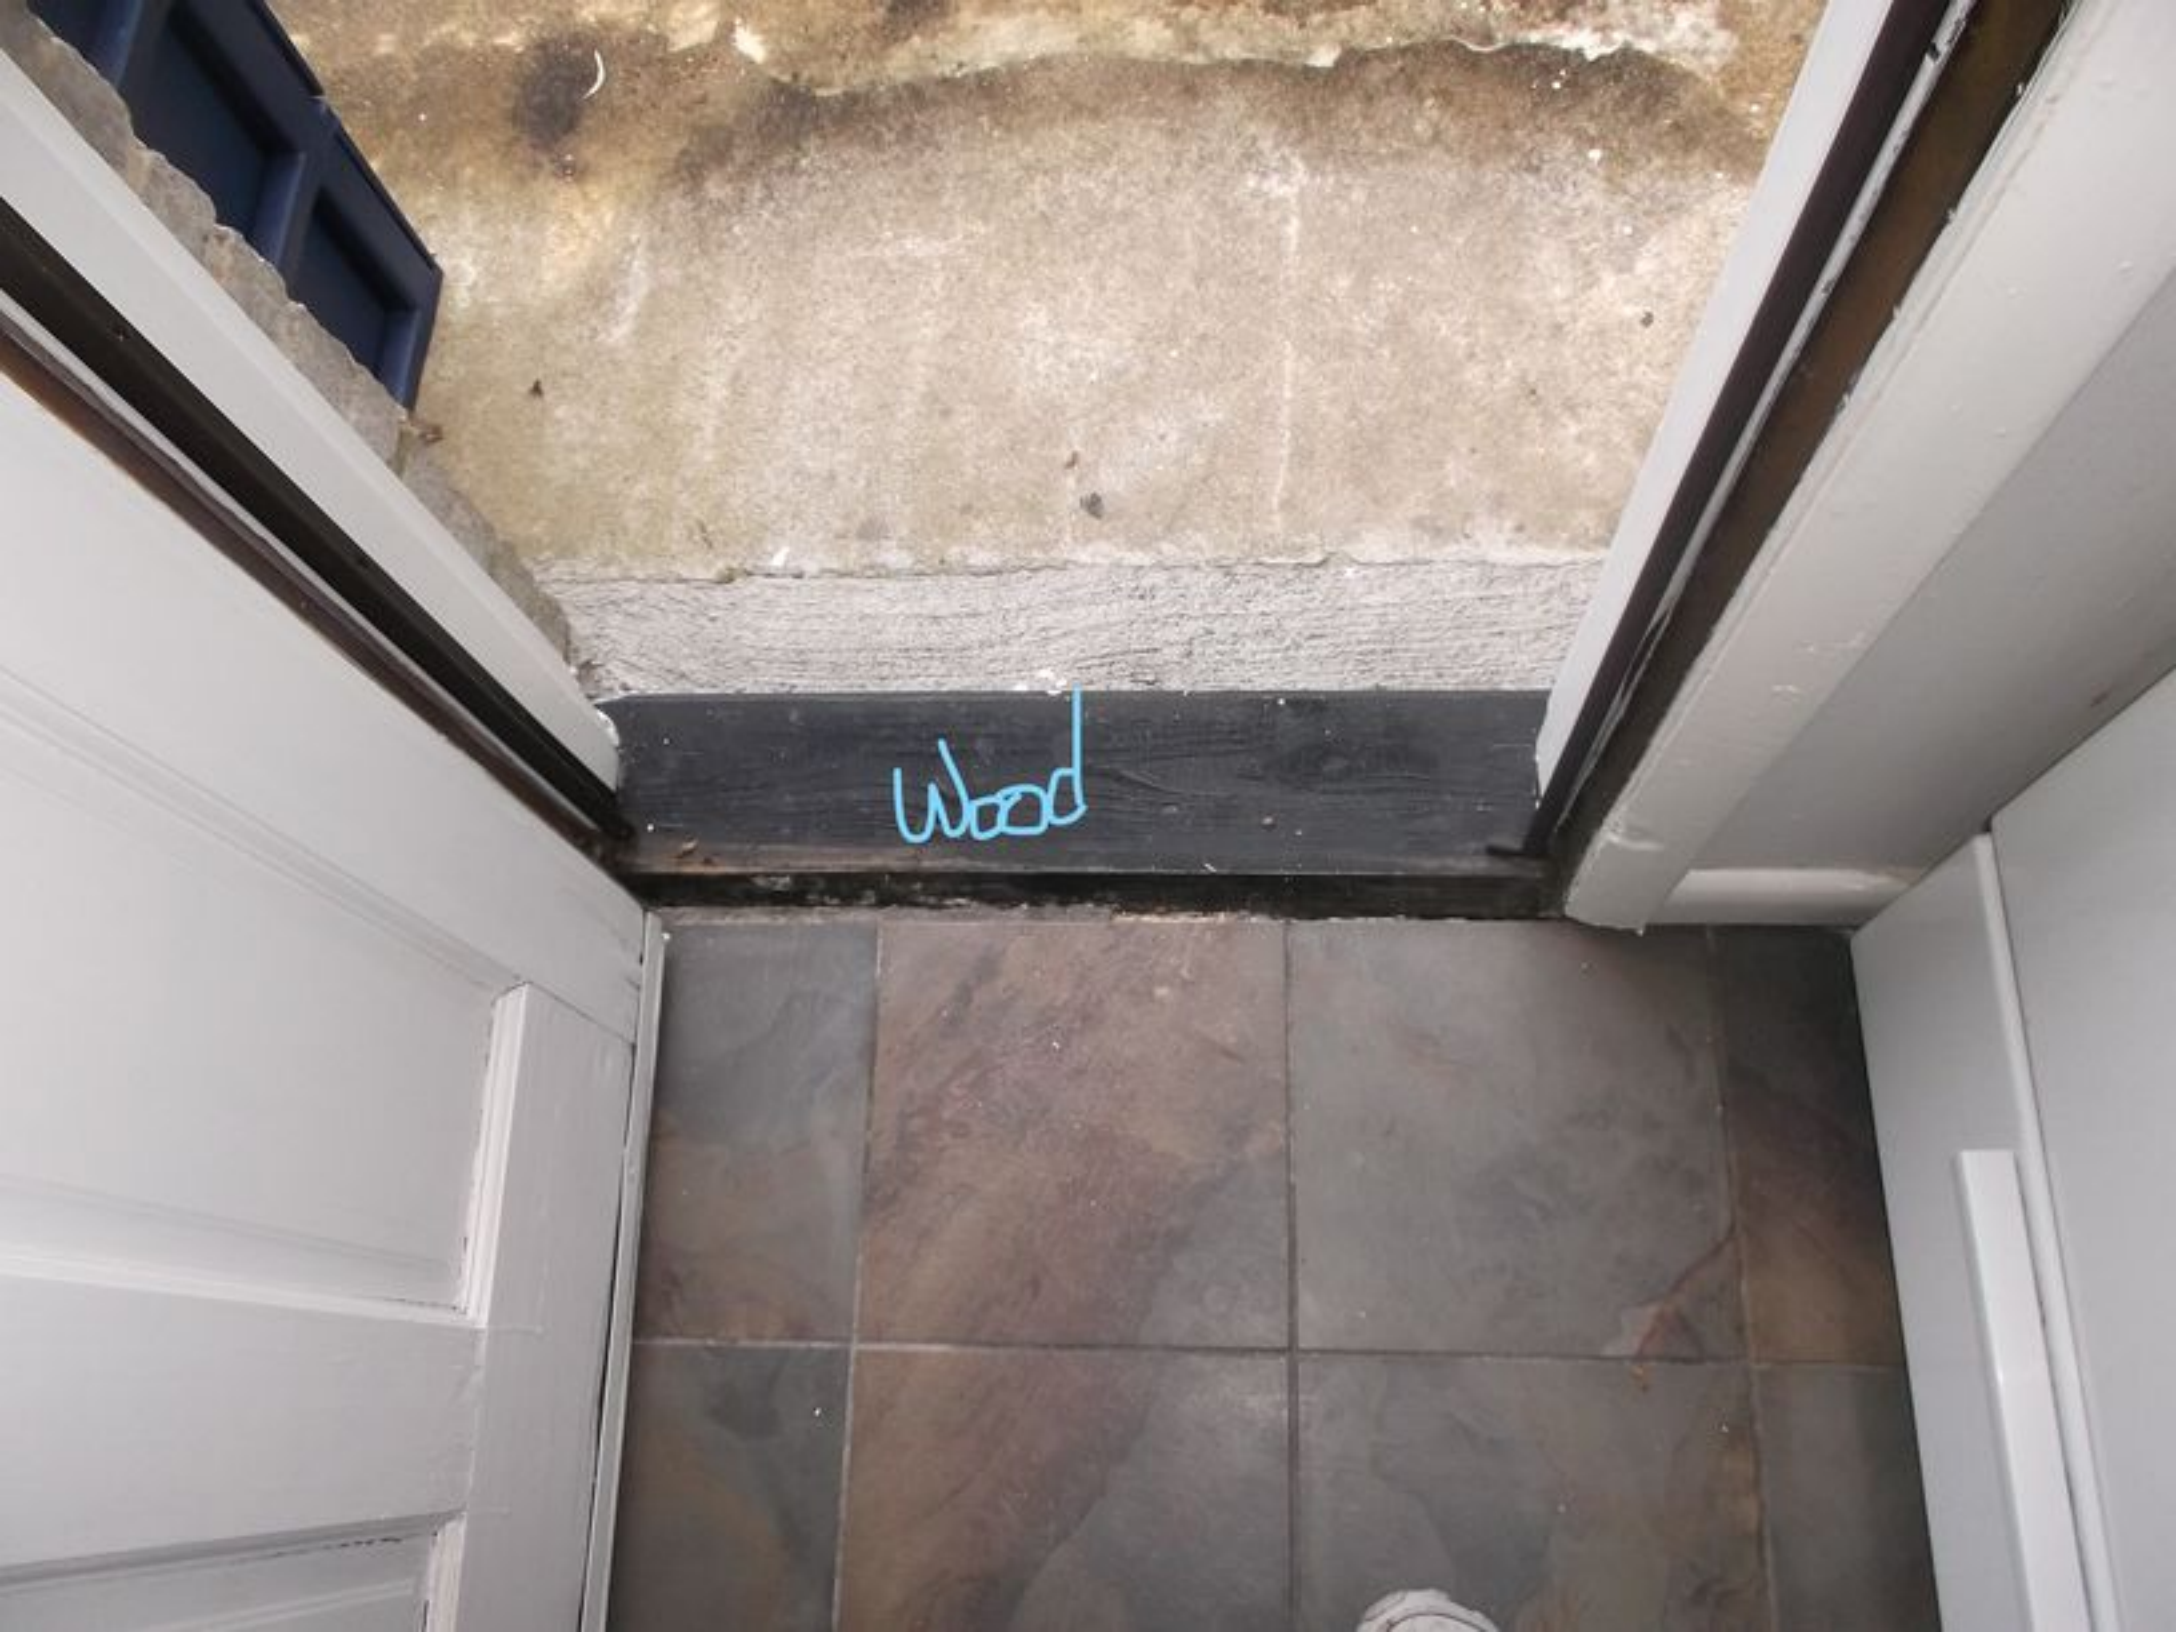
Wood

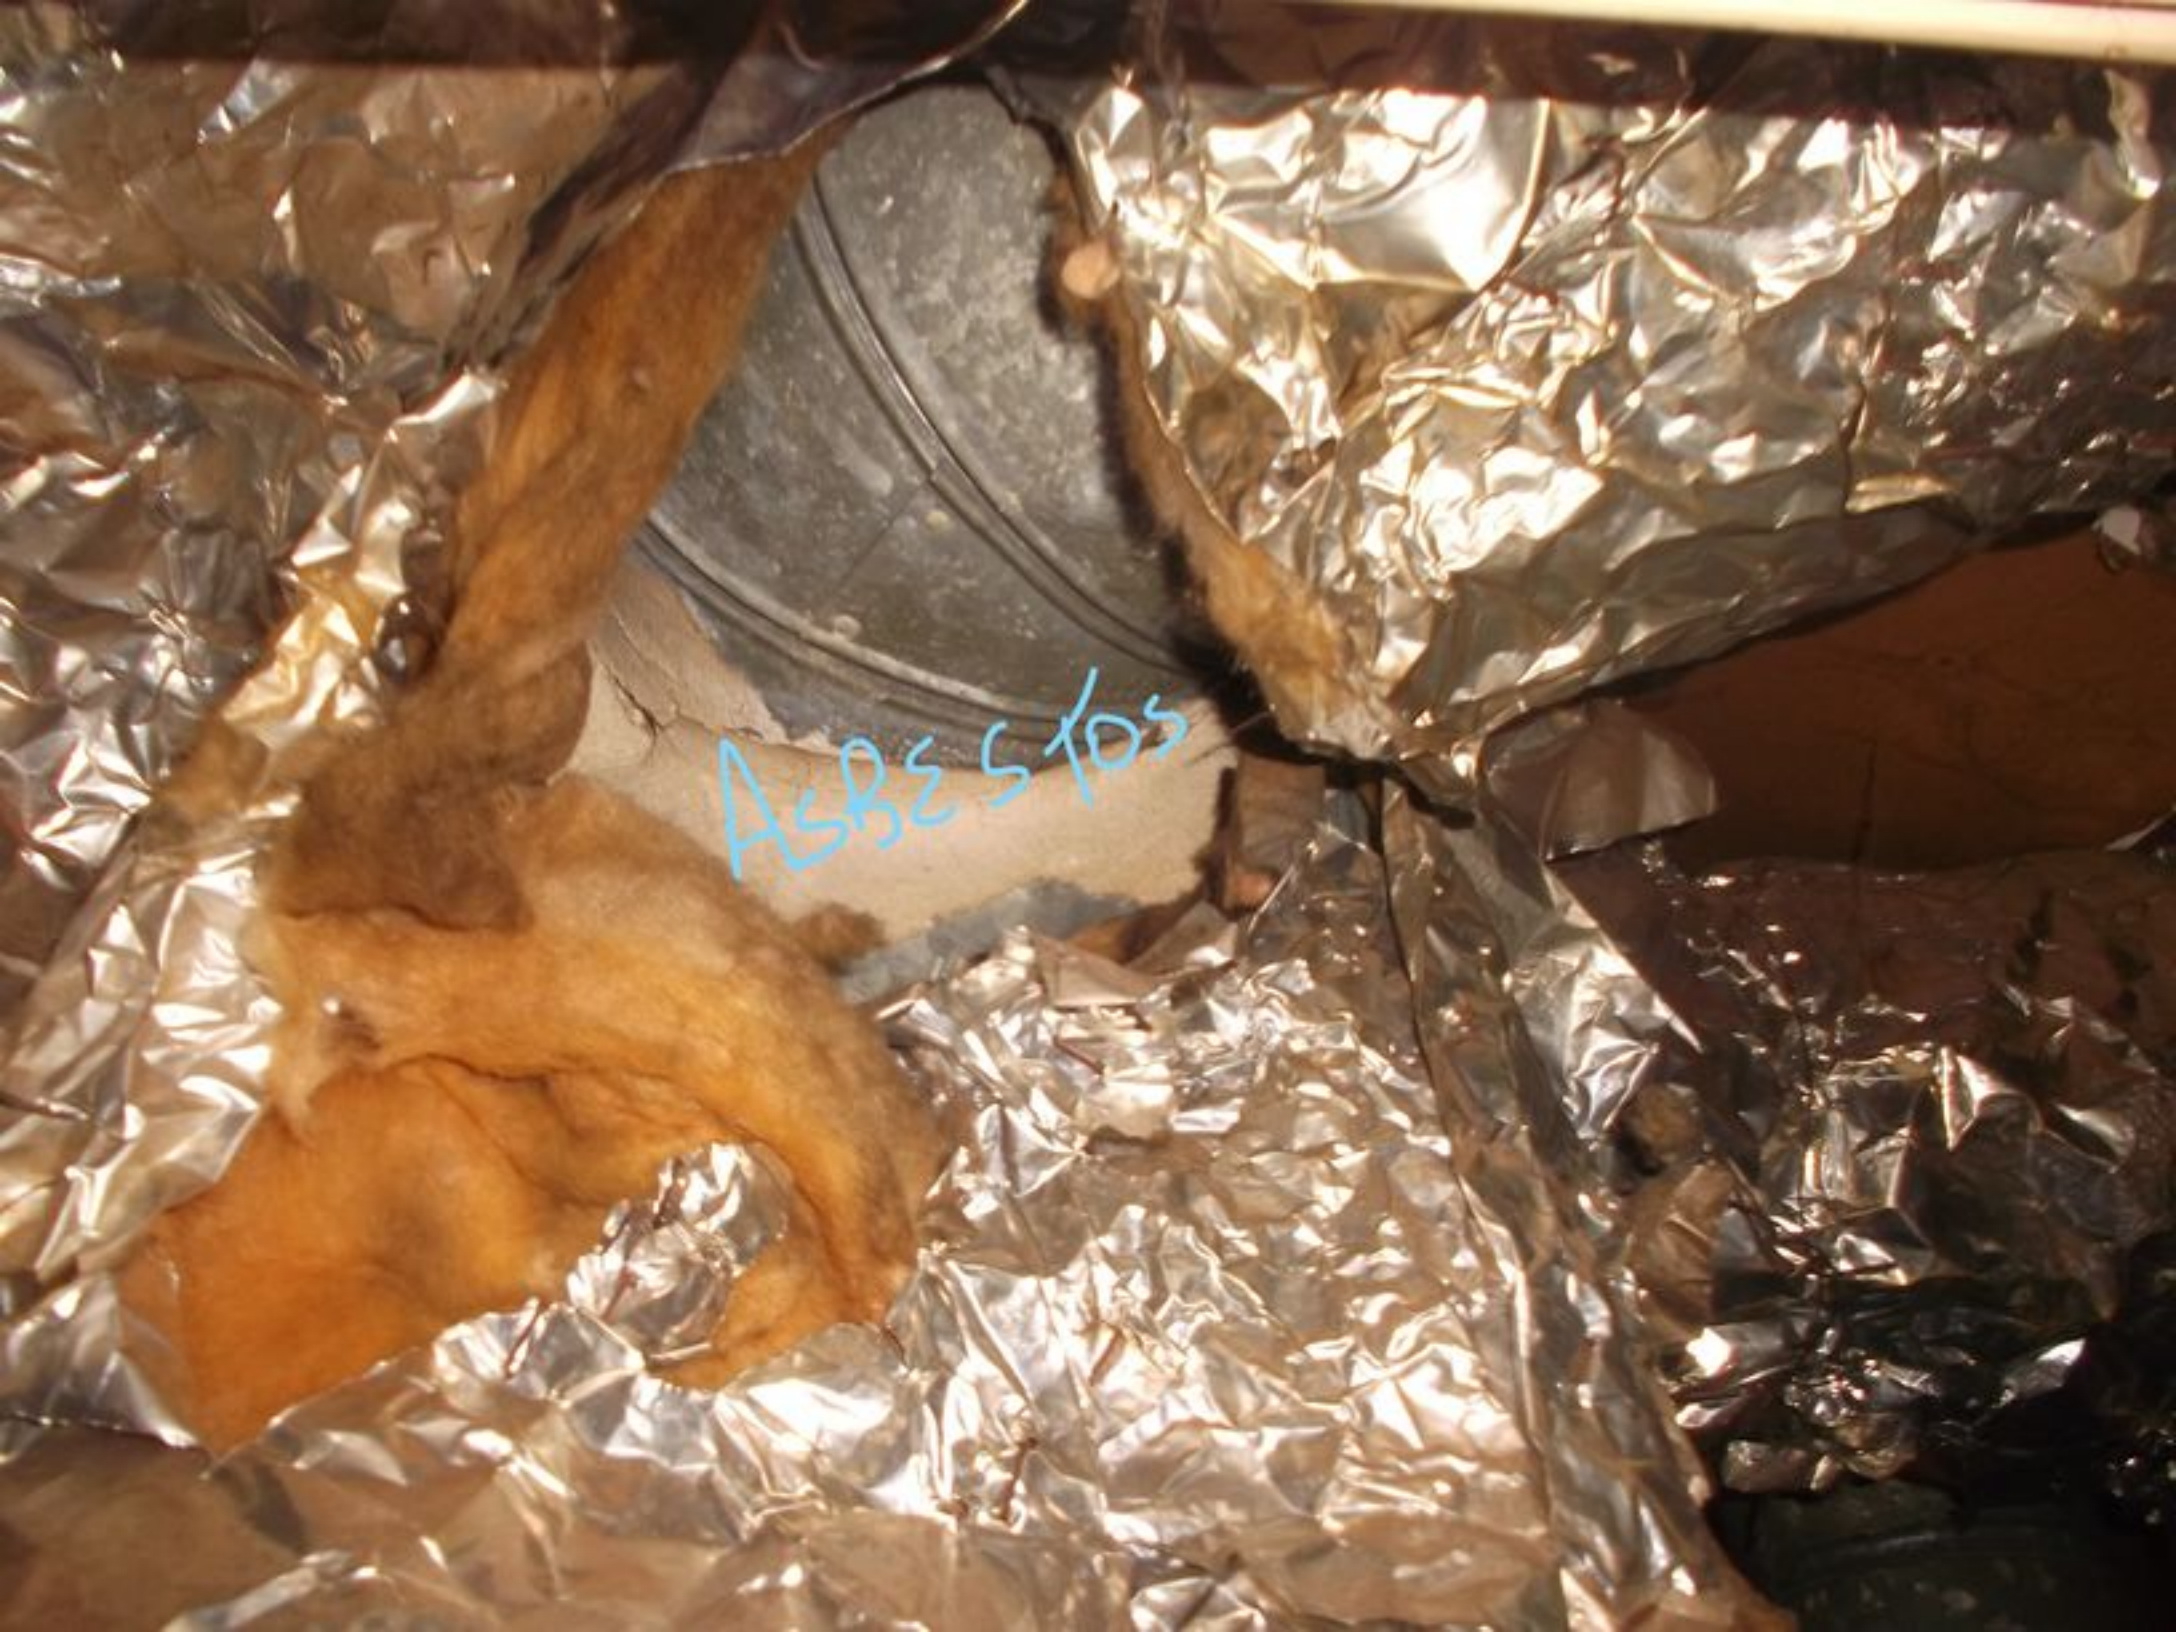
Asbestos

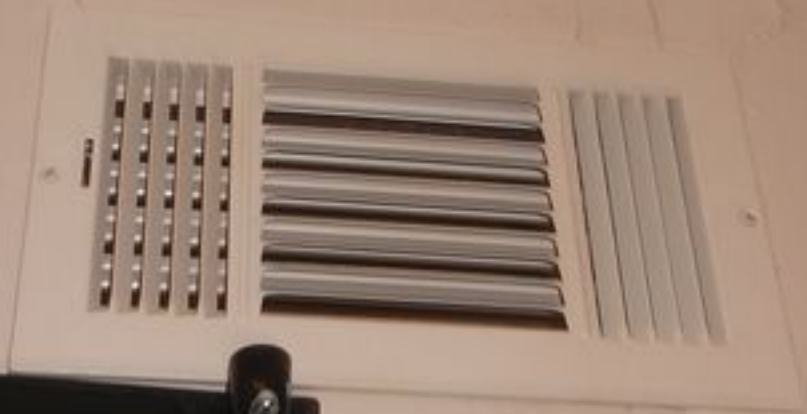
STAIN

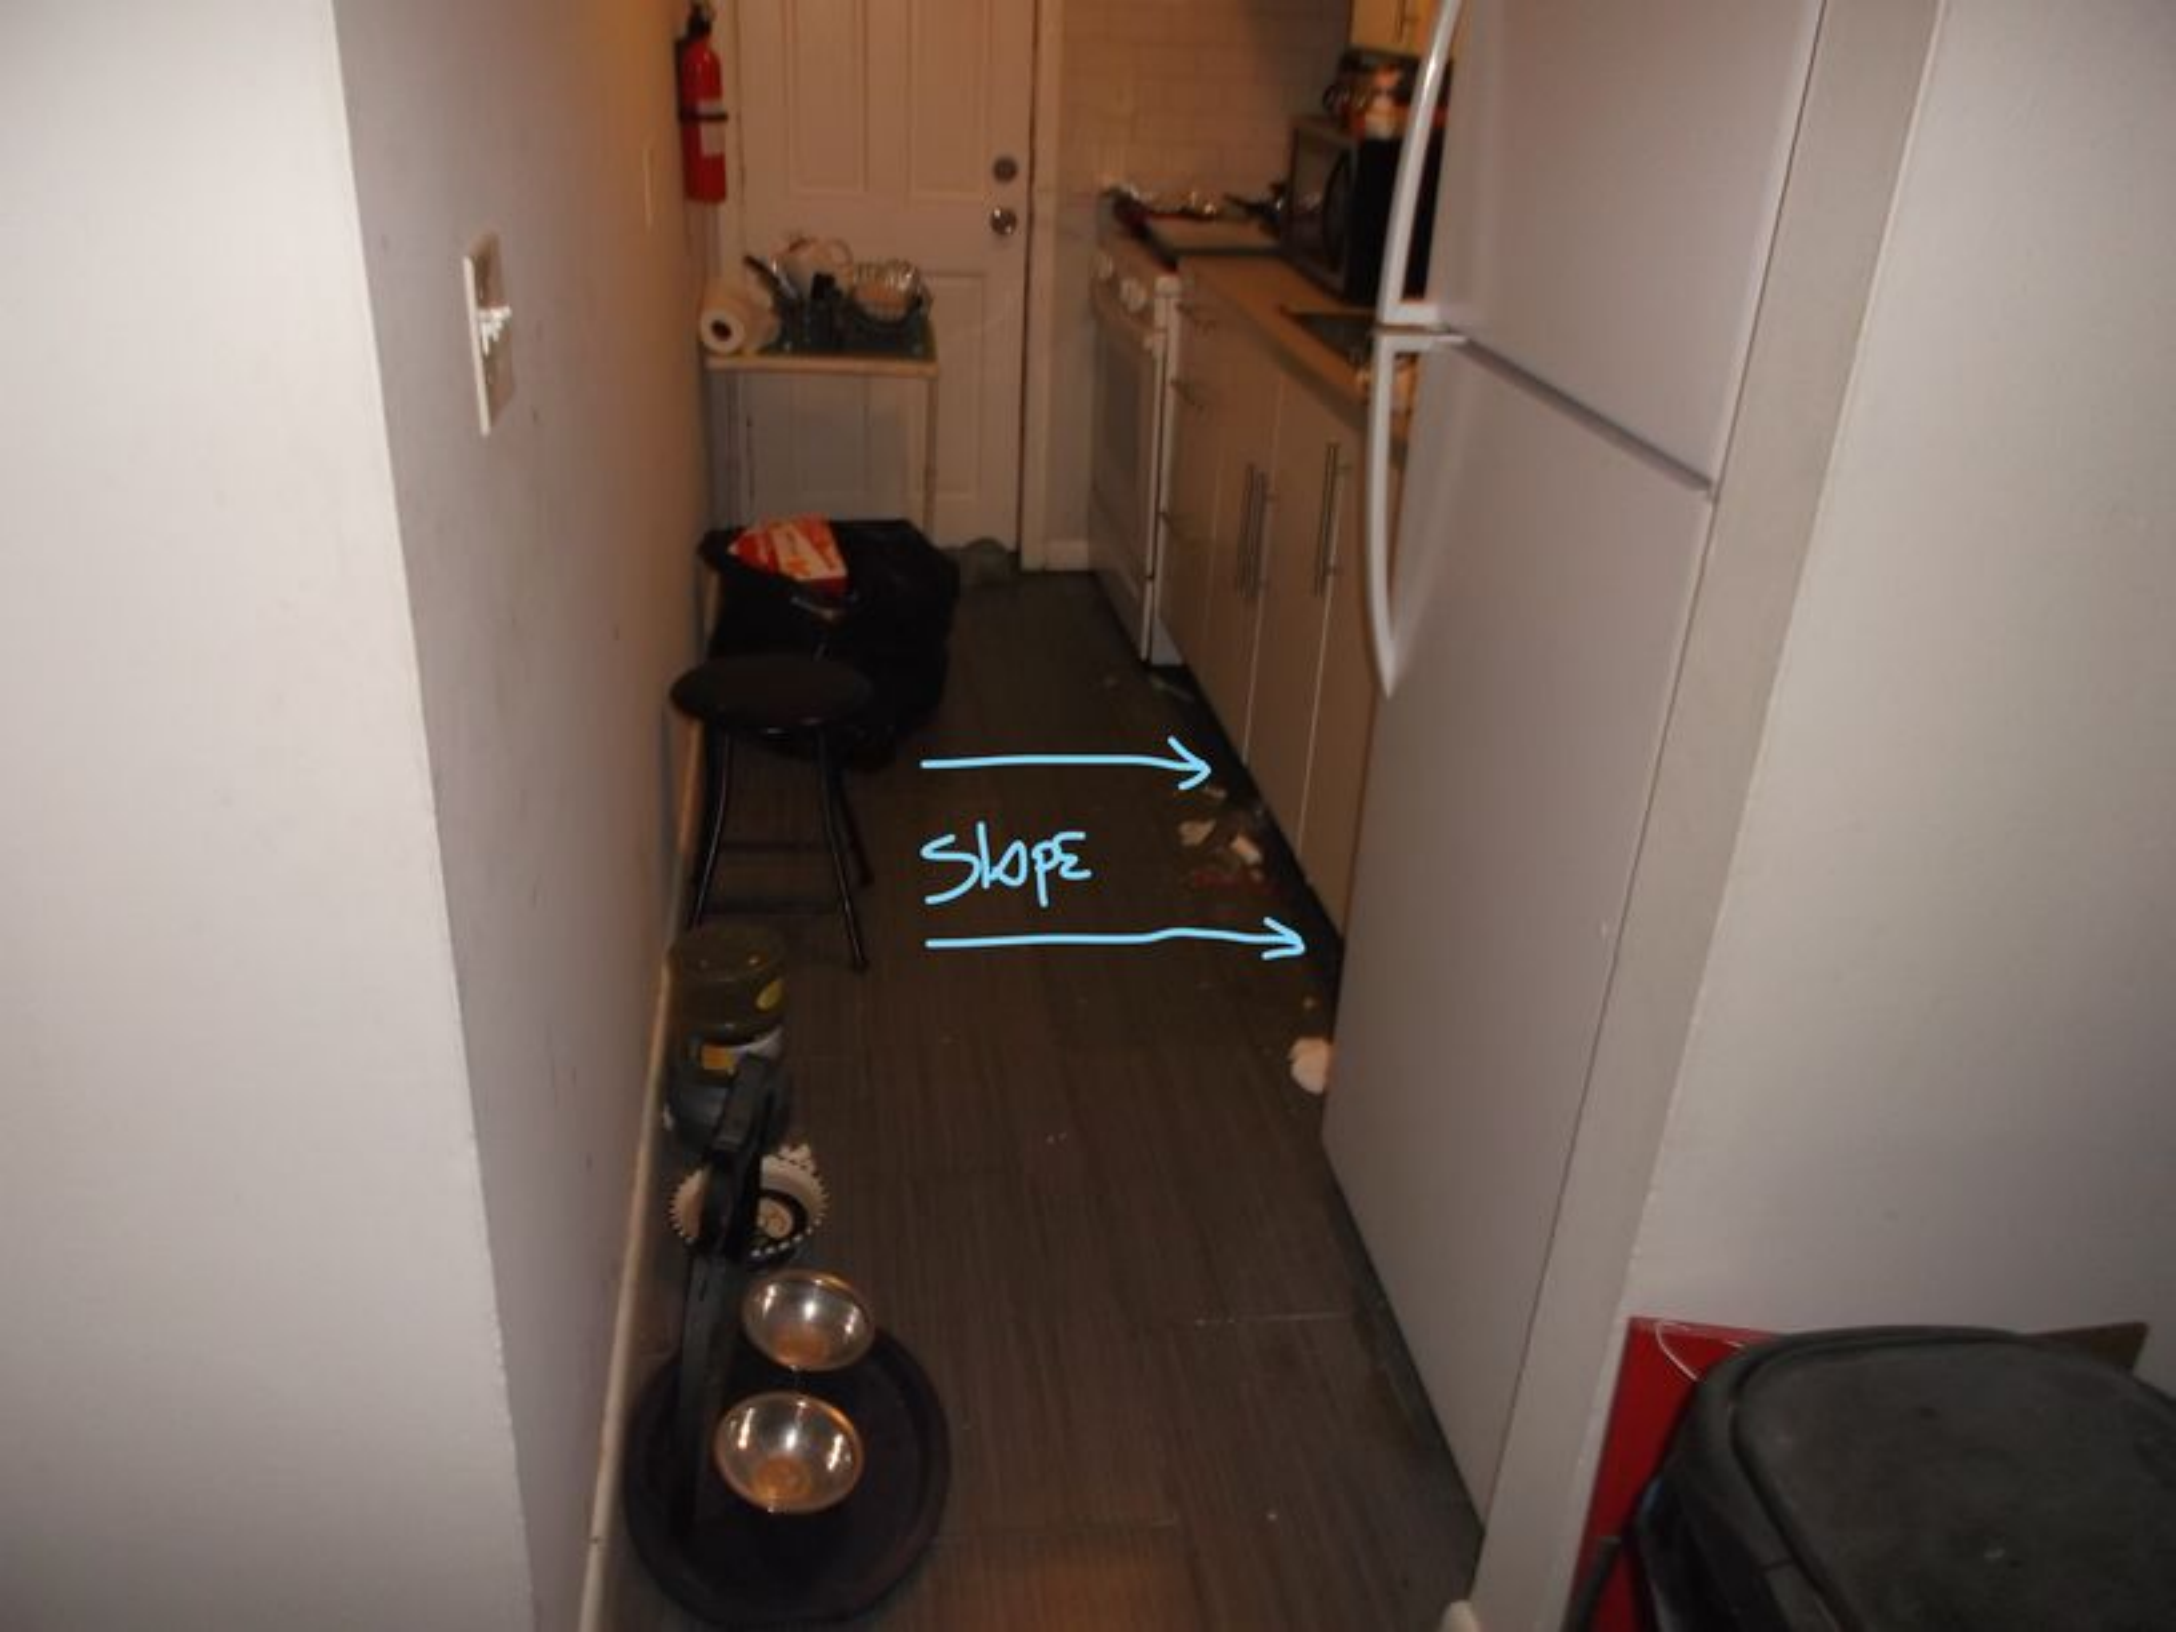
SLOPE

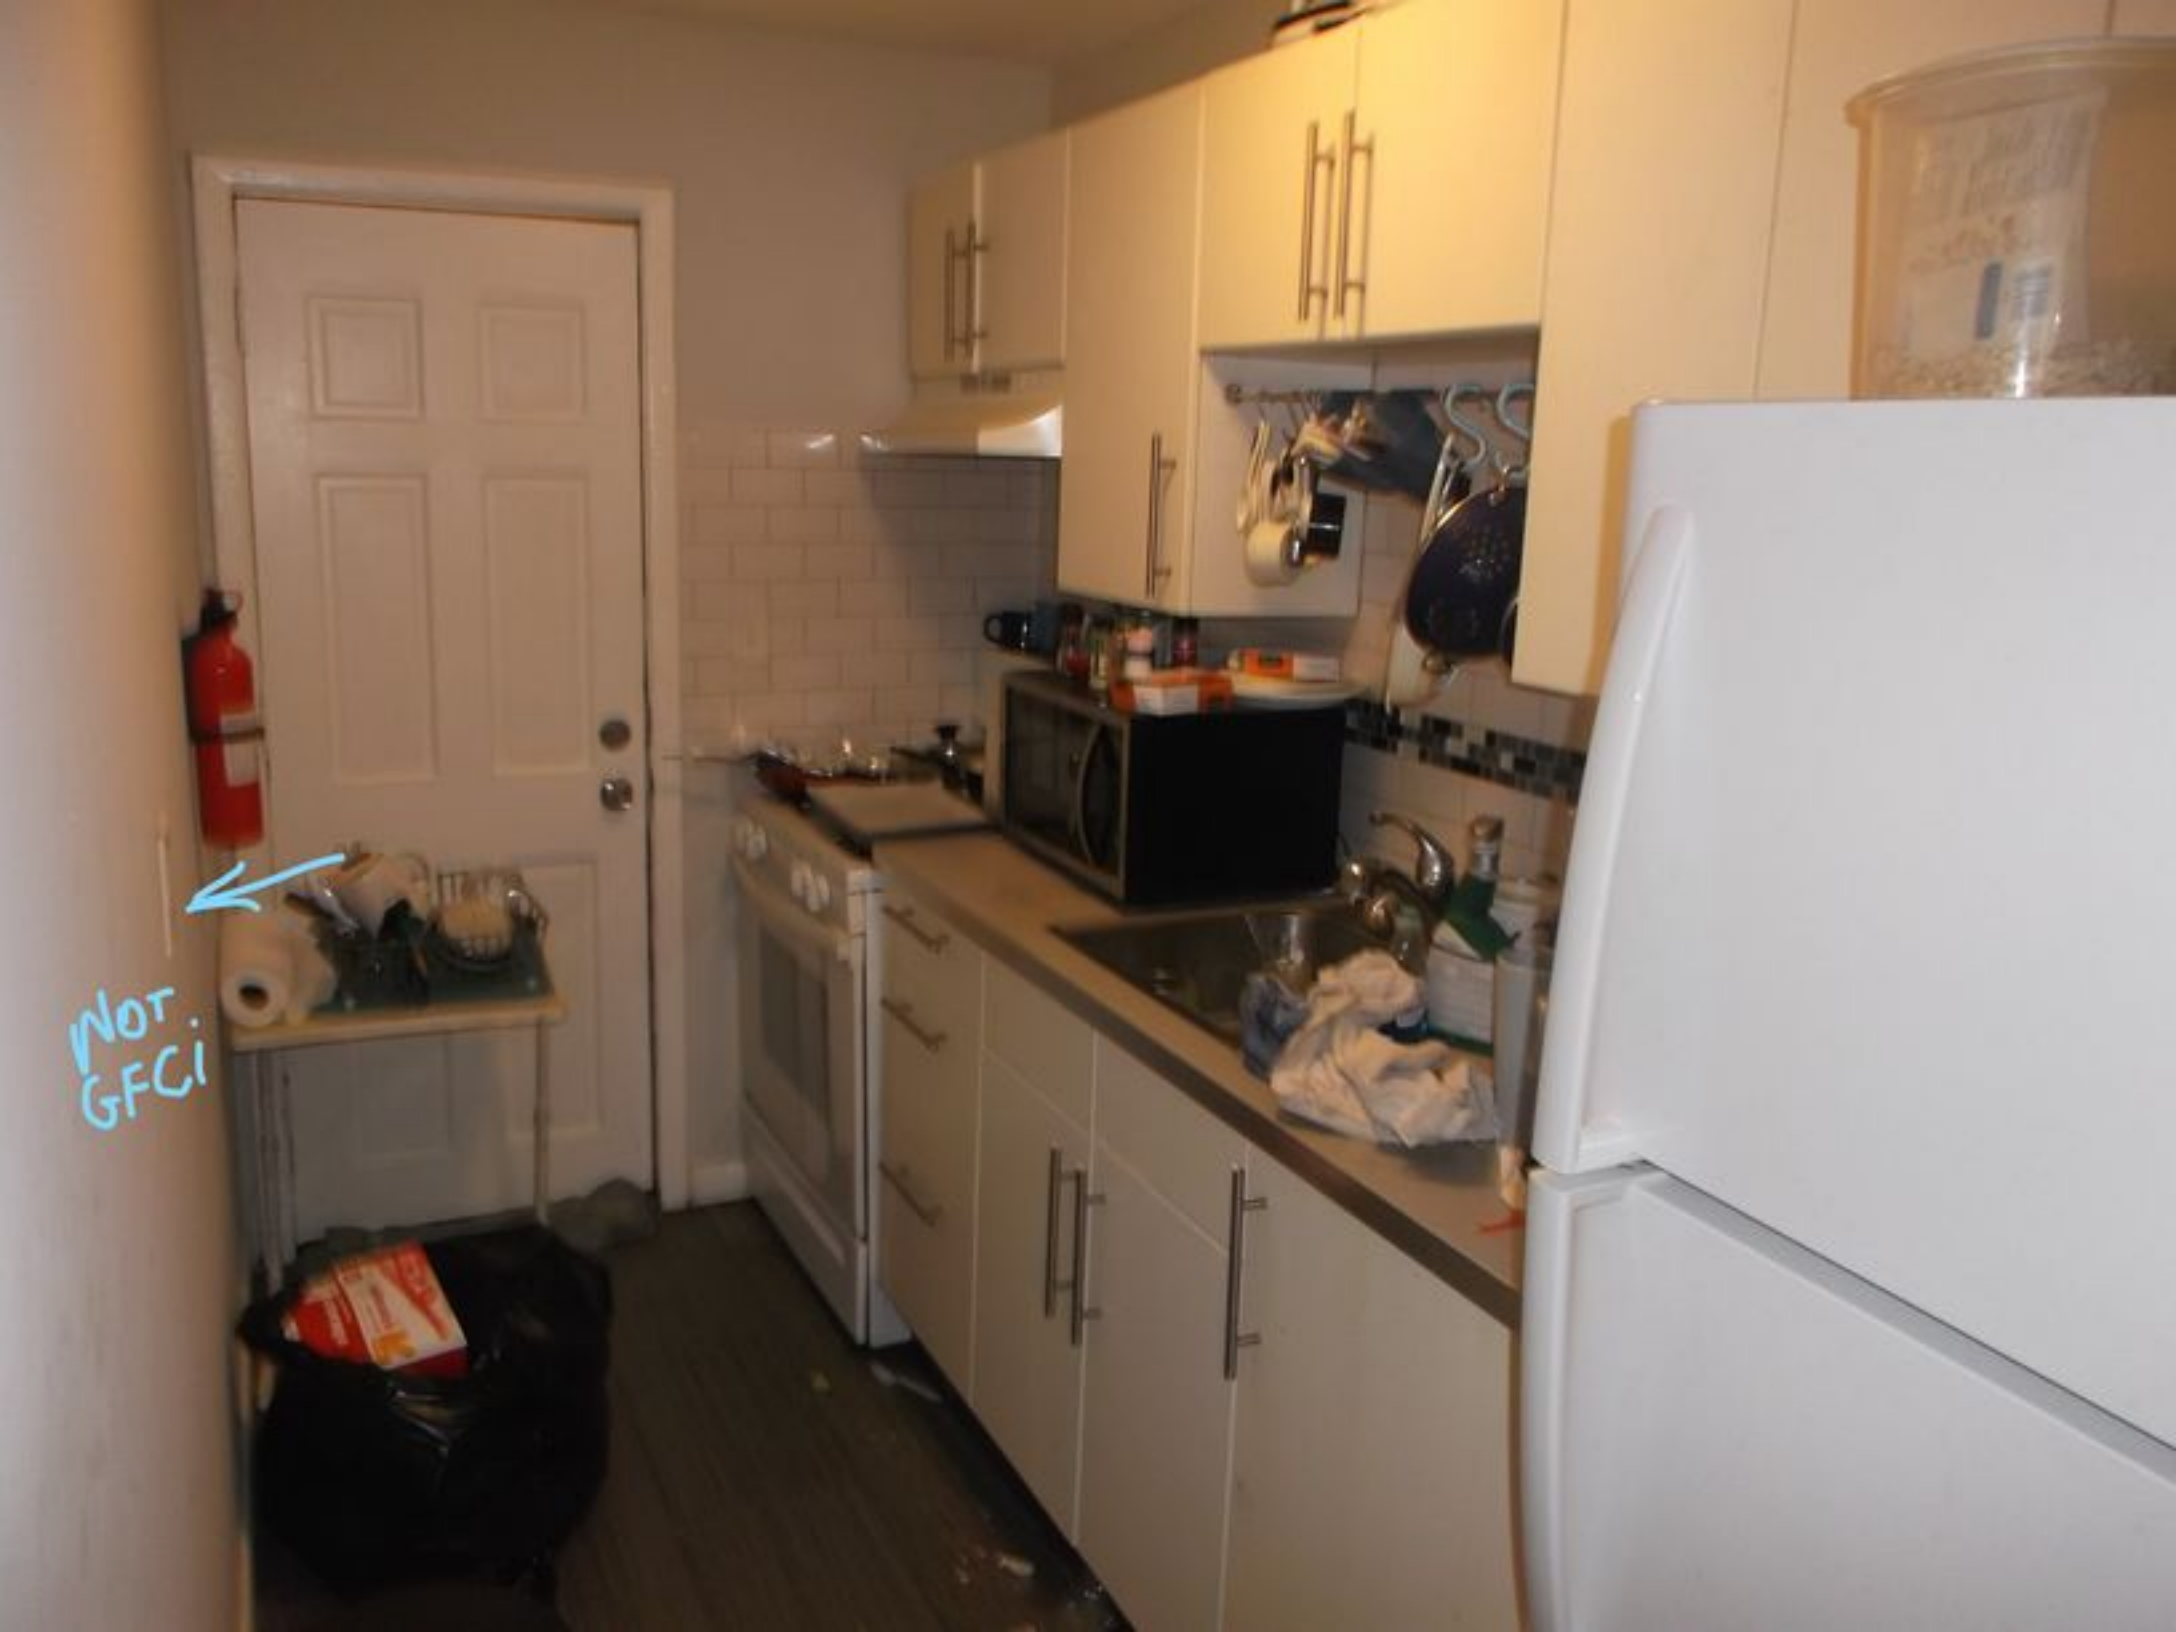
NOT
GFCI

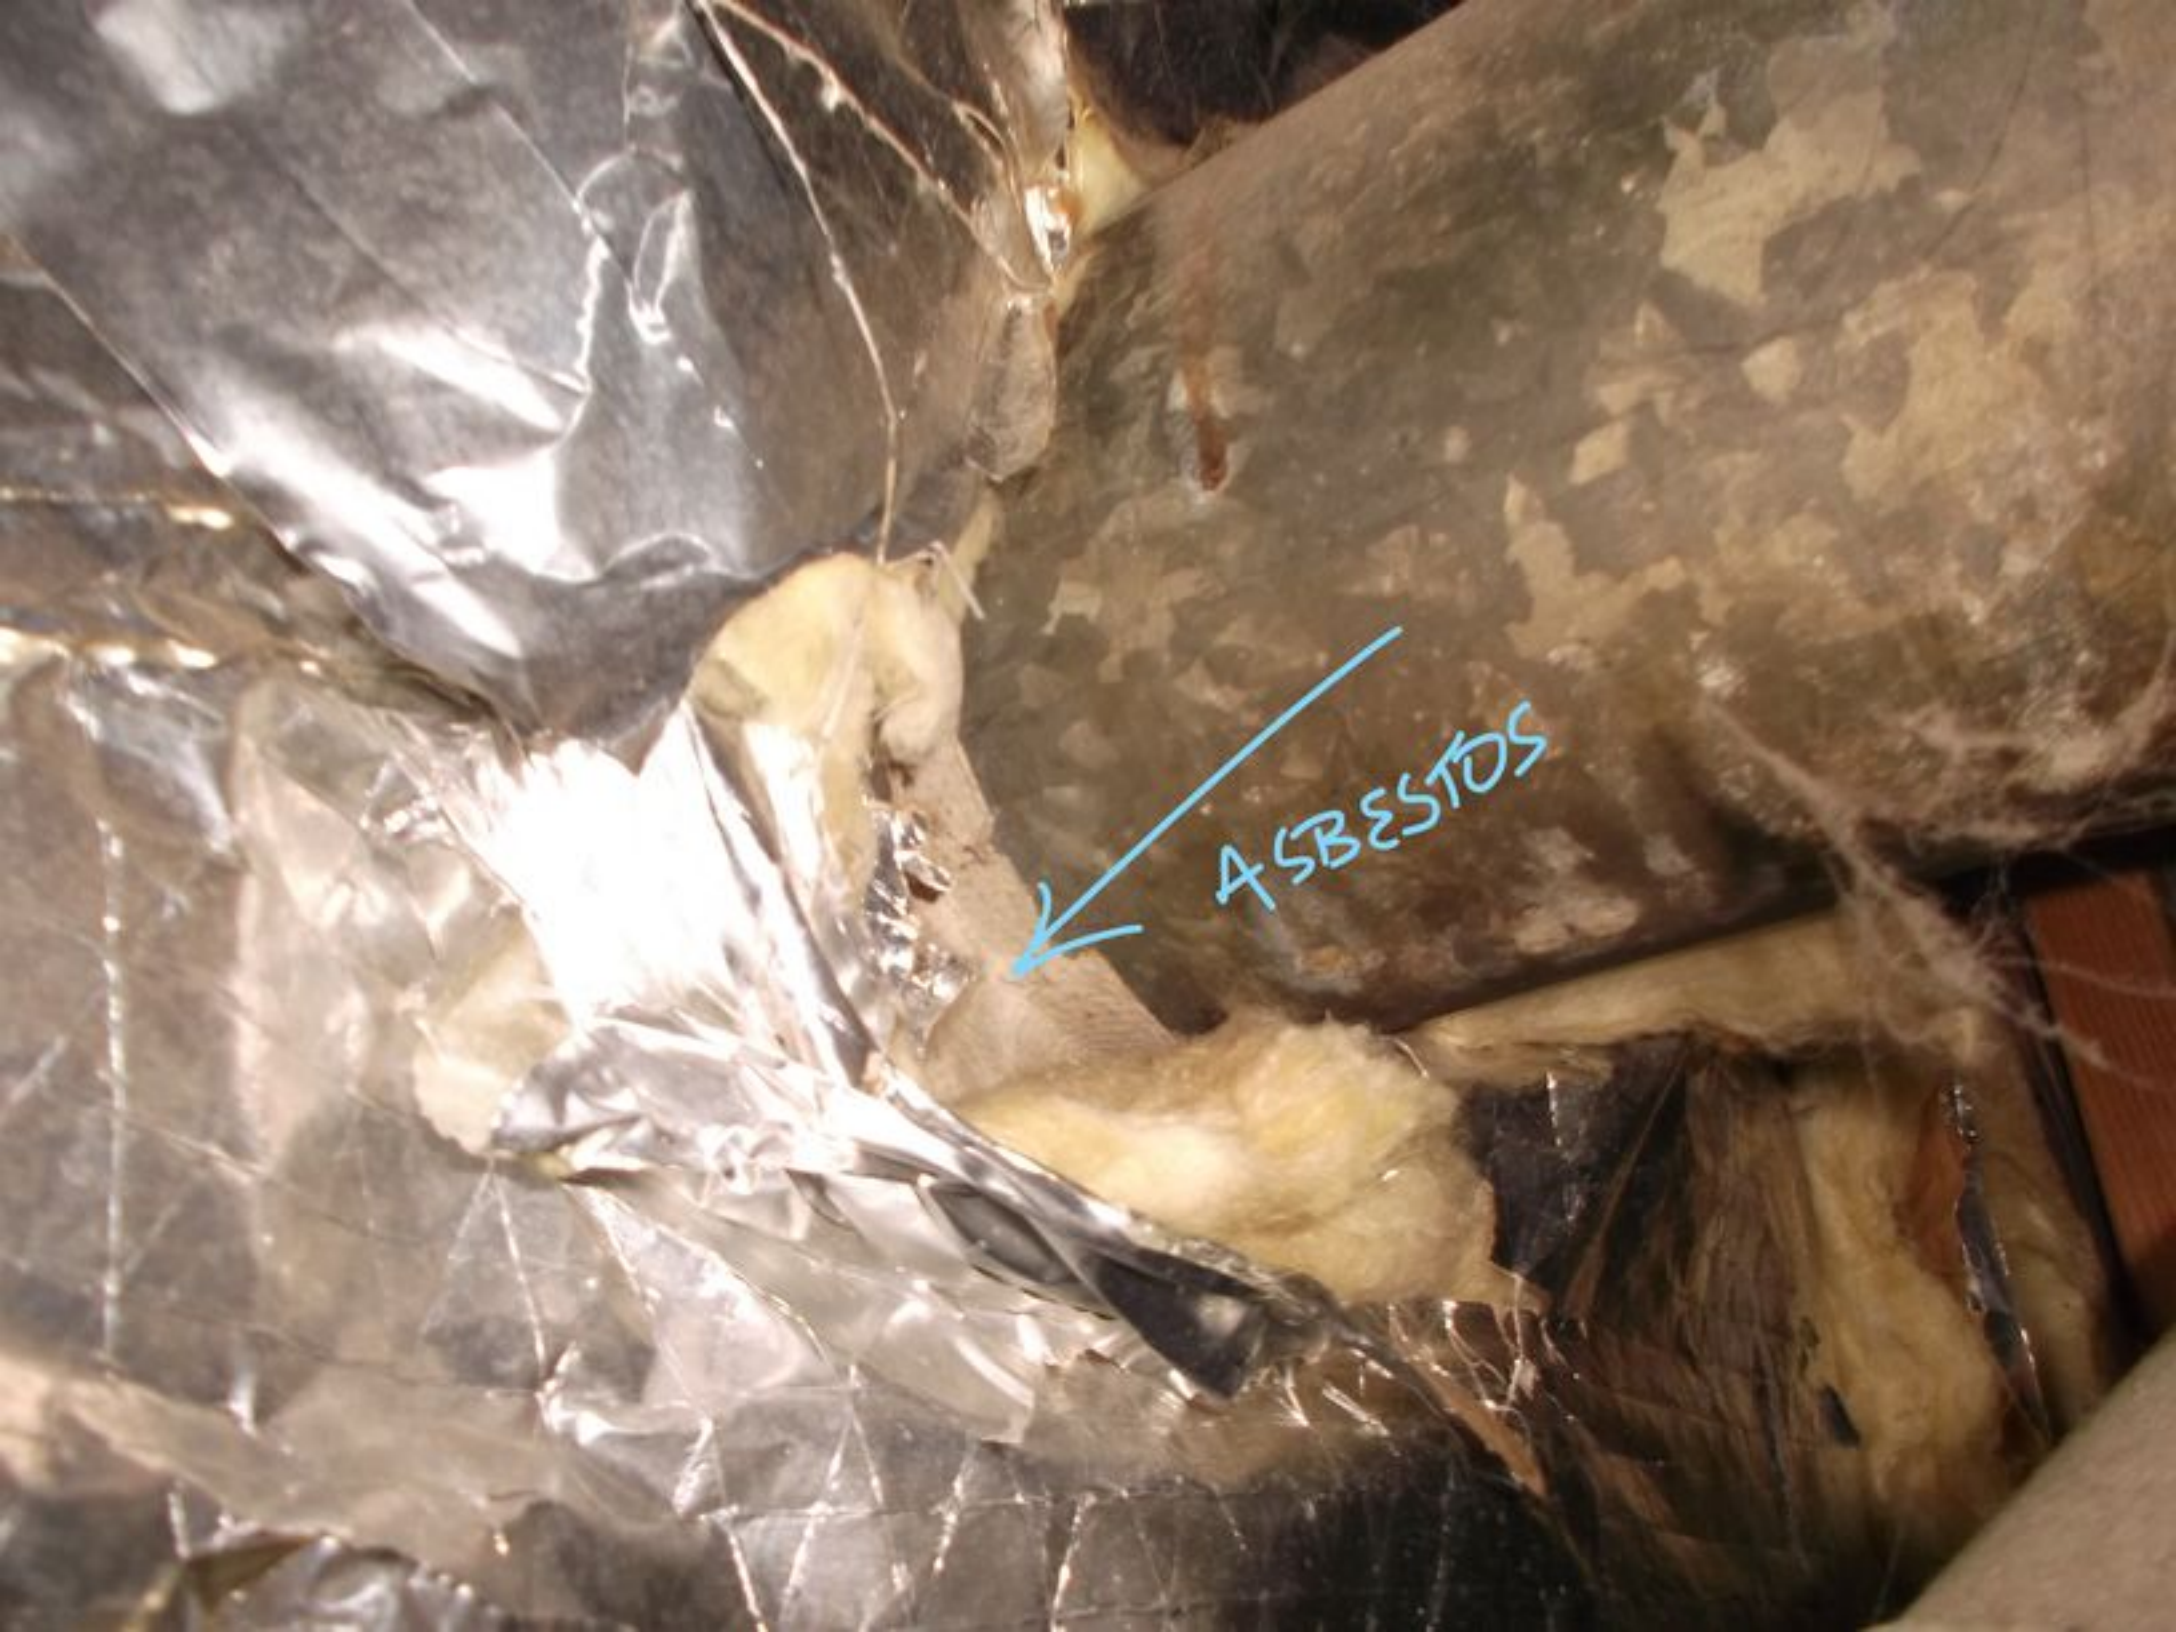
ASBESTOS
