Paris Pressley REI

3196 Church St. East Point, GA.

Page 3 KEY TO THE INSPECTION REPORT

Report #: 54

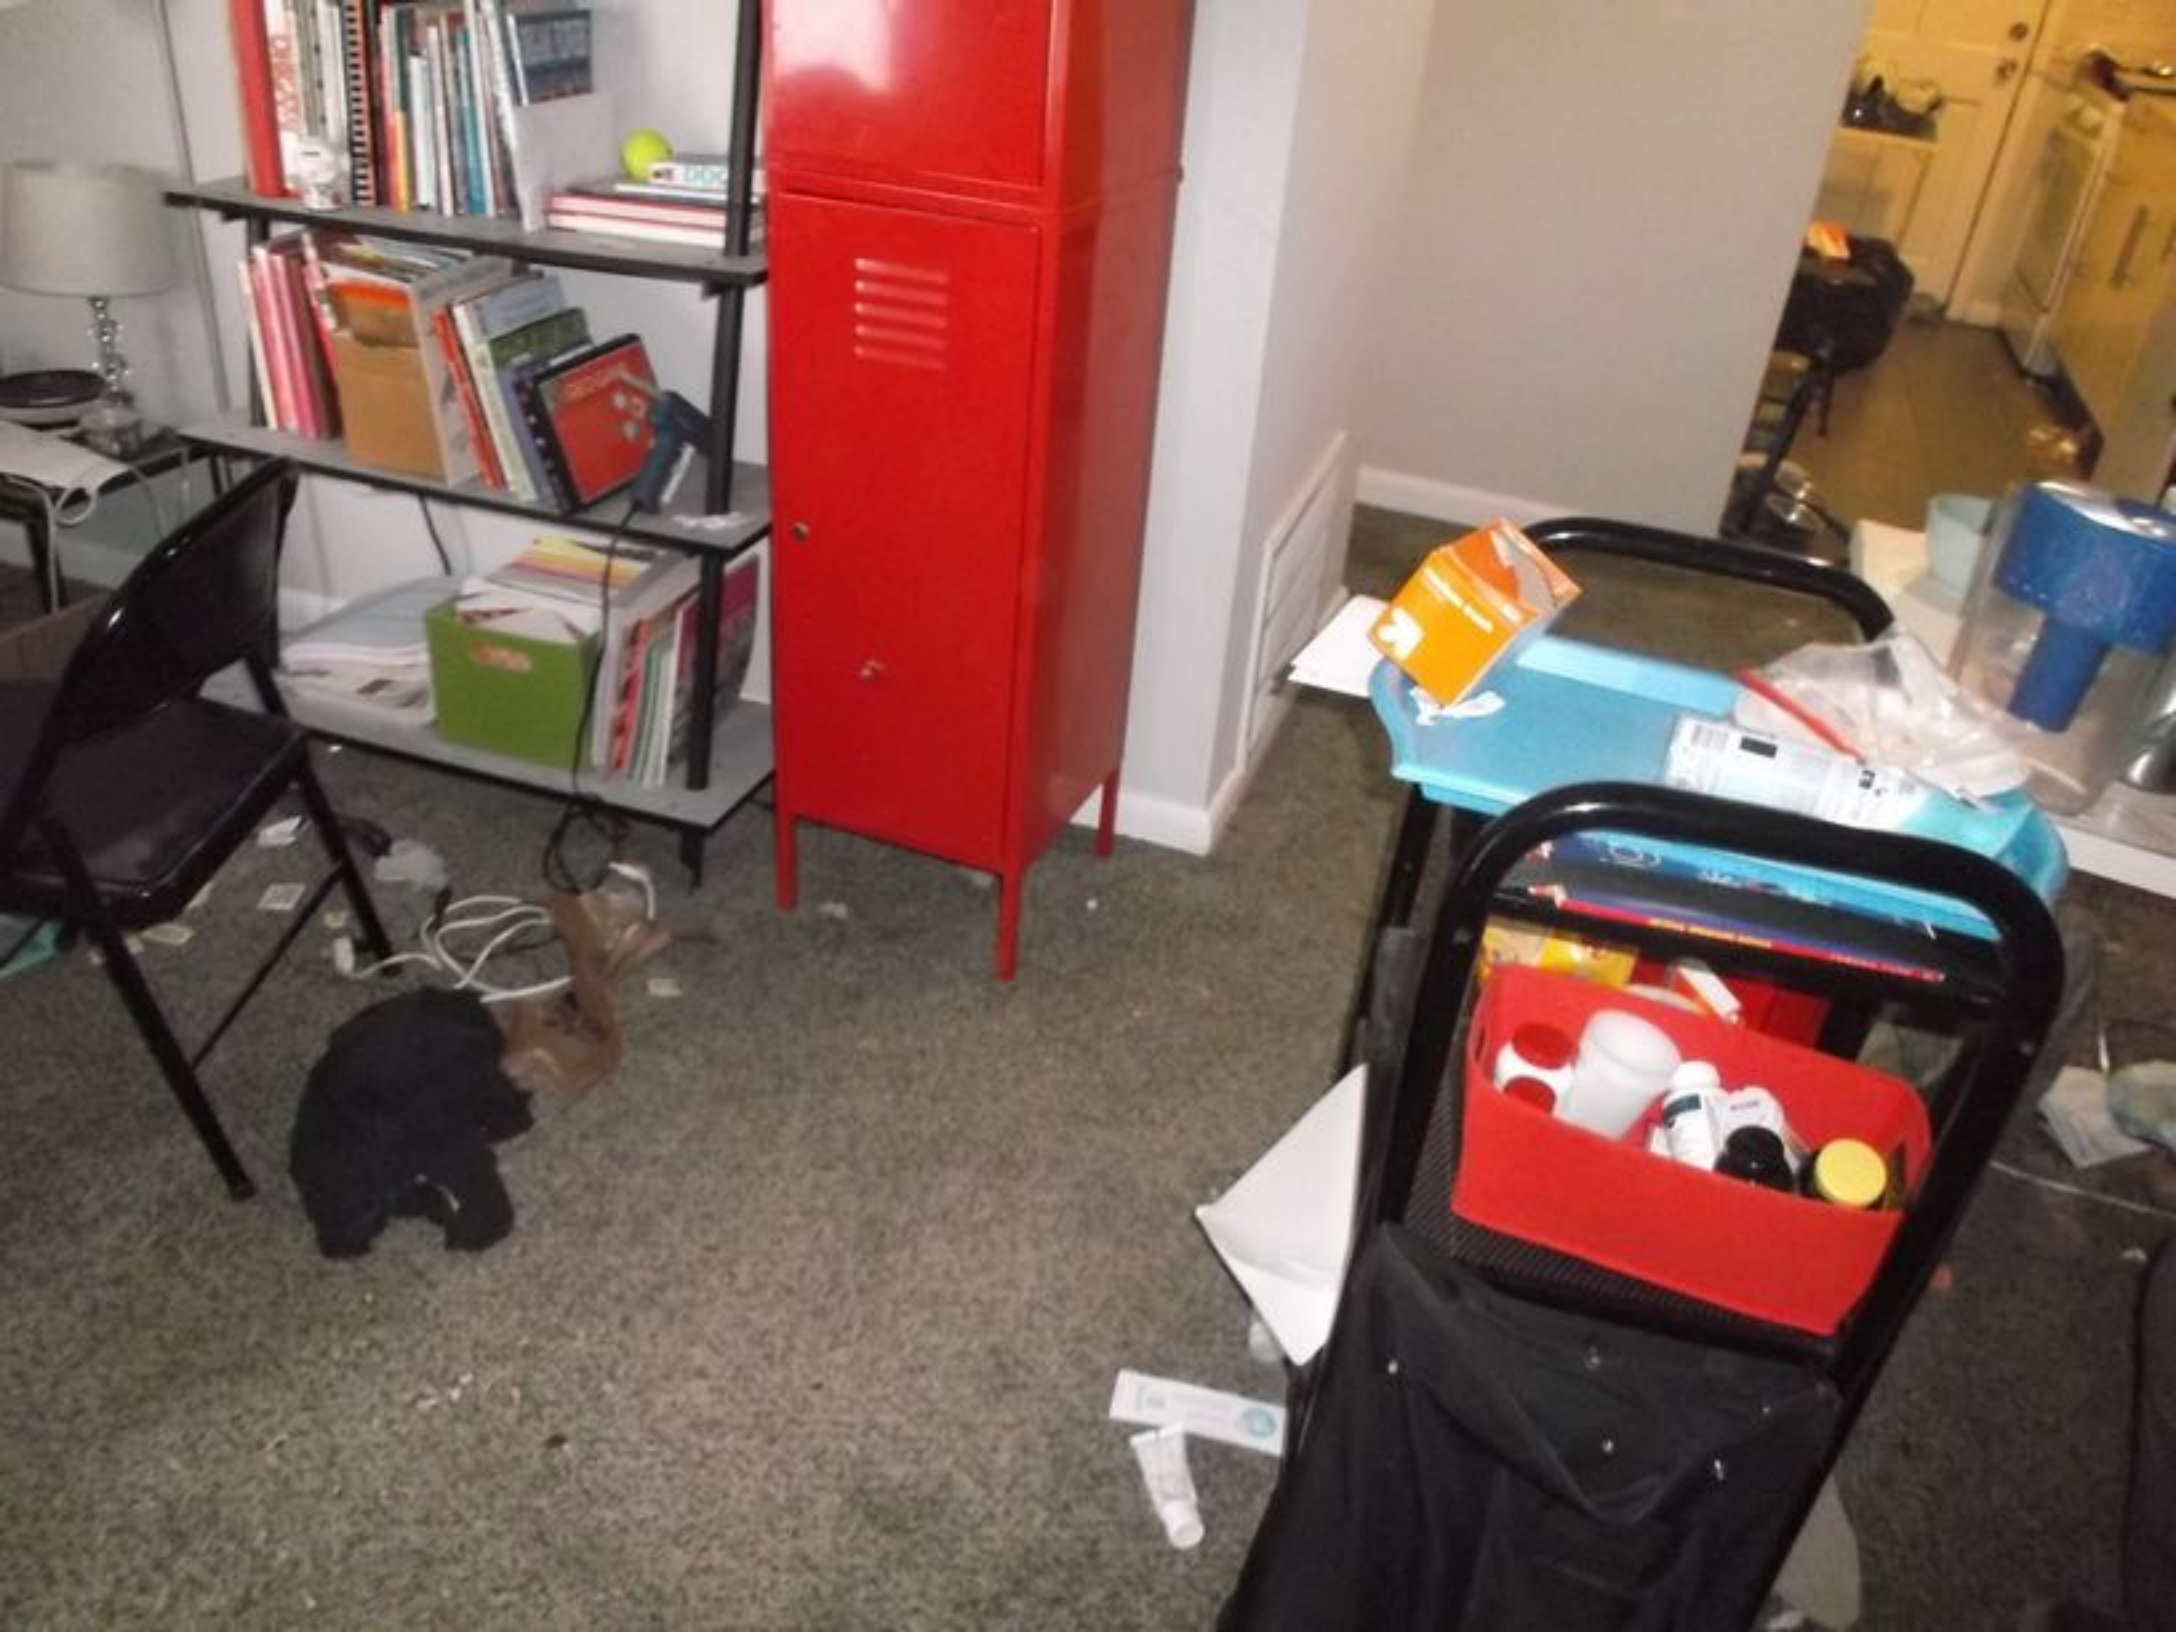
OPEN GROUND

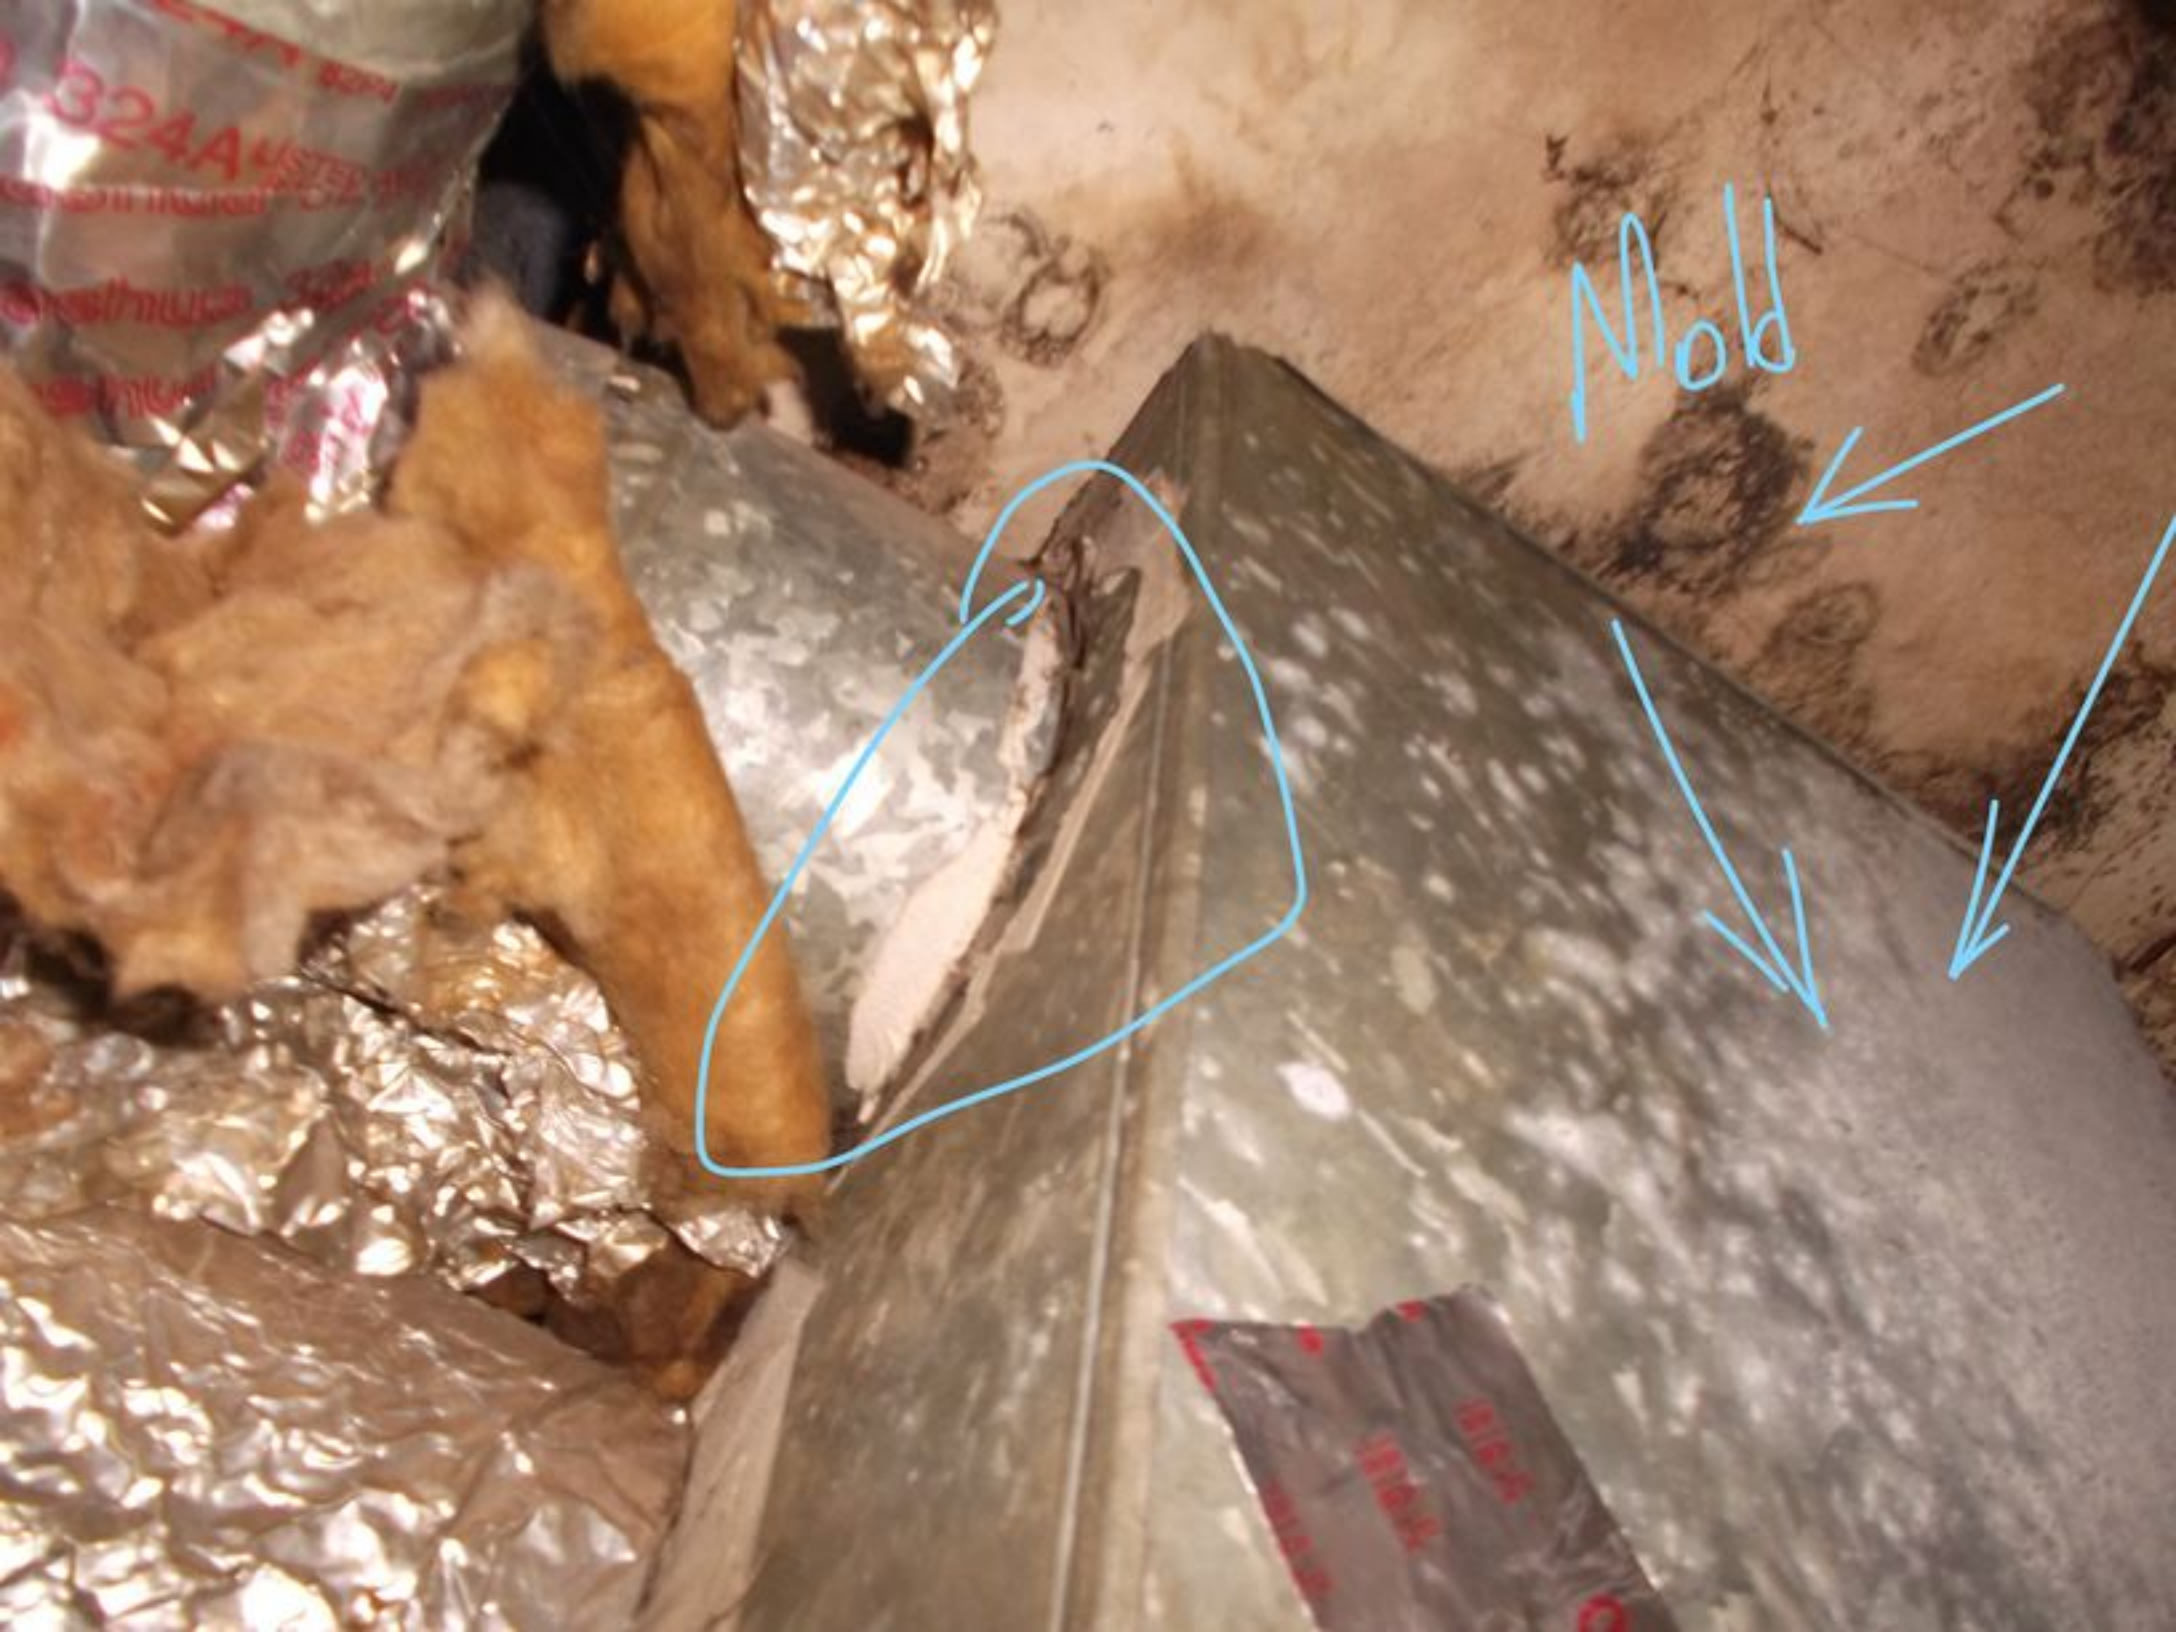
Mold

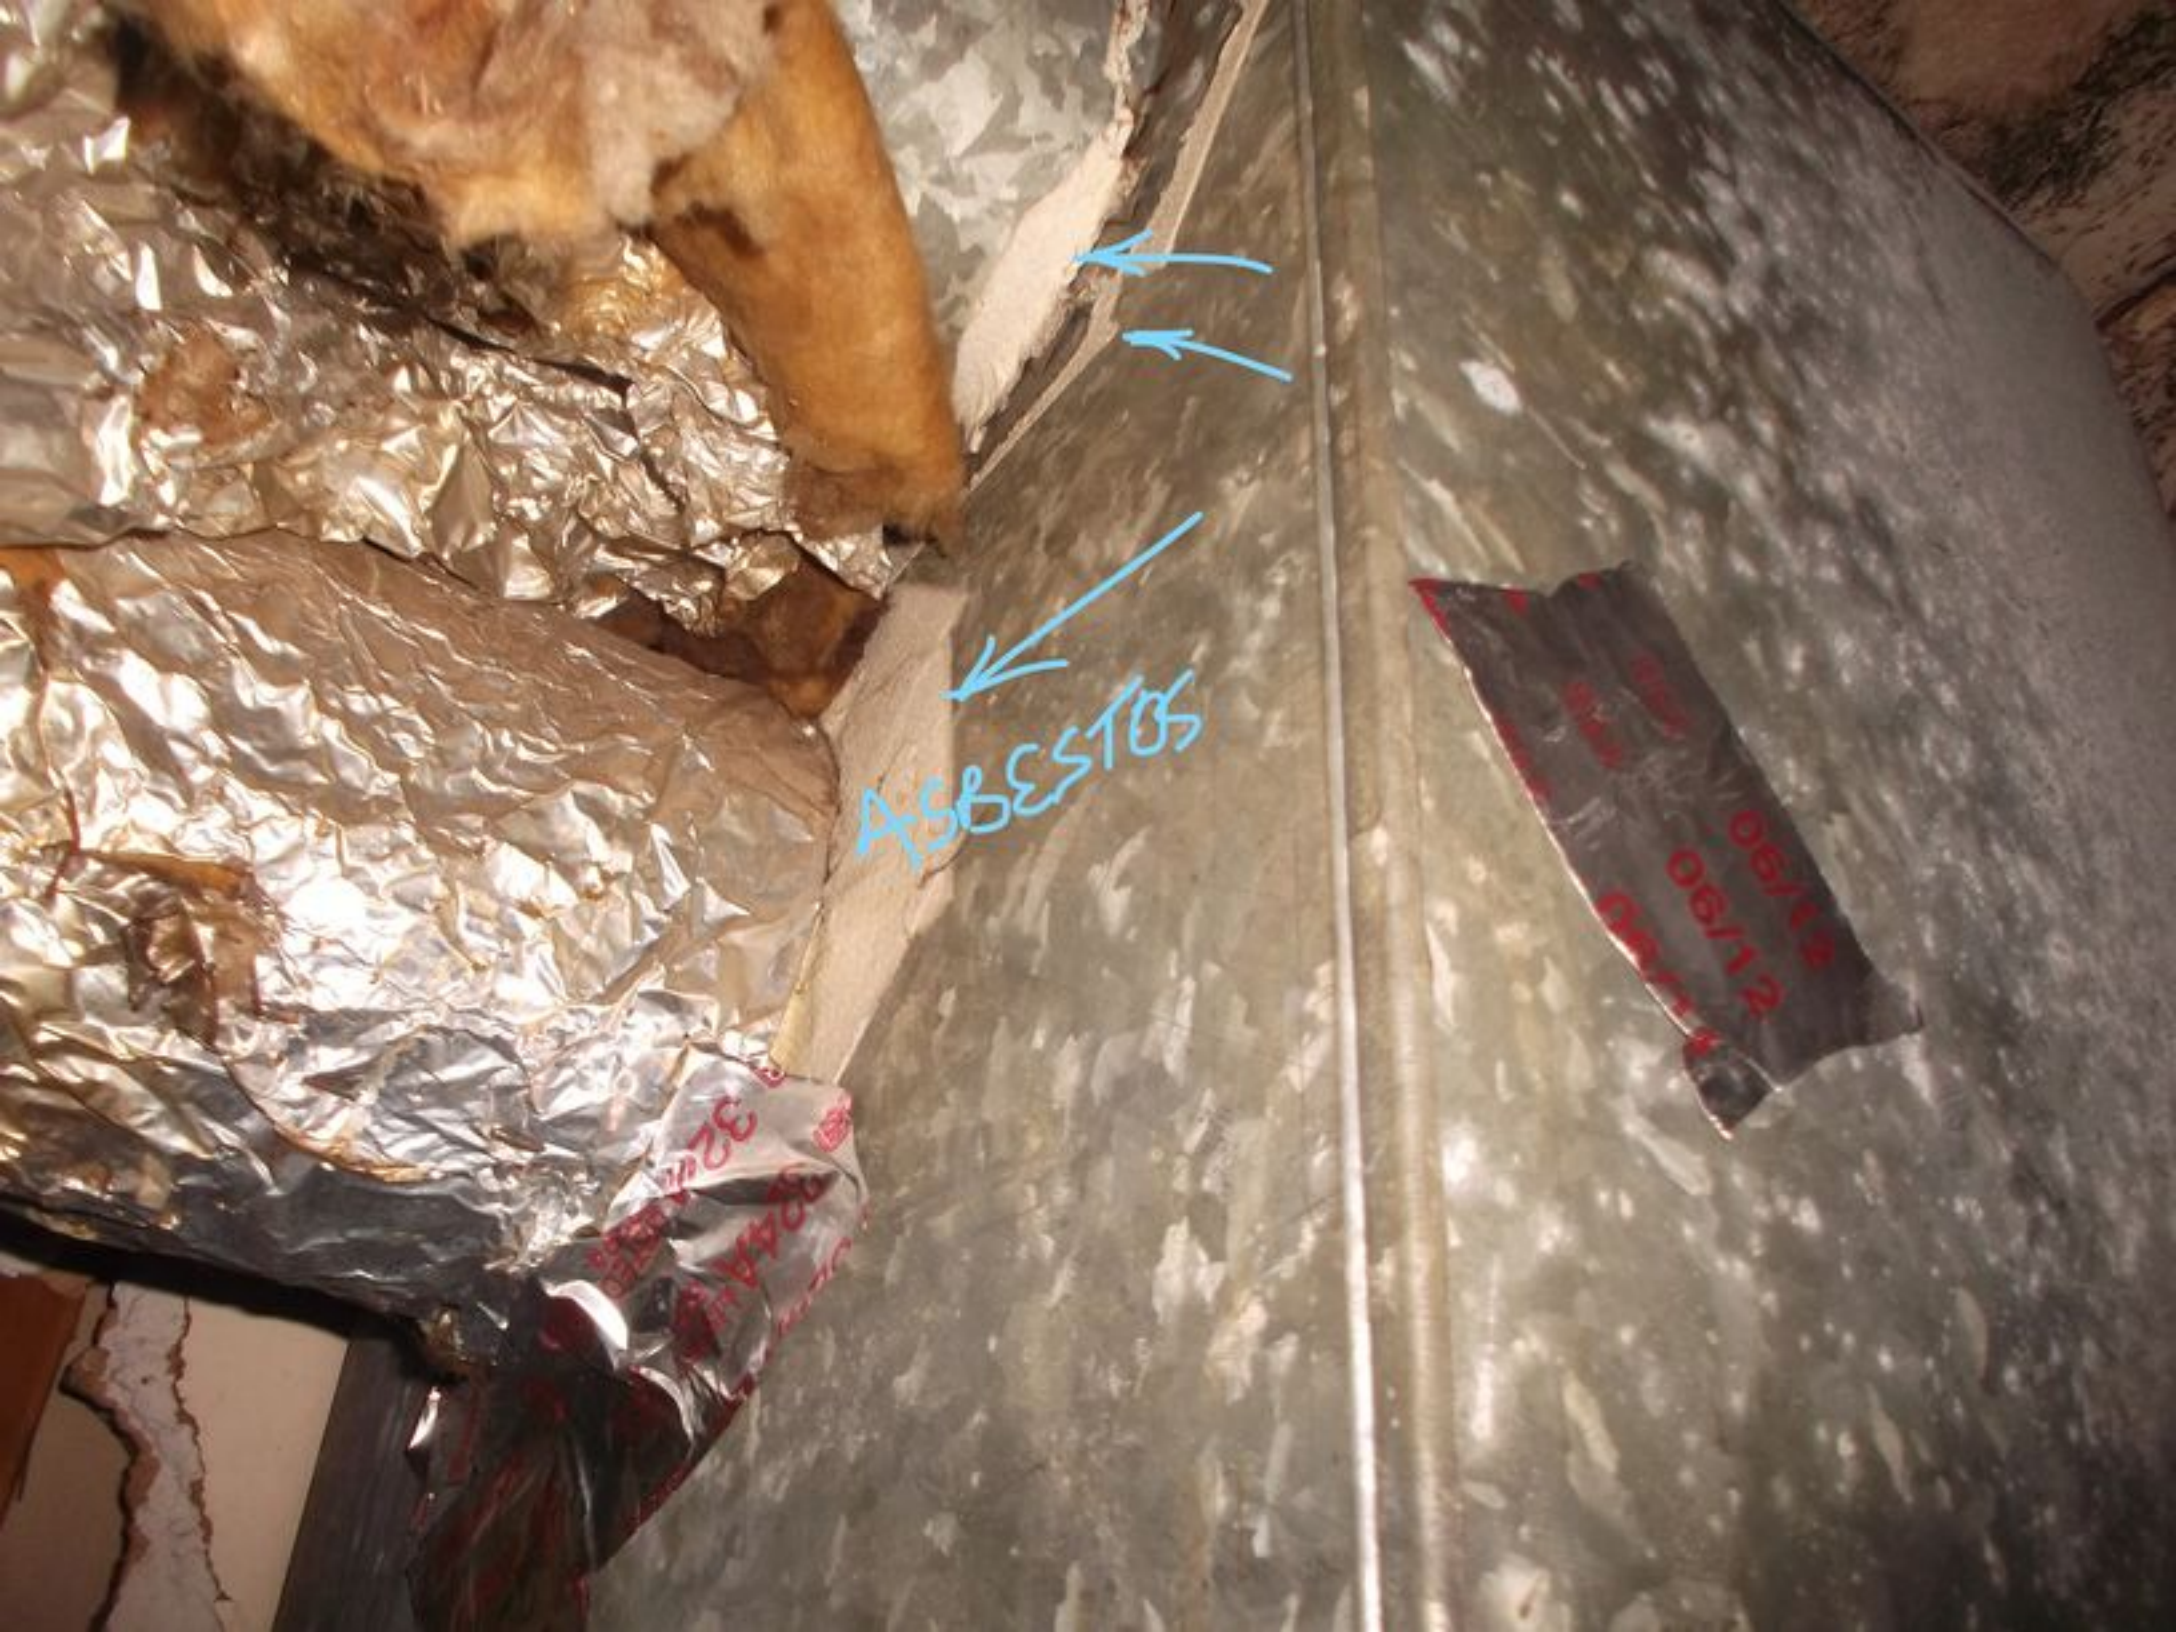
ASBESTOS

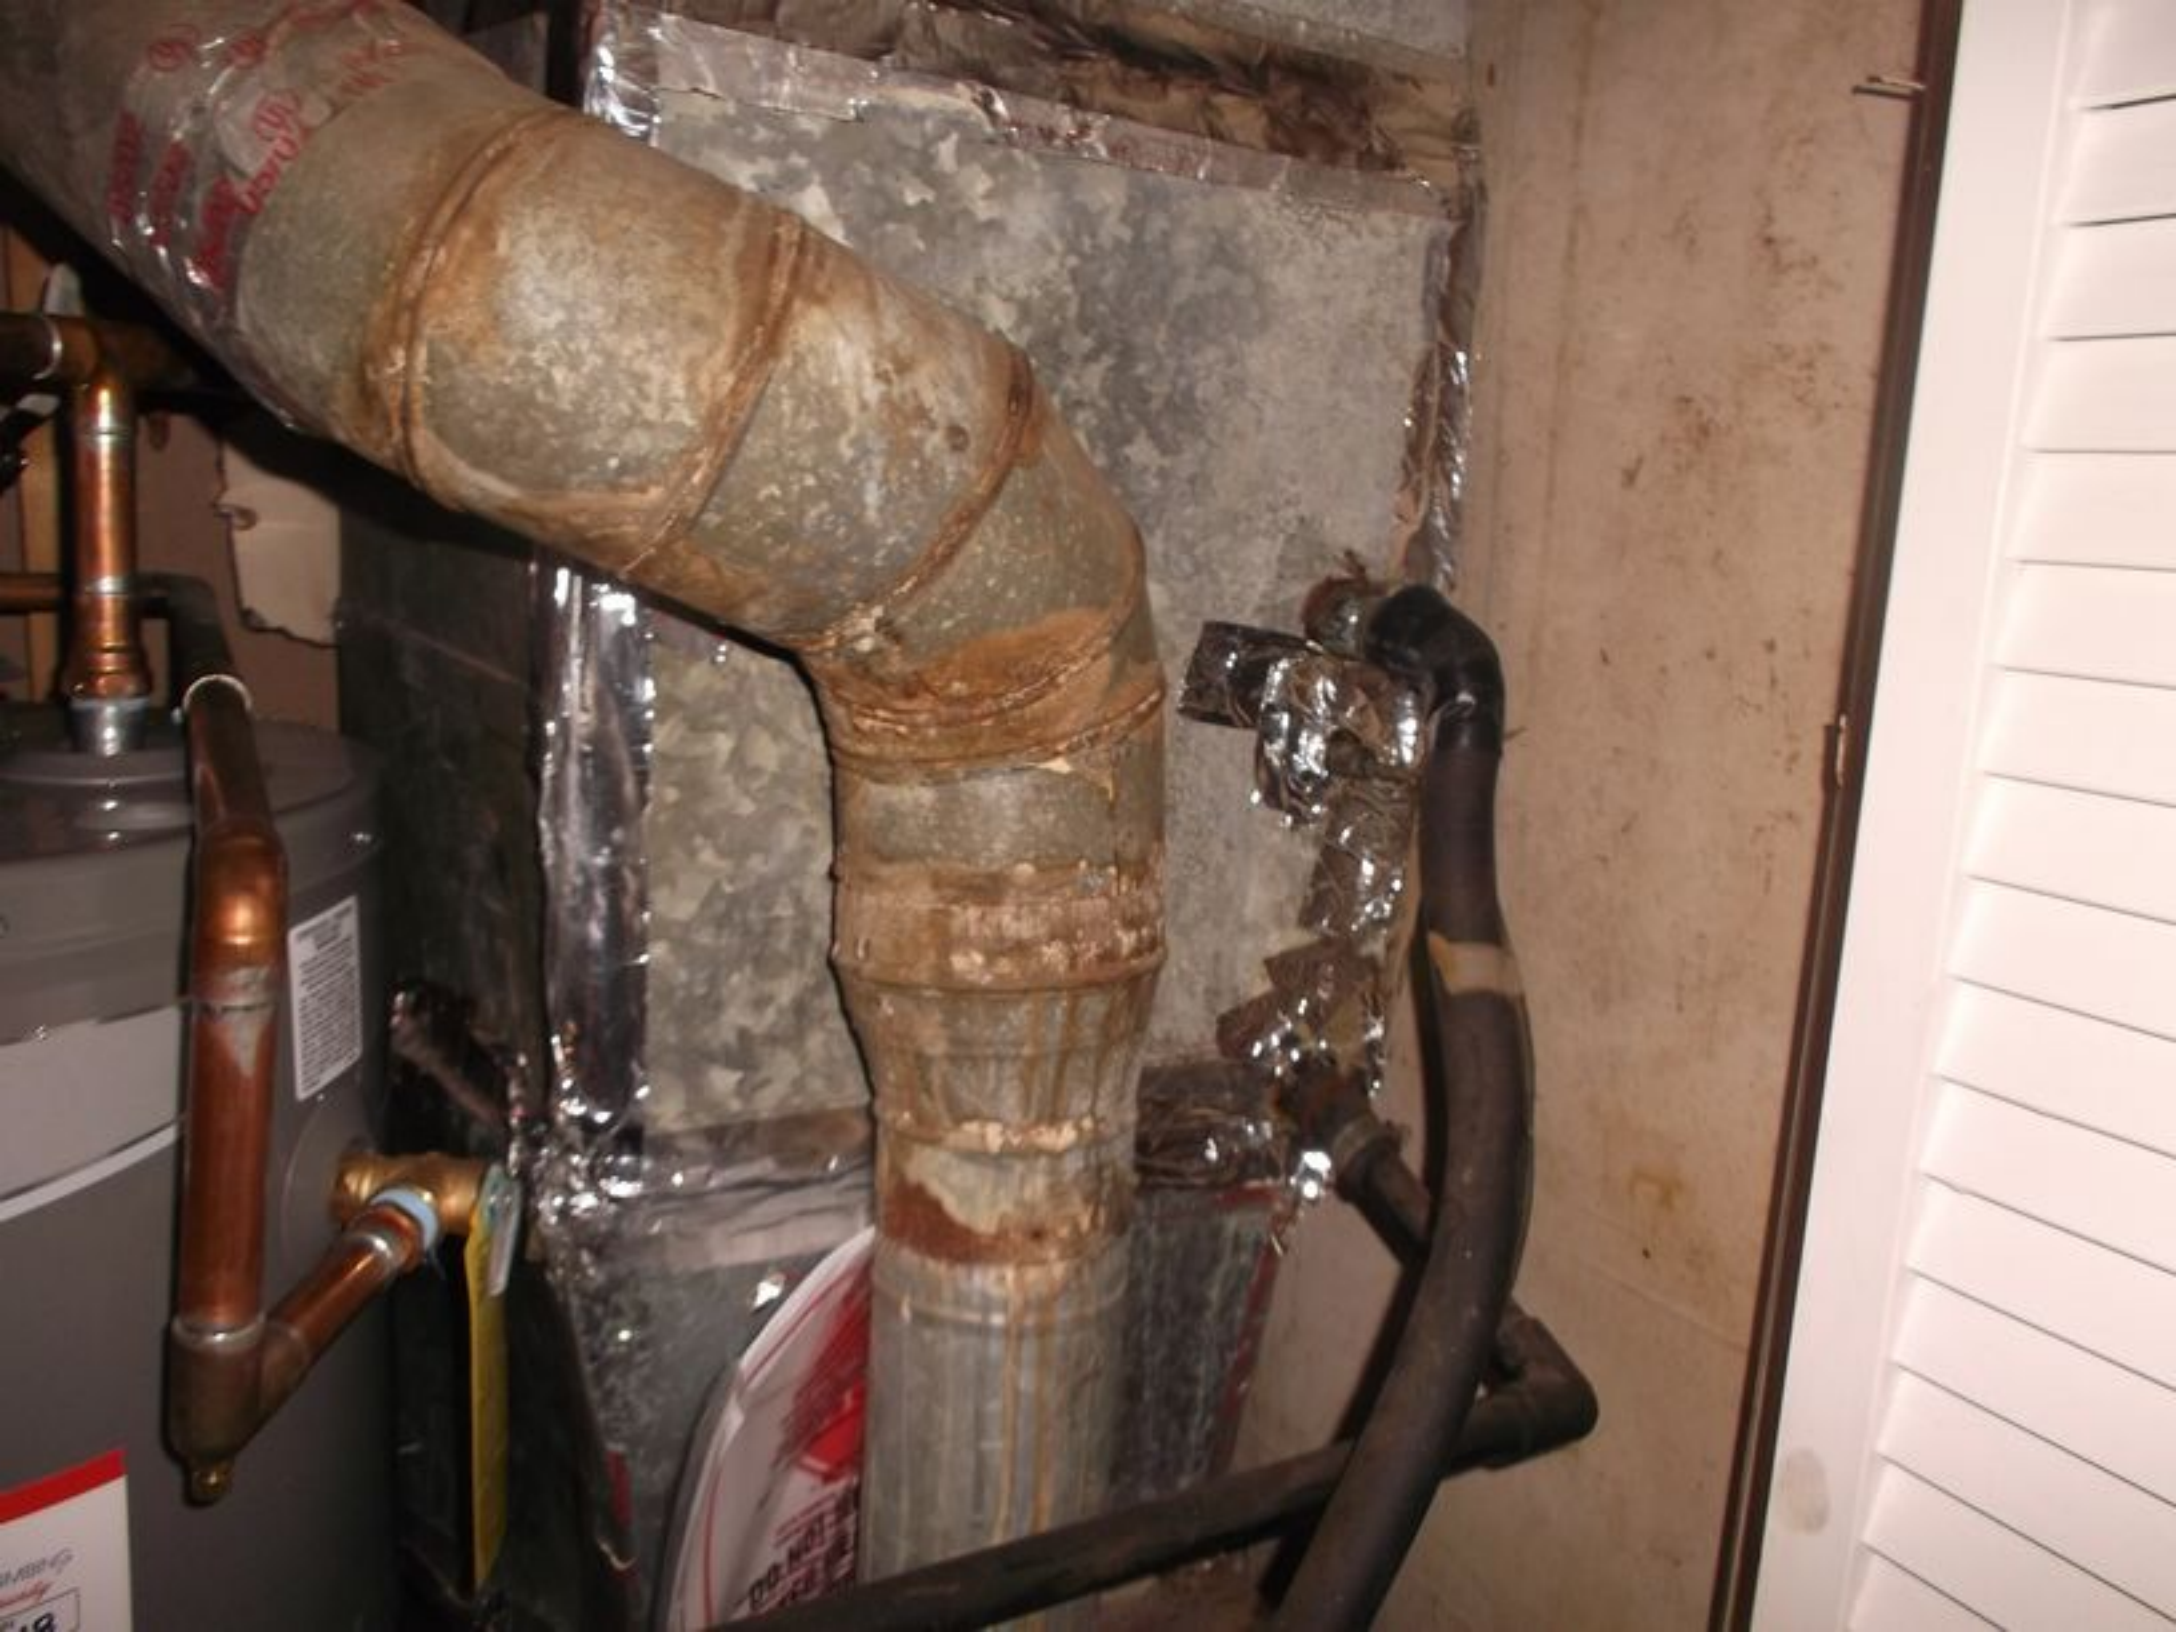
DAMAGED
ASB 24/05

Mold

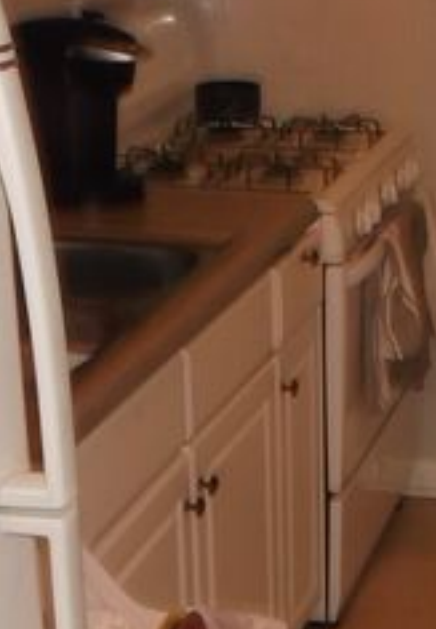
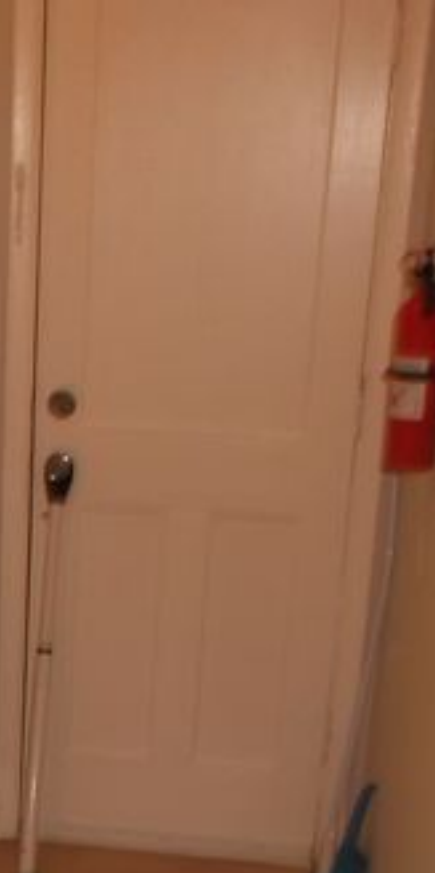
No GFCI

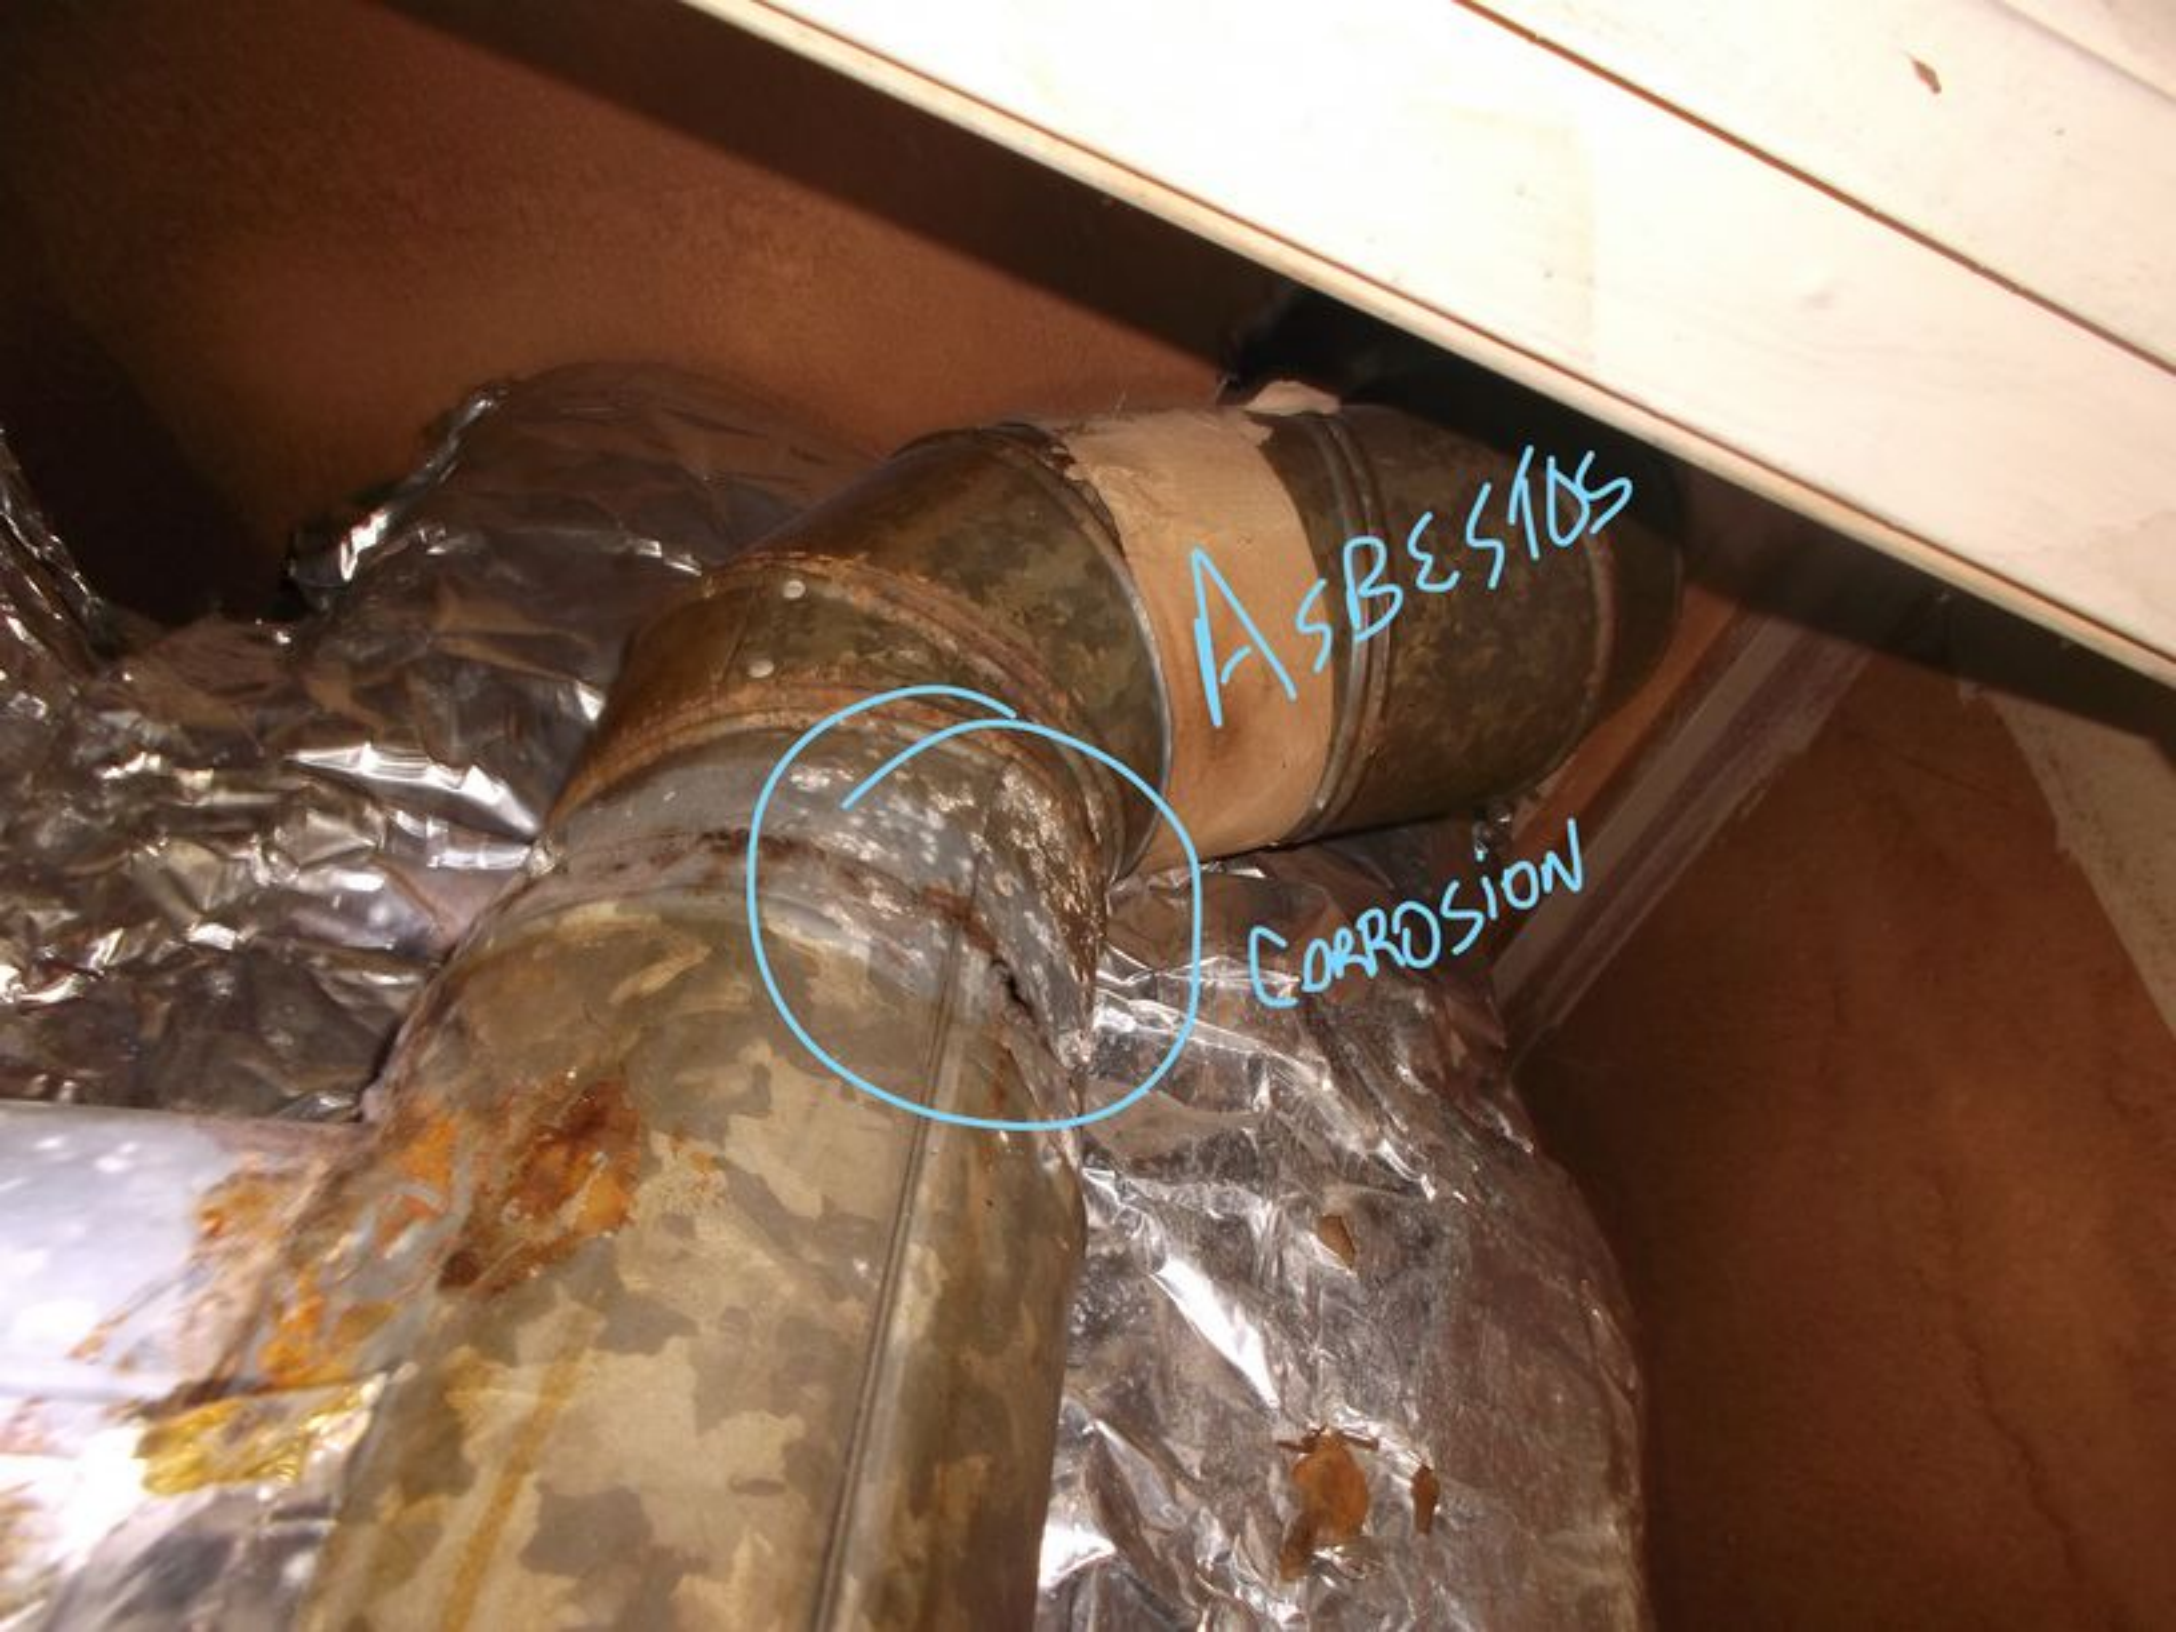
ASBESTOS

CORROSION

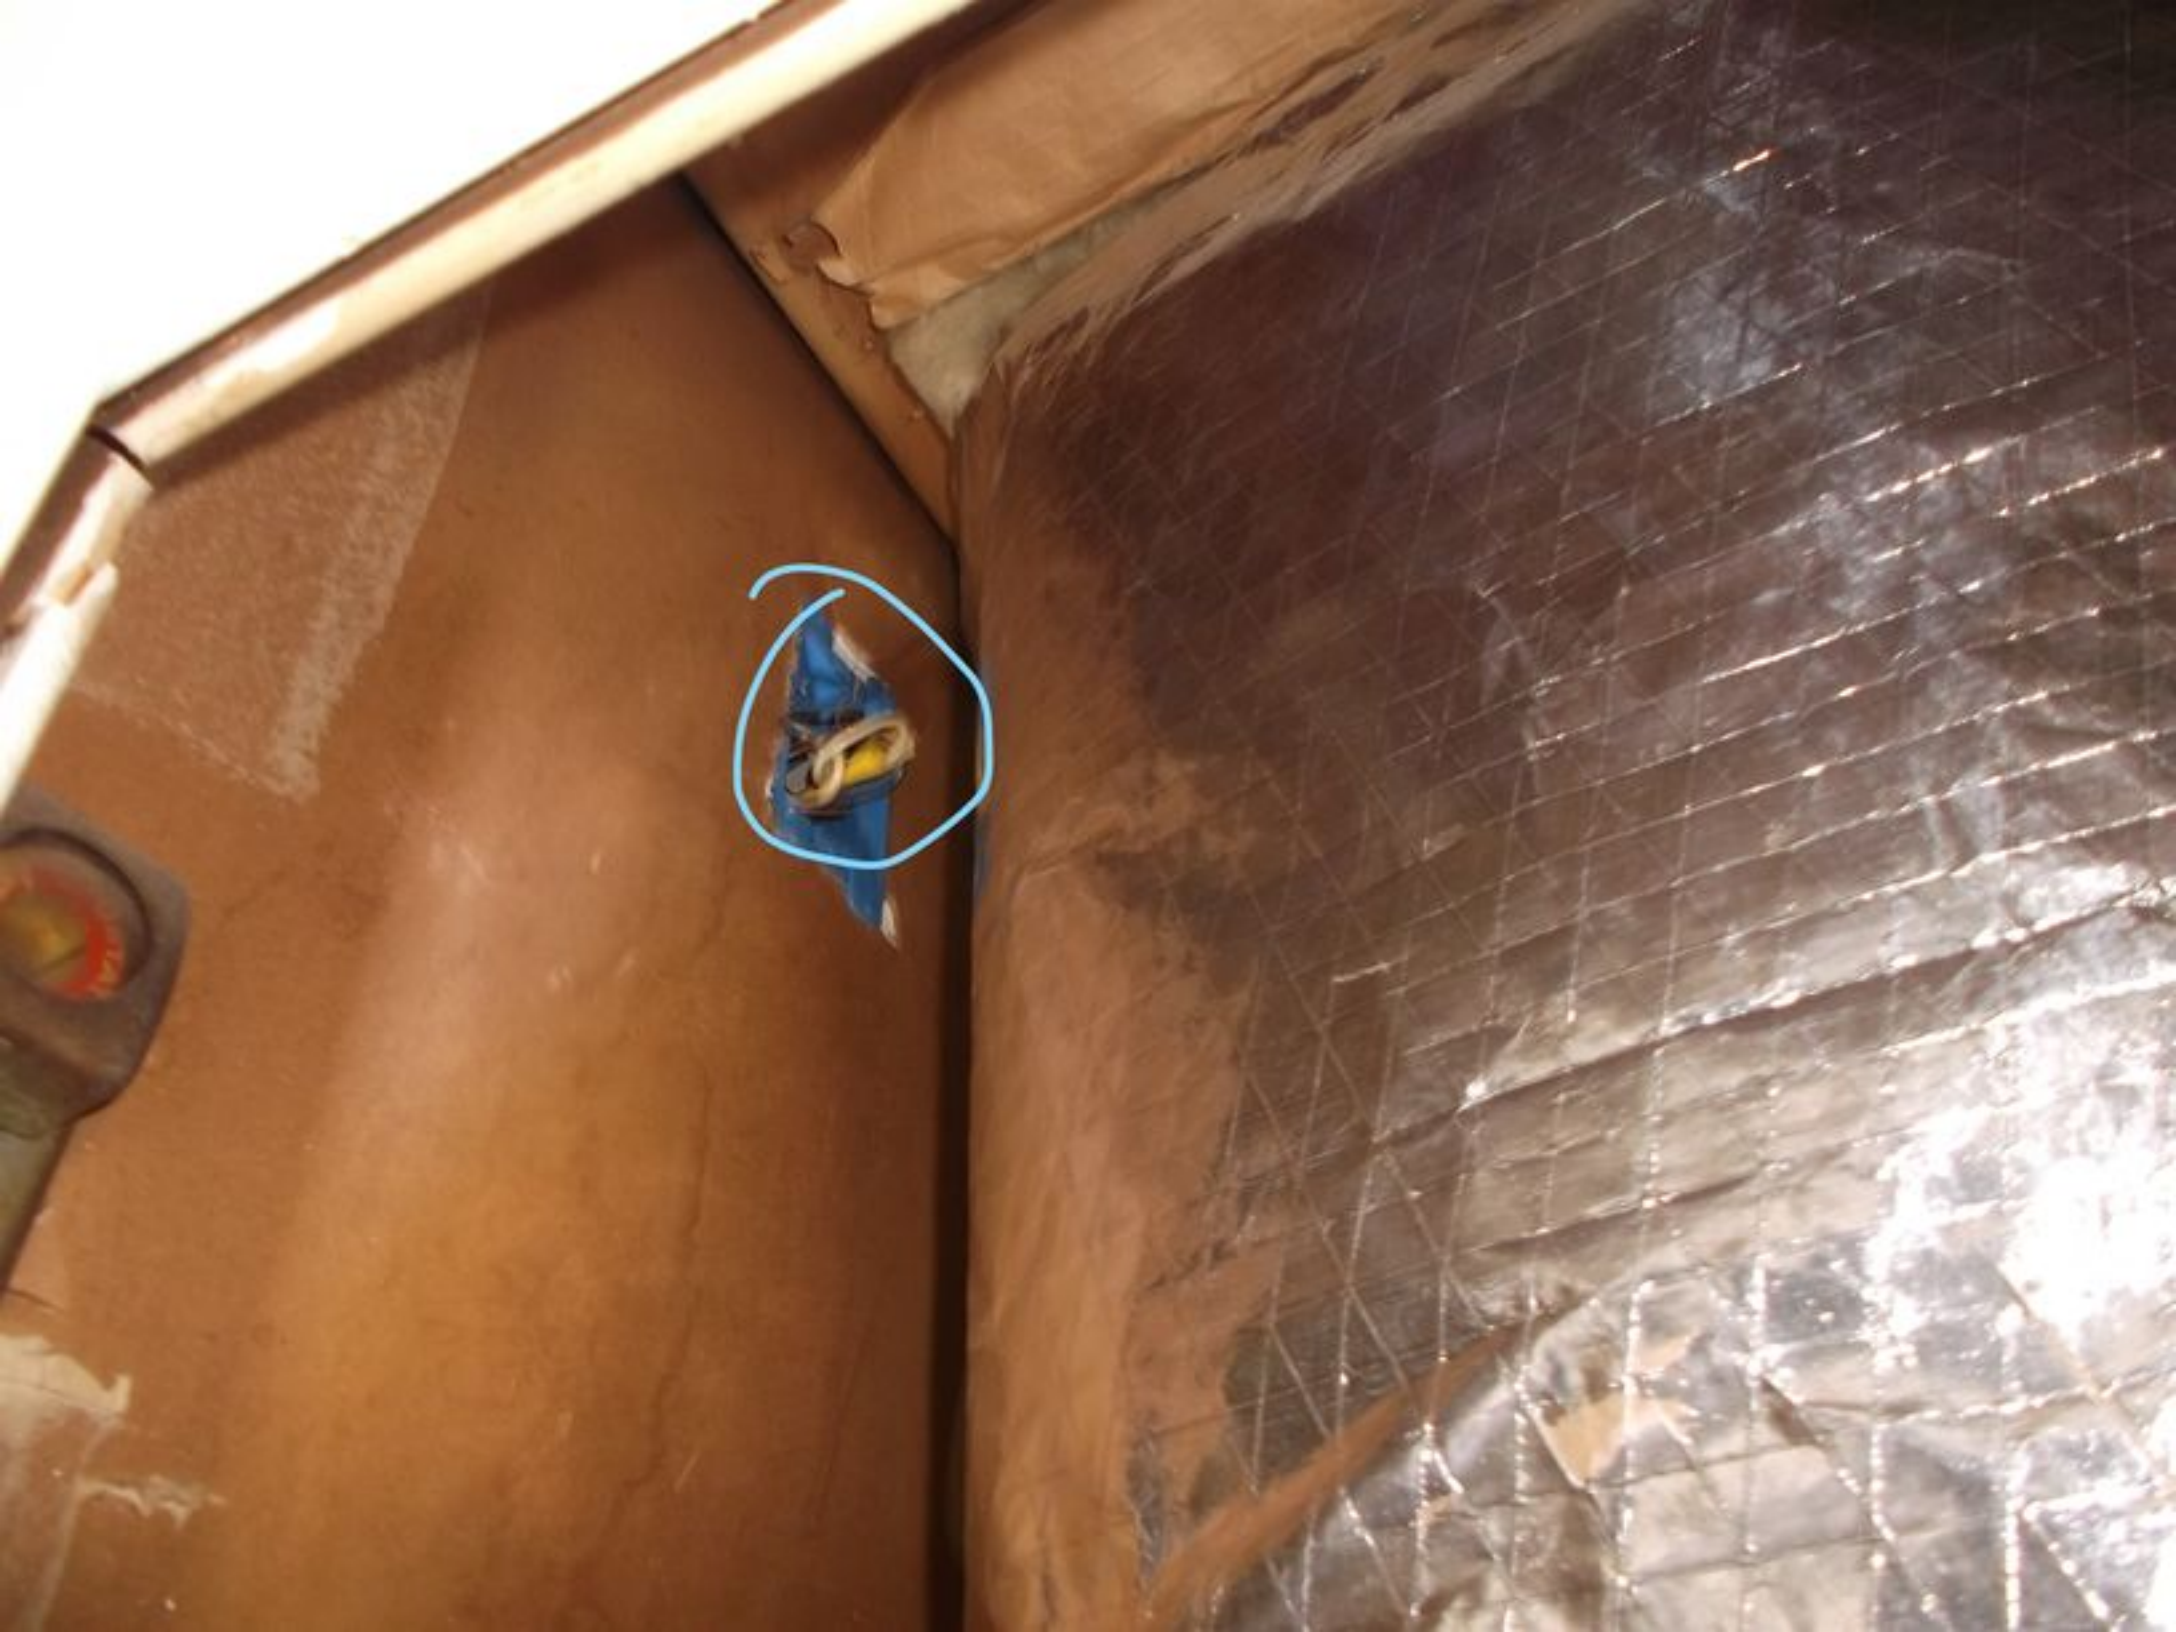
GAP
