# PROPERTY INSPECTION REPORT

203 Saint Nicholas Cir. Sandy Springs, GA. 30327

Mar 10, 2021

1599

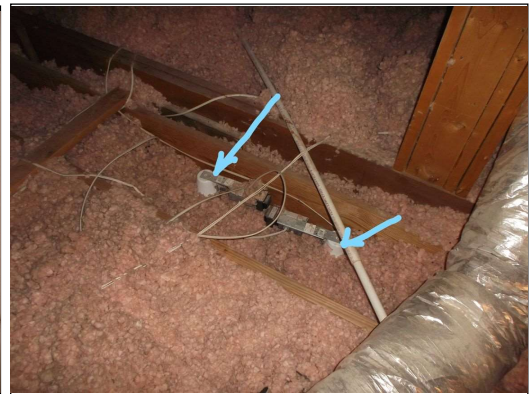
Verify ceiling lights are rated insulate contact

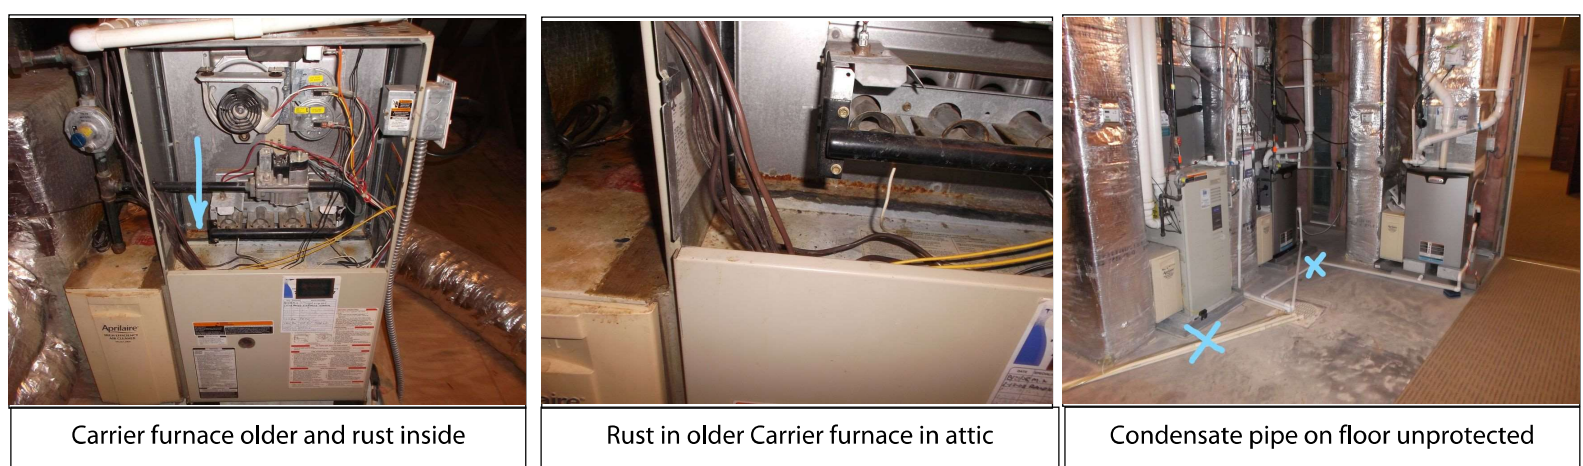
**Maintenance:**  
One furnace is older than all the rest and may be nearing end of use (rust inside Carrier furnace in attic); one Lennox furnace has rust inside; there is rust in the drain pan and on the air duct in the attic at the left furnace;

It is advised to have a certified HVAC tech check furnaces with rust in the controls area fr any defects or maintenance conditions;

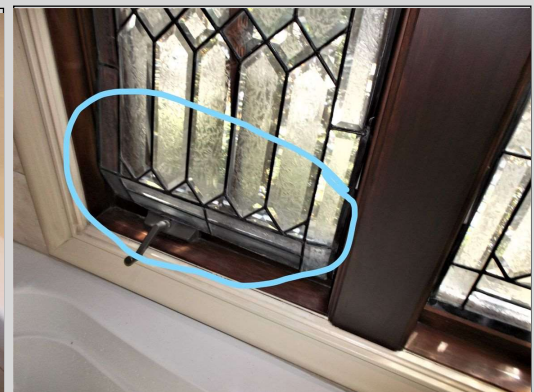
Leaded glass detached @ frt. bed bath window

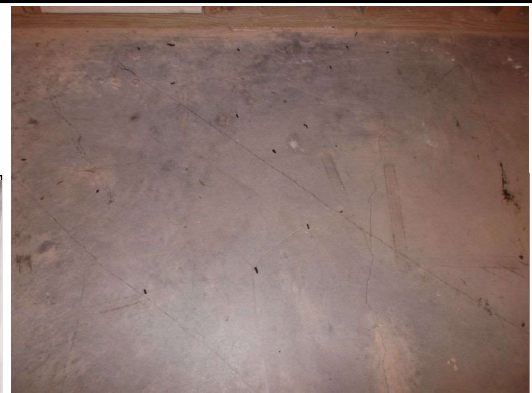
Mold and water intrusion to the sub floor seen from in the crawlspace (appears to be under kitchen or laundry area). There are dry water stains and damp foundation wall areas at the courtyard and rear side of the crawlspace (verify cause of any water intrusion and correct to prevent a damp basement and crawlspace); rat droppings on basement utility room floor;

Damp foundation wall and water stains

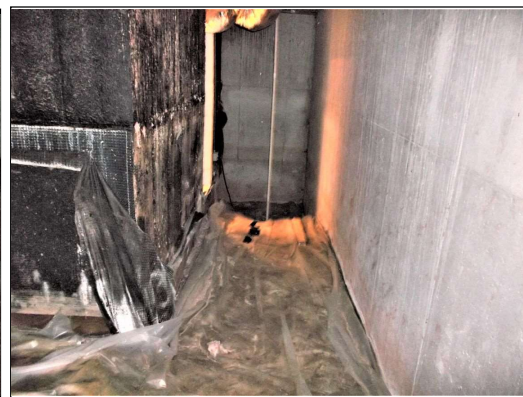
damp soil under plastic
