INSPECTION REPORT

RIDGEFIELD, CT 06877

Inspection Date: Saturday, November 18, 2023

RE: Report No. 1183, v.0
Ridgefield, CT 06877

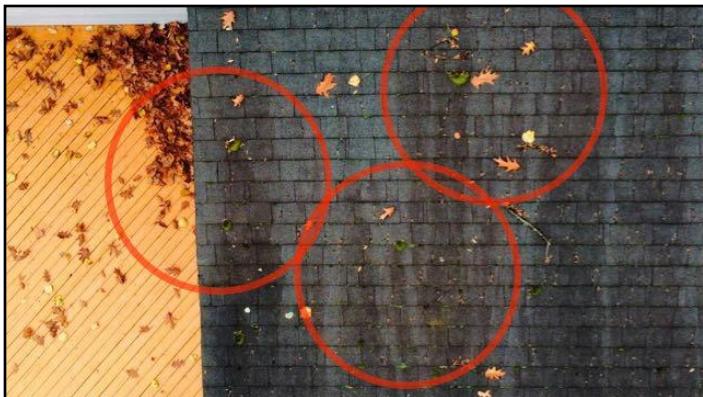
1. There were moss and lichens starting to gro...

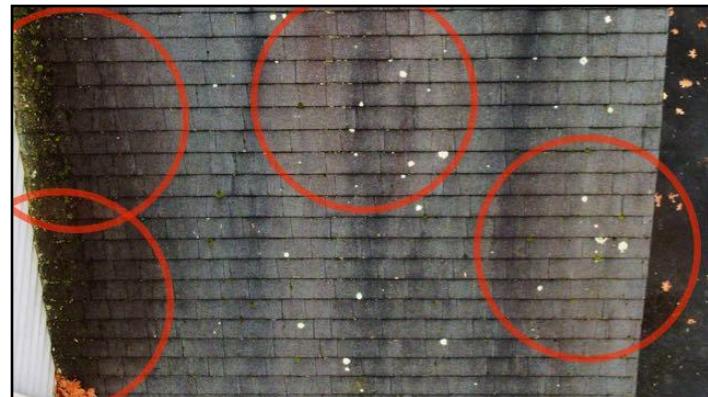
2. There were moss and lichens starting to gro...

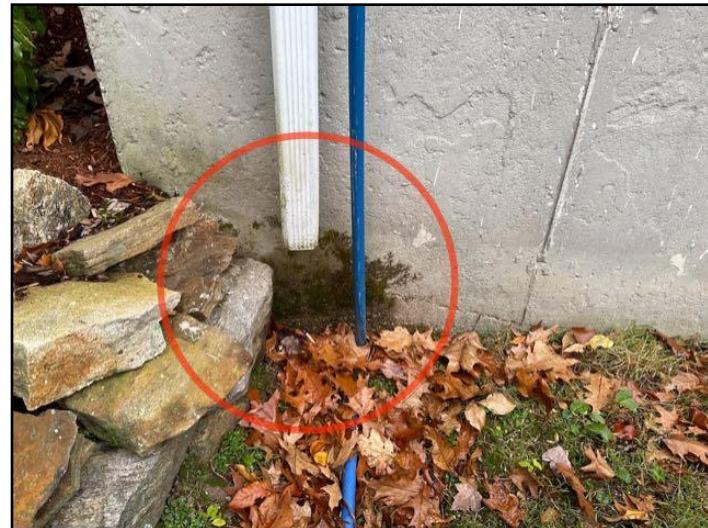
6. Discharge too close to building

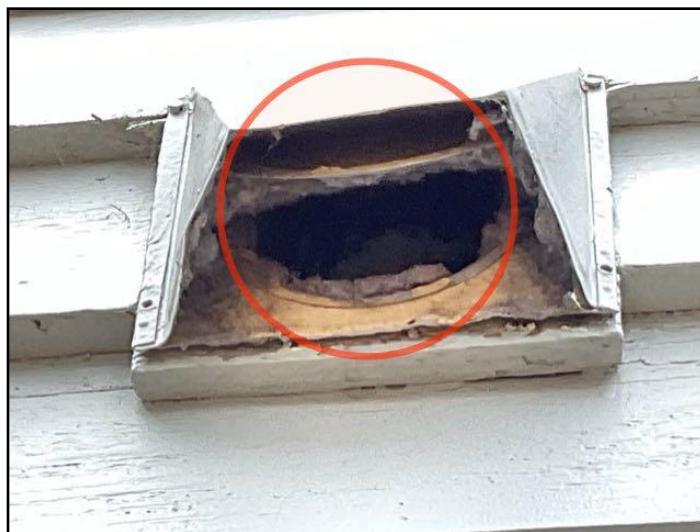
17. Cover does not close properly

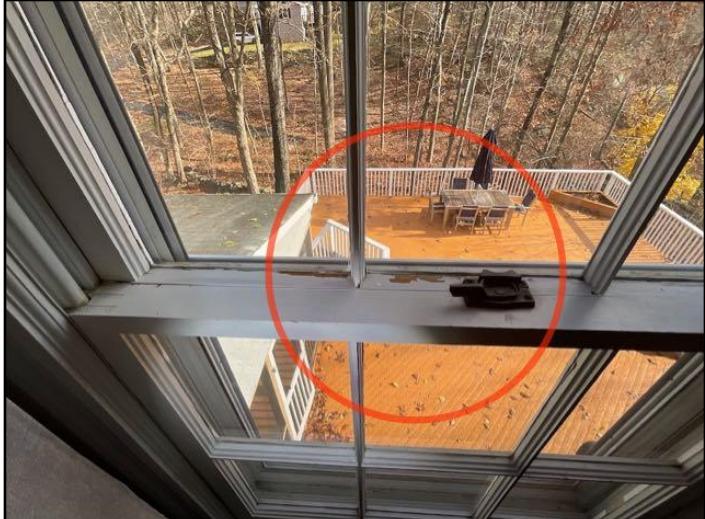
18. Putty missing, cracked or deteriorated

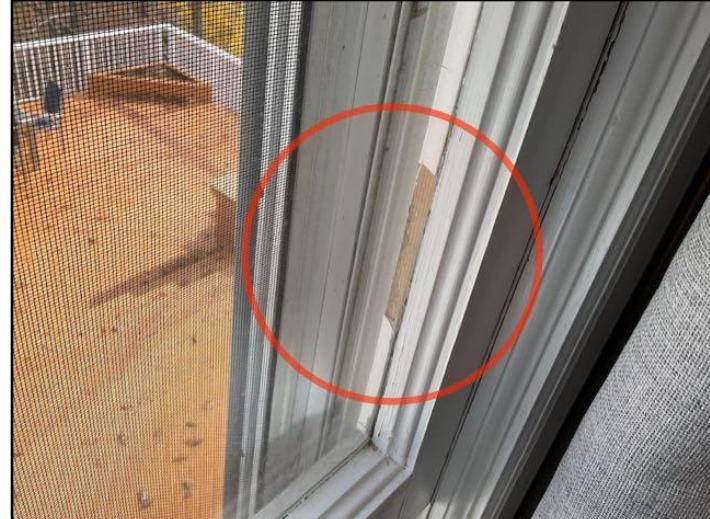
19. Putty missing, cracked or deteriorated

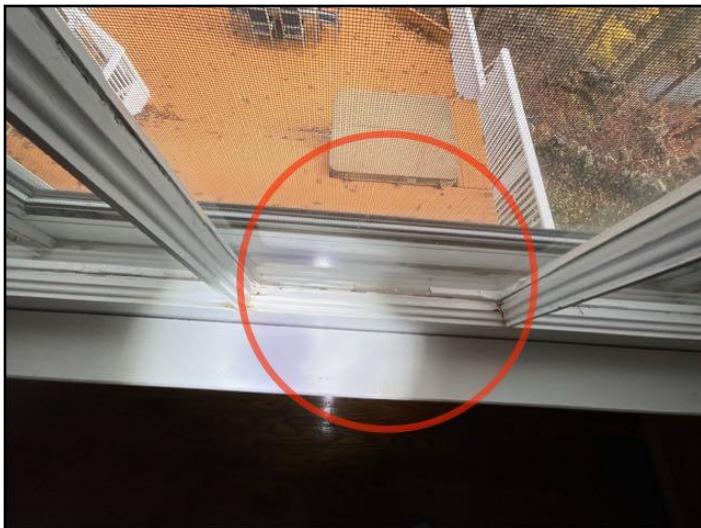
20. Putty missing, cracked or deteriorated

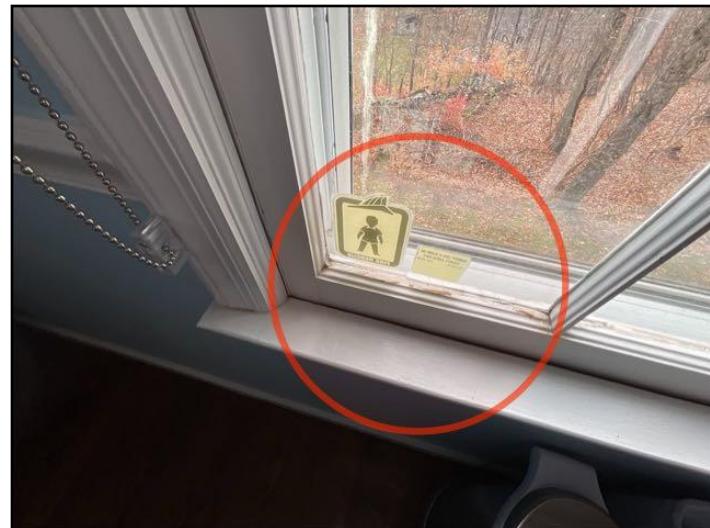
21. Putty missing, cracked or deteriorated

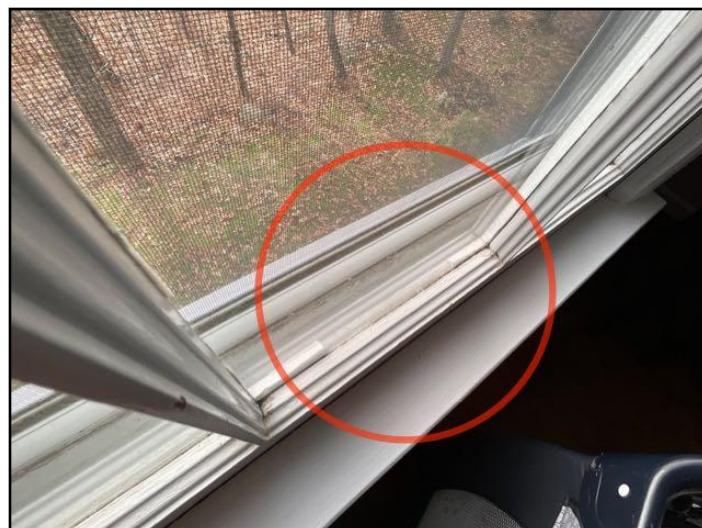
22. Putty missing, cracked or deteriorated

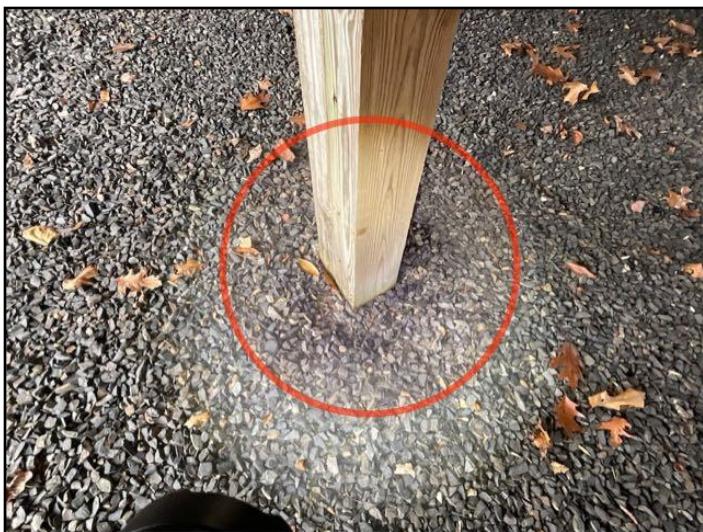
29. Wood/soil contact

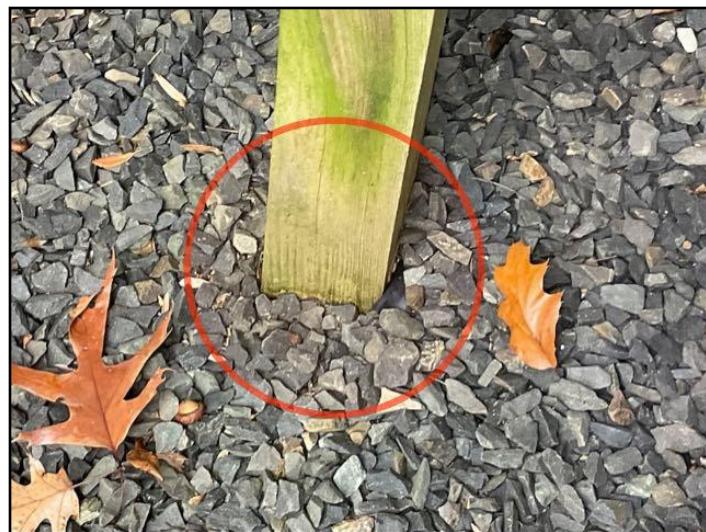
30. Wood/soil contact

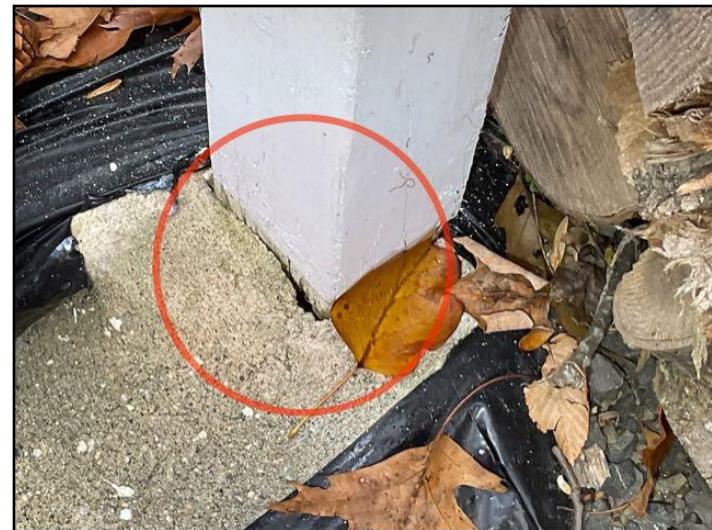
32.

11. Condition: • The deck support posts that were set in concrete had a gap between the concrete and the wood which could allow for water intrusion and subsequent rot. Recommend caulking the gaps to prevent water intrusion. This can be done by a qualified handyman.

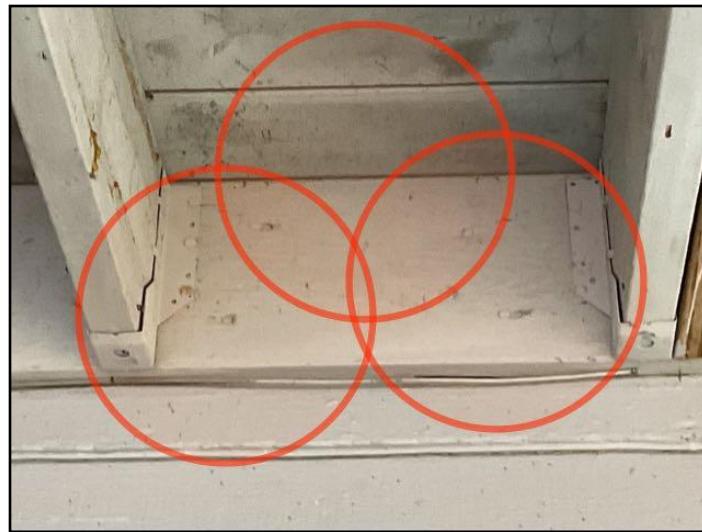
33. Ledgerboard problems

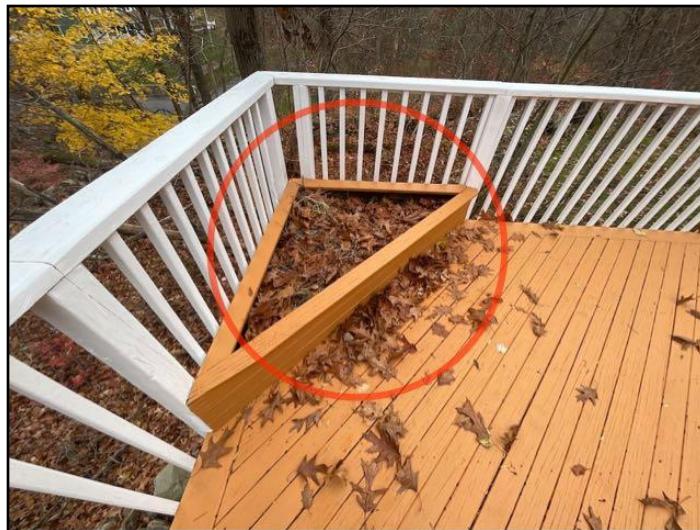
35. Rot

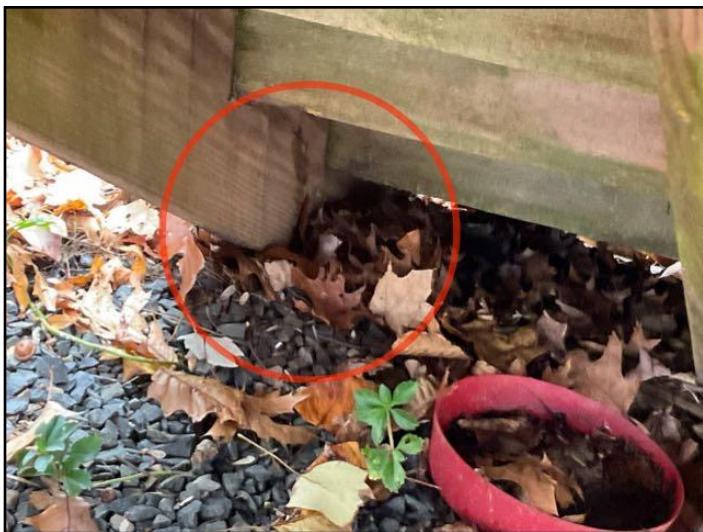
36. Wood/soil contact

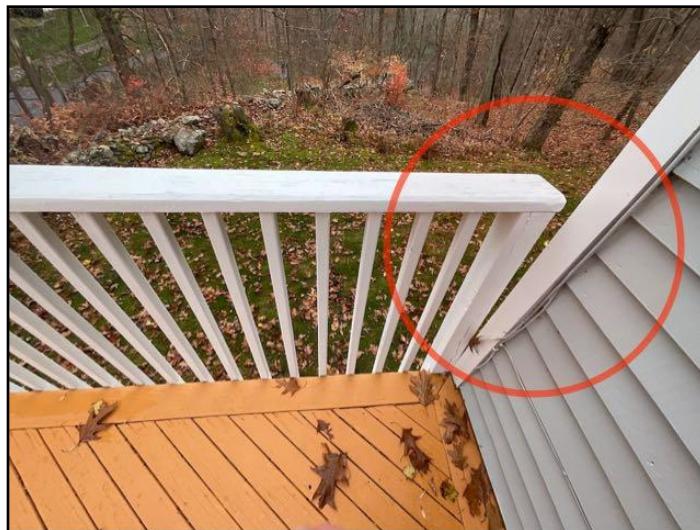
The handrail at the south side of the deck was not attached to the house and appeared weak. This is a potential safety hazard. Recommend evaluation and repair by a qualified contractor.

38. Weak

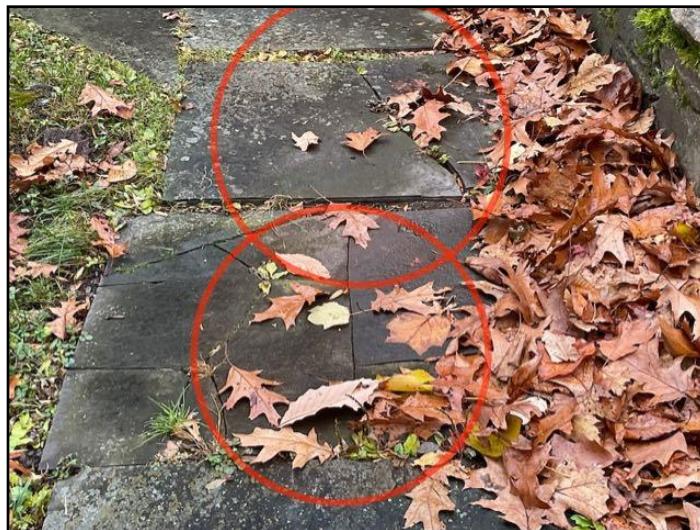
17. Condition: • The flagstones at the walkway have become damaged or displaced over time and need to be reset as they are now a potential trip hazard. Recommend evaluation and repair by a qualified mason.

39. The flagstones at the walkway have become...

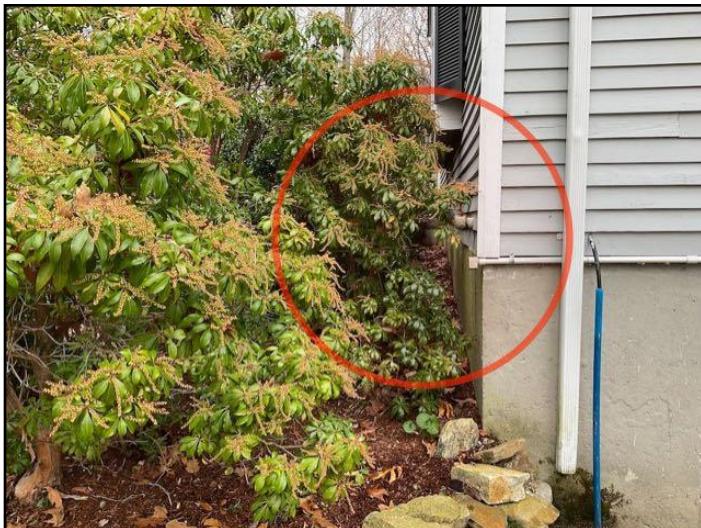
21. Condition: • Trees and plantings should be trimmed away from the siding. Having plants too close to the siding doesn't allow the siding to dry out and this could cause water damage to the siding or unsightly algae and other growth. In addition, plantings too close to the house can provide a convenient approach for insects and other wildlife. Recommend evaluation and remediation by qualified landscape contractor.

43. Trees and plantings should be trimmed away...

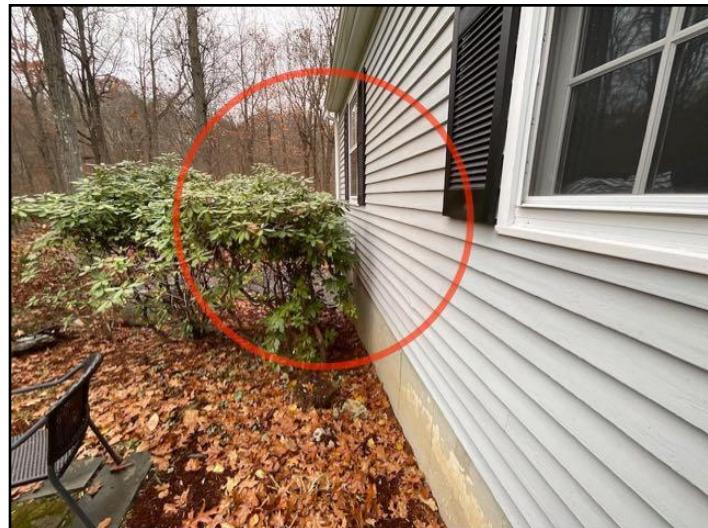
44. Trees and plantings should be trimmed away...

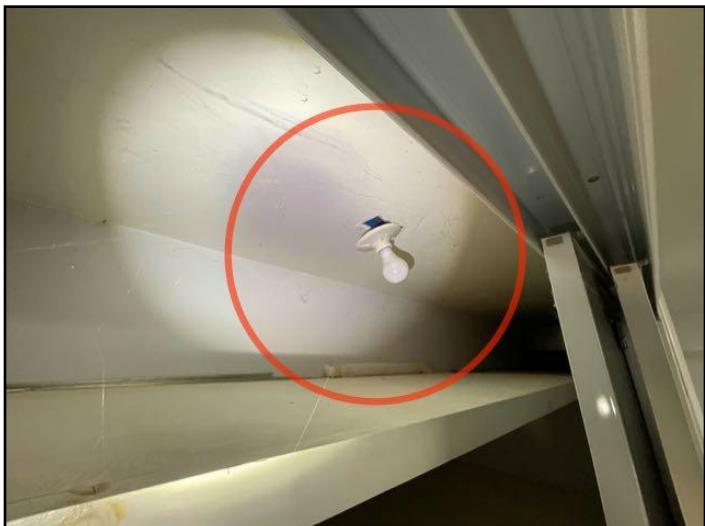
59.

36. Condition: • The lights in the basement exercise room closet were not working. One bulb was missing, and the other fixture was damaged. Recommend evaluation and repair by a licensed electrician.

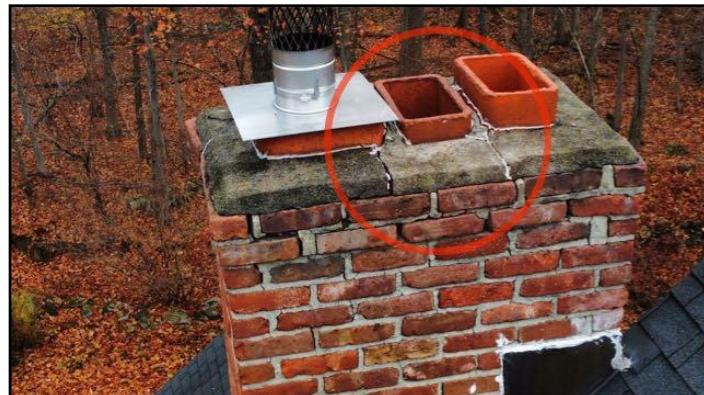
Condition: • Cracked - The crown at the top of the masonry chimney had cracks in it. This can result in water intrusion to the bricks, which freezes and thaws, eventually breaking the bricks. Recommend evaluation and repair by a qualified chimney mason.

This can result in a significant deferred expense to repair.

61. Cracked - The crown at the top of the...

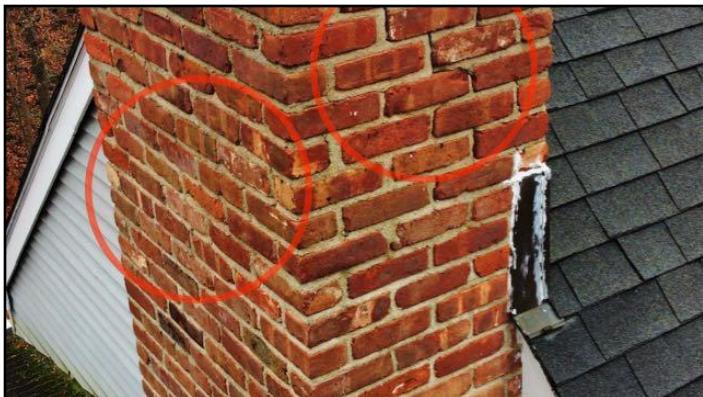
The bricks at the top of the chimney were spalling and becoming loose. Recommend evaluation and repair by a qualified mason. This can result in a significant deferred expense to repair.

62. Spalling/Loose Bricks

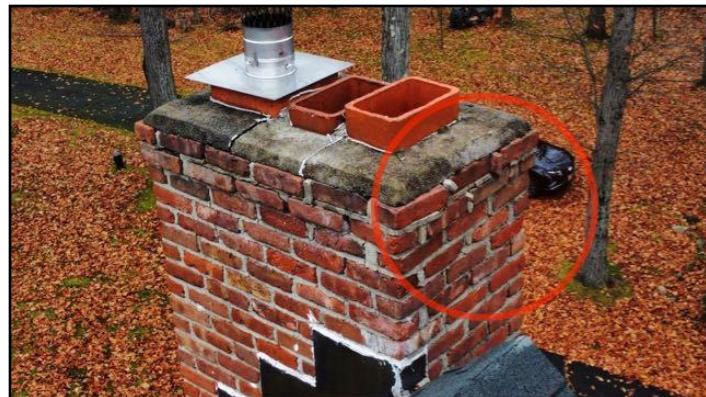
63. Spalling/Loose Bricks

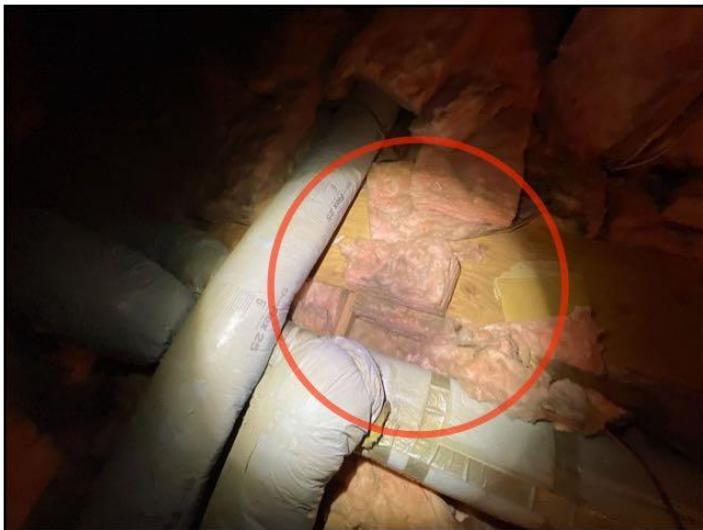
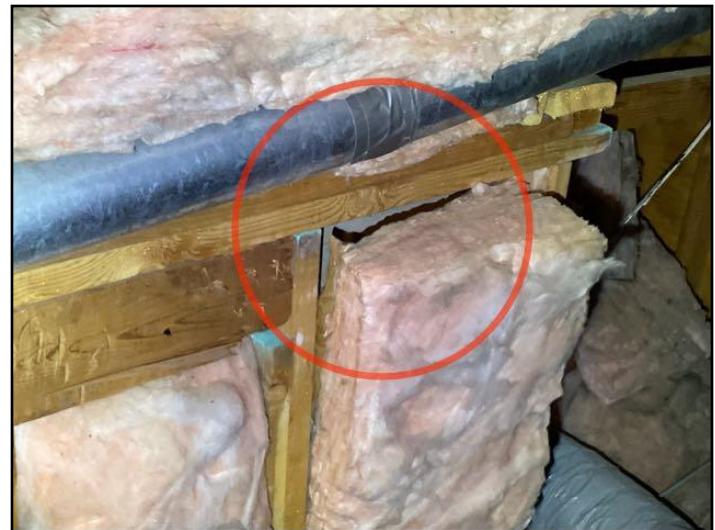
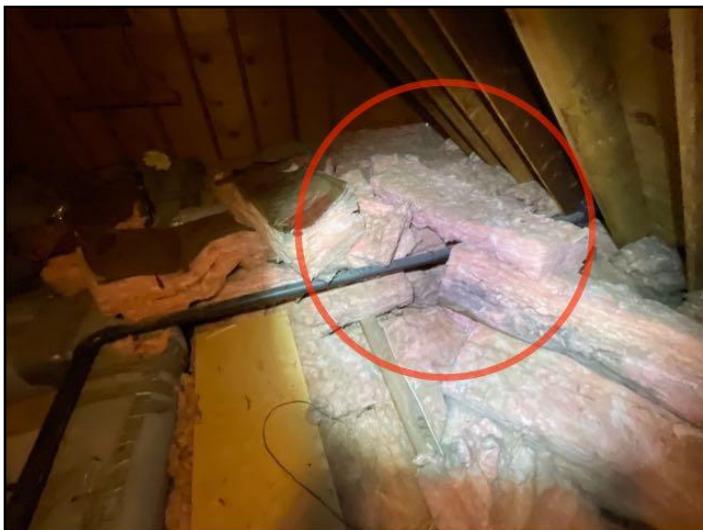
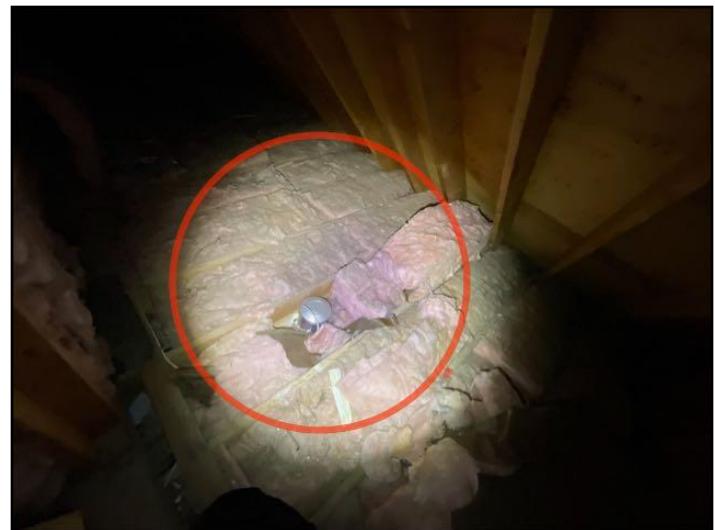
53. Condition: • There were various areas where the insulation was disrupted. This can lead to loss of heating in the winter and cooling during the summer. Recommend evaluation and repair by a qualified insulation specialist

70. There were various areas where the...

71. There were various areas where the...

72. There were various areas where the...

73. There were various areas where the...

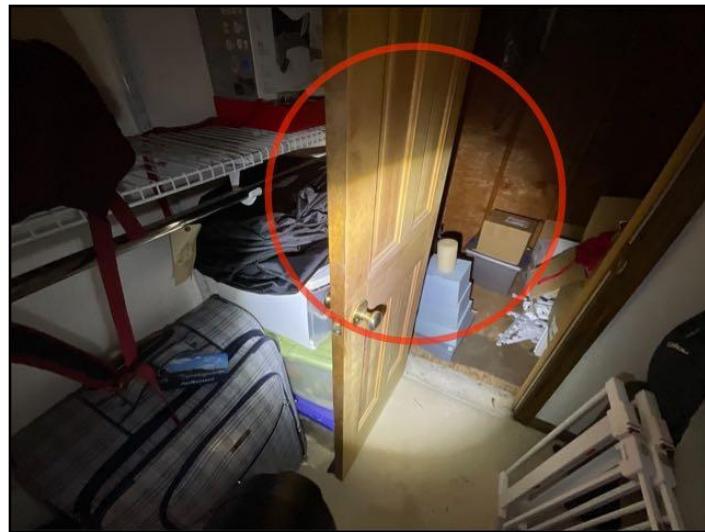
54. Condition: • The knee wall door was not insulated. Recommend insulation on the back of the door to help prevent heat and cooling loss. This can be done by an insulation specialist or handyman.

74. The knee wall door was not insulated....

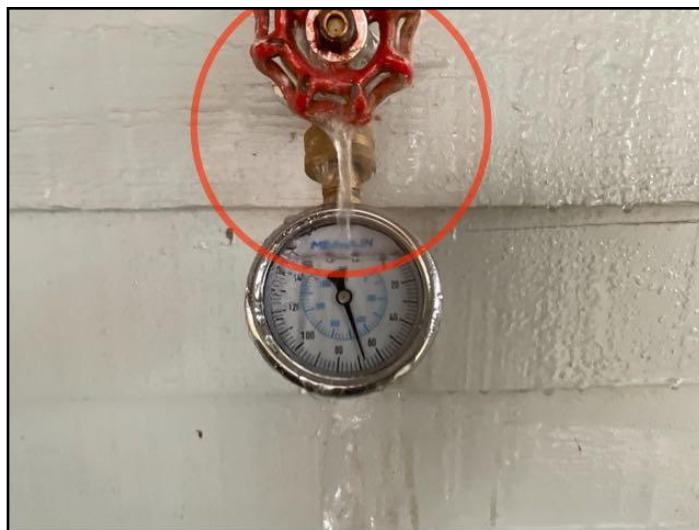
57. Condition: • [Leak or drip](#)

The hose bib at the east side leaked when the valve was opened. Recommend evaluation and repair by a licensed plumber.

Implication(s): Chance of water damage to structure, finishes and contents

77. *Leak or drip*

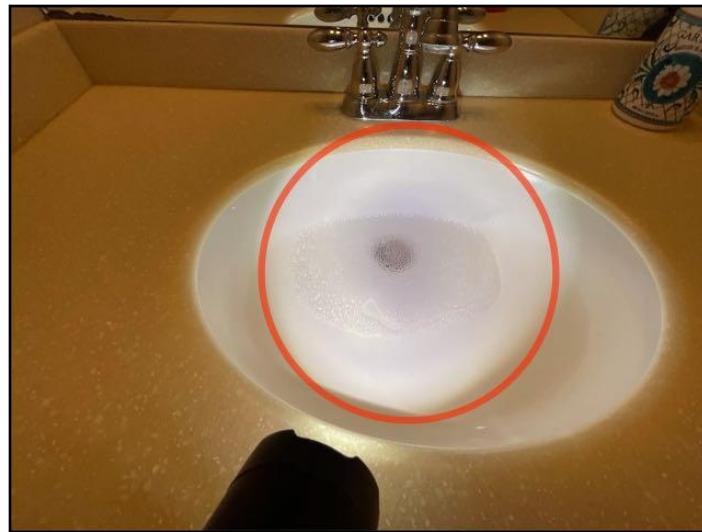
58. Condition: • Slow drain. Recommend snaking the drain or using a drain cleaner. This can be done by a qualified handyman.

Implication(s): Chance of water damage to structure, finishes and contents

78. Slow drain. Recommend snaking the drain or...

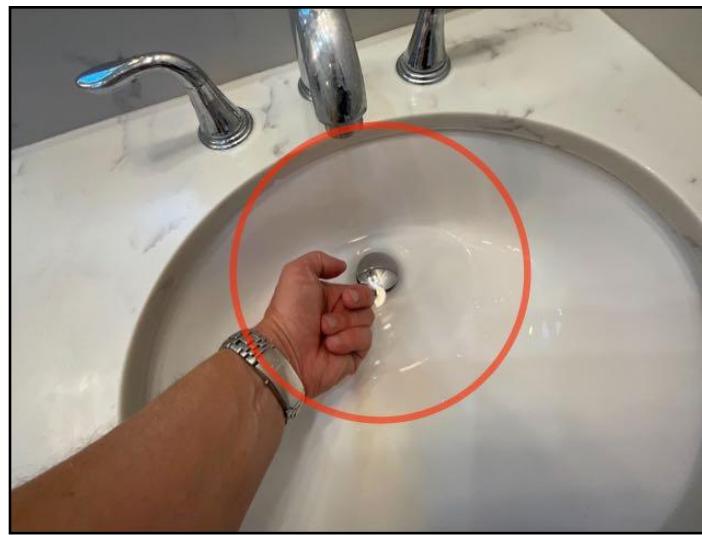
59. Condition: • Drain stop ineffective

The drain stop to the right hand sink in the master bathroom did not work properly and had to be lifted for the sink to drain. Recommend evaluation and repair by a qualified handyman or plumbing contractor.

Implication(s): Nuisance | Reduced operability

79. Drain stop ineffective

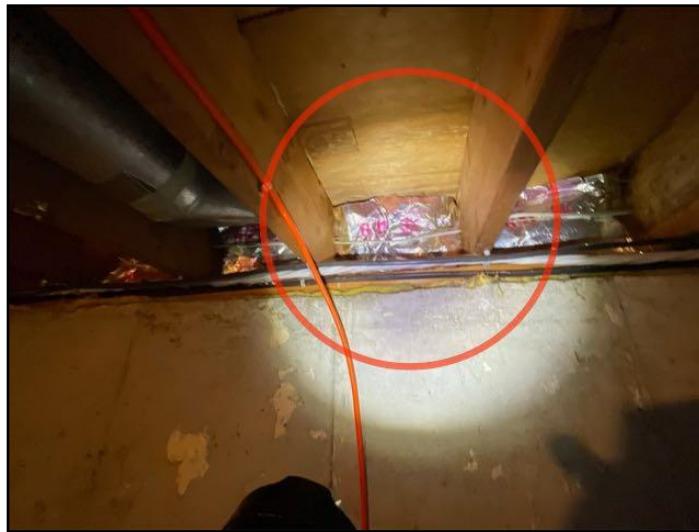
- Storage/furnishings. Recommend that the owner inspect again at final walkthrough prior to closing
- Storage in closets and cabinets / cupboards. Recommend that the owner inspect again at final walkthrough prior to closing
- Views of the basement sill were blocked by fiberglass insulation.

85. Views of the basement sill were blocked by...

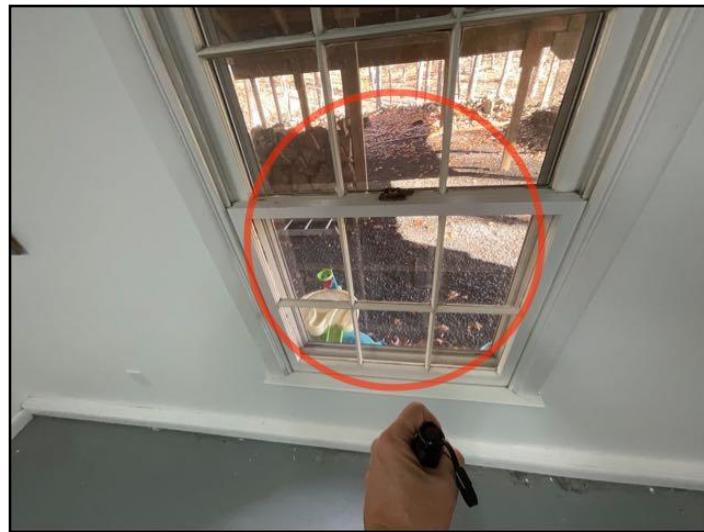
66. Condition: • Painted shut

The window at the exercise room appeared to be painted shut. Recommend evaluation and repair by a qualified painting contractor or handyman.

Implication(s): Equipment inoperative | Nuisance

86. Painted shut

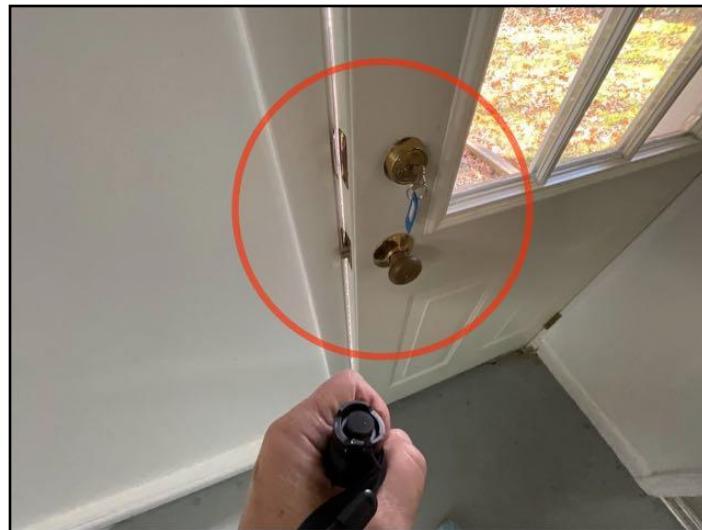
68. Condition: • Door lock was controlled by a key turn mechanism from the inside and not a thumb turn mechanism.

This can be a potential safety hazard if the key can't be found in an emergency and the locked door is needed for egress. Recommend replacing the key turn with a thumb turn by a qualified locksmith.

In addition, the door did not latch properly. This should be addressed by the locksmith or handyman as well.

88. Door lock was controlled by a key turn...

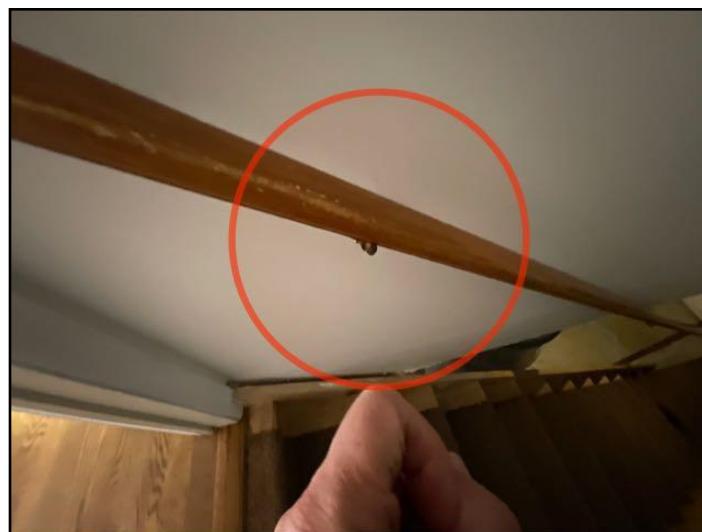
69. Condition: • Loose

Note that the handrail to the basement stairs was loose. Recommend evaluation and repair by a qualified handyman.

Implication(s): Fall hazard

89. Loose

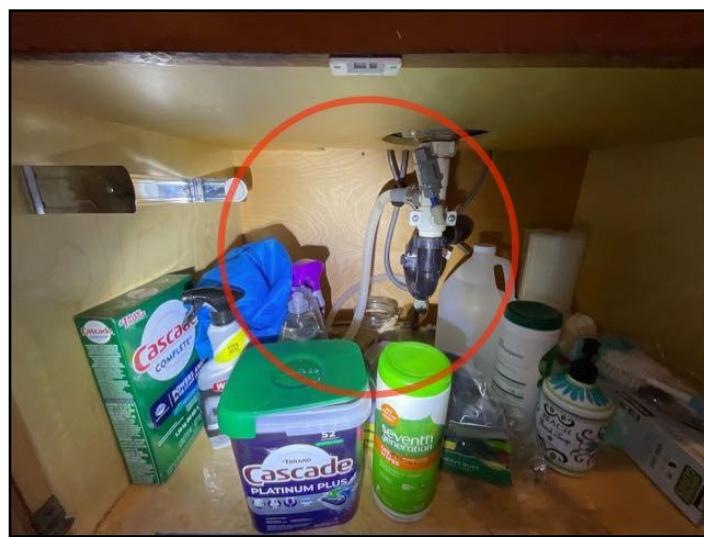
Implication(s): Back-flow of water into the dishwasher, possibly contaminating dishes

94. Backflow prevention high loop missing

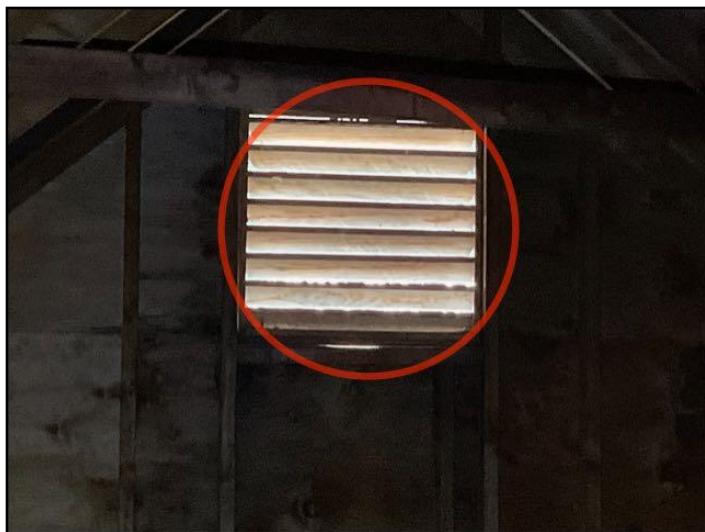
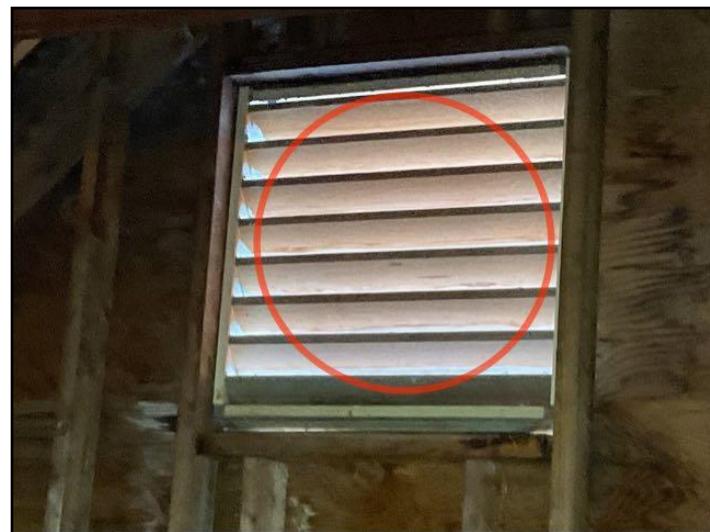
• There didn't appear to be any screening inside of the gable vents at the attic. (I couldn't get close enough to see due to lack of a covered pathway). This can lead to unwanted pest intrusion. Recommend evaluation and repair if necessary by a qualified handyman.
